CRASH TESTING OF VARIOUS TEXTURED BARRIERS

DEPARTMENT OF TRANSPORTATION
ENGINEERING SERVICES
MATERIALS ENGINEERING AND TESTING SERVICES

September 2002

1. REPORT NO. FHWA/CA/TL-2002/03	2. GOVERNMENT ACCESSION NO.	3. RECIPIENT'S CATALOG NO.	
4. TITLE AND SUBTITLE CRASH TESTING OF VARIOUS TEXTURED BARRIERS		5. REPORT DATE September, 2002

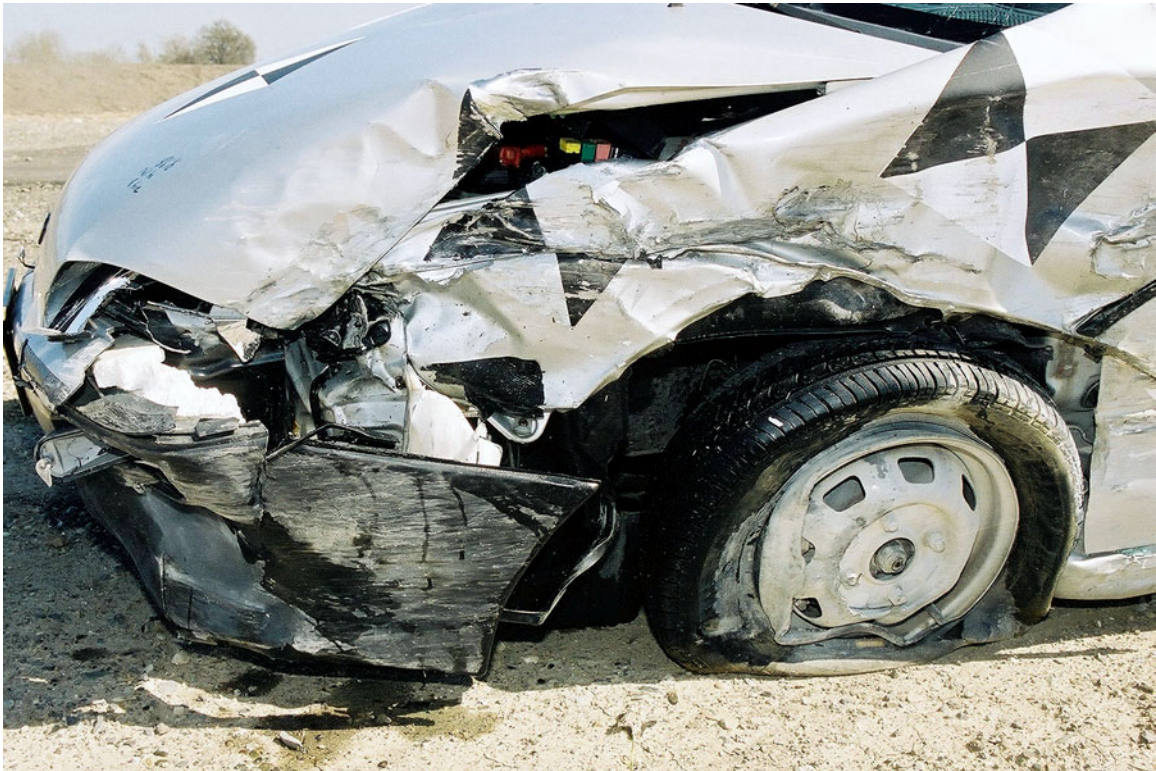
Figure 2-6. Left front corner of test vehicle after Test 581

The left front quarter section of the vehicle was moderately damaged in the initial impact with the barrier. The left front fender, hood, bumper, headlamp area, grille, and suspension components were all affected. The driver side doorframe was deformed outward but the door remained latched. The left front tire was also ruptured. Some minor damage along the left side of the vehicle and to the left rear quarter occurred as the vehicle continued to contact the barrier after the initial impact. The maximum deformation of the driver side floorboard was 105 mm, mostly in the vicinity of the wheel well. This was within the generally accepted limit of 150 mm.³ Nevertheless, this deformation was of some concern because it occurred in the narrowest part of the driver footwell and was greater than what is usually seen in an 820C test. Moreover, it was the result of the left front wheel being pushed back in the wheel well, indicative of snagging. The decision to run test 3-11 on the cobble texture was based on snagging concerns.

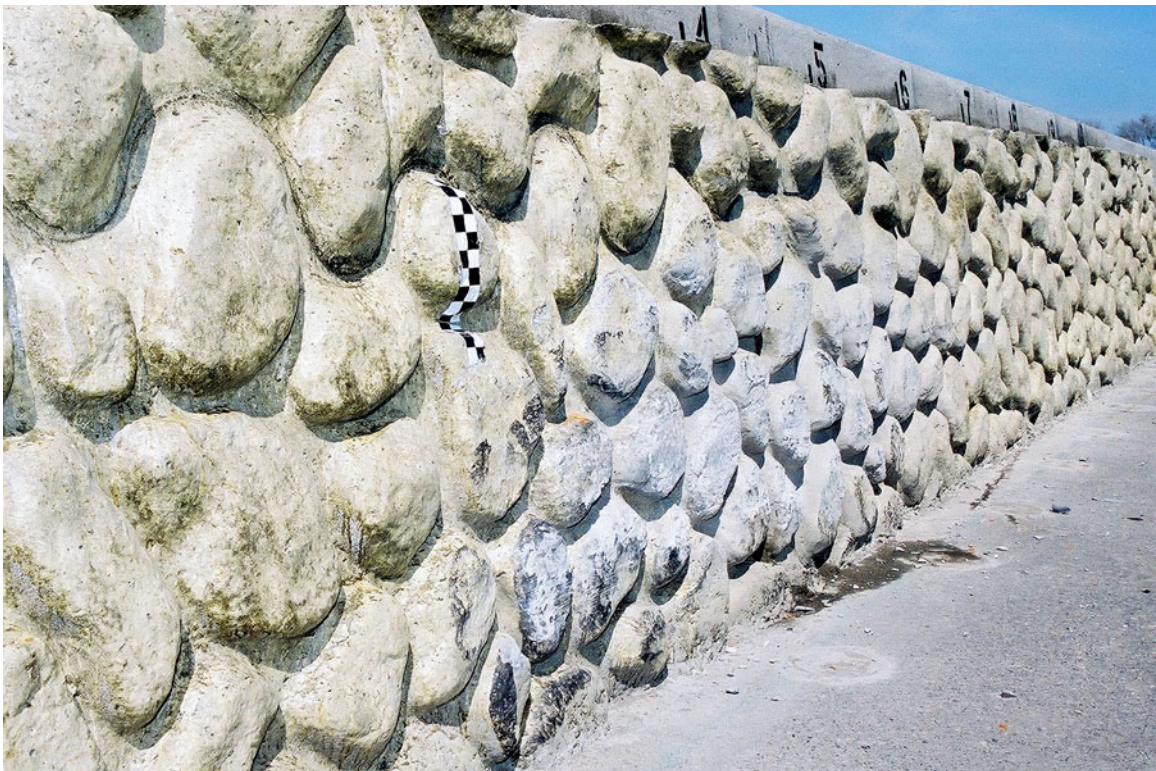
Figure 2-8 Cobble pattern test article after Test 581

Barrier Damage: Minor scrapes, gouges, and chipping on some cobbles. The barrier would not require immediate repair.

The damage to the barrier was cosmetic in nature and would not need immediate repair to remain crashworthy. This damage consisted of minor scrapes and gouges in the concrete surface of the barrier which. The gouges and scrapes could be filled or patched on-site by maintenance crews.

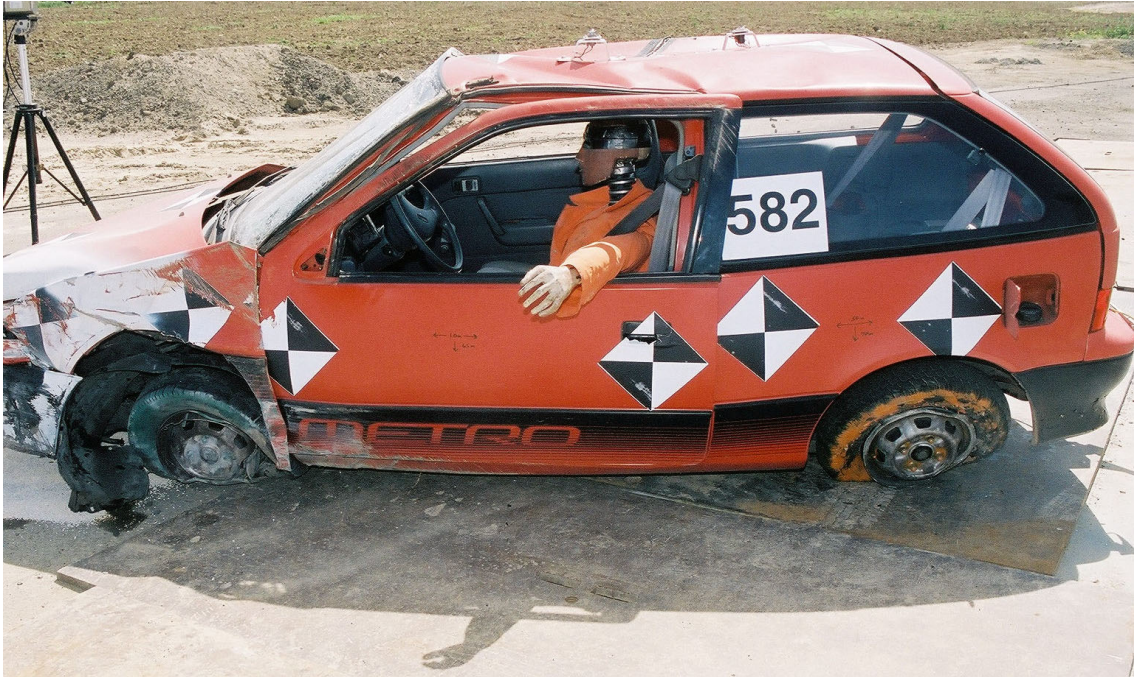
Figure 2-13 Test vehicle after Test 582

The left front corner of the vehicle was moderately damaged in the initial impact with the barrier. The left rear quarter section suffered minor damage during the secondary impact with the barrier. The majority of the damage to the vehicle was sustained during the post-impact rollover. The driver-side door remained latched even though film analysis showed a 160 mm opening along the top of the door. The amount of passenger compartment deformation was minimal and the floorboard deformation was well below the 150-mm informal limit.

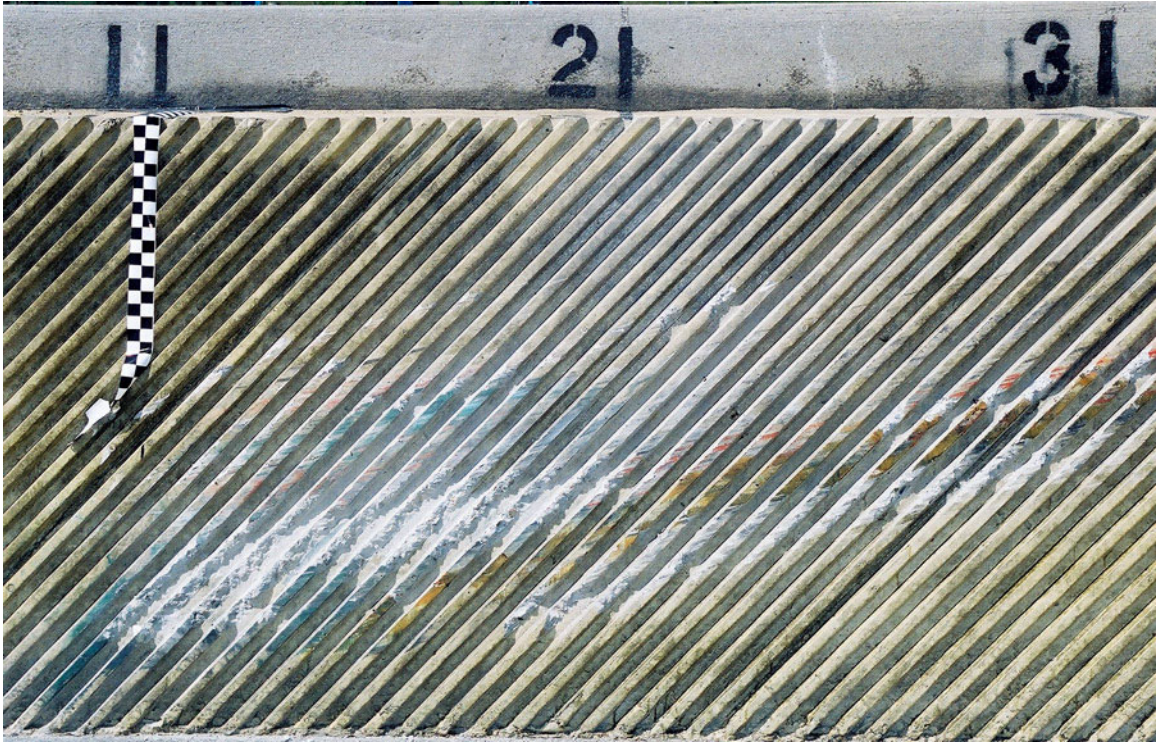
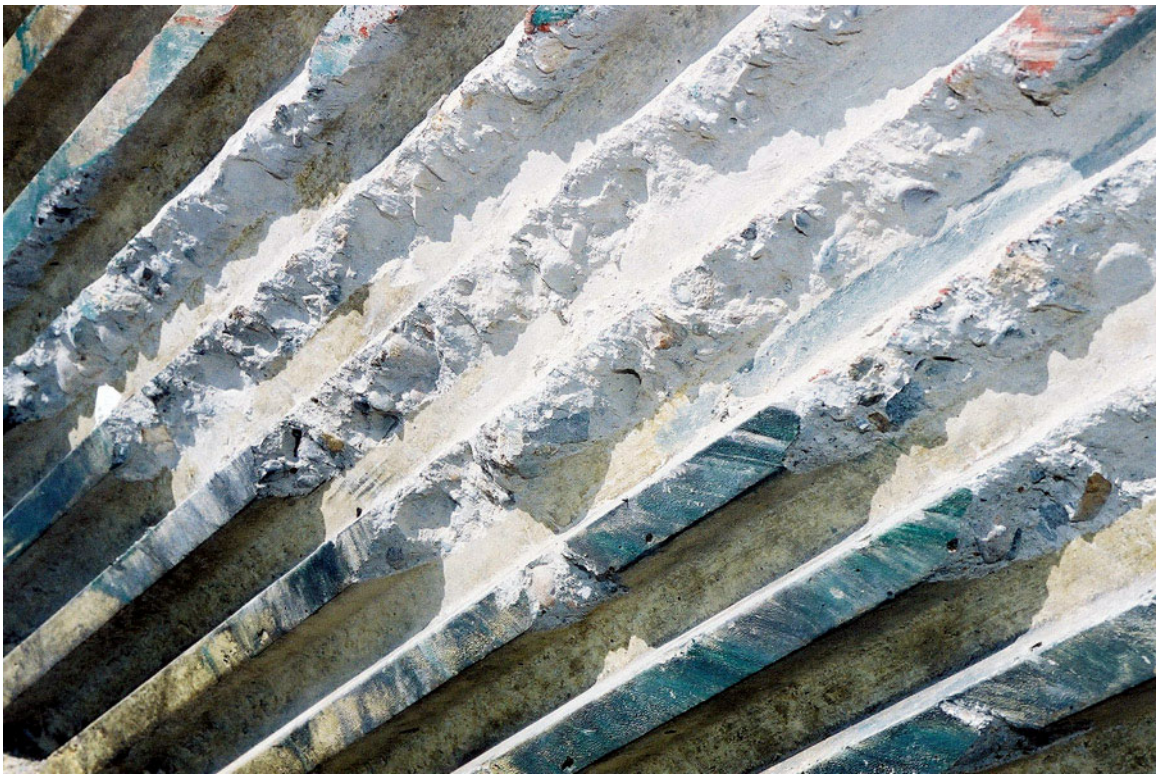
Figure 2-14 Test article after Test 582

Many of the concrete flutes along the path of the wheel assemblies were broken away at their base (i.e. where they meet the solid surface of the barrier). The typical length of each of these broken sections of flute was about 175 mm. The barrier could remain in service and would remain crashworthy until repairs could be implemented. Repair times for this barrier would be lengthy due to the extent of the damage and geometric nature of the pattern.

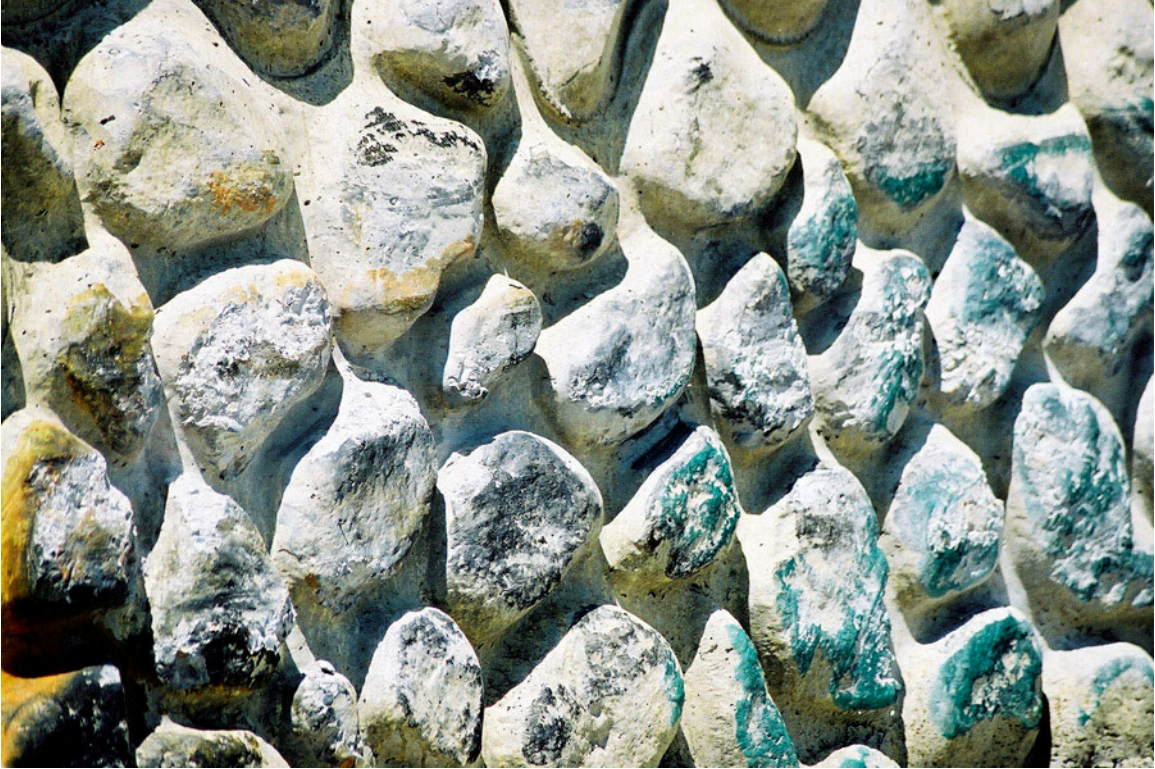
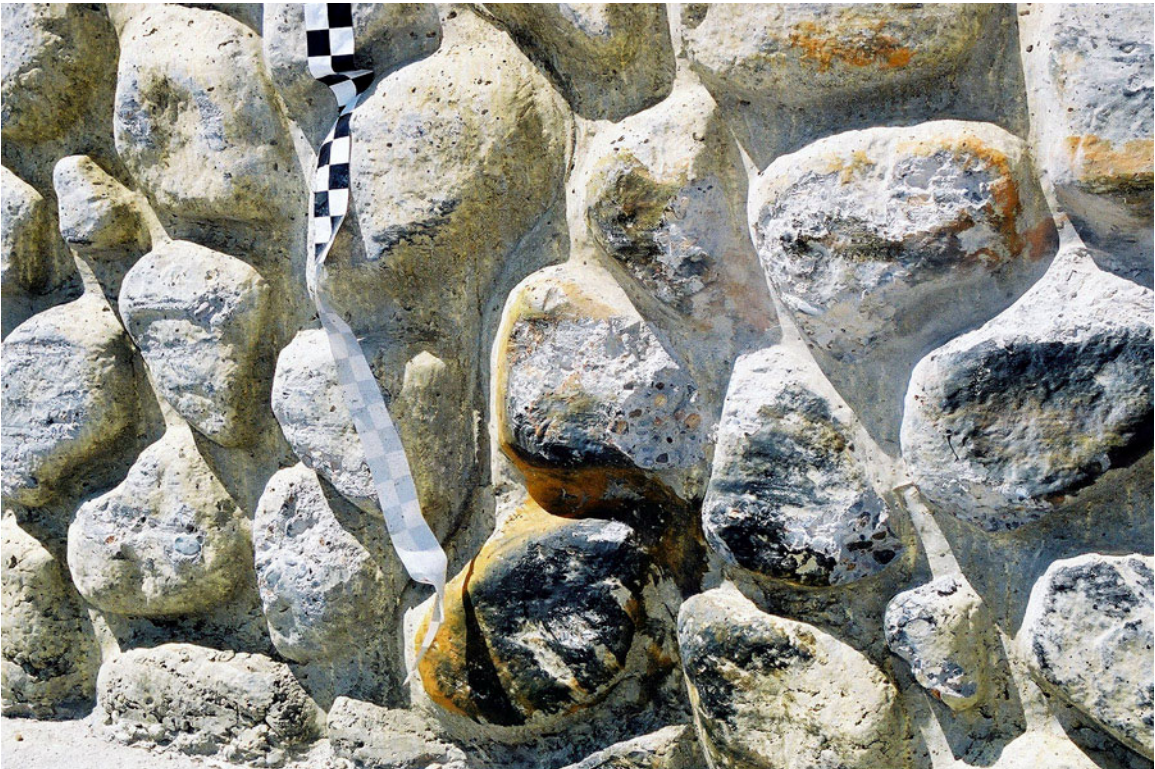
Figure 2-21 Test article after Test 583 (downstream of impact point)

Most of the damage to the barrier was superficial scraping and gouging. The vehicle impact caused some edges of individual cobbles to chip or break off (Figure 2-21 and Figure 2-22). The barrier would not require immediate repair. The gouges and scrapes could be filled on-site by maintenance crews.

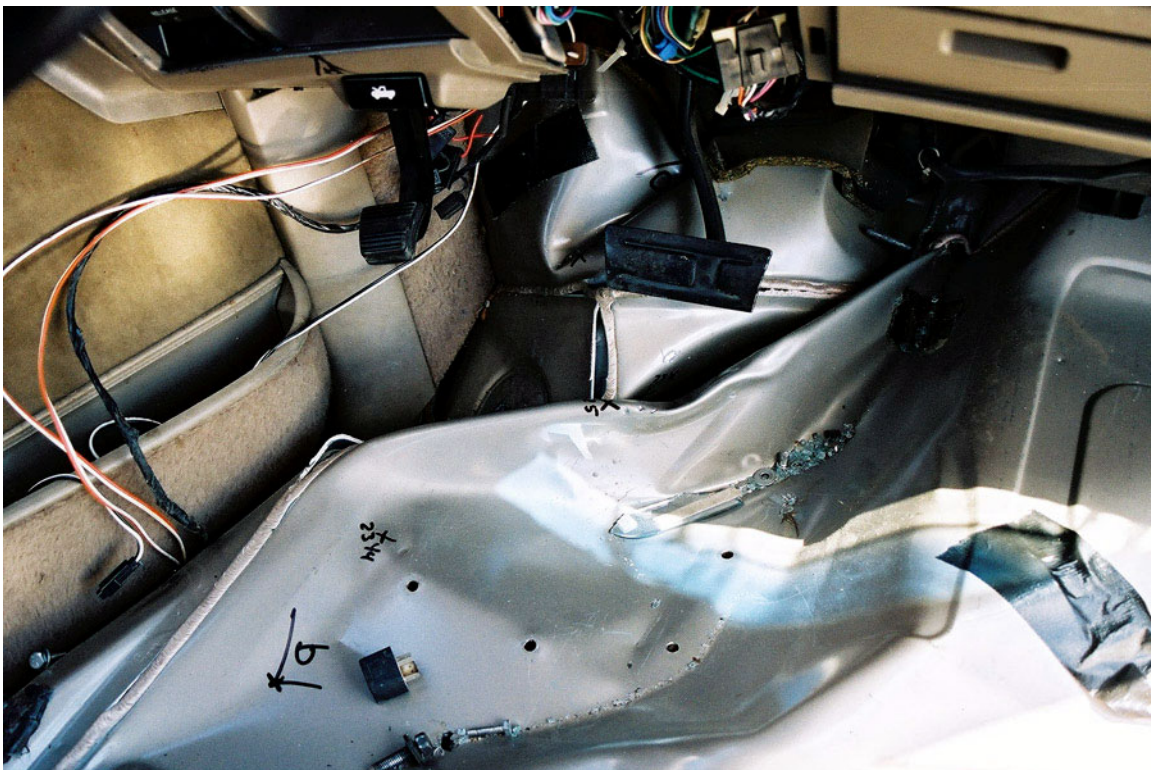
Figure 2-24 Vehicle floorboard deformation after Test 583

The left front corner of the vehicle was substantially damaged in the initial impact with the barrier. The left side of the vehicle also had significant scraping and the door was pushed rearward. The driver-side door remained latched even though the top window frame portion was buckled outward from the cab roof by 250 mm. The left front bumper and left fender were pushed rearward and inward. The left side tires were deflated but the right side tires remained inflated. The left front wheel assembly was pushed rearward enough to cause excessive deformation of the driver's side floorboard area (Figure 2-24). This amount of deformation exceeded the upper limit of 150 mm which has been informally proposed by the FHWA and is generally accepted by the roadside safety community.

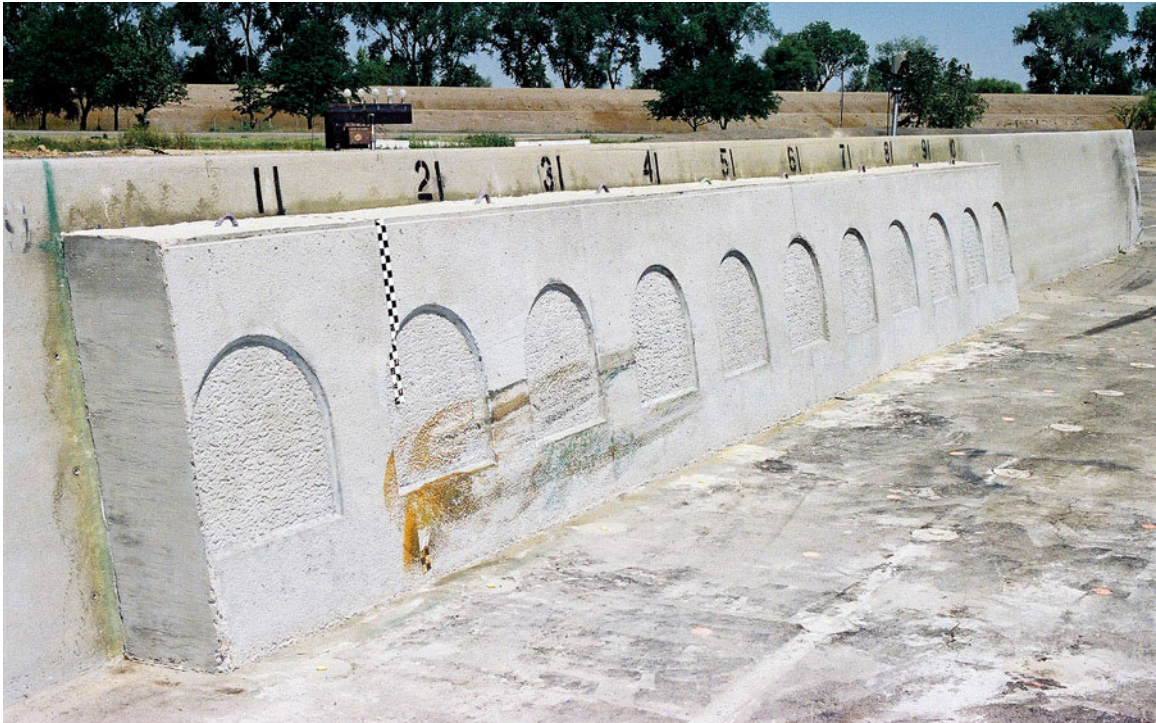
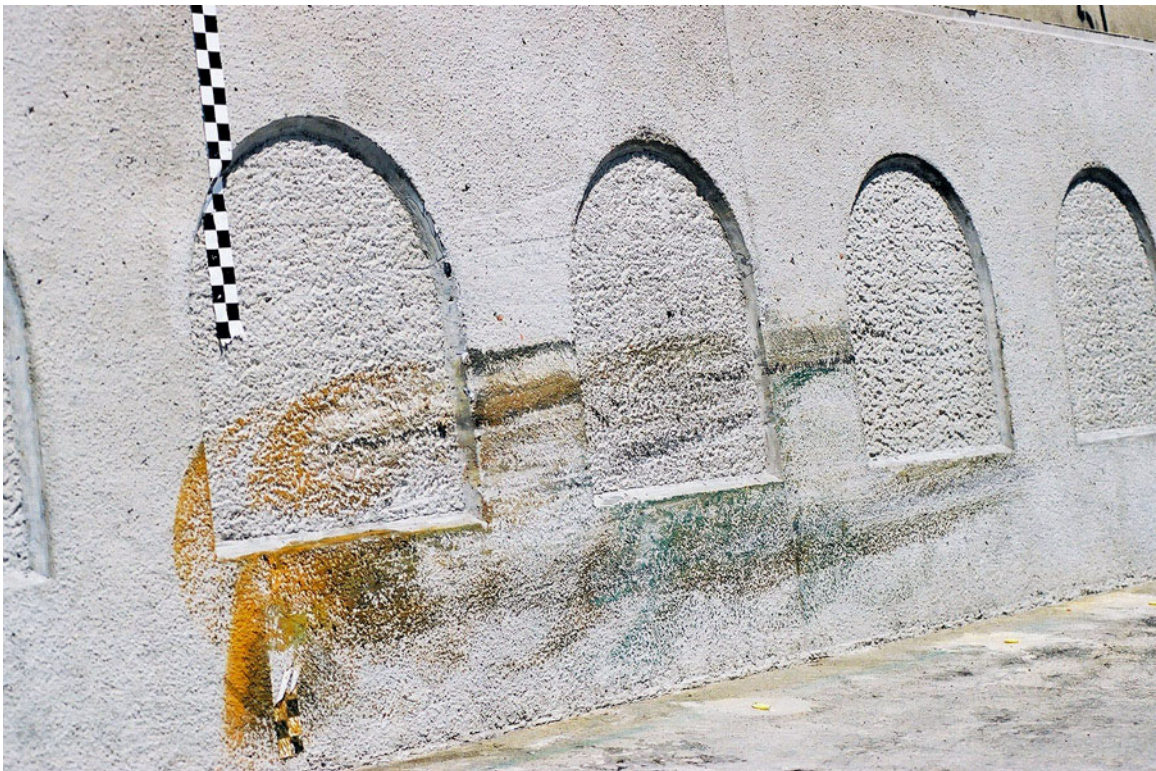
Figure 2-29 Test article after Test 584

Barrier Damage: Very minor scraping of the sandblast surfaces. No chipping or gouging was observed. The barrier would not require immediate repair.

There was essentially no permanent damage to the barrier. The vehicle caused only minor scrapes to the concrete surface of the barrier. The barrier would not require immediate repair.

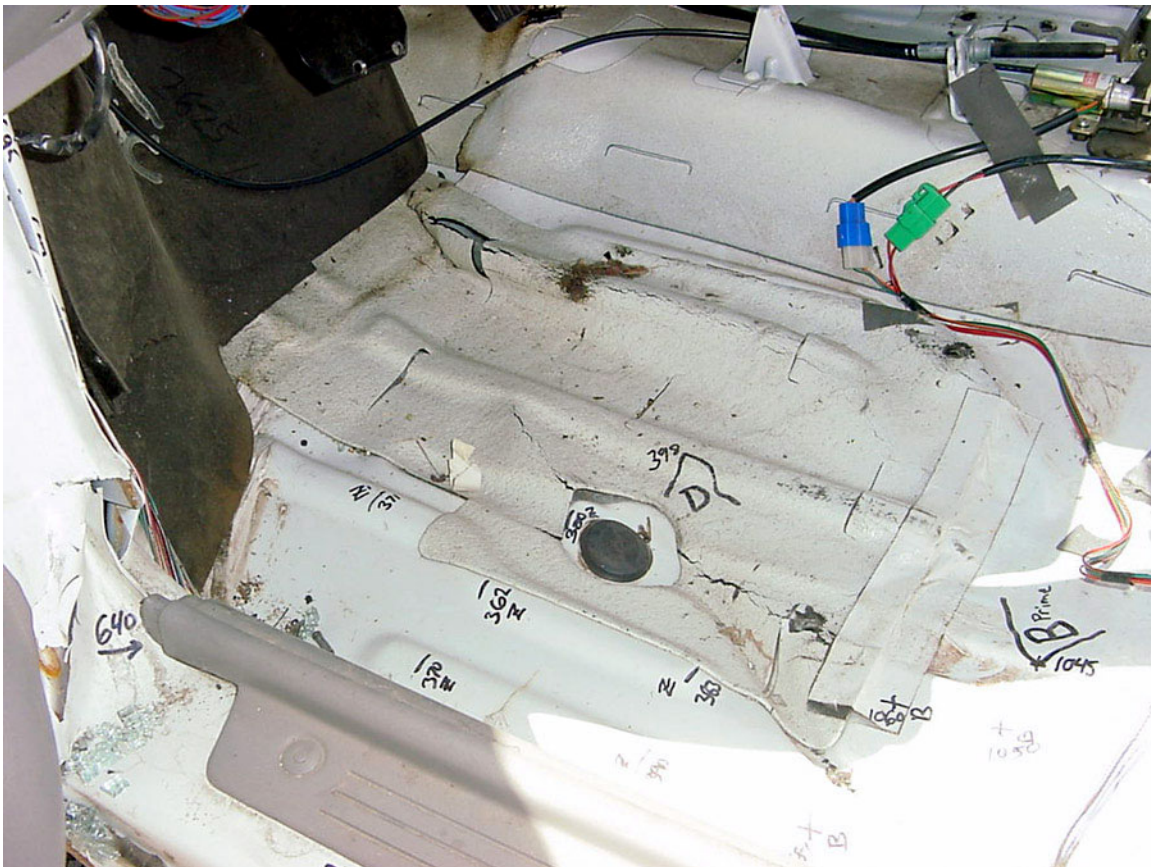
Figure 2-32 Test 584 vehicle floorboard deformation

The left front corner of the vehicle was moderately damaged in the initial impact with the barrier. The left side of the vehicle had minor scraping and the door was pushed slightly rearward. The driver-side door remained latched even though film analysis showed a 115 mm gap along the top edge of the doorframe during the impact. The left front bumper and left fender were pushed slightly rearward and inward. All four tires remained inflated. The left front tire and wheel assembly were pushed rearward enough to cause minor deformation of the drivers side floorboard area. This deformation was no more than 40 mm and would not pose a serious threat to an occupant, Figure 2-32.

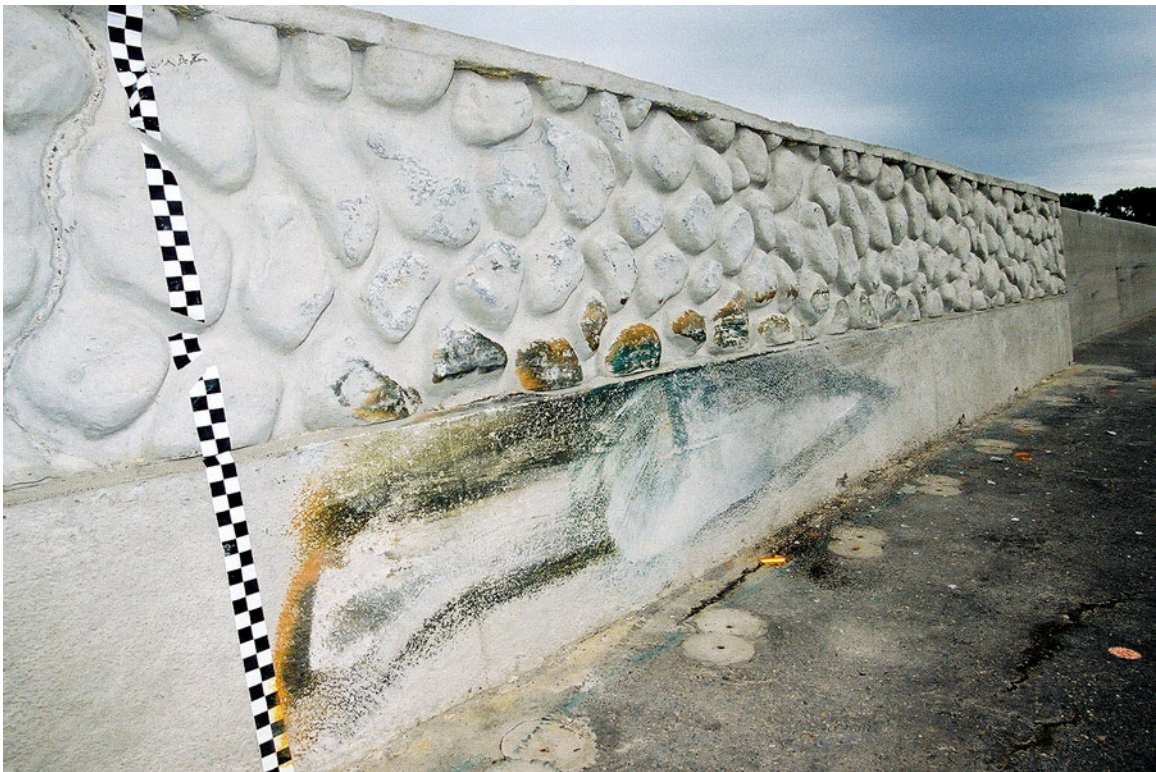
Figure 2-36 Cobble-Reveal test article after Test 585

Barrier Damage: Very minor scraping of the sandblast and cobblestone surfaces. No chipping or gouging was observed. The barrier would not require immediate repair.

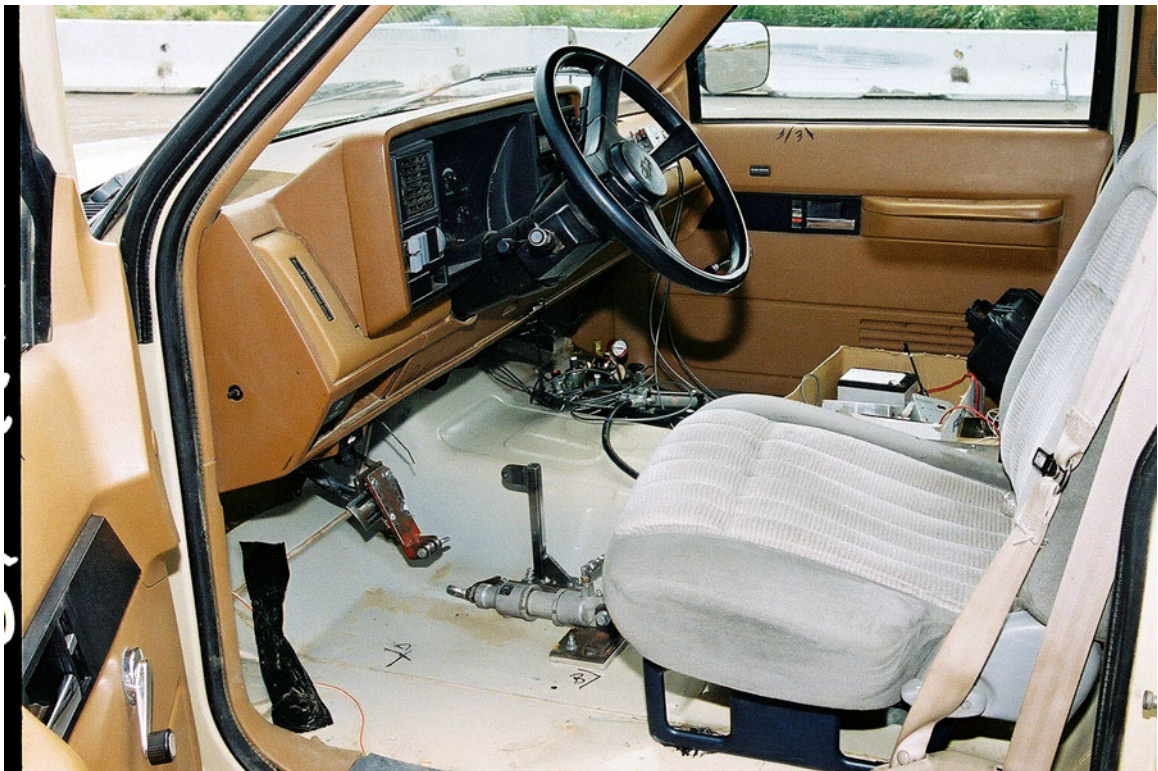
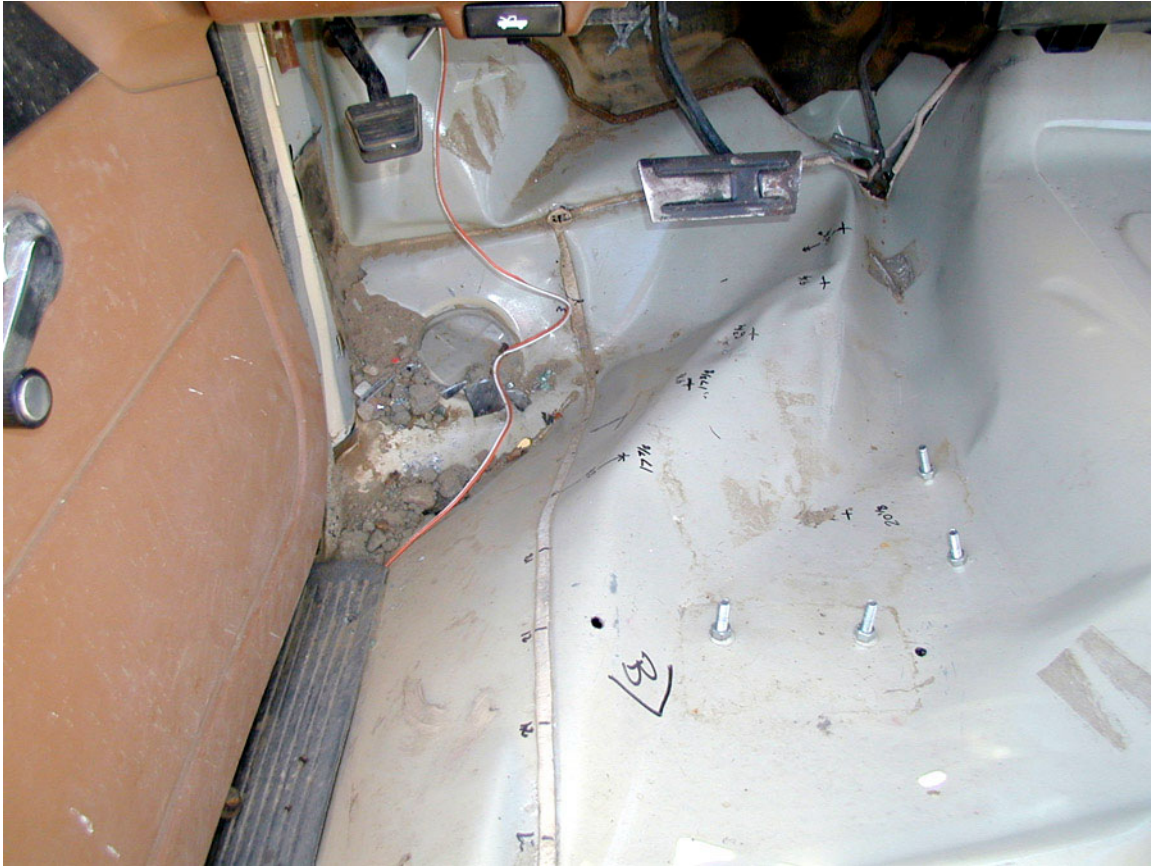
The left front quarter section of the vehicle was moderately damaged in the initial impact with the barrier. The left front fender, hood, bumper, headlamp area, grille, and suspension components were all affected. The driver side doorframe was deformed outward but the door remained latched. Some minor damage along the left side of the vehicle and to the left rear quarter panel occurred as the vehicle continued to engage the barrier after the initial impact. The left front rim was damaged, however the tire remained inflated. The force of the initial impact drove the left front tire and rim assembly rearward into the underside of the driver side floorboard. This caused some deformation (buckling) of the floorboard, which did not exceed 98 mm. This was within the accepted limit of 150 mm. Compare Figure 2-38 and Figure 2-39.
