Vehicle Crash Tests of the Type 70 Bridge Rail

January 1998

VEHICLE CRASH TESTS OF THE TYPE 70
BRIDGE RAIL

FINAL REPORT # FHWA/CA/ESC-98-06

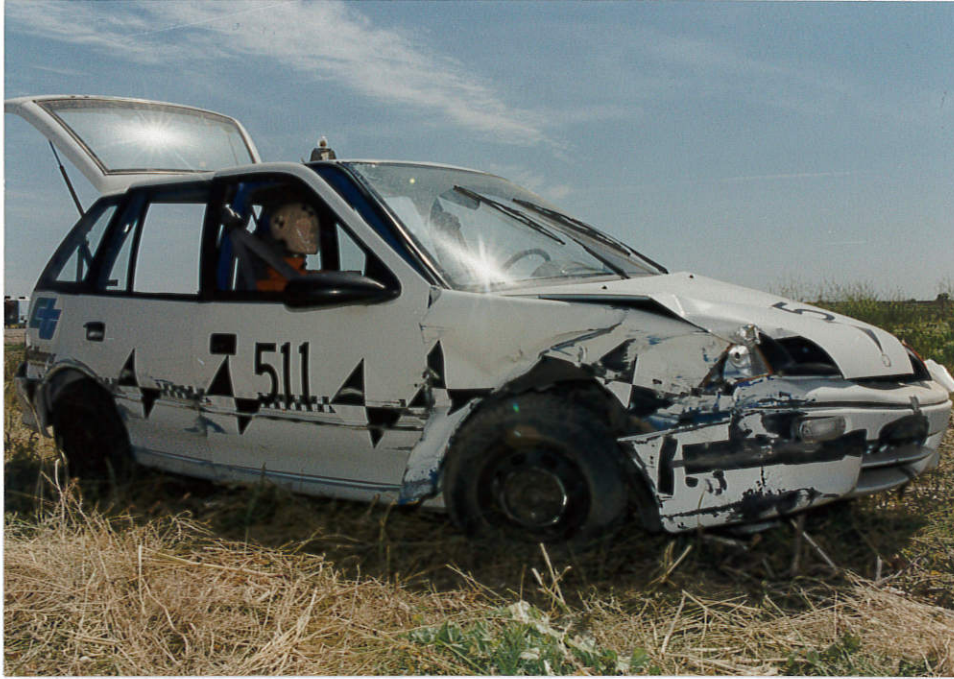
Figure 2.9 - Right Front Of Vehicle 511 After Impact

The right front section of the vehicle sustained crushing of the bumper and frame, damage to the suspension and a flat tire. The hood crumpled, but did not penetrate the cab.

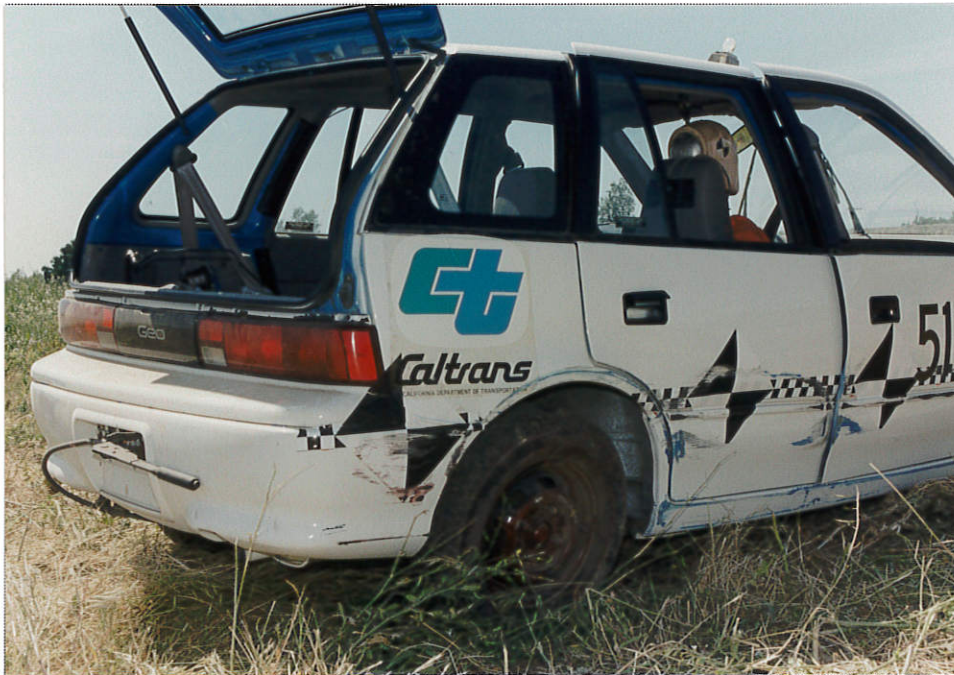
Figure 2.10 - Right Rear Of Vehicle 511 After Impact

As the vehicle turned parallel to the barrier, the sheet metal on the entire right side came into contact with the barrier face. The rear right tire rubbed along the barrier, but was not damaged beyond moderate scuffing.

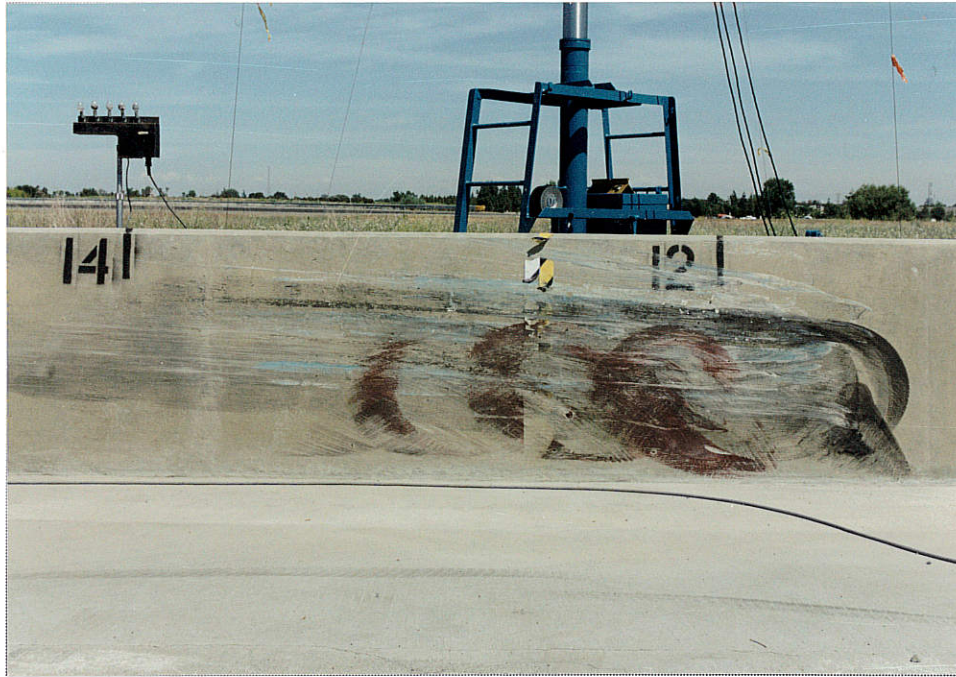
Figure 2.11 - Test 511 Impact Scuff Marks On The Type 70 Barrier

Barrier damage was cosmetic only, consisting of scrapes and tire marks. Both of the right side tires left marks along the face of the barrier for the 6.5 meters of contact. Small amounts of concrete spalled from the face of the barrier where the vehicle's sheet metal made contact.

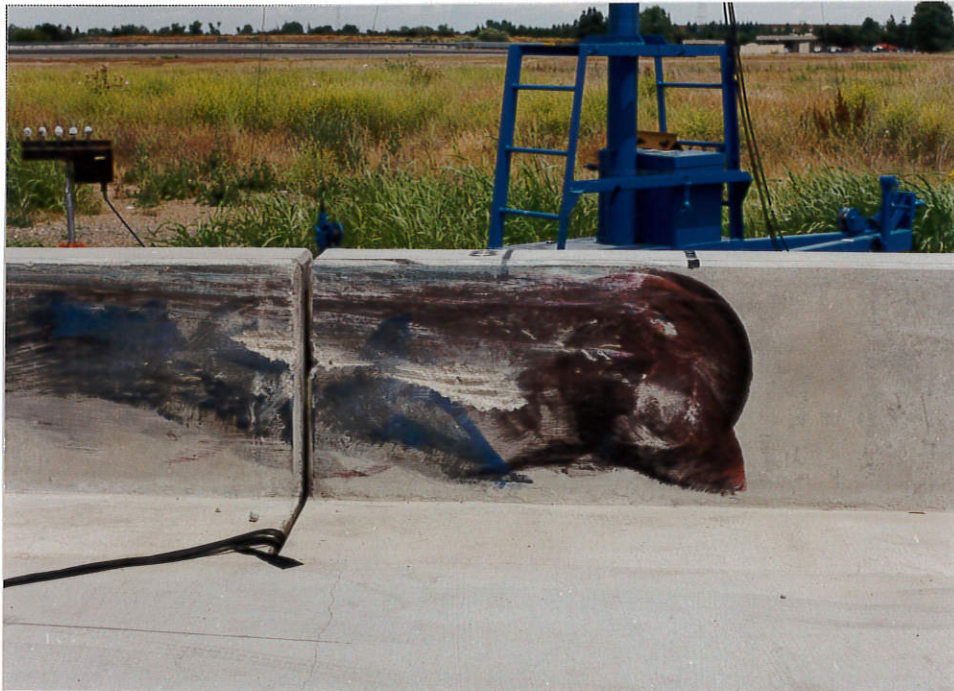
Figure 2.19 - Scuff Marks on Barrier for Test 512

The barrier sustained a 200 mm-long gouge just upstream from the impact area. The gouge was 20 to 100 mm wide and up to 20 mm deep. A second gouge, located just downstream from impact, was only half the size of the first. Other barrier damage was cosmetic only, consisting of scrapes and tire marks. Both of the right side tires left marks along the face of the barrier for the 6.5 m of contact. Small amounts of concrete spalled from the face of the barrier where the vehicle's sheet metal made contact.

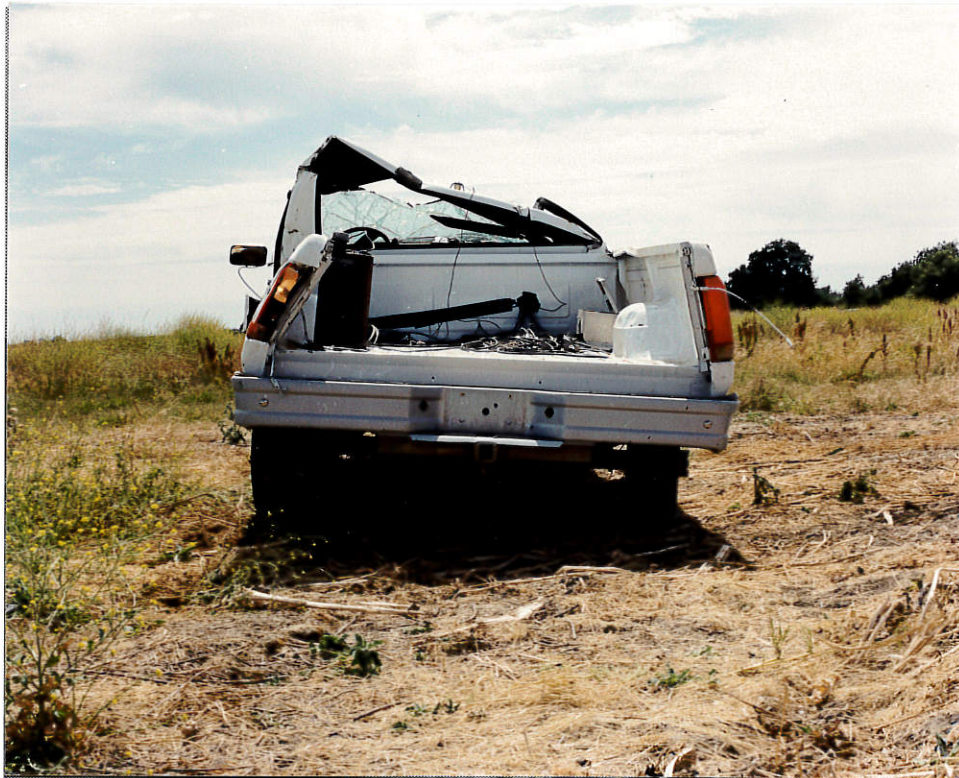
Figure 2.21 - The Back Side Of Tested Vehicle 512

The rollover caused major damage to all sides of the vehicle including the top and undercarriage. With the forward end of the drive shaft broken loose from the transmission, it was allowed to swing freely but did not detach from the rear axle. The passenger side of the cab was crushed to a level even with the bottom of the door window.

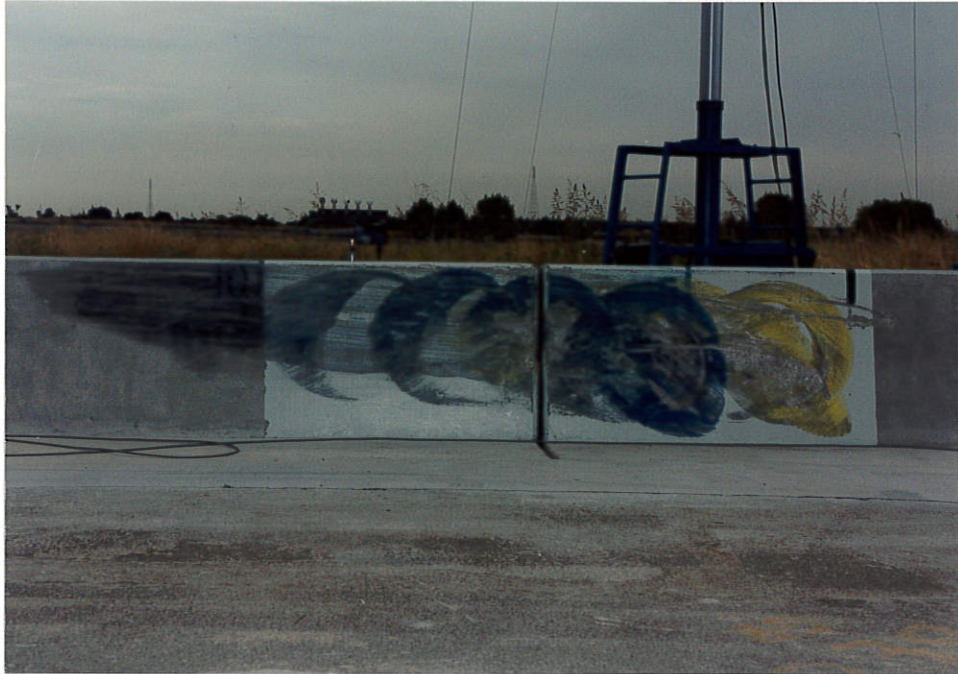
Figure 2.41 - Scuff Marks On The Barrier for Test 515

Damage consisted of only moderate scraping and tire scuffing over a length of four meters

Since this was a repeat of test 512, the impact location for test 515 was set at the same location as test 512. In order to minimize the effects that test 512 had made on the barrier (i.e. spalling and scraping on the barrier face), the barrier had been patched with a high strength vertical patching material and painted. The subsequent impact damage due to Test 515 consisted of only moderate scraping and tire scuffing. The total damage length was only slightly more than 4 m.
