*California Department of Transportation
Division of Maintenance*

Bridge Number : 10 0136
Facility Carried: STATE ROUTE 1
Location : 01-MEN-001-43.74
City :
Inspection Date : 05/15/2012

Bridge Inspection Report

STRUCTURE NAME: ALBION RIVER

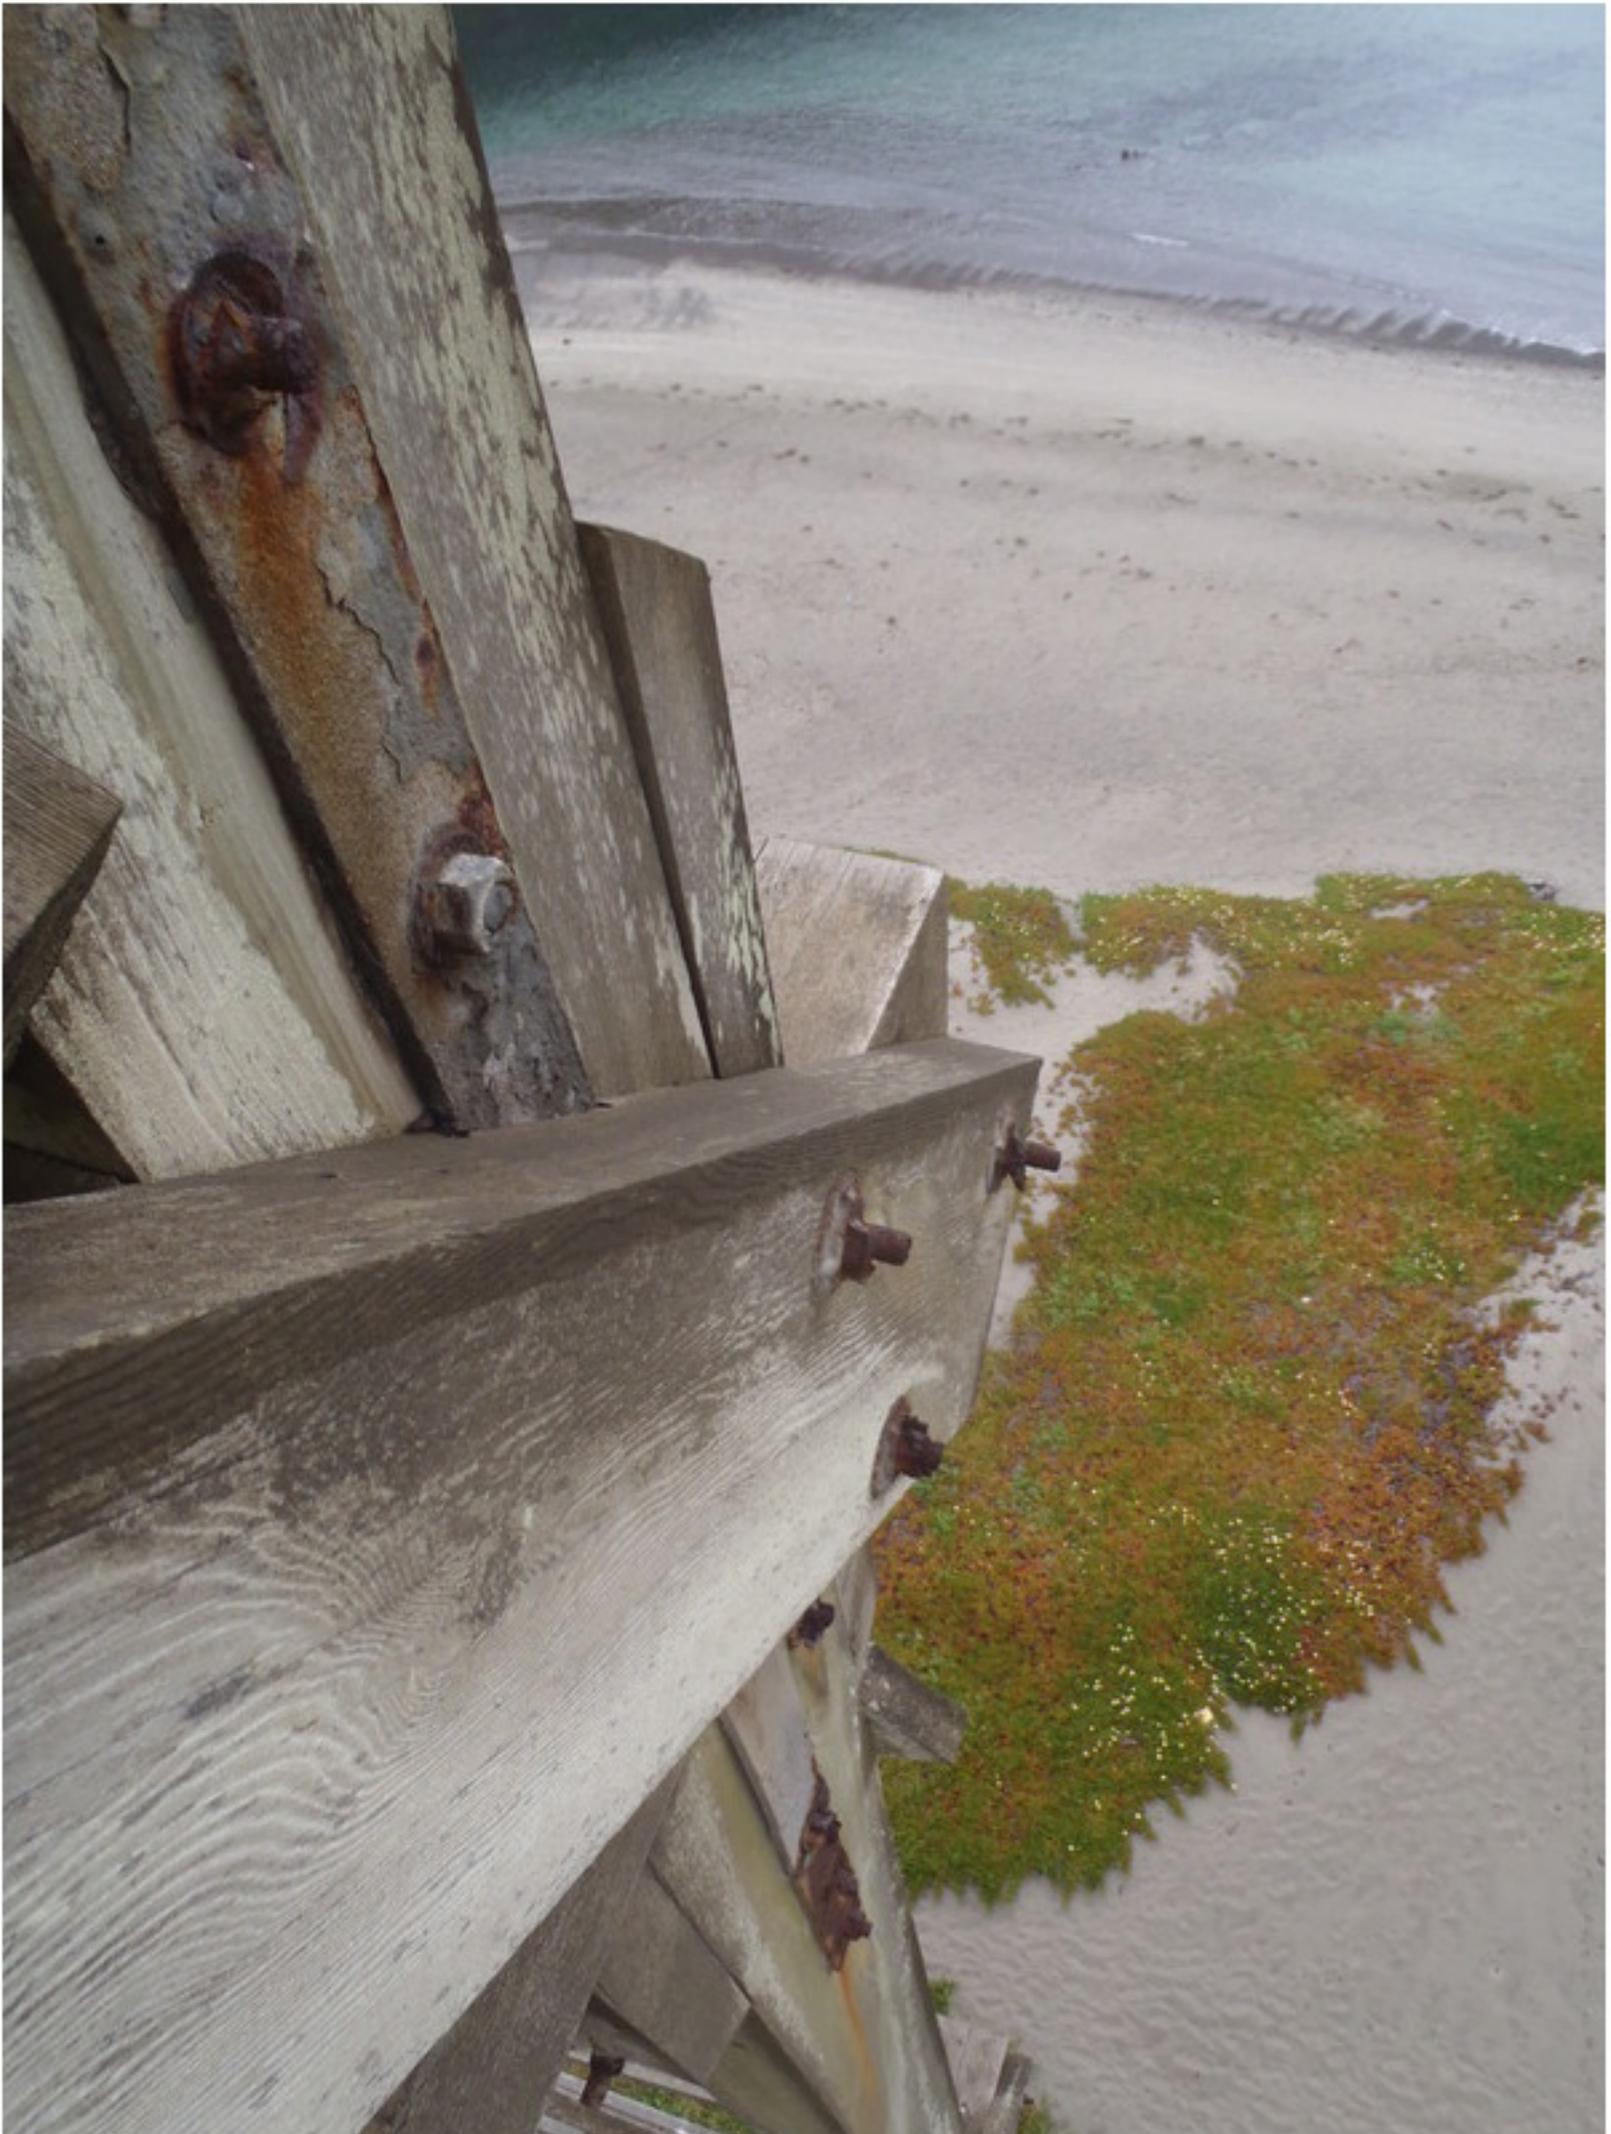
Photo No. 1

Looking down at corroded nuts on threaded rods at a splice plate for Column 1 of Bent 20

The bolted connections in the towers have historically been replaced by the District 01 Bridge Crew. Currently, on average approximately 50 to 70% of the nuts are failed due to corrosion from the marine environment. (See photos No. 1 thru 10, dated 05/15/12, in BIRIS.) Due to the amount hardware needing replacement, the district should consider having the work done by contract, which should cover replacement of all of the threaded rods and nuts. There are approximately 5,000 threaded rods with nuts that need replacement, 2,500 to 3,500 of which are failed.

The steel straps located at every level, which connect/tie the timber legs/columns between each level to the ones above or below across the horizontal timber beams, have moderate to severe areas of corrosion. (See photos 1, 3, 5, 6, & 8, dated 5/15/2012, in BIRIS.)

Remove and replace the steel bolted connections and hardware (threaded rods, malleys, nuts, straps, etc.) and timber scabs throughout the entire timber sub-structure as necessary. Work By: Bridge Crew. Estimated cost: \$75,000.

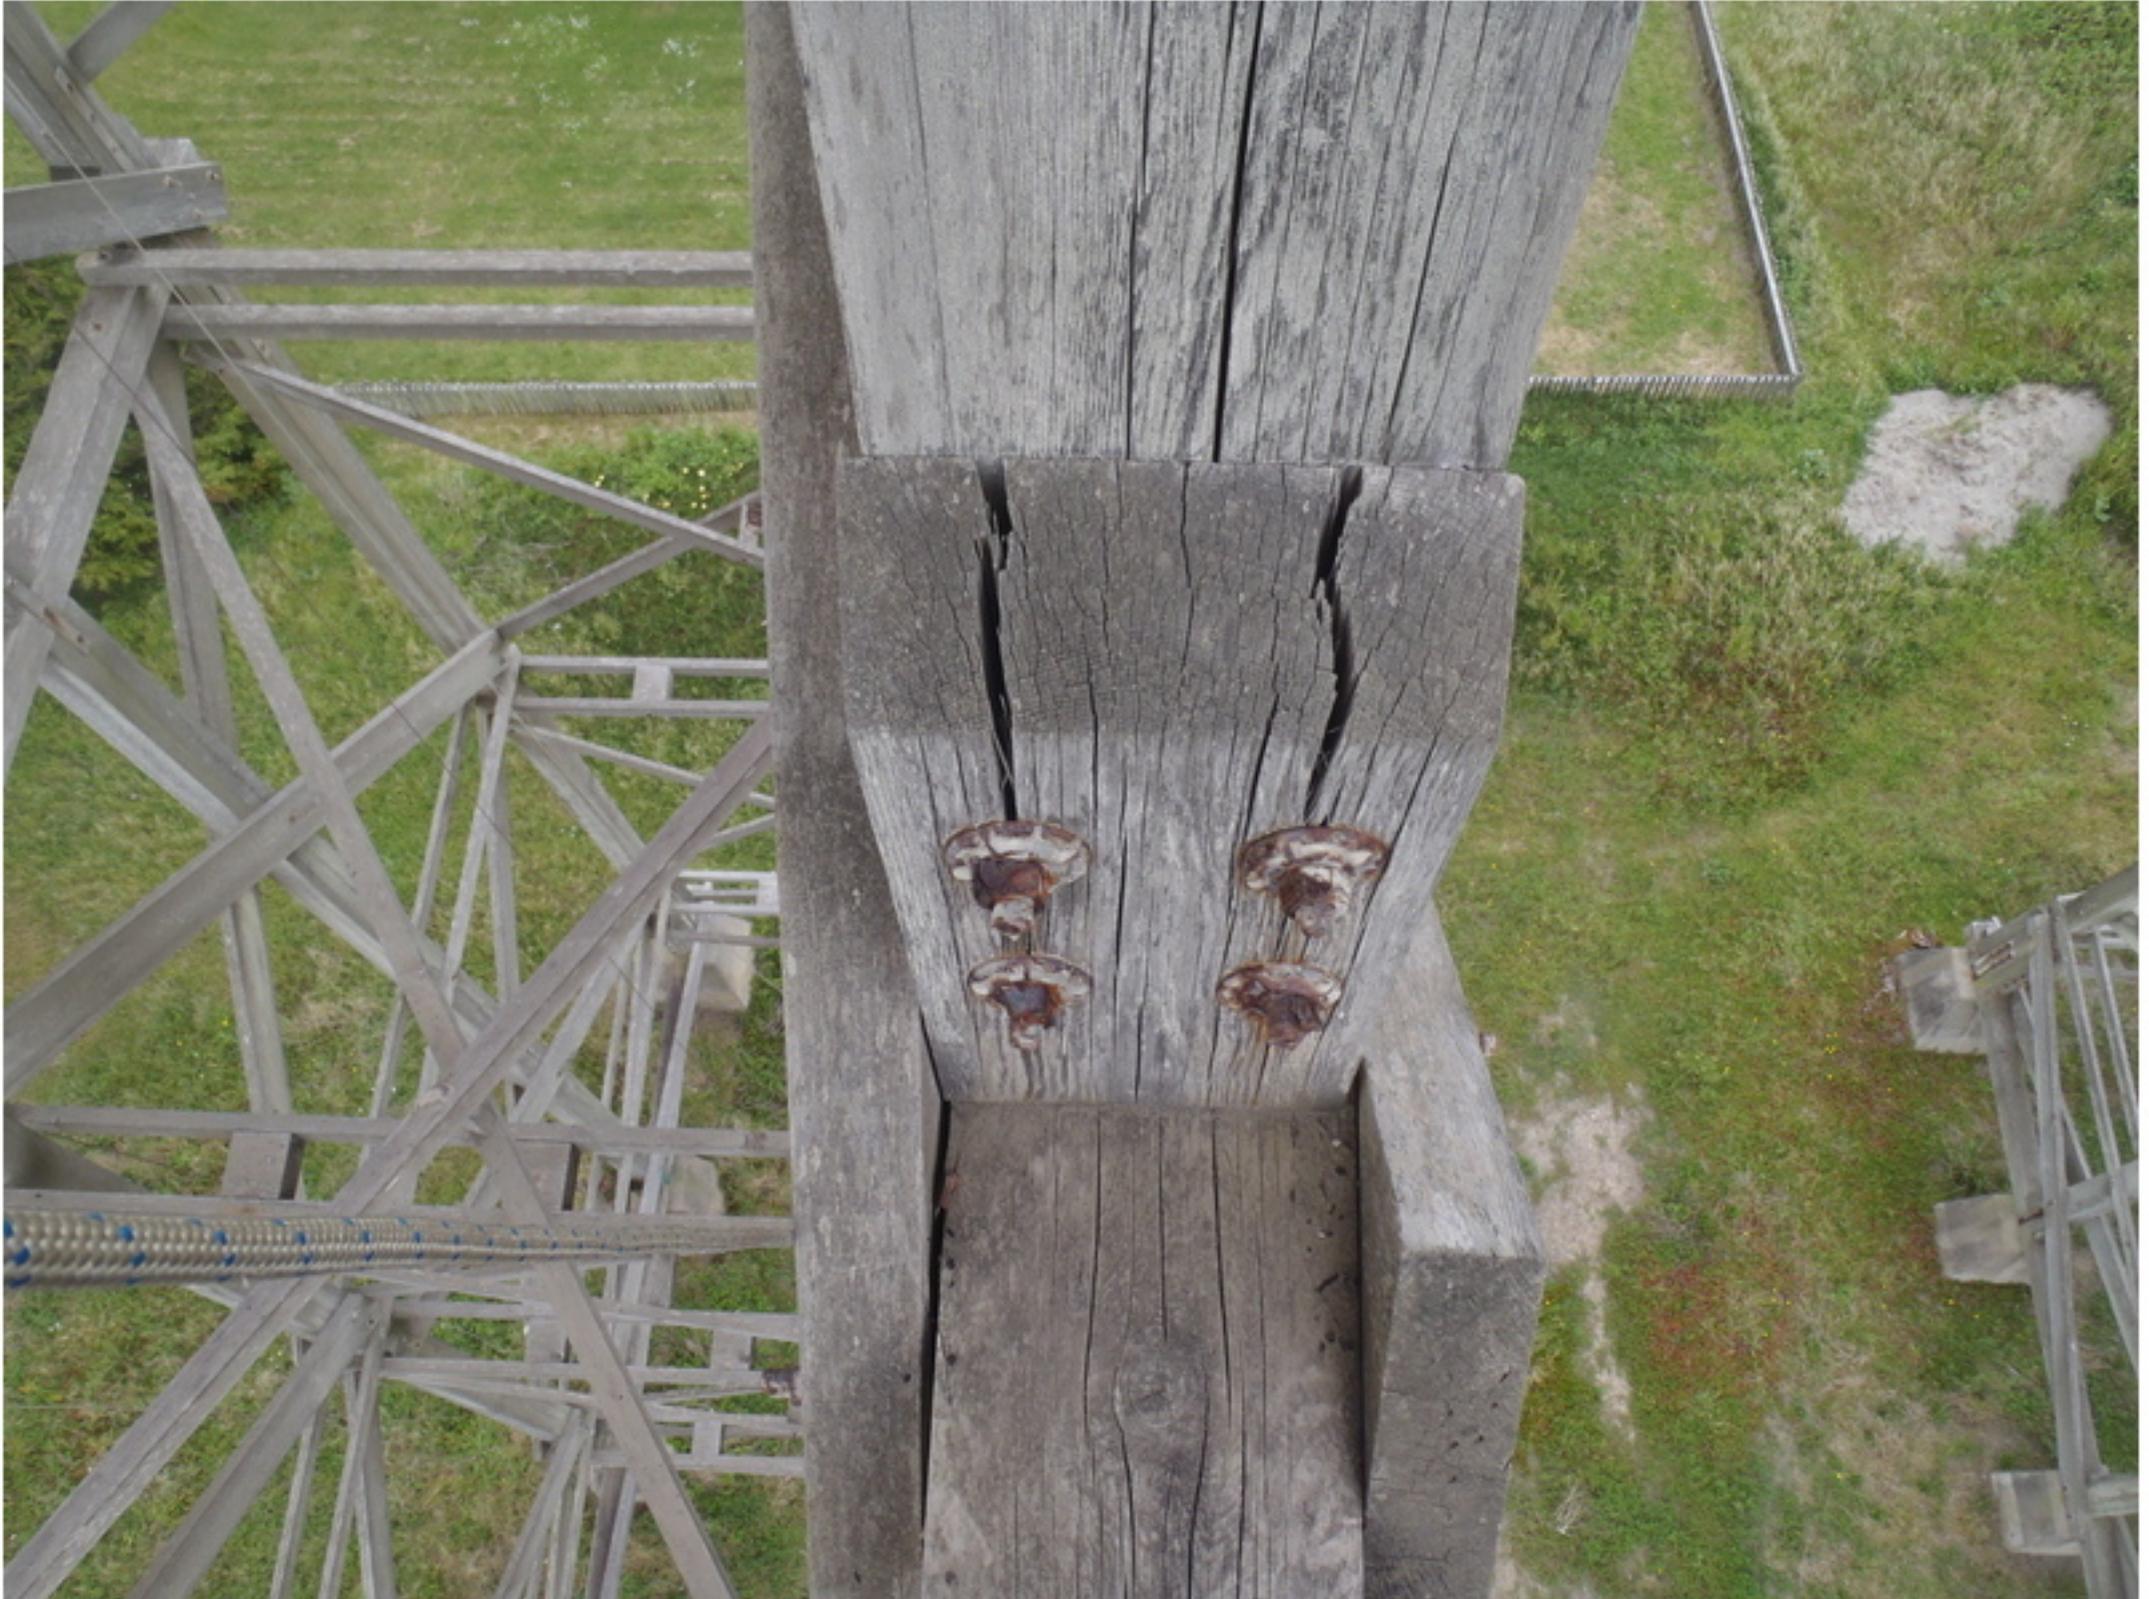
At least 15 to 20% of the timber scabs at the connections of the legs/columns between each level have 0.25 to 0.5 inch wide splits where the threaded rods, malleys, and nuts have compressed and distorted the wood. (See photos 2, 7, & 9, dated 5/15/2012, in BIRIS.)

Photo No. 2
Looking down at the corroded nuts on the threaded rods at the third tier/level of Bent 21

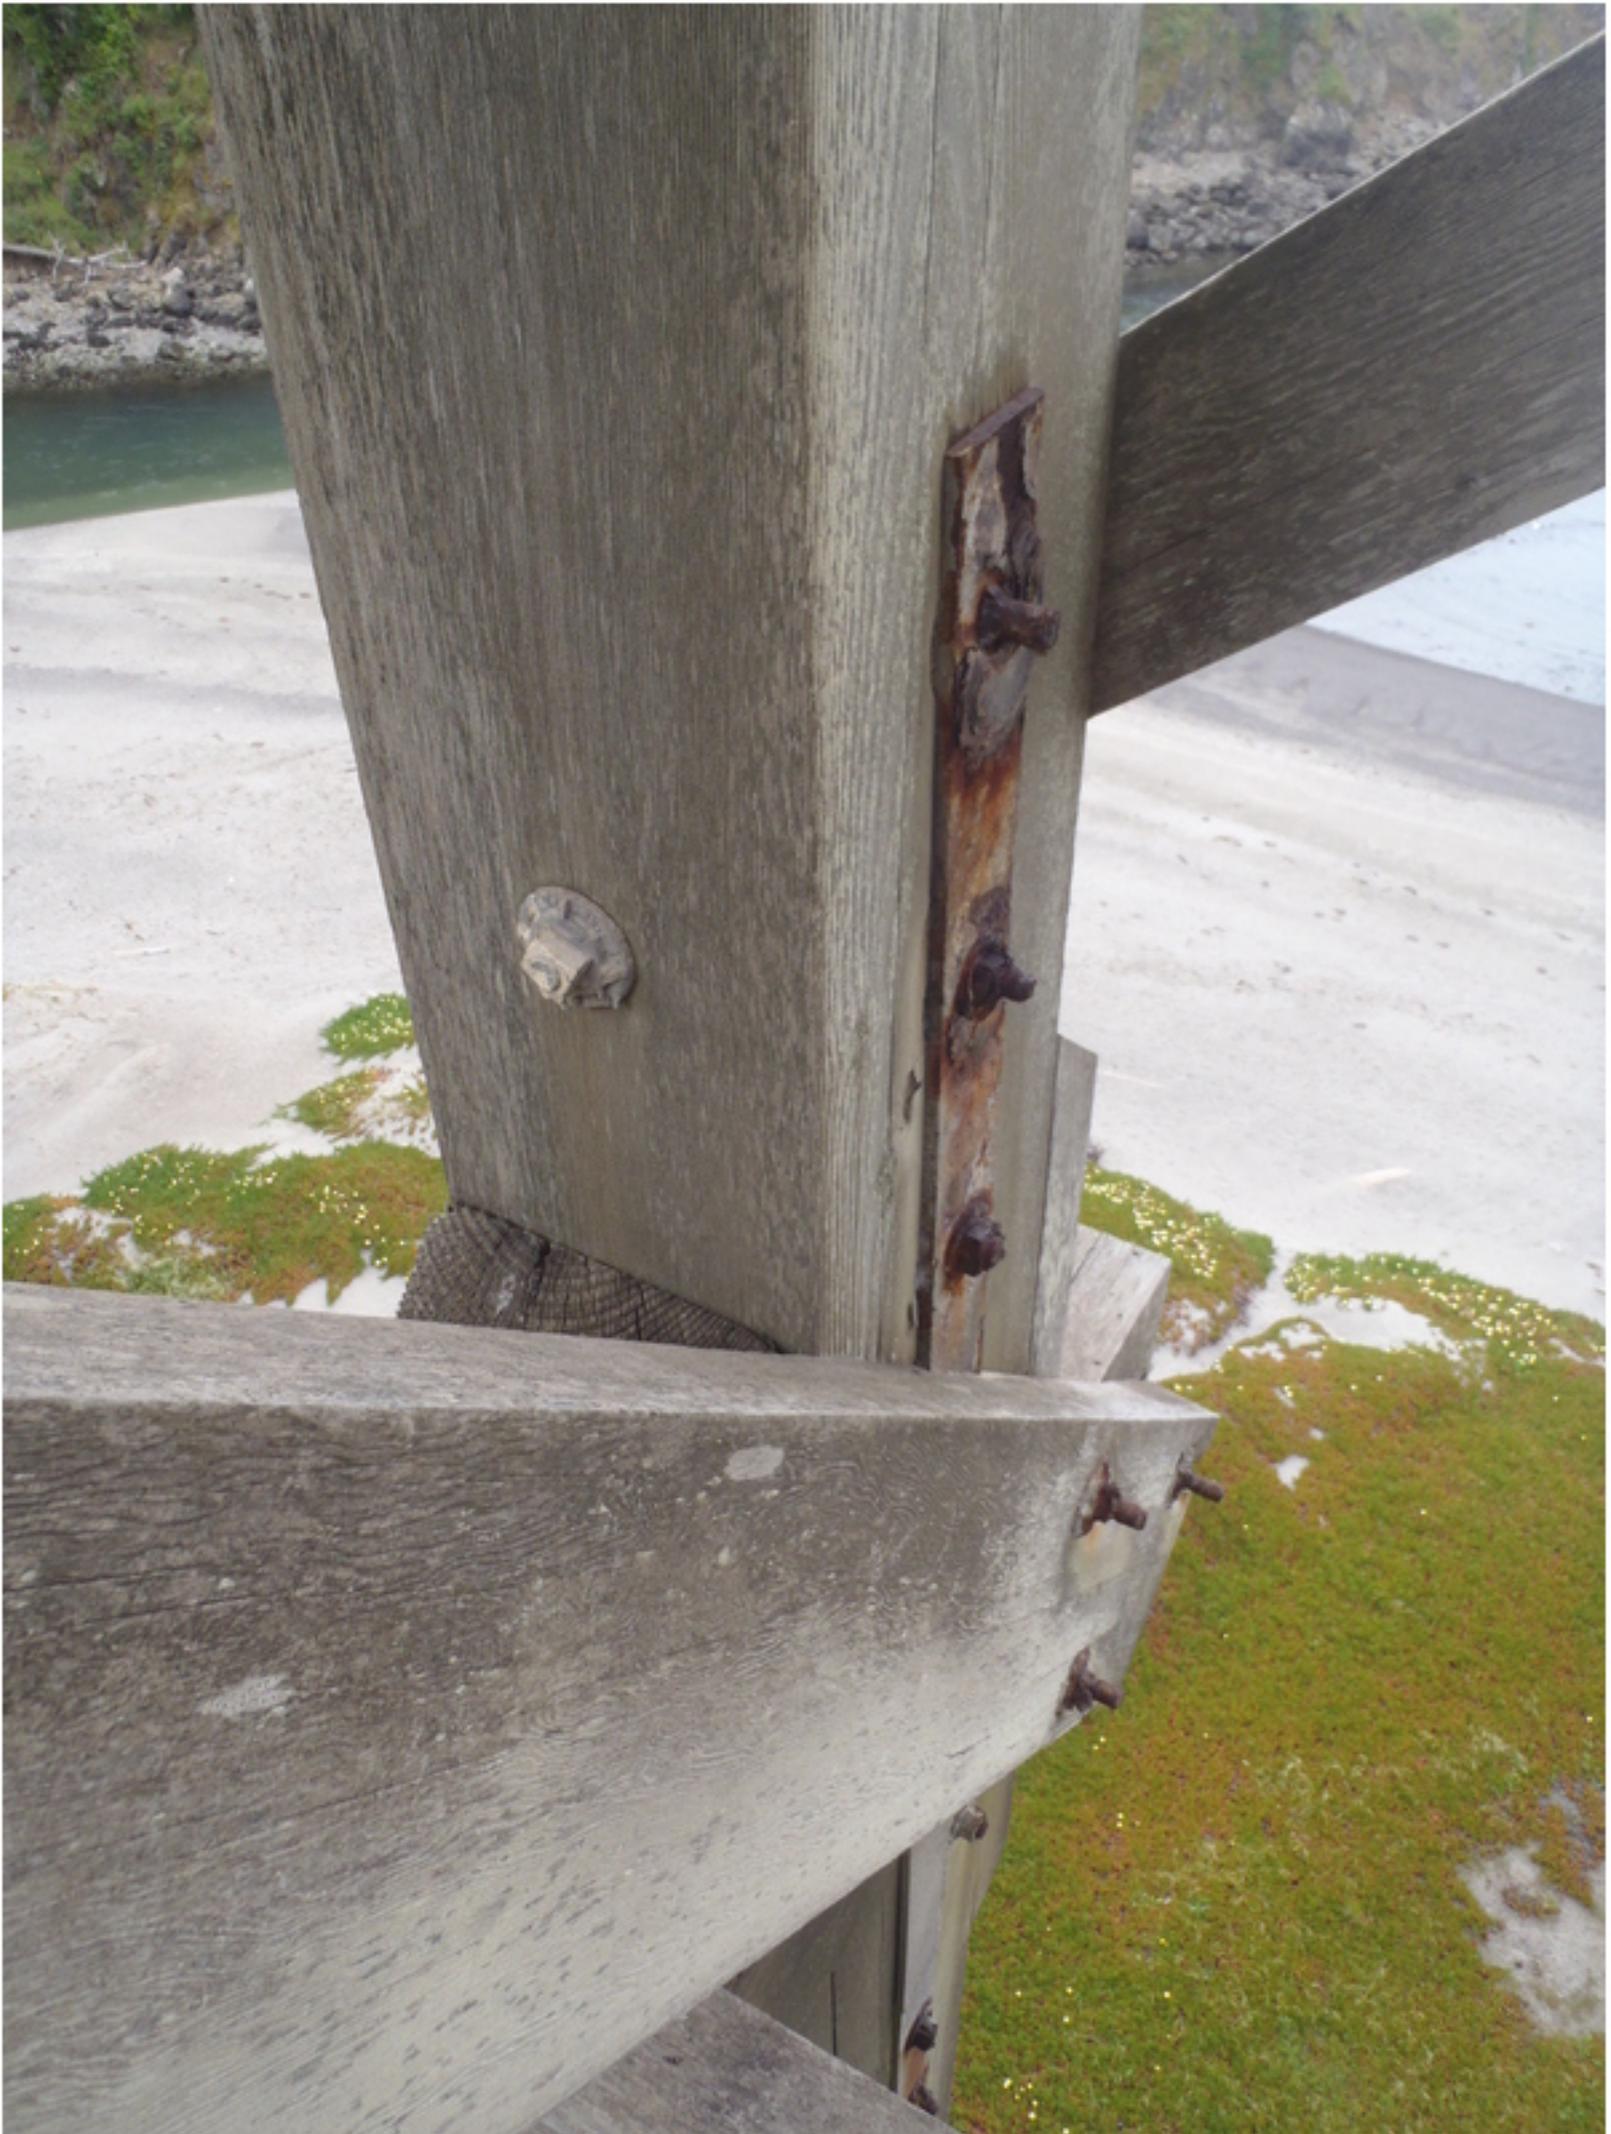
Photo No. 3

Looking down at corroded nuts on threaded rods at a splice plate for Column 1 of Bent 21

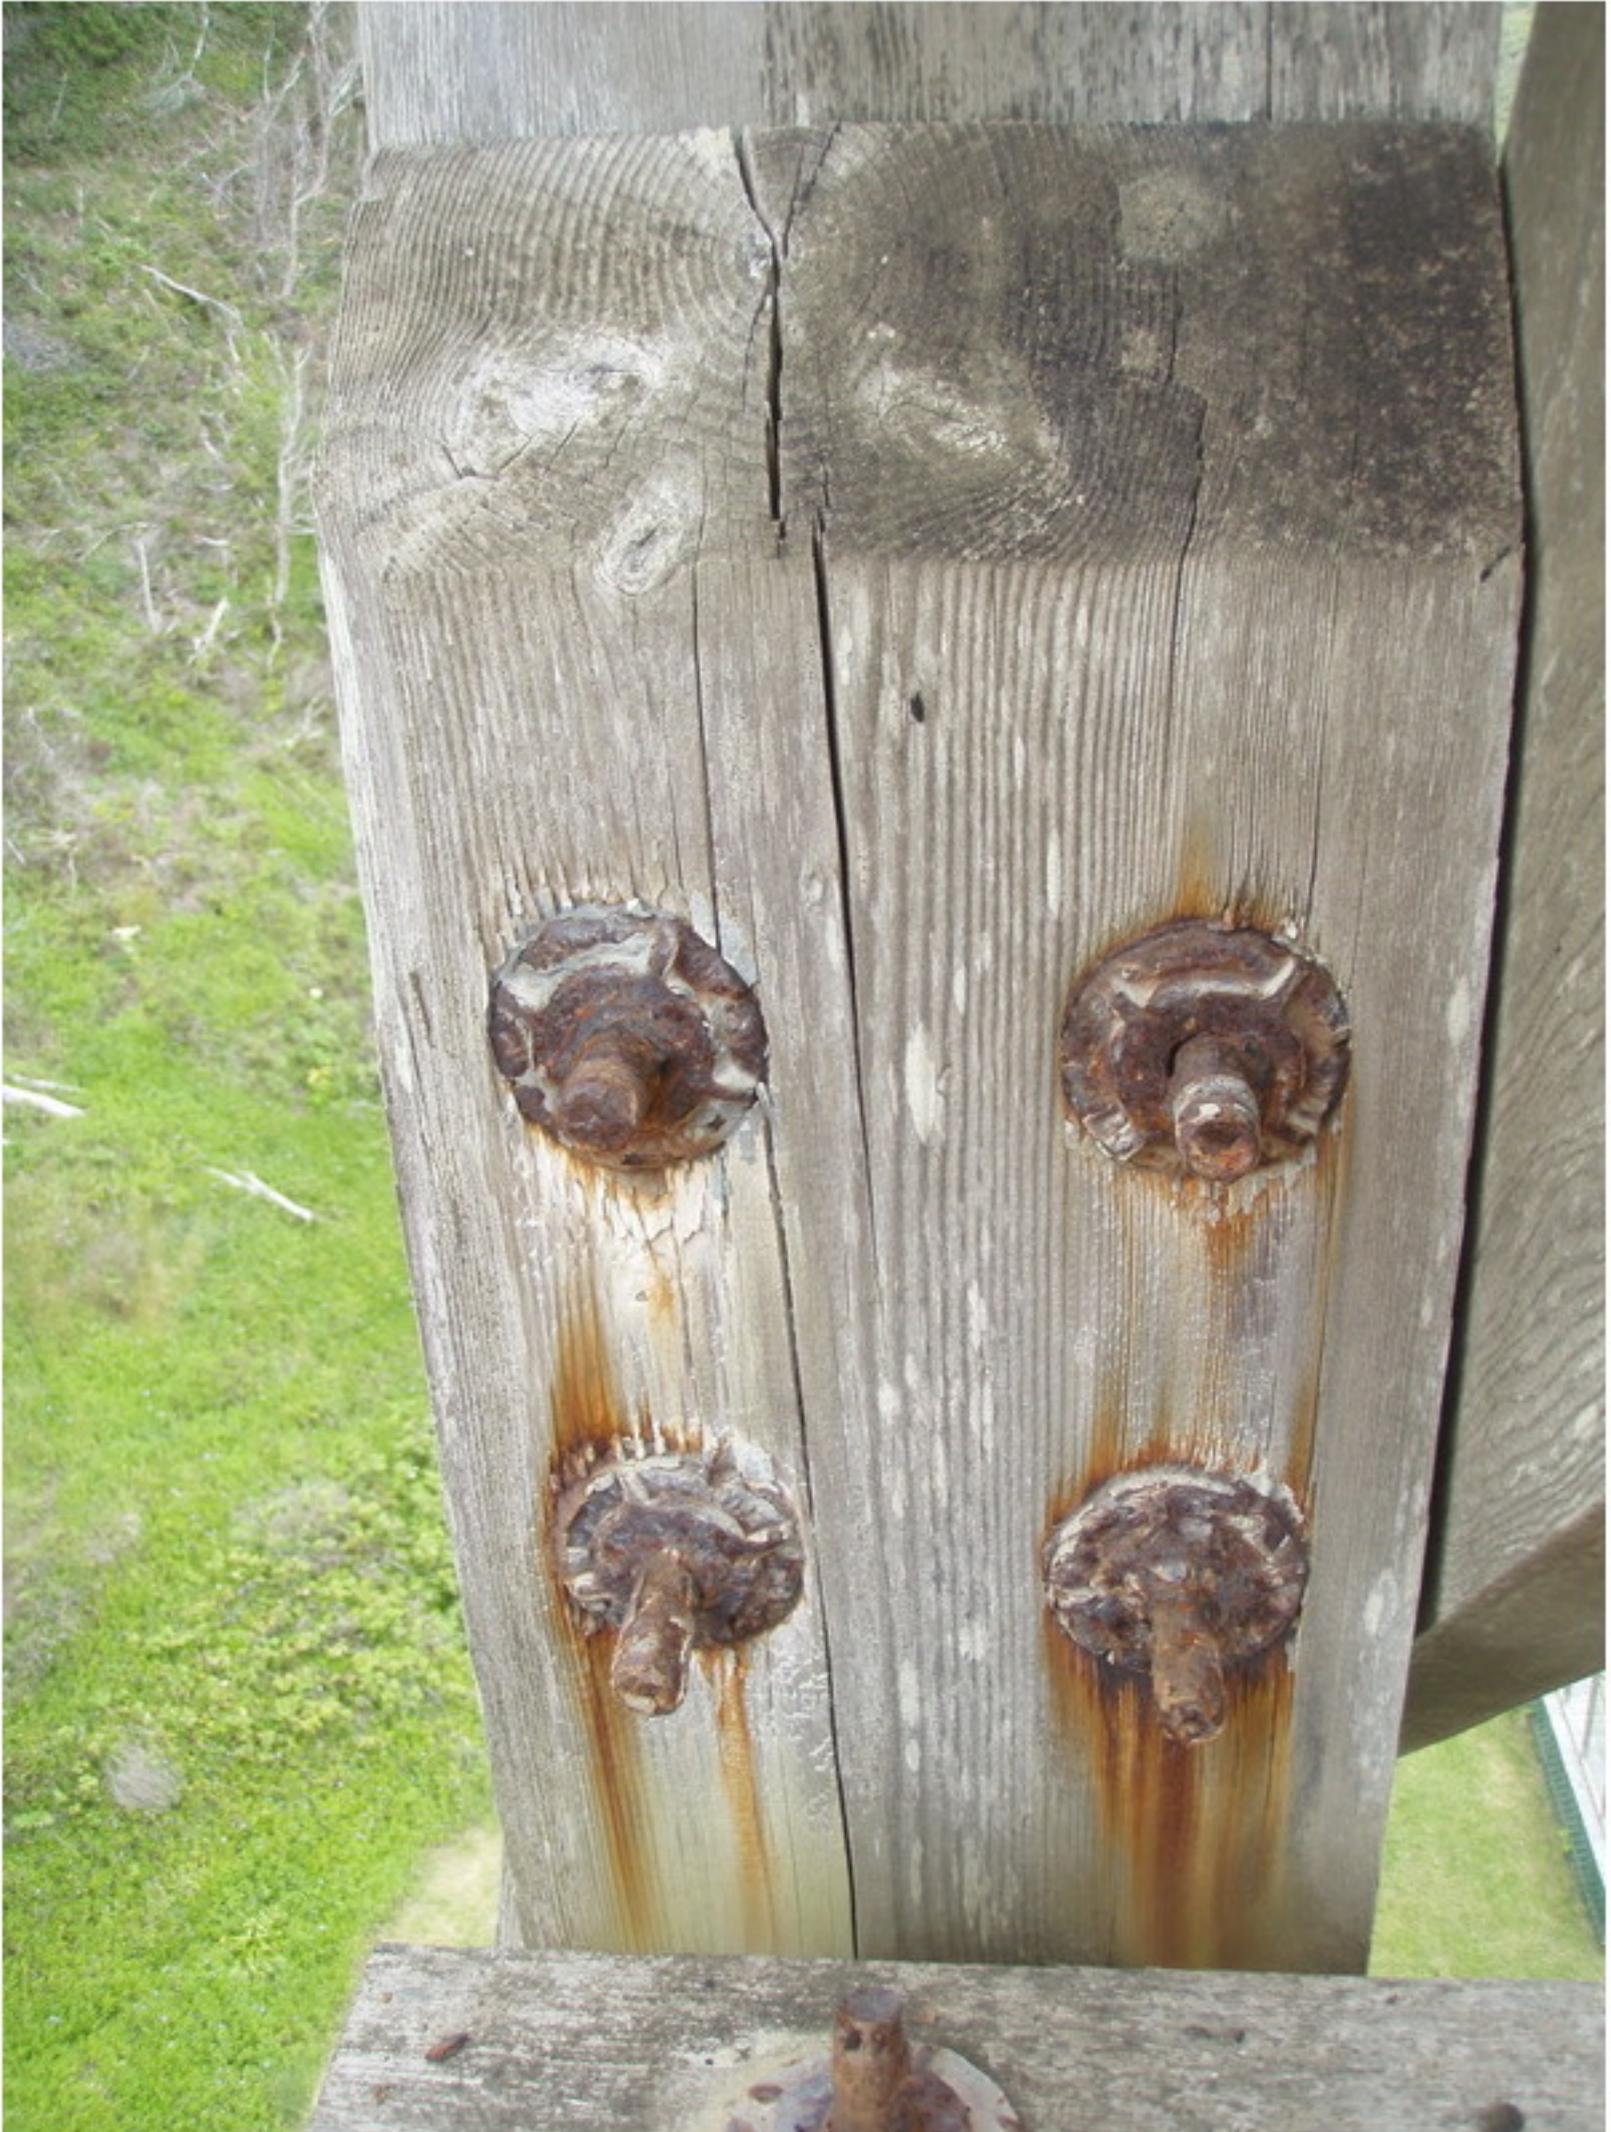
Photo No. 4

Looking down at the corroded nuts on the threaded rods at the second tier/level of Bent 24

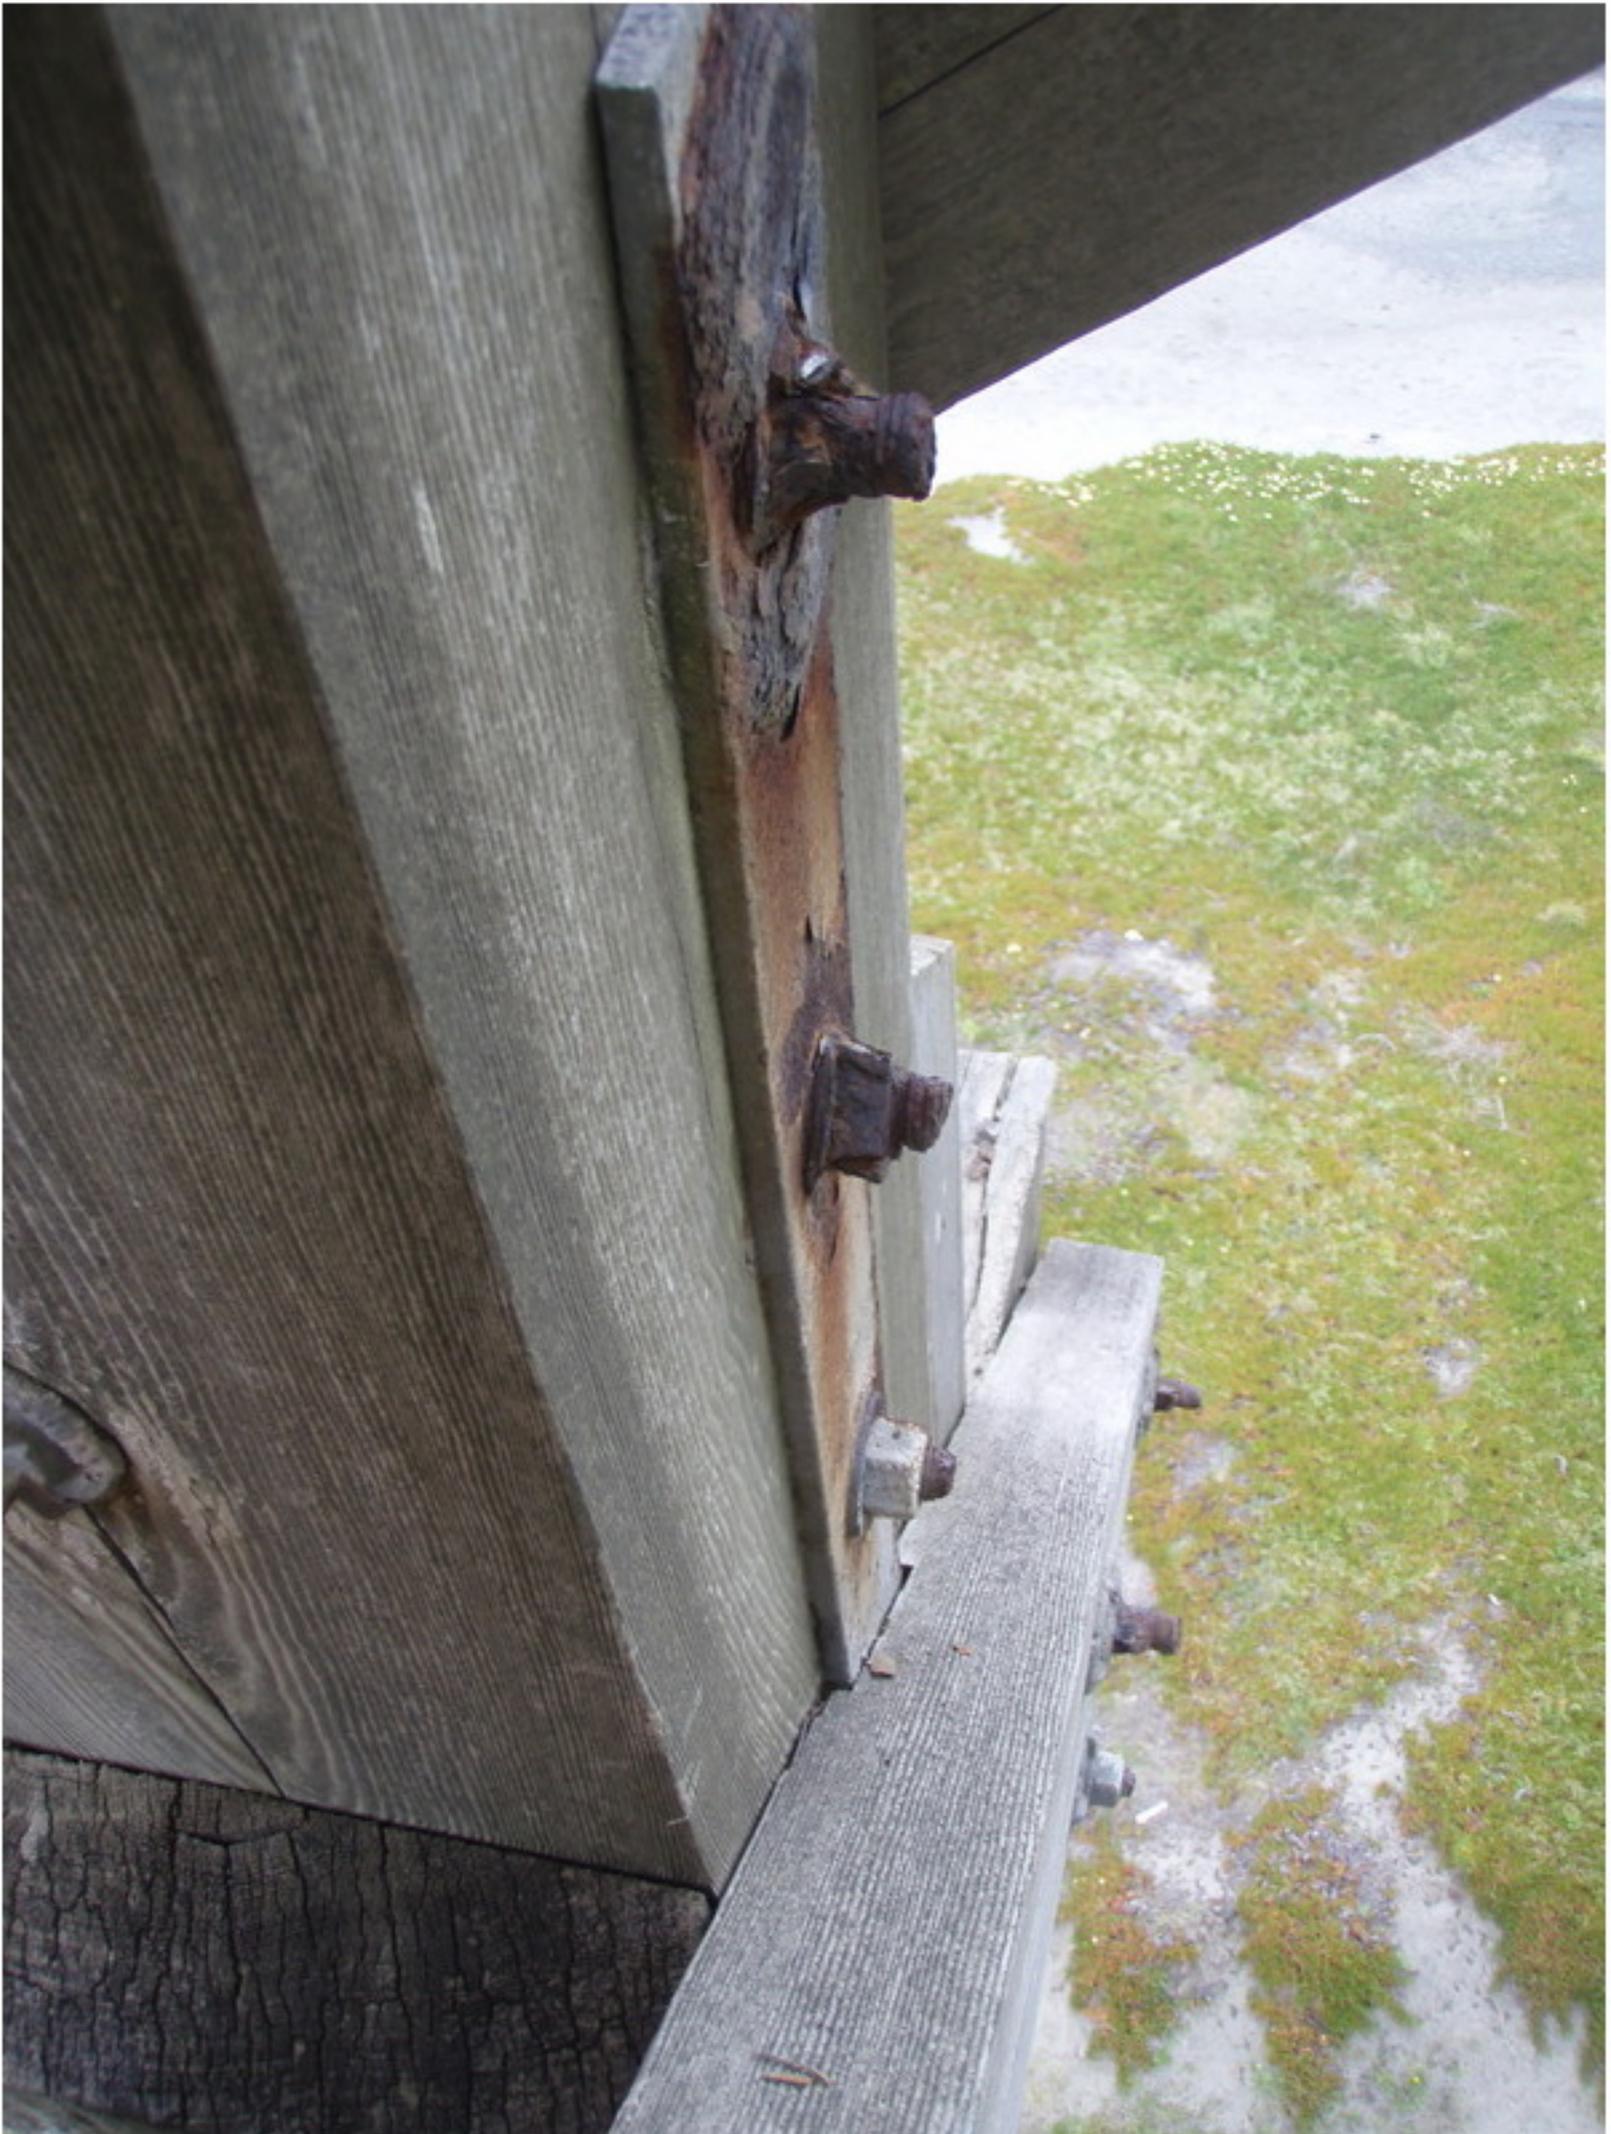
Photo No. 5

Looking down at corroded nuts on threaded rods at a splice plate for Column 1 of Bent 25

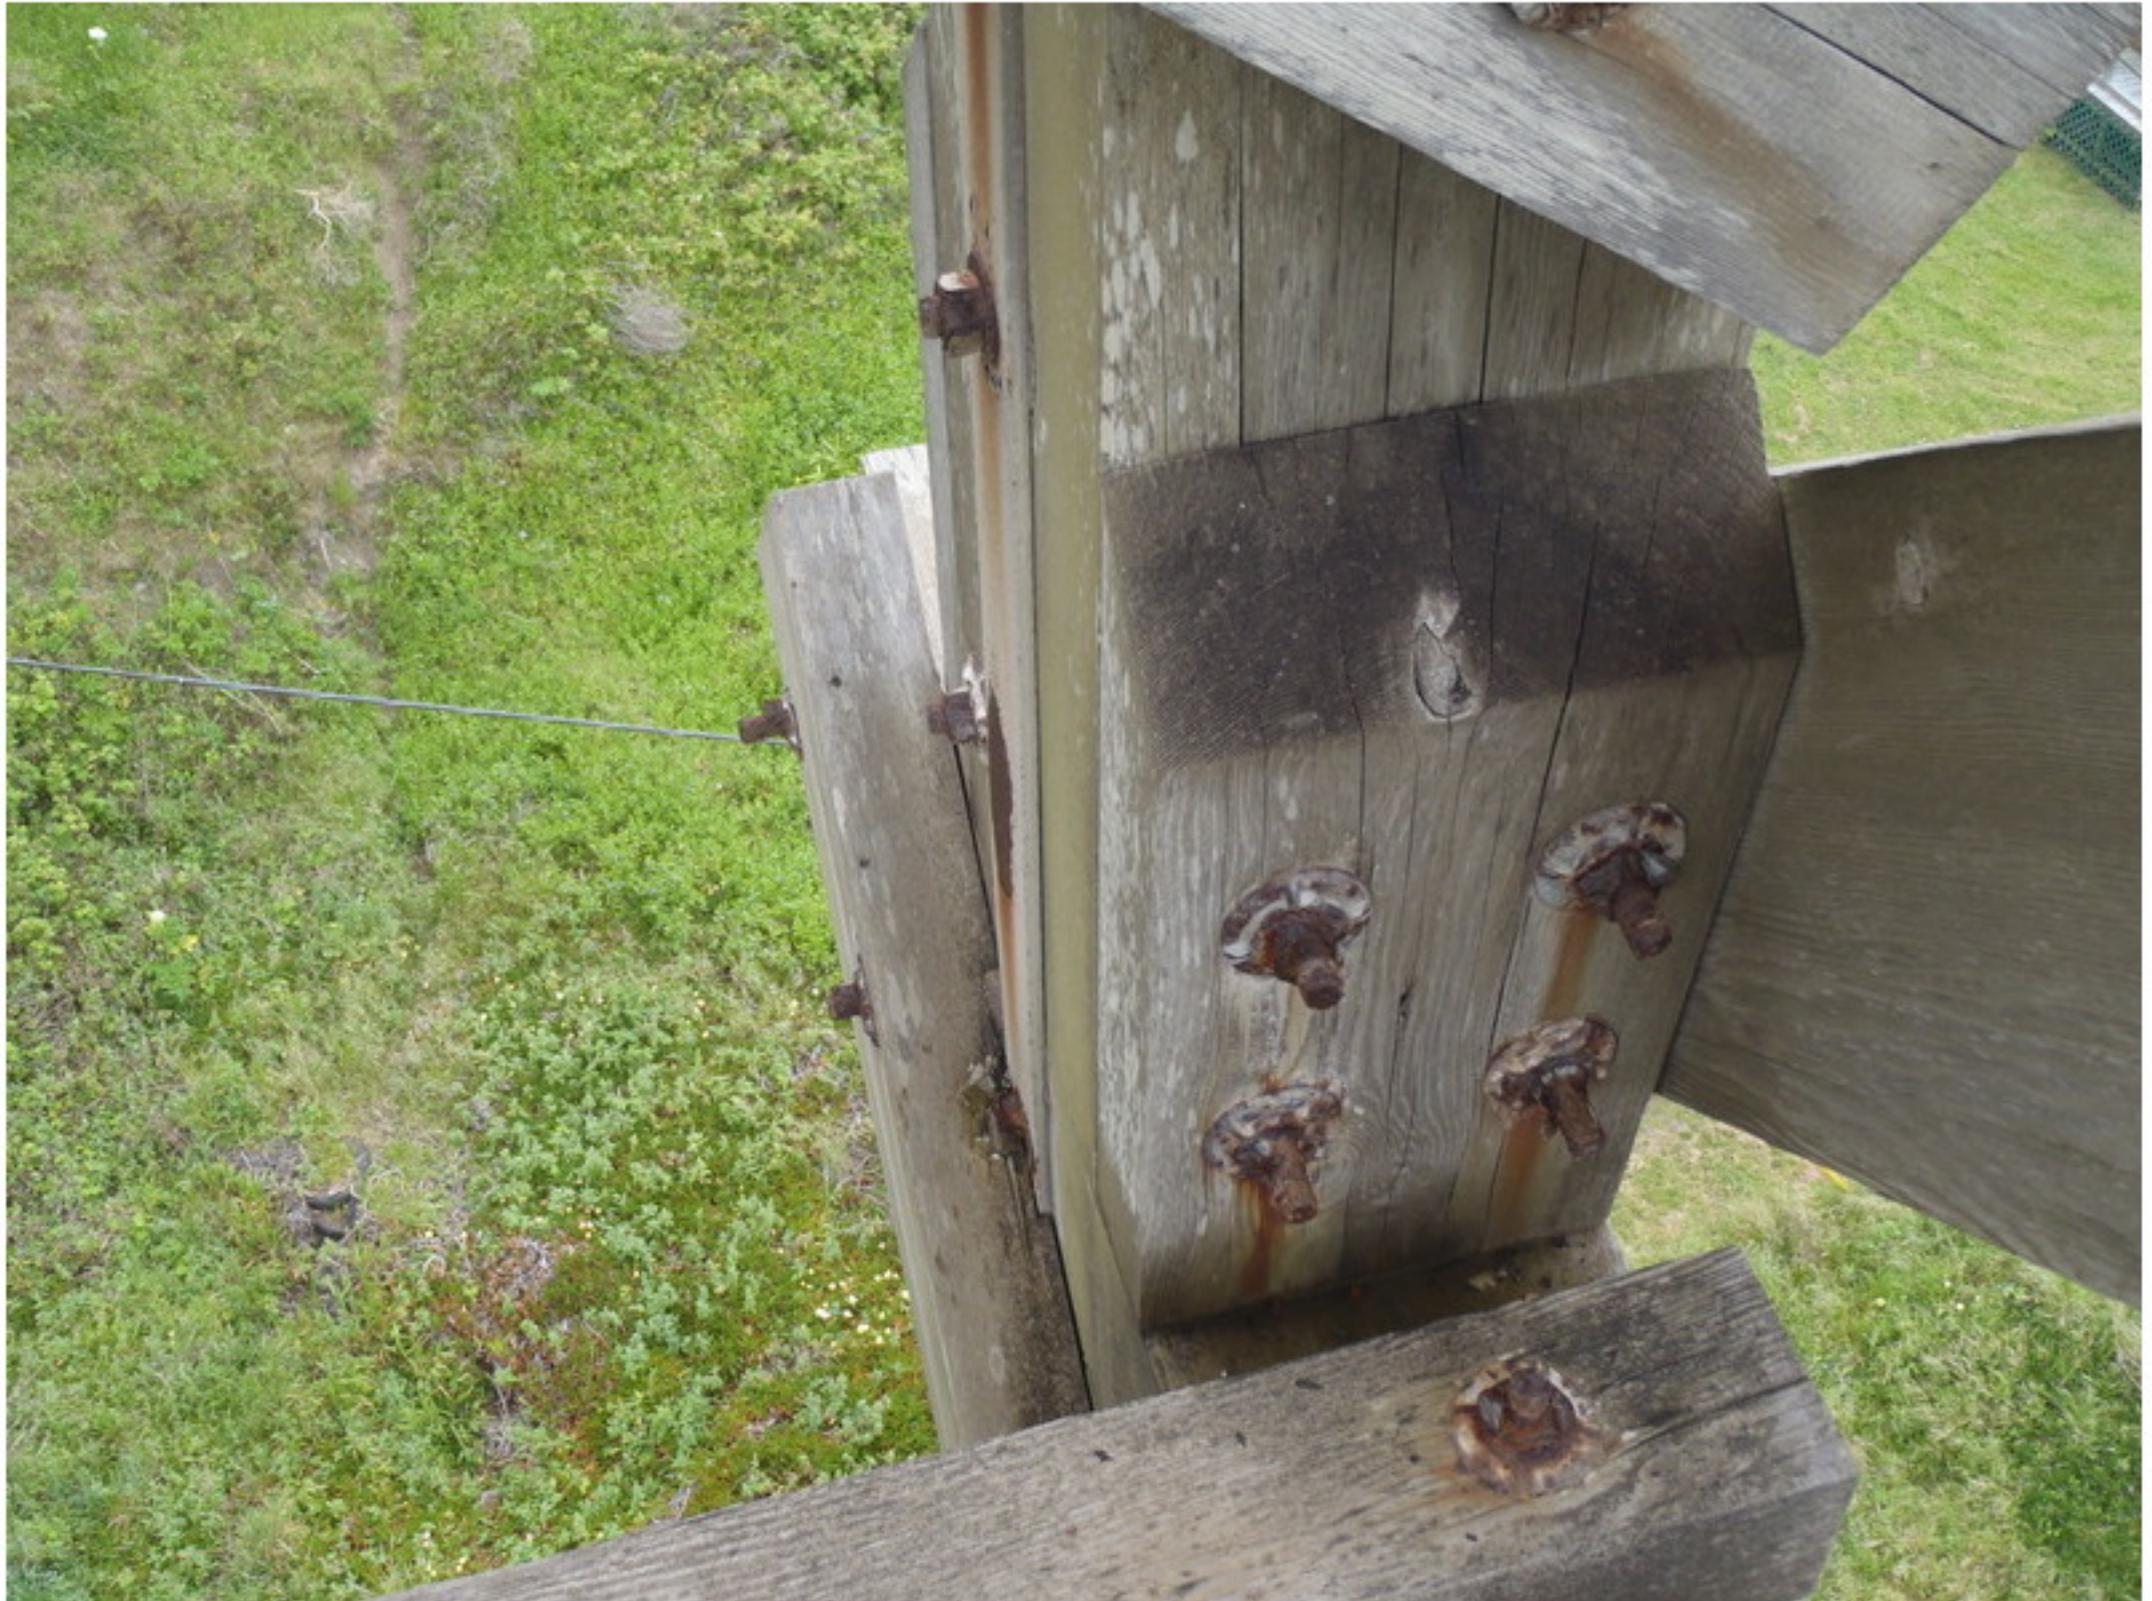
Photo No. 6

Looking down at the corroded nuts on the threaded rods at the third tier/level of Bent 25
