*California Department of Transportation
Division of Maintenance*

Bridge Number : 10 0136
Facility Carried: STATE ROUTE 1
Location : 01-MEN-001-43.74
City :
Inspection Date : 05/15/2012

Bridge Inspection Report

STRUCTURE NAME: ALBION RIVER

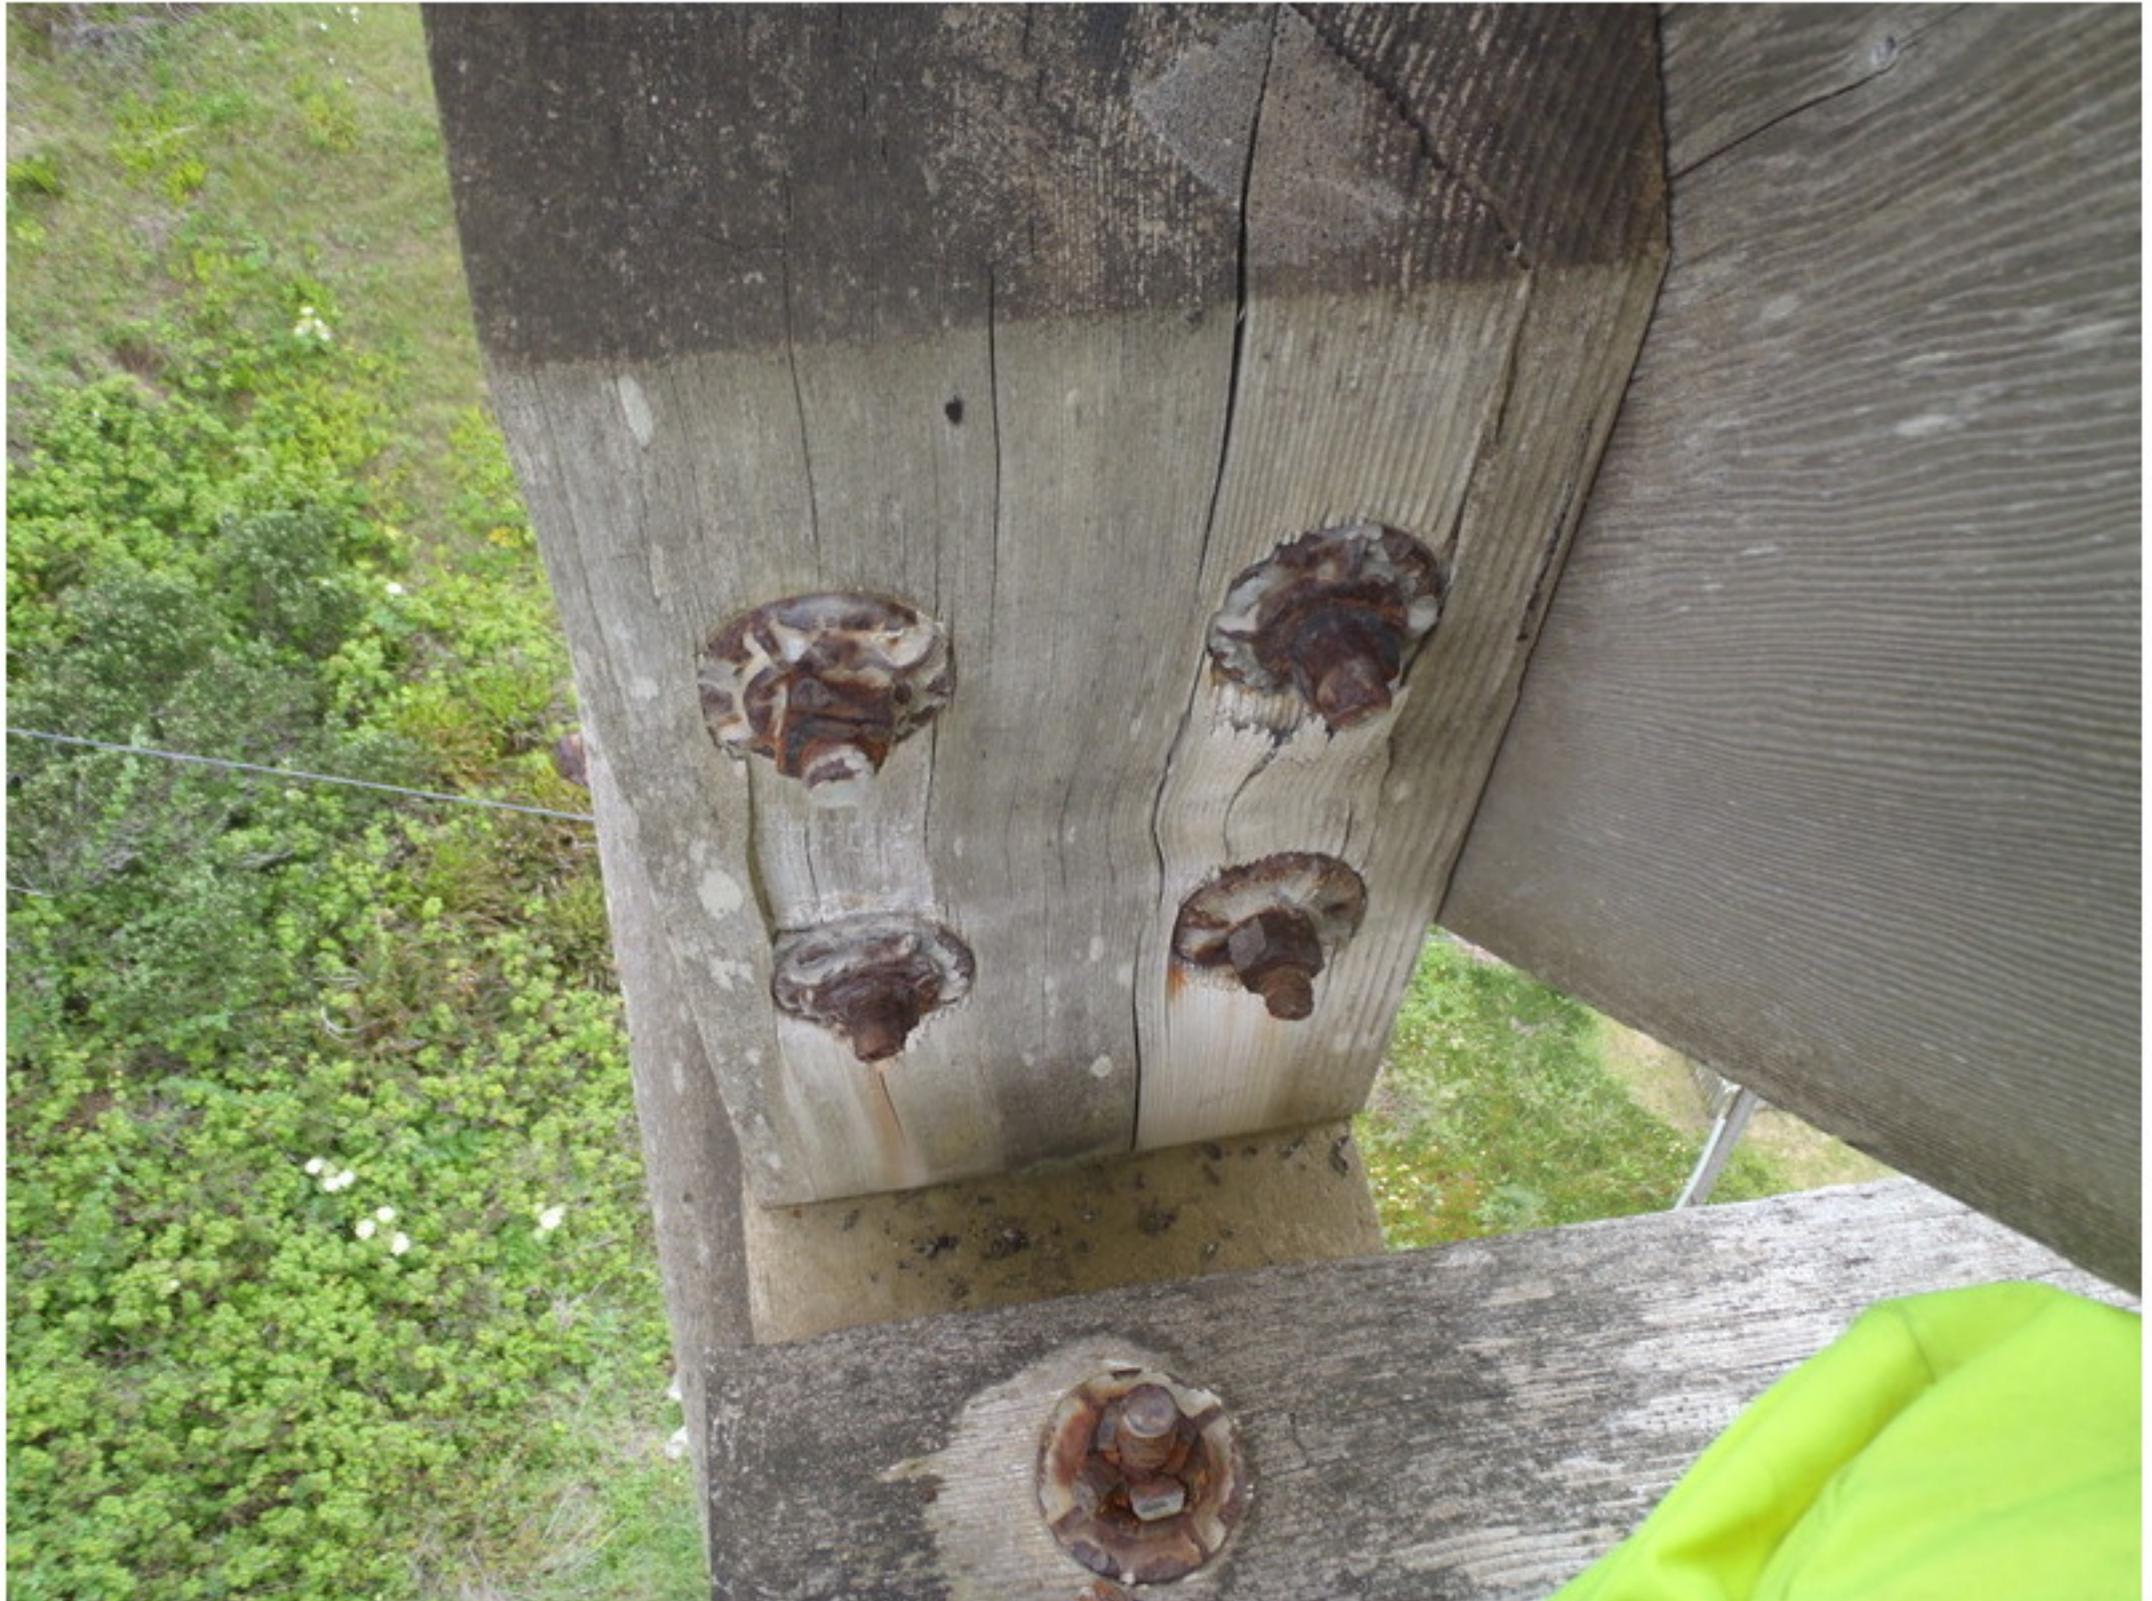
The bolted connections in the towers have historically been replaced by the District 01 Bridge Crew. Currently, on average approximately 50 to 70% of the nuts are failed due to corrosion from the marine environment. (See photos No. 1 thru 10, dated 05/15/12, in BIRIS.) Due to the amount hardware needing replacement, the district should consider having the work done by contract, which should cover replacement of all of the threaded rods and nuts. There are approximately 5,000 threaded rods with nuts that need replacement, 2,500 to 3,500 of which are failed.

At least 15 to 20% of the timber scabs at the connections of the legs/columns between each level have 0.25 to 0.5 inch wide splits where the threaded rods, malleys, and nuts have compressed and distorted the wood. (See photos 2, 7, & 9, dated 5/15/2012, in BIRIS.)

Photo No. 7
Looking down at the corroded nuts on the threaded rods at the first tier/level of Bent 26

Remove and replace the steel bolted connections and hardware (threaded rods, malleys, nuts, straps, etc.) and timber scabs throughout the entire timber sub-structure as necessary. Work By: Bridge Crew. Estimated cost: \$75,000.

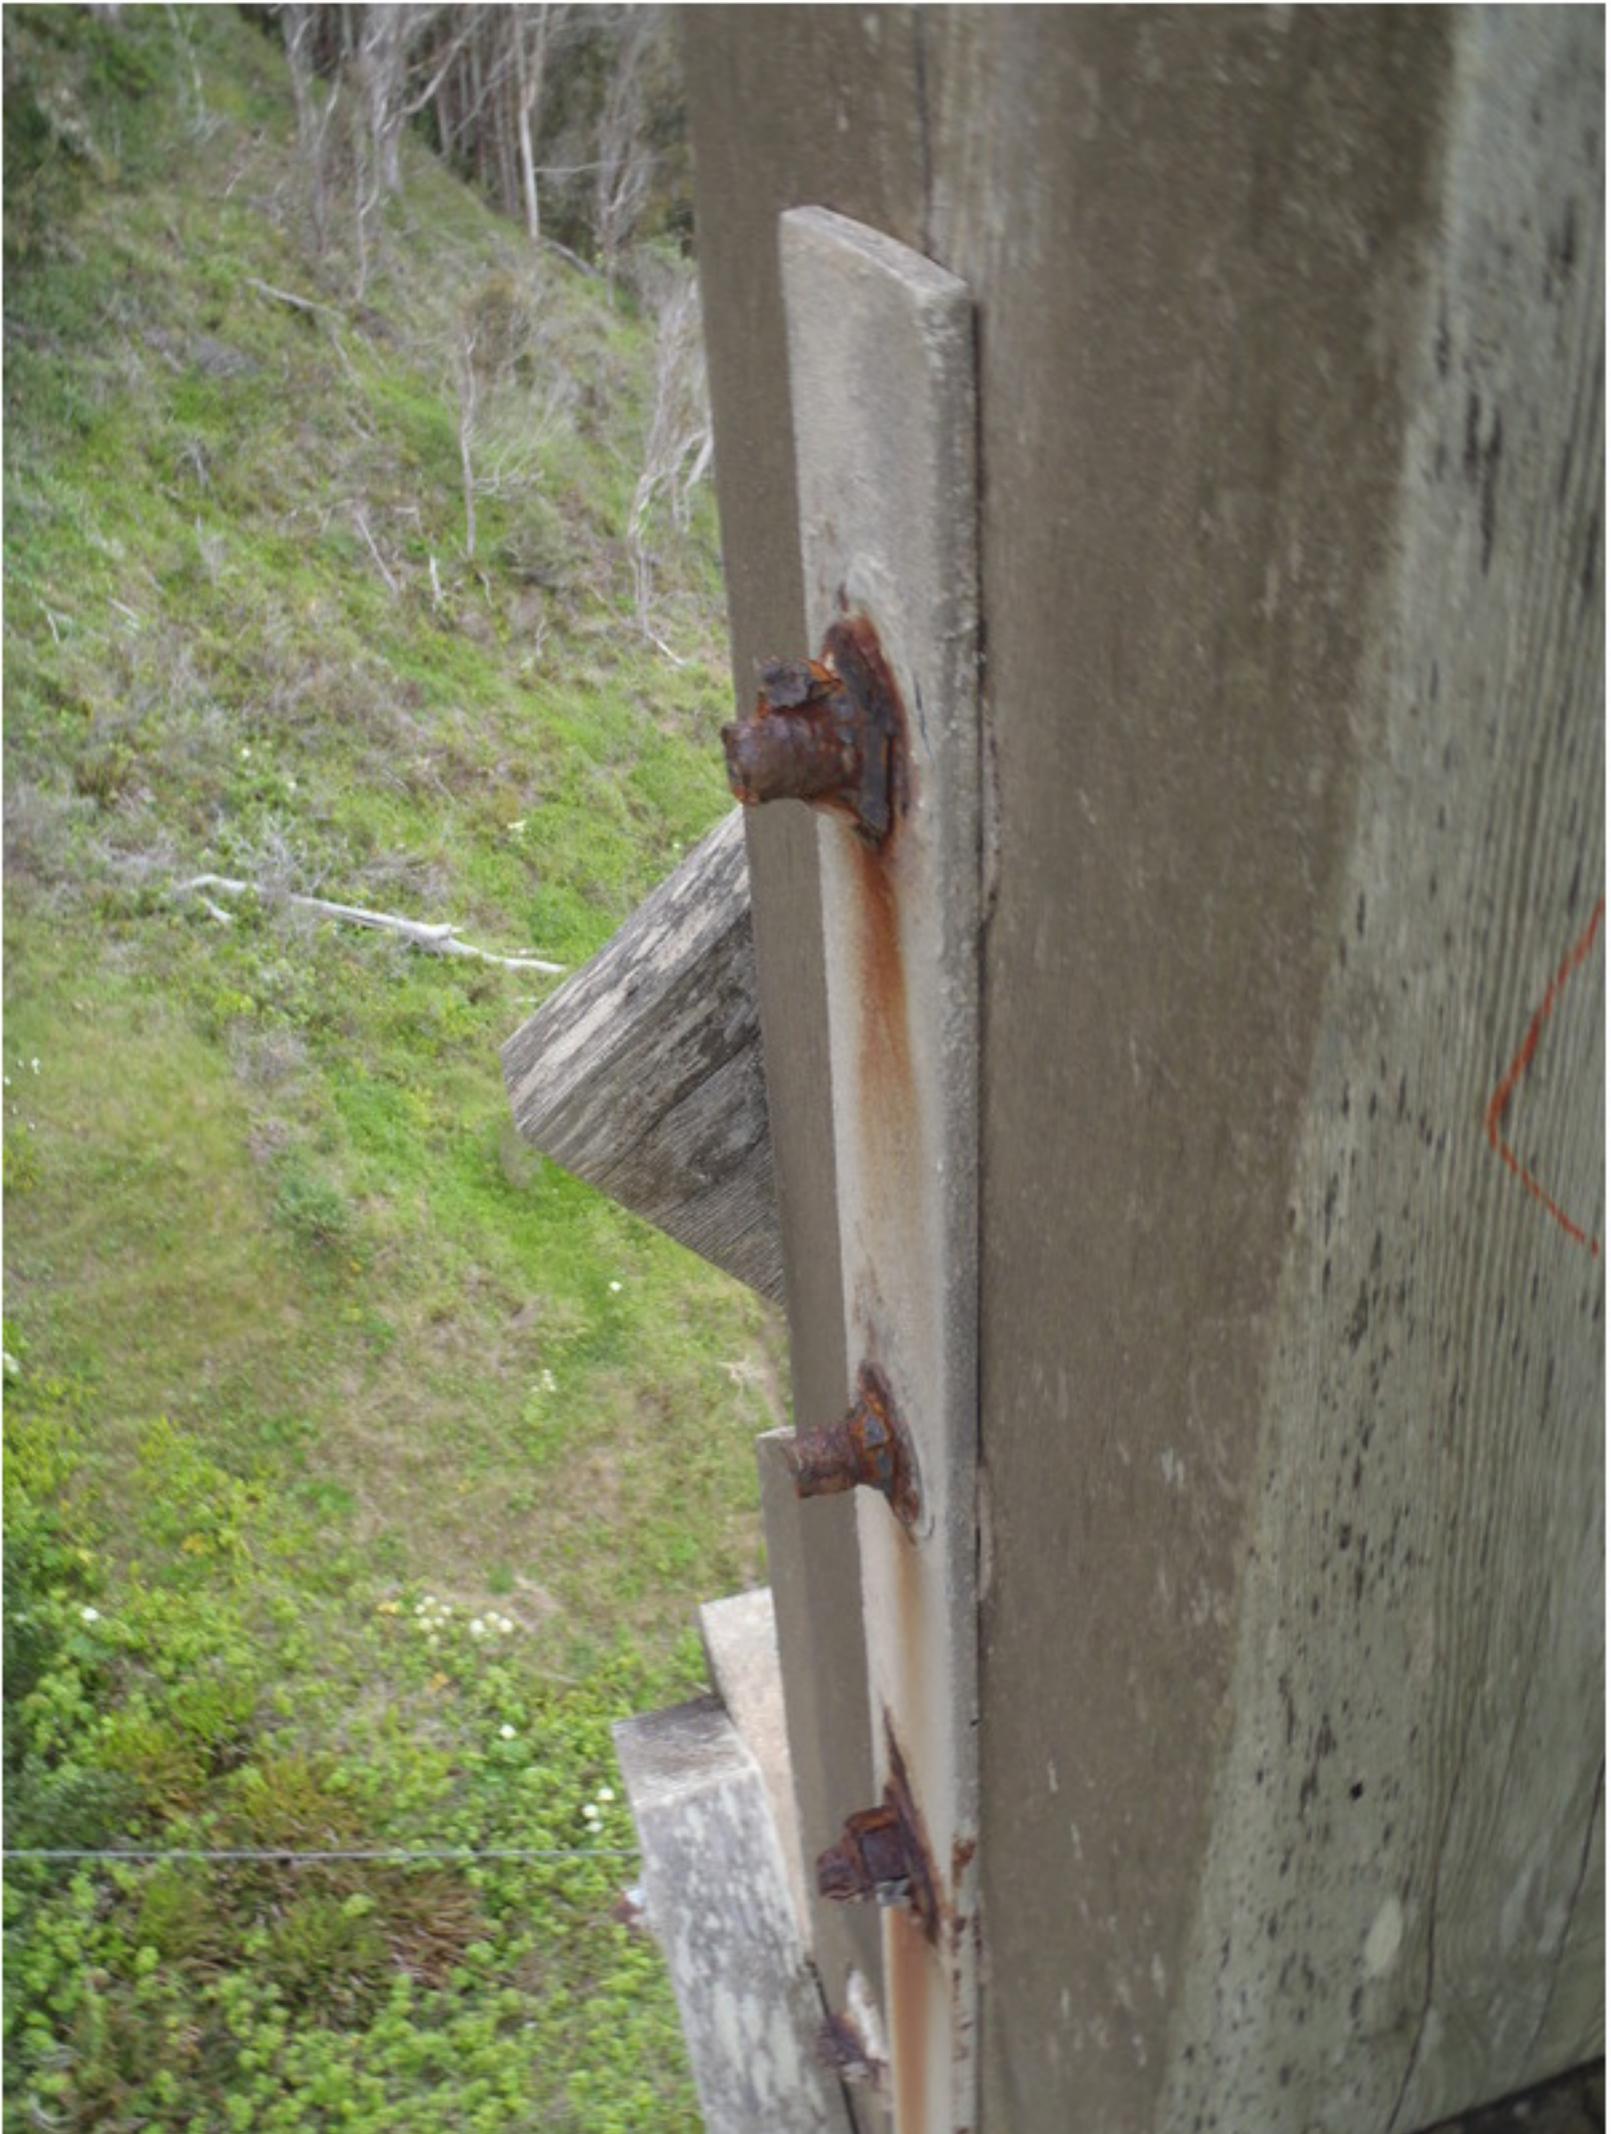
Photo No. 8

The steel straps located at every level, which connect/tie the timber legs/columns between each level to the ones above or below across the horizontal timber beams, have moderate to severe areas of corrosion. (See photos 1, 3, 5, 6, & 8, dated 5/15/2012, in BIRIS.)

Looking down at corroded nuts on threaded rods at a splice plate for Column 4 of Bent 26

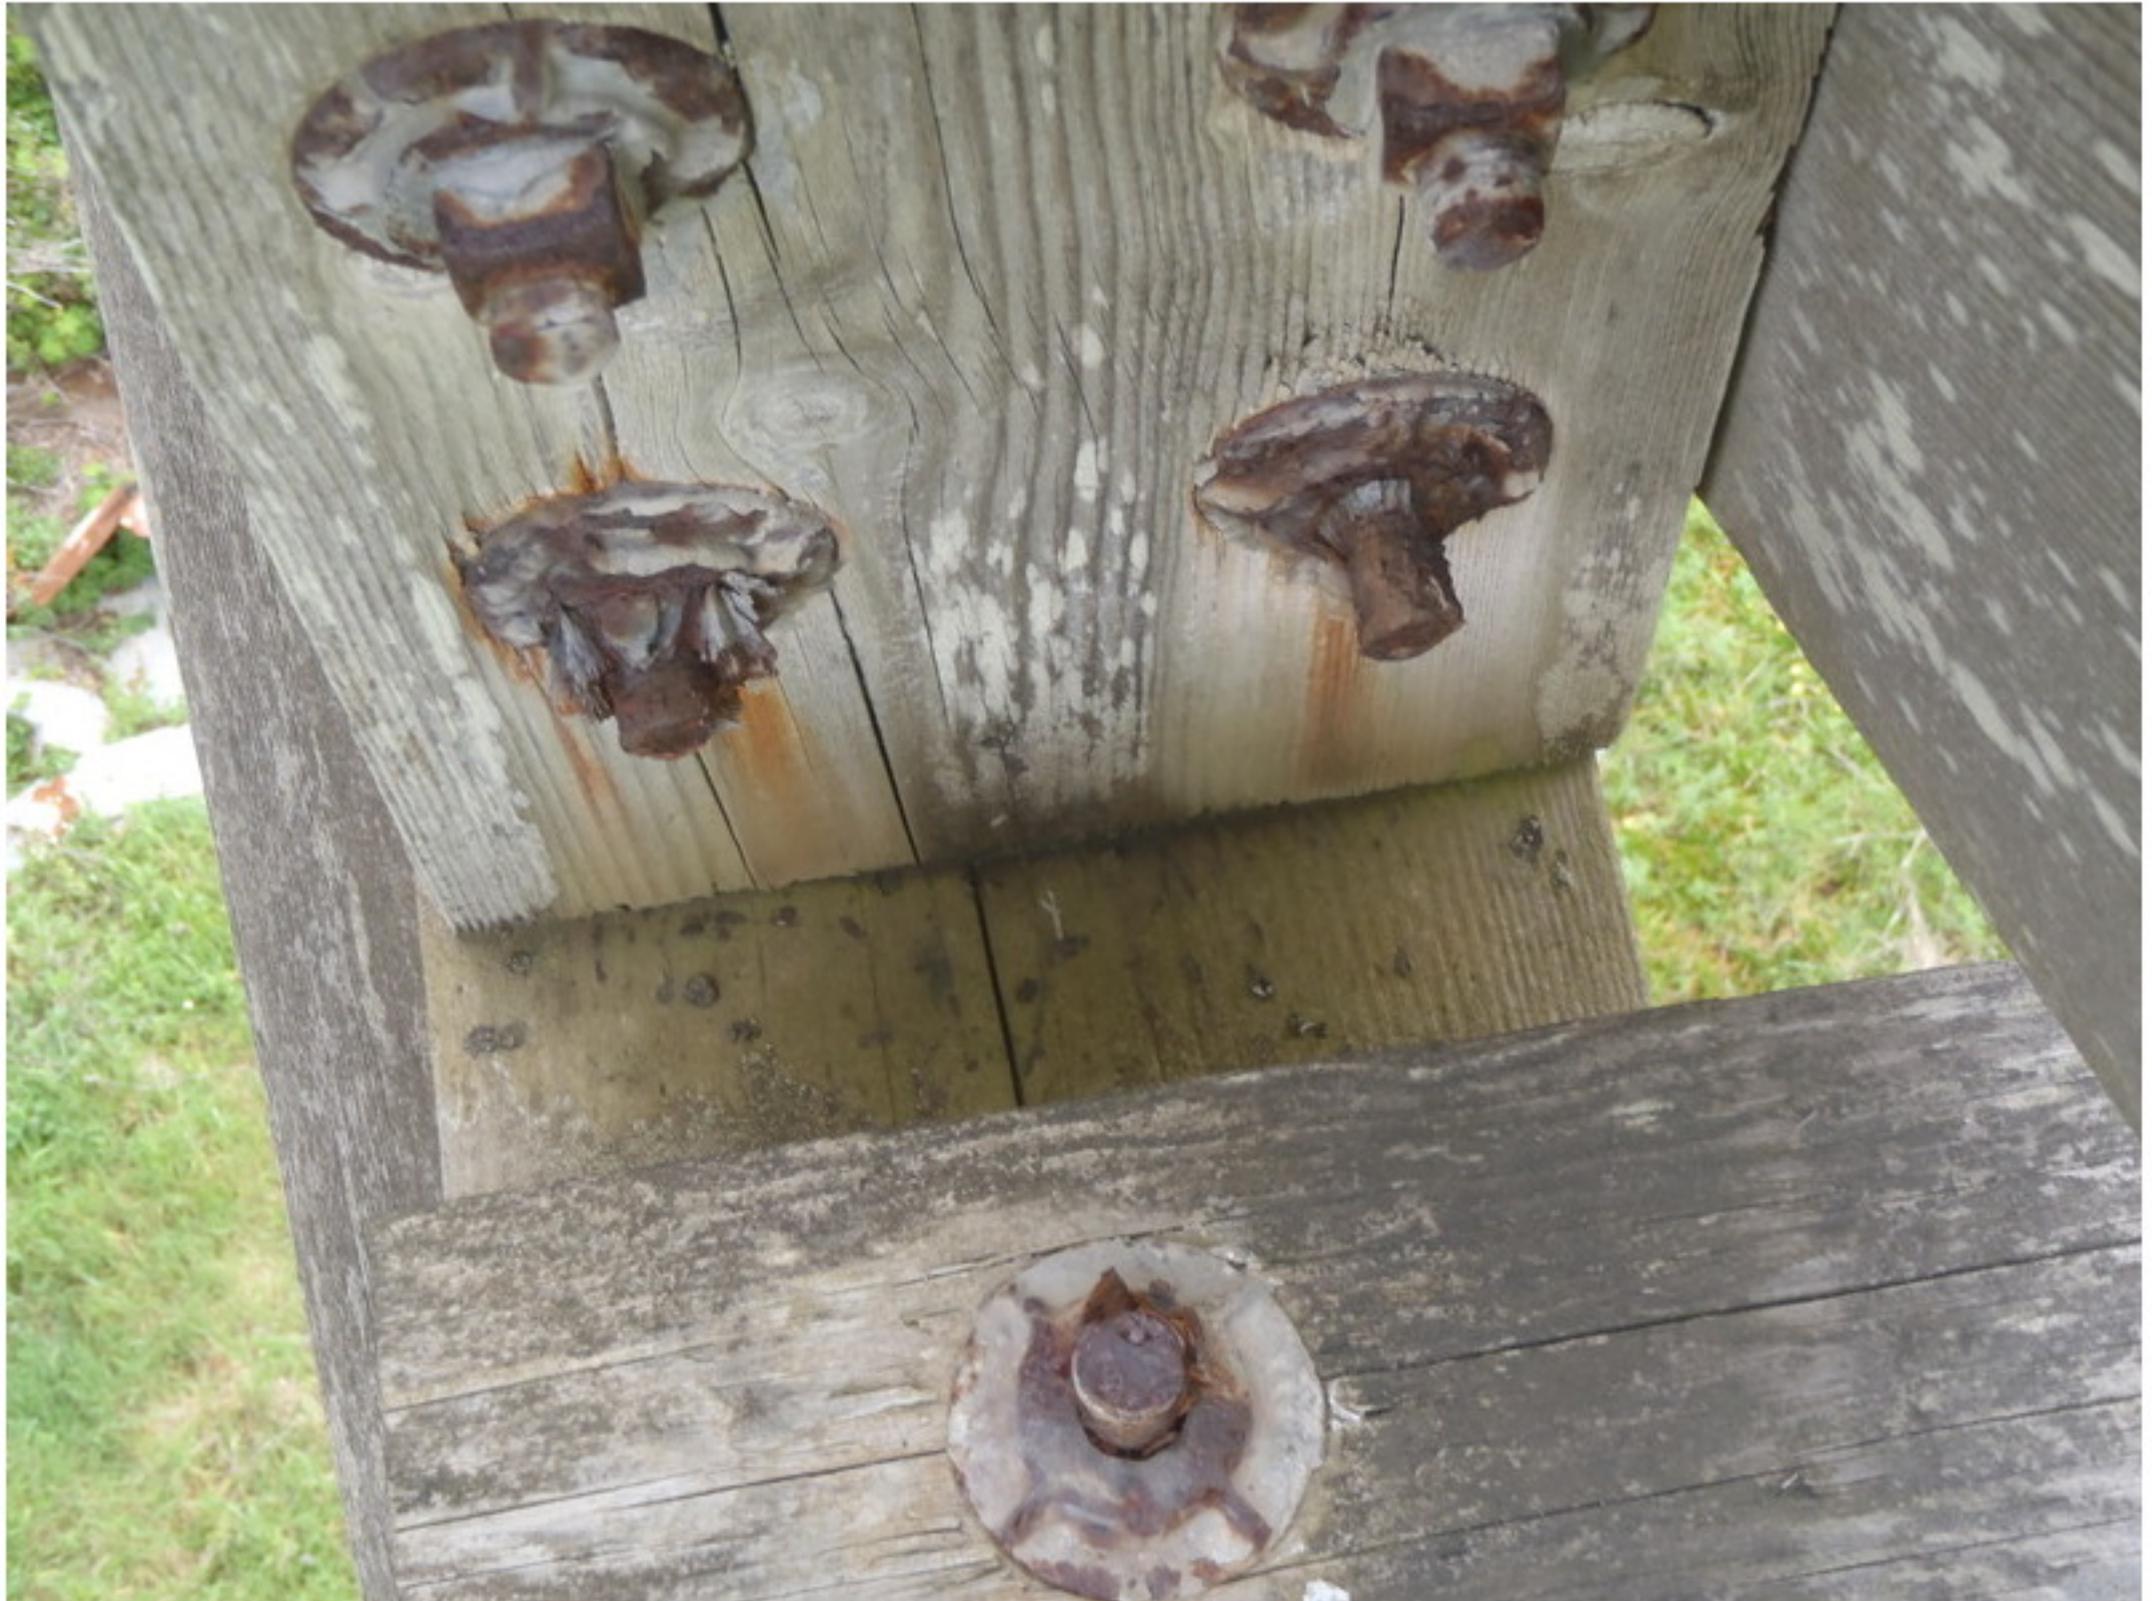
Photo No. 9

Looking down at the corroded nuts on the threaded rods at the fifth tier/level of Bent 26

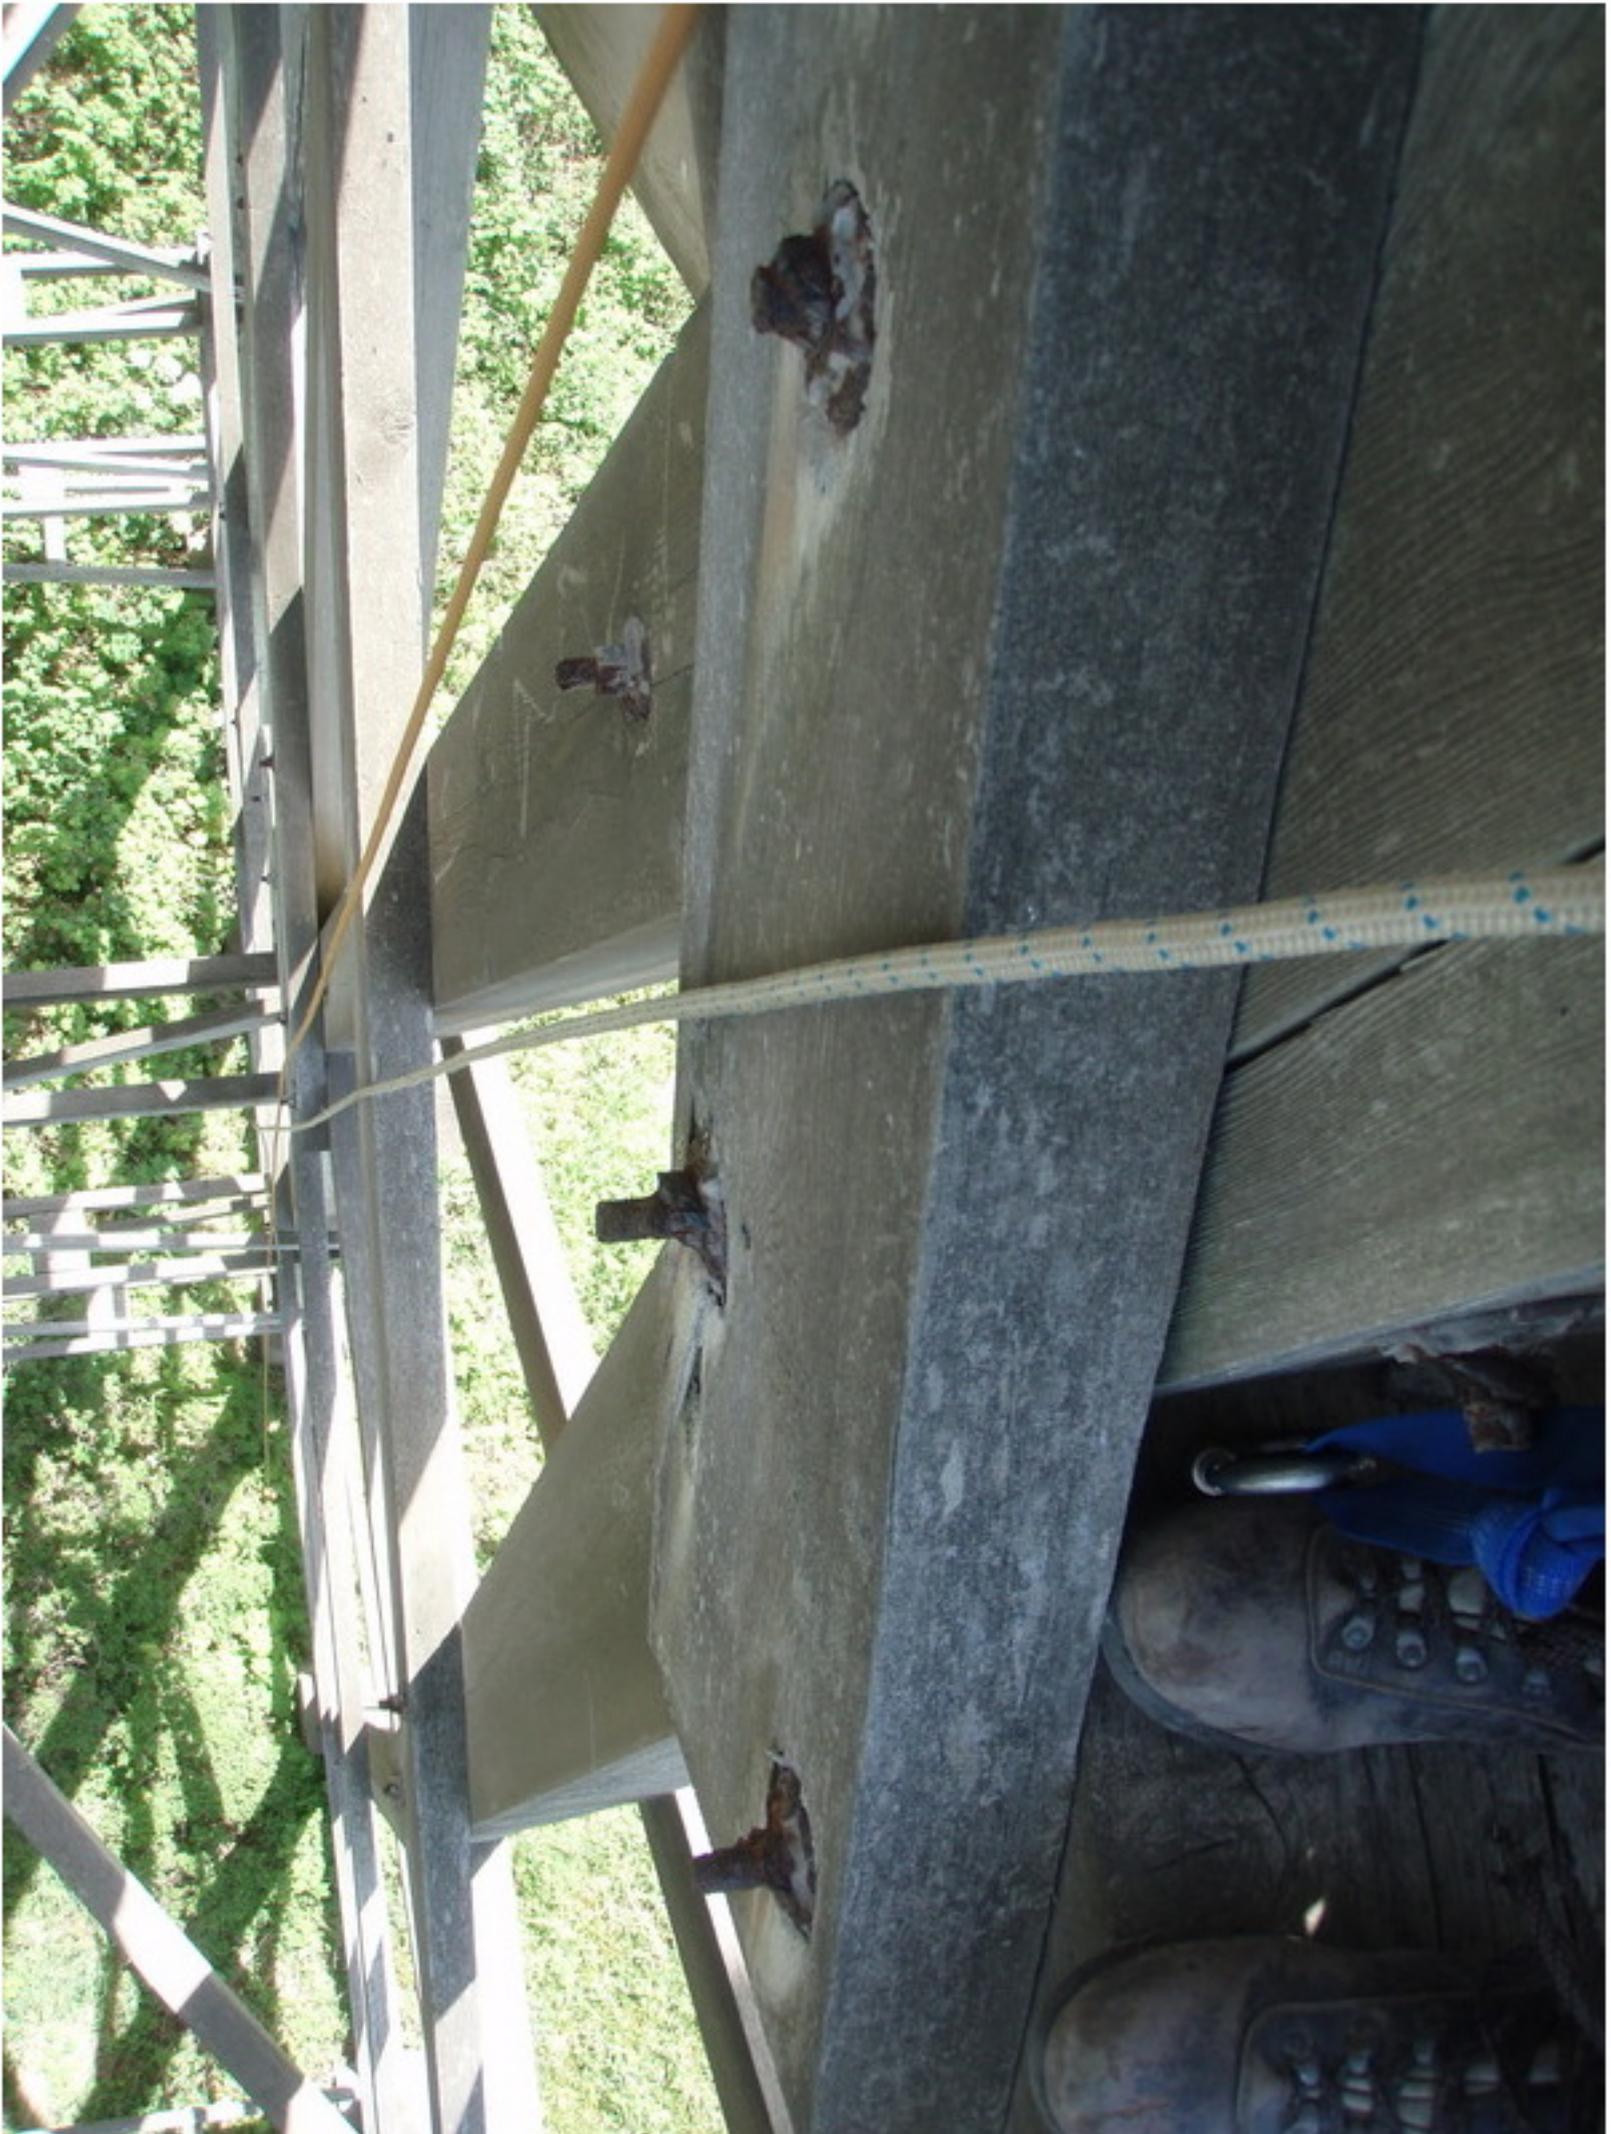
Photo No. 10
Looking down at the corroded nuts on the threaded rods at the third tier/level of Bent 27
