PRELIMINARY GEOTECHNICAL RECOMMANDATION

File: 04-NAP-128 PM 29.7
04-2G9501
Slipout Repair

Subject: Preliminary Geotechnical Recommendation

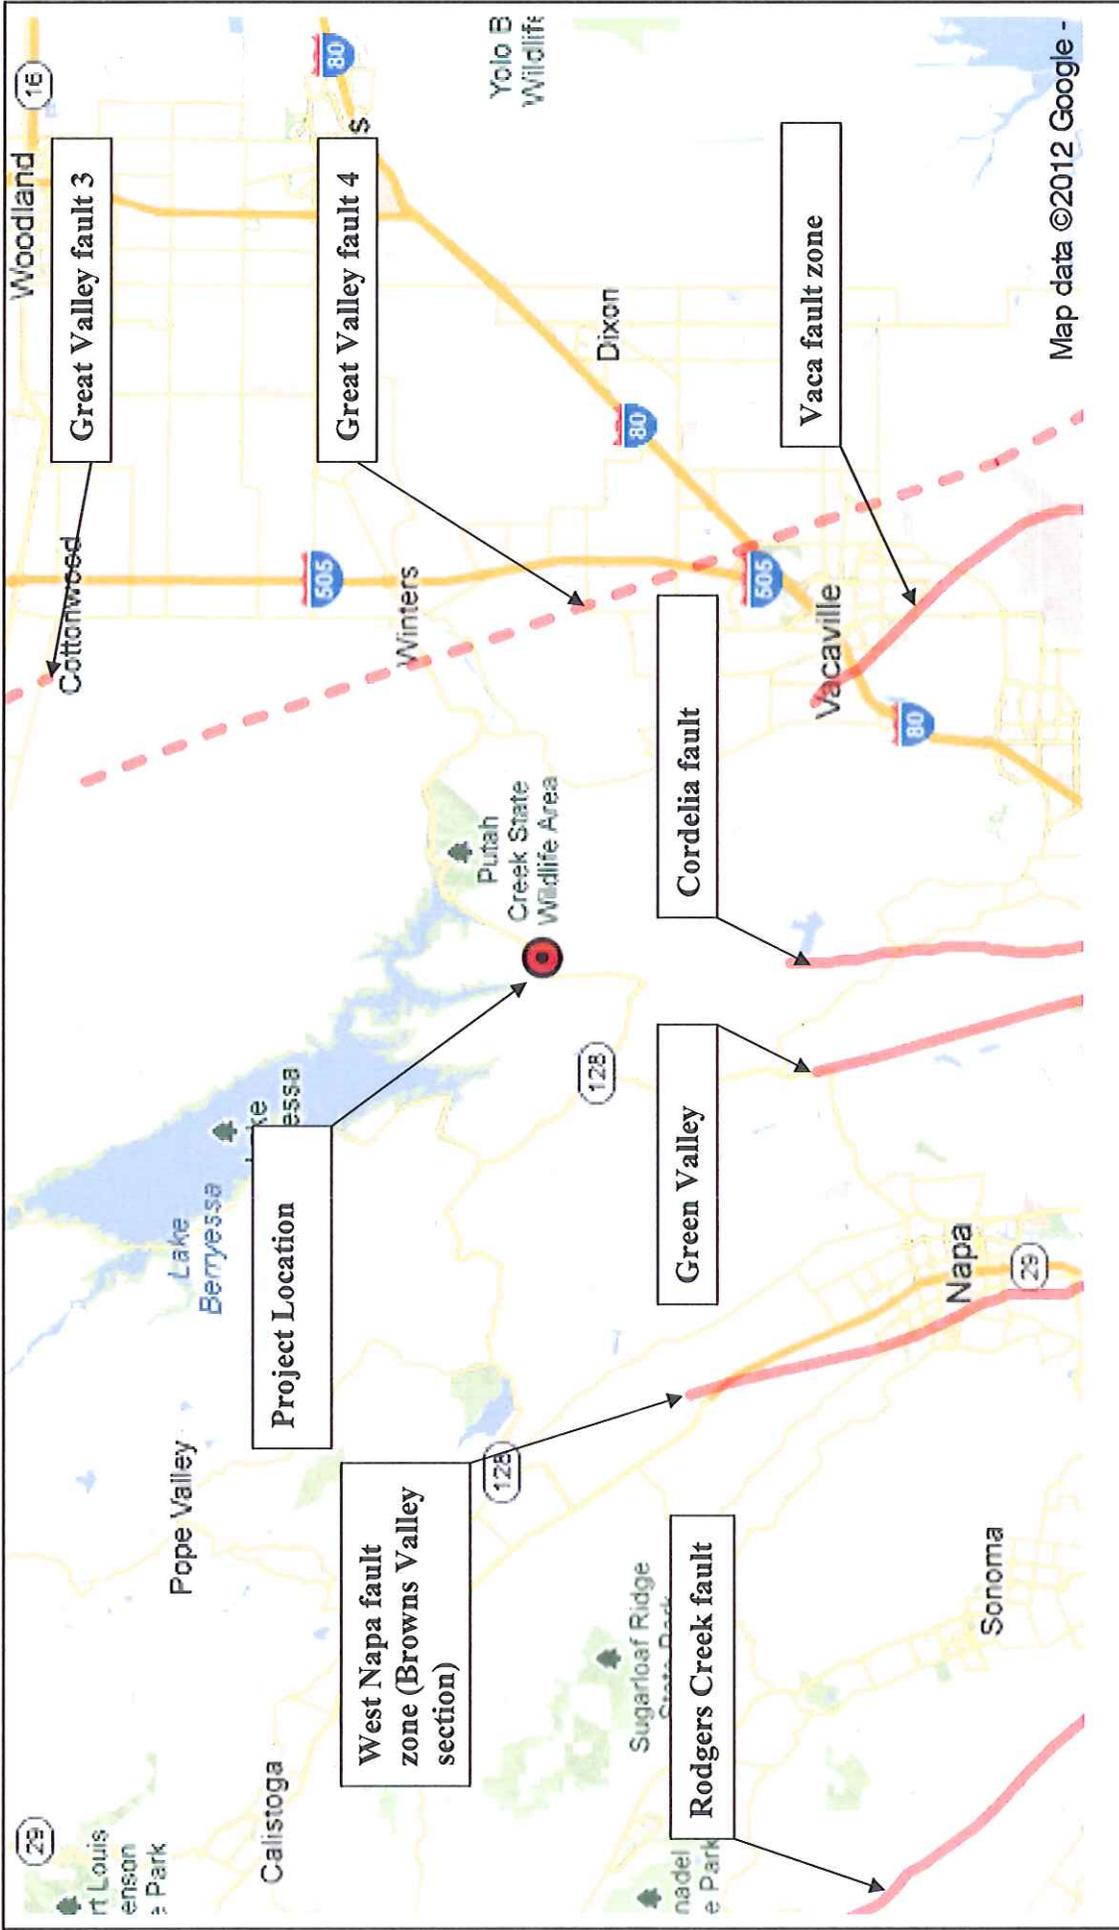
<p>Engineering Service Center DIVISION OF ENGINEERING SERVICES OFFICE OF GEOTECHNICAL SERVICES GEOTECHNICAL DESIGN BRANCH (WEST) – BRANCH B</p>	<p>SCALE Not to Scale</p>
<p>04NAP-128 PM 29.77</p>			<p>FAULT MAP EFIS 0400021255 NOVEMBER 2012 FIGURE 4</p>

The controlling fault for the project is Great Valley fault 4. Fault data is present in Table 1, and fault locations presented on Figure 4. The highest PGA is 0.682. This PGA was calculated with the USGS Probabilistic model, using the USGS Seismic Hazard Map (2008) and a 975 year return period. According to the Alquist-Priolo Earthquake Fault Zone Maps, there are no surface faults within the limits of the project site, so surface rupture should not be an issue, see attached Exhibit B.
