M e m o r a n d u m*Flex your power!
Be energy efficient!***To:** Jiwanjit Palaha – District 07
Project Manager**Date:** January 16, 2012**Attention:** Giap Hoang, Project Engineer**File:** 07-LA-10-PM 42.5
EA: 07-3X0101
Slope Stability Analysis**From:** DEPARTMENT OF TRANSPORTATION
DIVISION OF ENGINEERING SERVICES
Geotechnical Services
Office of Geotechnical Design South 1
Branch B**Subject:** Revised Geotechnical Investigation Report for 57-10 Interchange Cut Slope near Station 15+00

The site is located east of the I-10 WB to SR-57 NB Connector facing the westerly direction. The slope is in a cut located at postmile 42.5 near I-10 WB to SR 57 NB Connector Alignment Station 15+00. The top of the slope being evaluated is approximately 250 feet above the ramp roadway grade. Based on measurements made in the field and cross sections provided to our office the slope is at a 1.7:1 grade within the bottom 100 feet and steepens to a 1.5:1 grade within 100 to 200 feet above the travel way elevation. At the present time, no distress was observed along the slope face or within the travel way at the toe of the slope. Photos of the cut slope are attached to this memo in Appendix A. A Vicinit

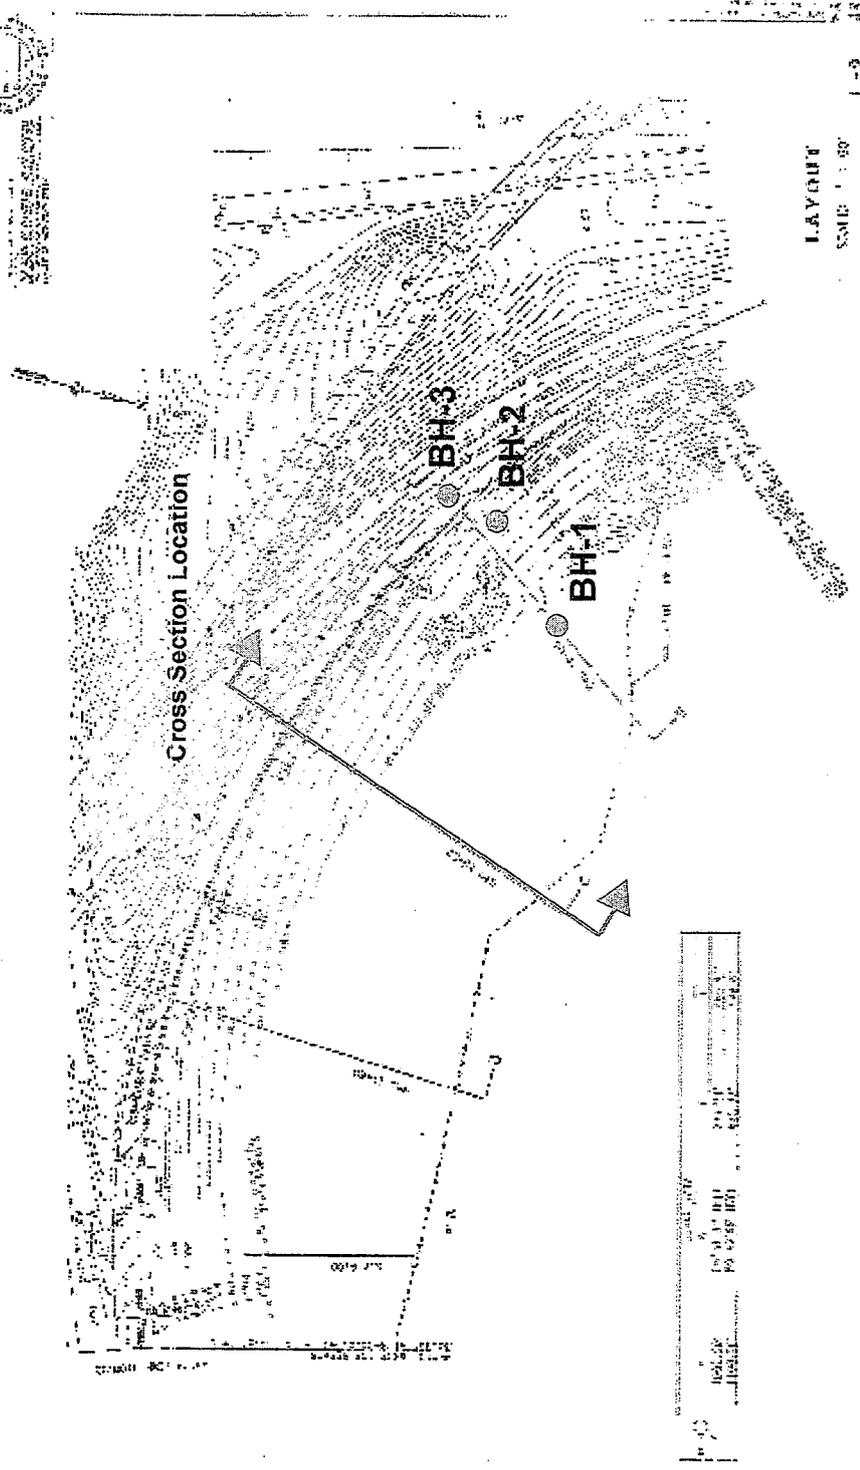
Boring Location Plan- Figure 2

The geotechnical investigation for this project consisted of obtaining soil boring information from the investigation performed for the September 8th Report. From that investigation, two exploratory borings were drilled within the buttress repair area to the north. The borings, labeled as BH-1 and BH-2 were drilled along the slope face to depths of 55 feet and 48 feet, respectively. The borings from this buttress area were applied to the project area due to the similarity of the formational materials. The borings were advanced utilizing a mud rotary method with a CS 2000 drill rig for BH-1 and CS-1000 track mounted rig for BH-2. Both rigs were equipped with an automatic hammer. Boring locations were determined based upon field observations. The elevation of the boring locations is based on layout plans provided by District

Design. A third boring, BH-3, was performed to collect a bulk sample at the toe of the slope. Figure 2 included as an attachment shows the location of the borings.

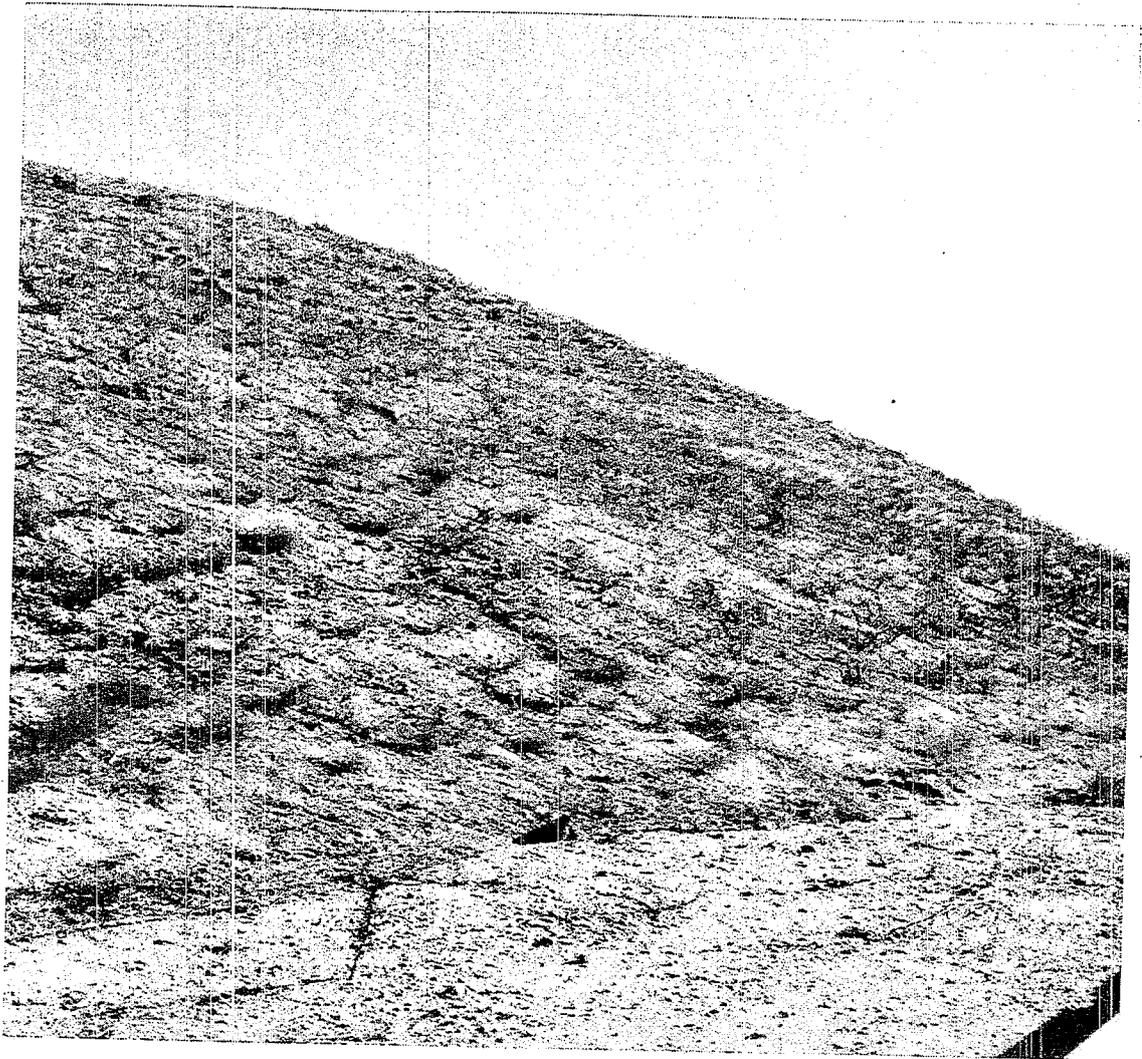
Photo 1 – View of Slope from Northwest

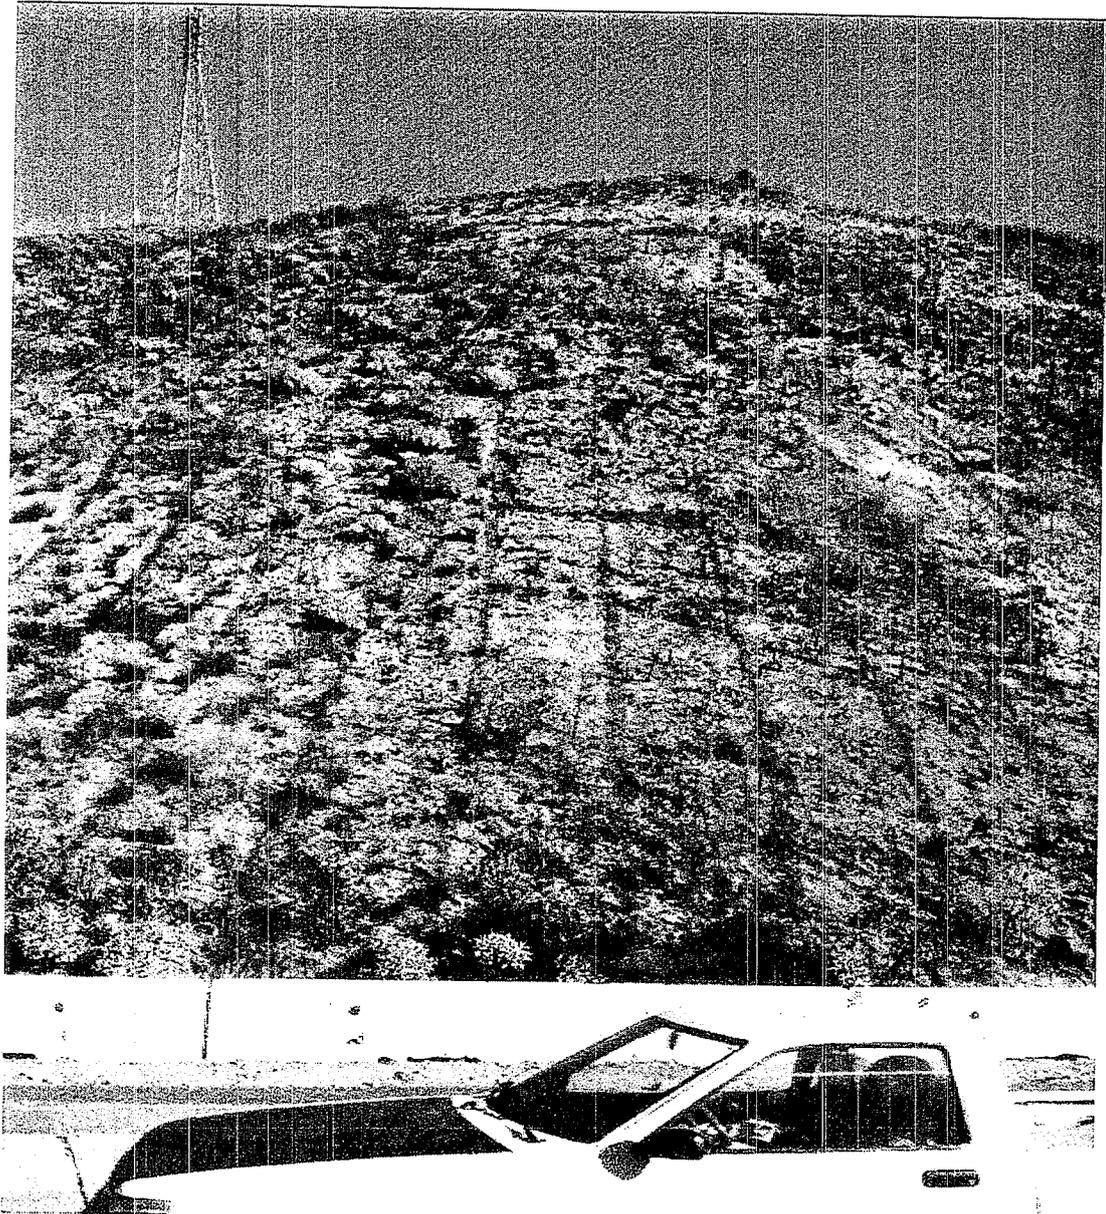
Photo 2 – View of Slope from West

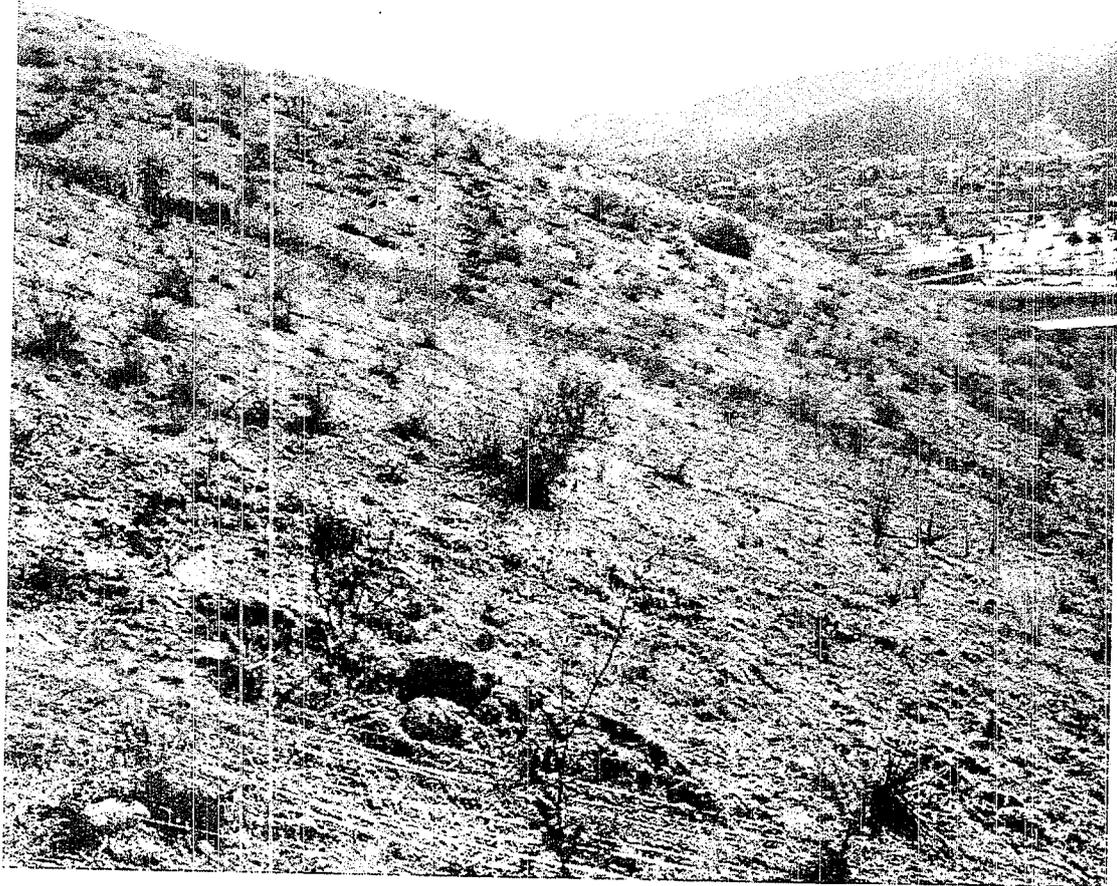
Photo 3 – View of Slope from North

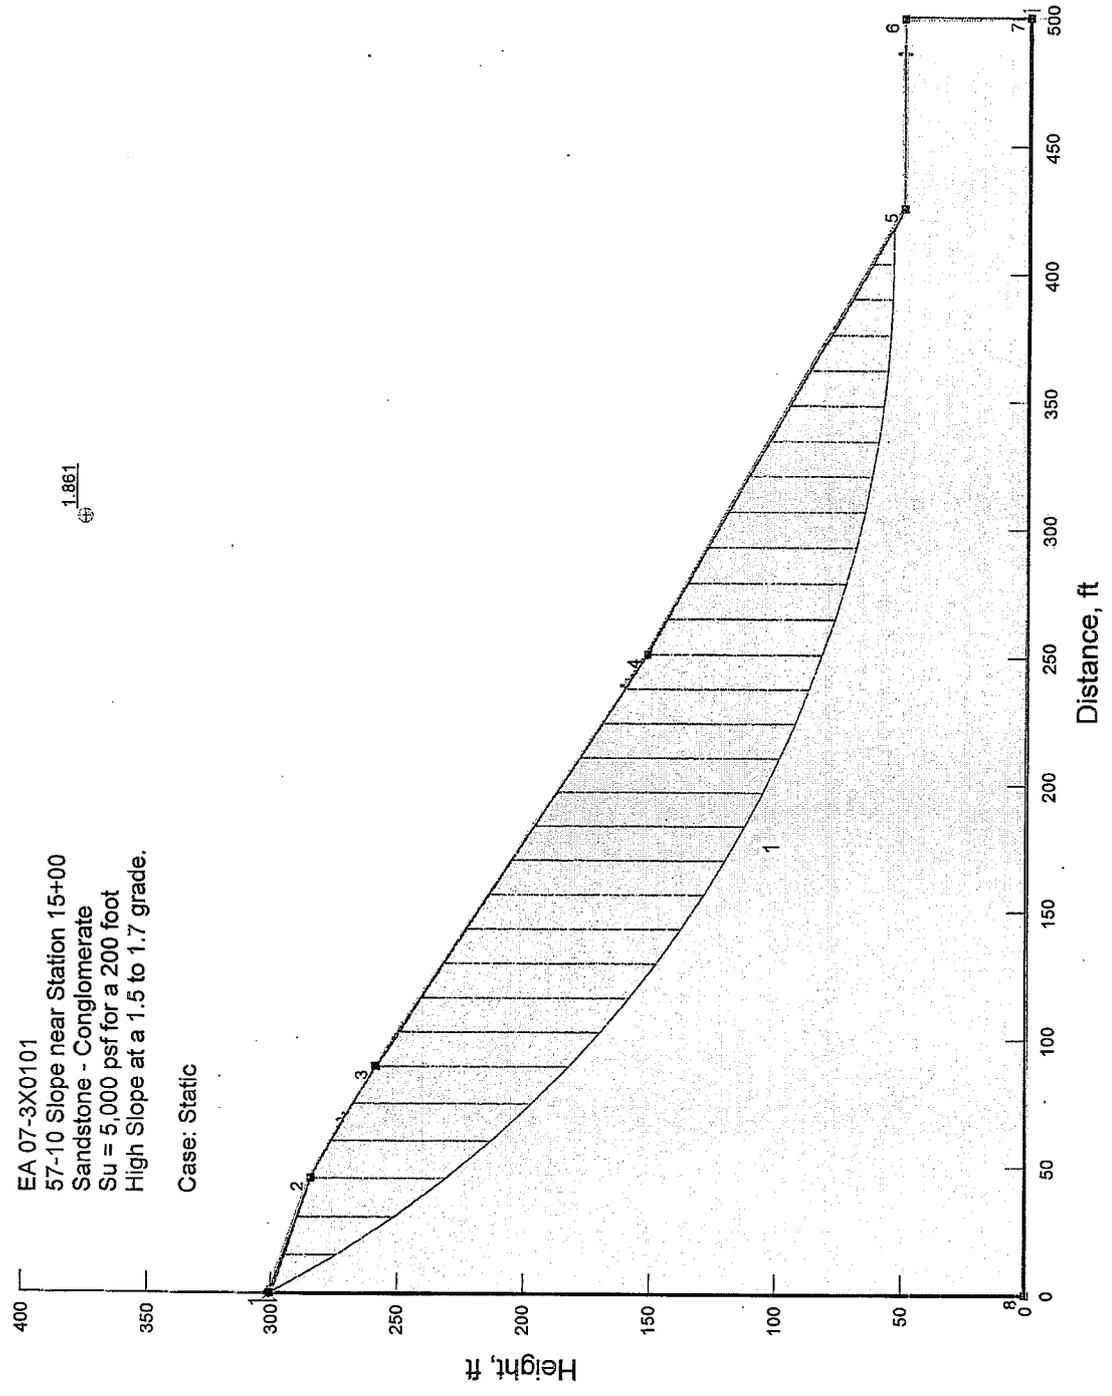
Figure A-1

Results of the analysis are shown in Appendix B as Figures B-1 and B-2. Figure B-1 shows the static case where the factor of safety is 1.86. Per the Bridge Design Specifications, BDS (April 2000, Section 4.4.9) the minimum factor of safety for static conditions is 1.5. Figure B-2 shows stability results under seismic conditions. Based on a PGA of 0.5g a pseudostatic coefficient of 0.2 was used in the analysis. The Factor of Safety generated was 1.22. the minimum factor of safety under seismic conditions should exceed 1.1.

EA 07-3X0101
 57-10 Slope near Station 15+00
 Sandstone - Conglomerate
 Su = 5,000 psf for a 200 foot
 High Slope at a 1.5 to 1.7 grade.

④ 1.861

Case: Static

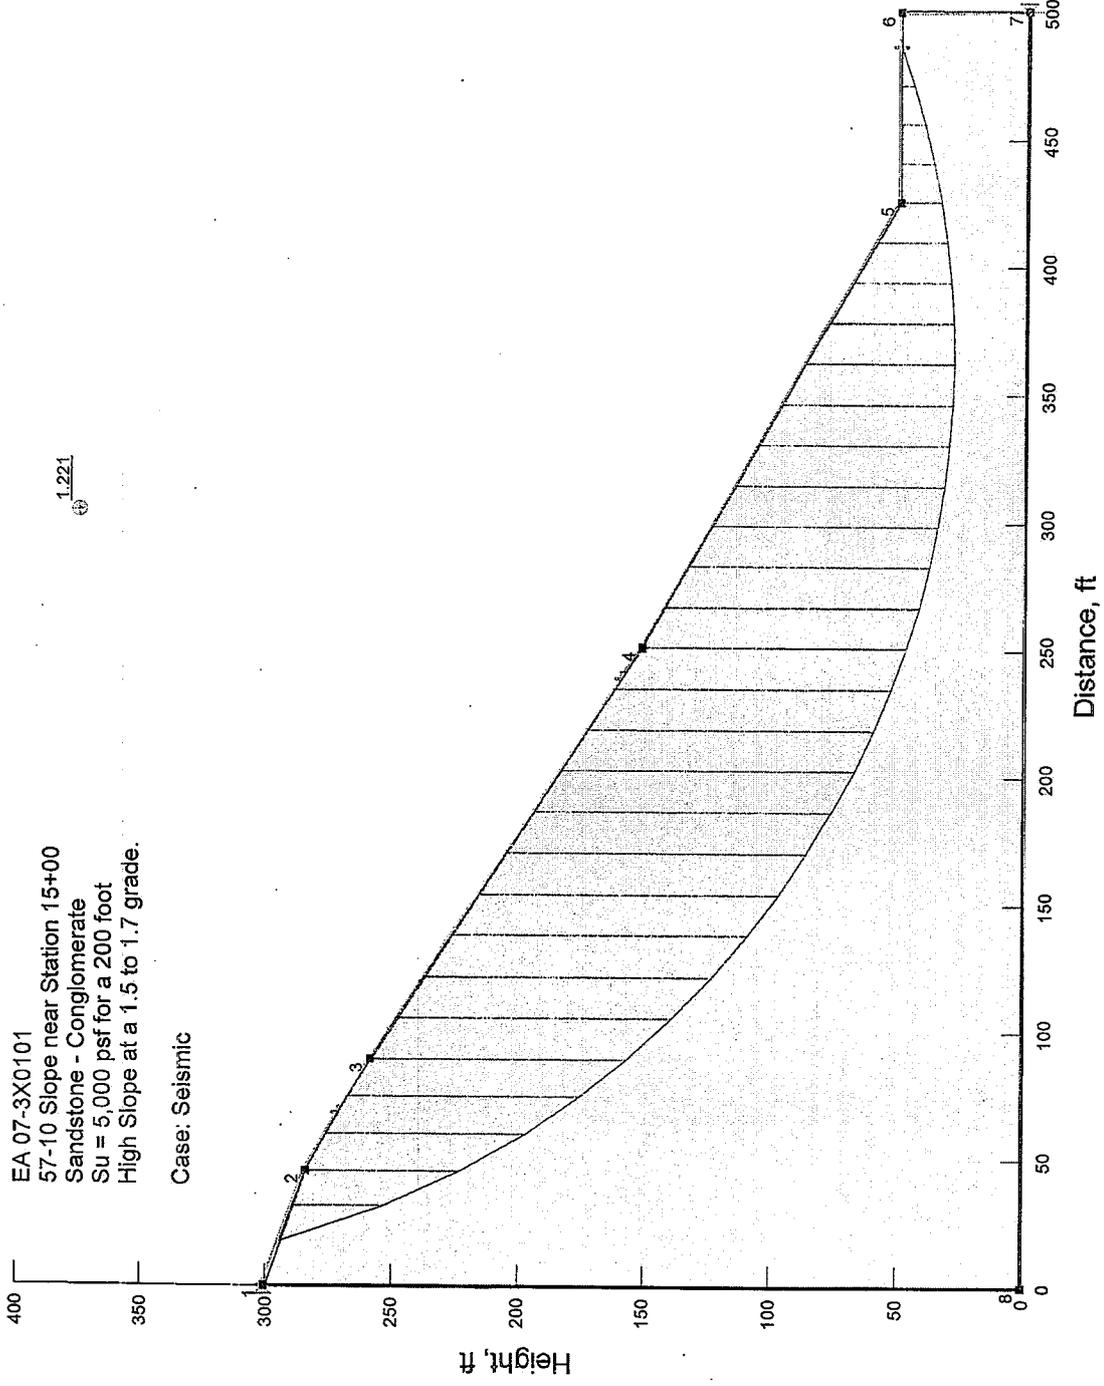
Figure A-2

EA 07-3X0101
57-10 Slope near Station 15+00
Sandstone - Conglomerate
Su = 5,000 psf for a 200 foot
High Slope at a 1.5 to 1.7 grade.

Case: Seismic

1.221

- 1) The slope should be monitored regularly for sign of distress and erosion. After periods of heavy rainfall the slope should be checked for signs of erosion or tension cracking.
- 2) An erosion cover such as an erosion control mat should be considered for application over the slope face. This will help prevent erosion gullies from forming after periods of heavy rainfall. The mat should extend to Station 15+00 from the latest Layout Plan Sheet.
- 3) In order to control rainfall runoff extending eastward the existing lower bench of the buttress along with the concrete v-ditch is also advisable. The lower bench should extend to Station 15+00 from the latest Layout Plan Sheet.
