MATERIALS INFORMATION HANDOUT

**Contract Number
08-1E2204**

**08-SBd-127
PM 3.00 / 10.50
PM 37.70 / 41.47**

Cold In-Place Recycling

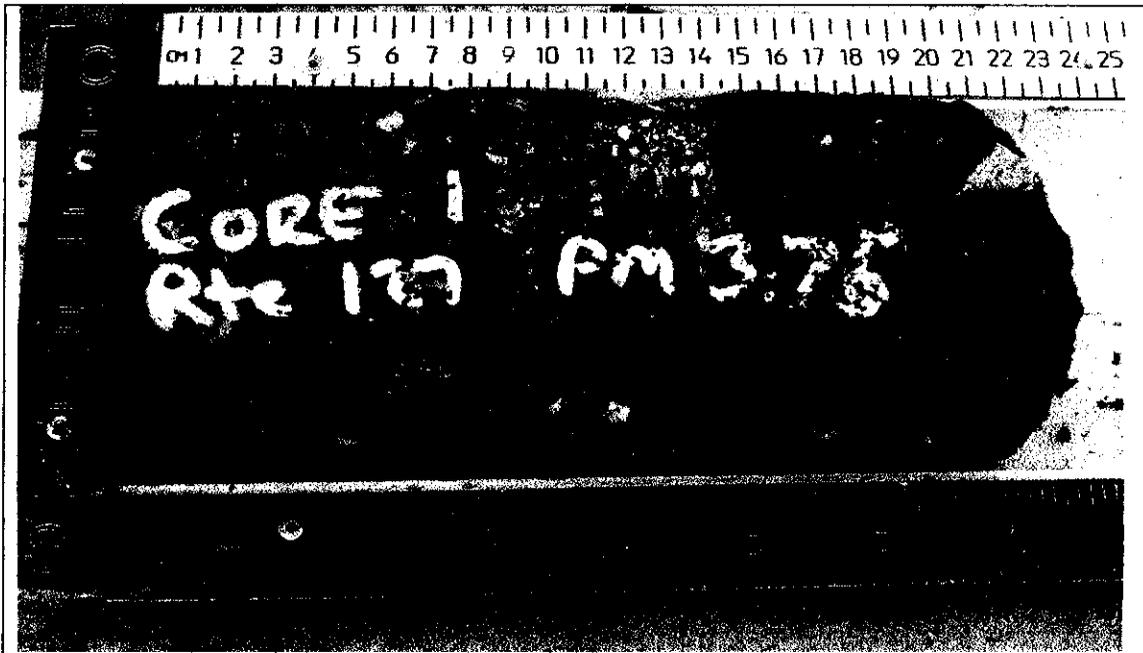
Core # 1 N/B, Lane # 1 PM 3.75 Total Thickness 0.72'

Post Mile	Direction, Lane	Photo Name	Layer 1	Layer 2	Layer 3	Class II AB or Native	Total Thickness	Remarks
3.75	N/B, Lane # 1	Core 1	0.02' SC	0.42' DG	0.28' RM	NAT	0.72'

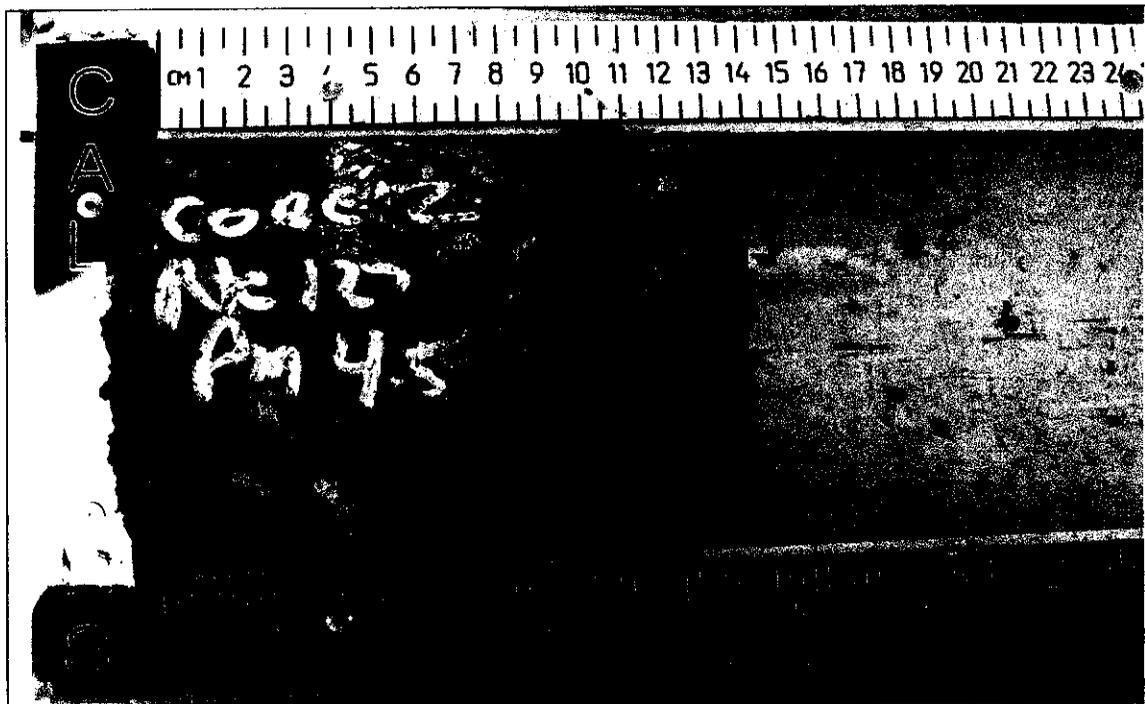
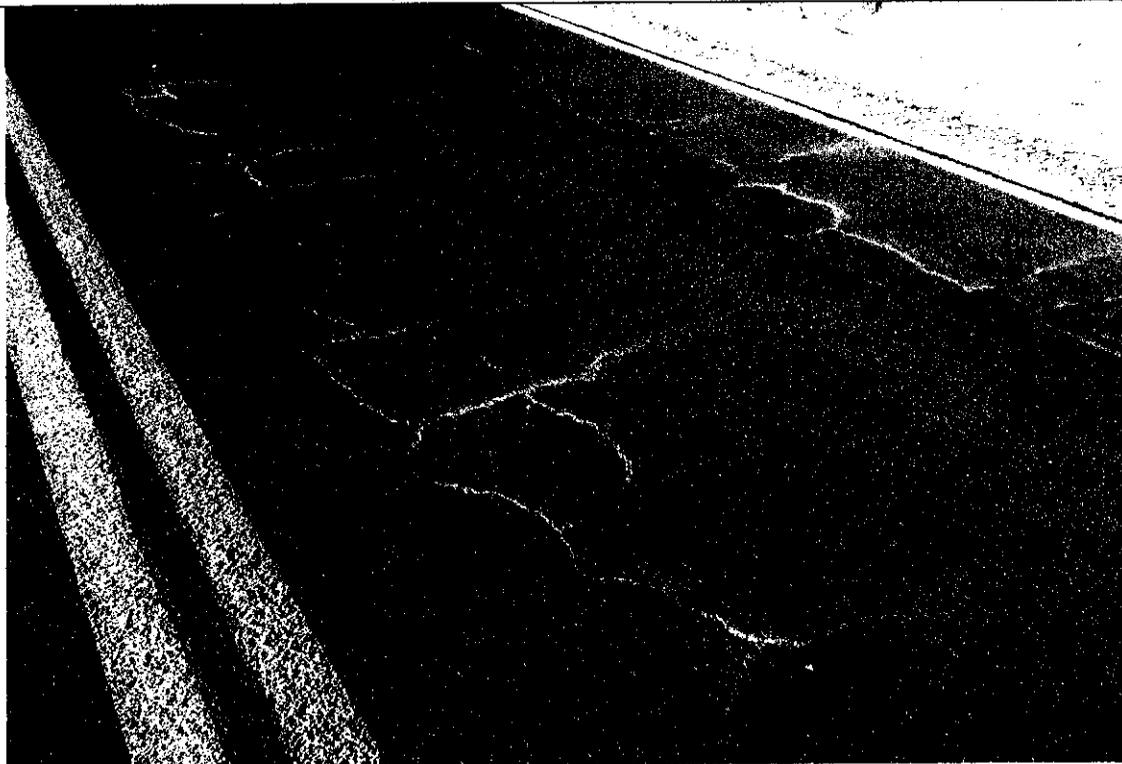
Core # 2 S/B, Lane # 1 PM 4.50

4.50	S/B, Lane # 1	Core 2	0.02' SC	0.42' DG		NAT	0.44'	Core shows rubber material. Core delaminated.
5.25	S/B, Lane # 1	Core 3	0.02' SC	0.28' DG	0.20' RM	NAT	0.50'	Core shows rubber material.

Total Thickness 0.44'

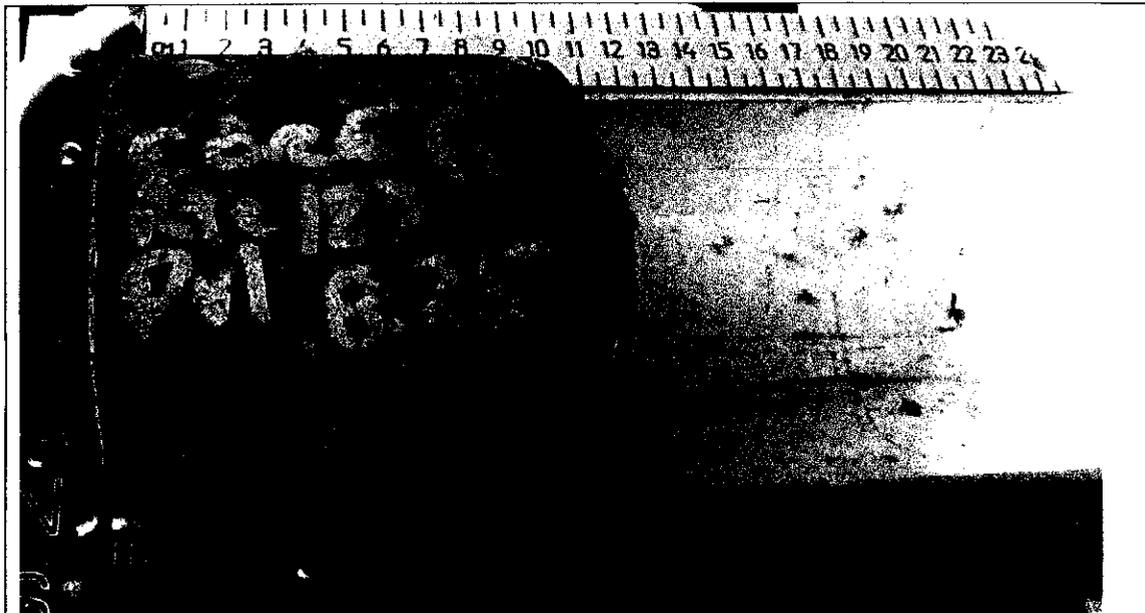
Core # 6 S/B, Lane # 1 PM 8.25 Total Thickness 0.36'

8.25	S/B, Lane # 1	Core 6	0.02' SC	0.22' DG	0.12' RM	NAT	0.36'	Core shows rubber material.
9.60	S/B, Lane # 1	Core 7	0.02' SC	0.24' DG	0.22' RM	NAT	0.48'	Core shows rubber material.

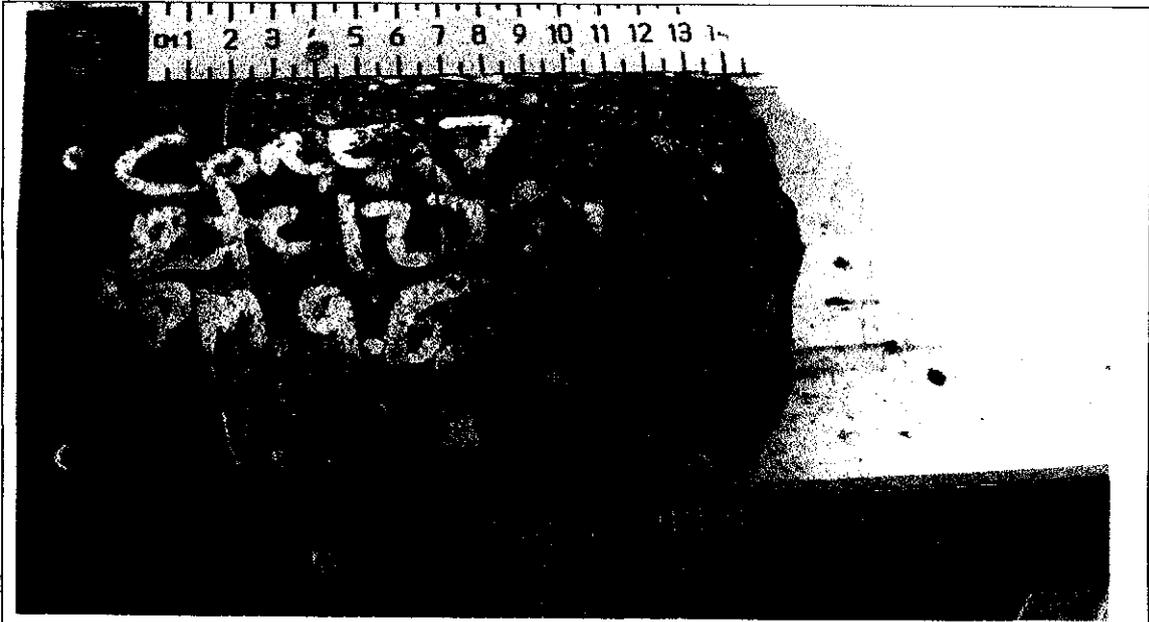
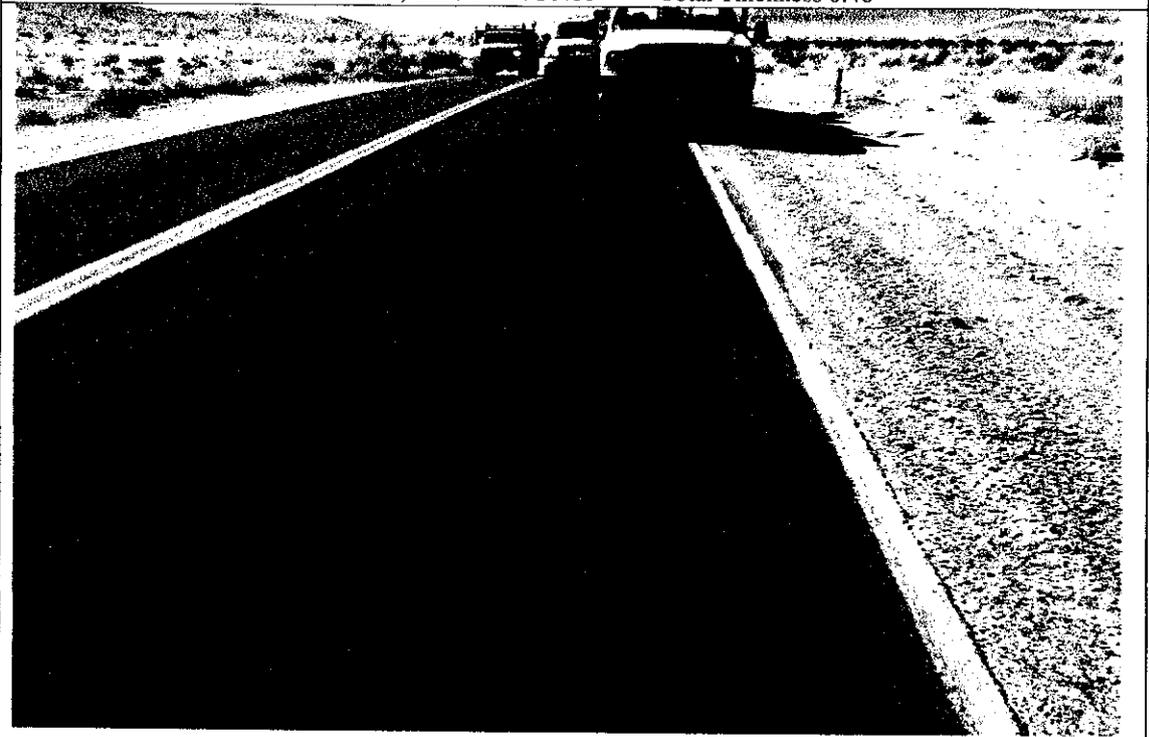
Core # 7 S/B, Lane # 1 PM 9.60

Total Thickness 0.48'

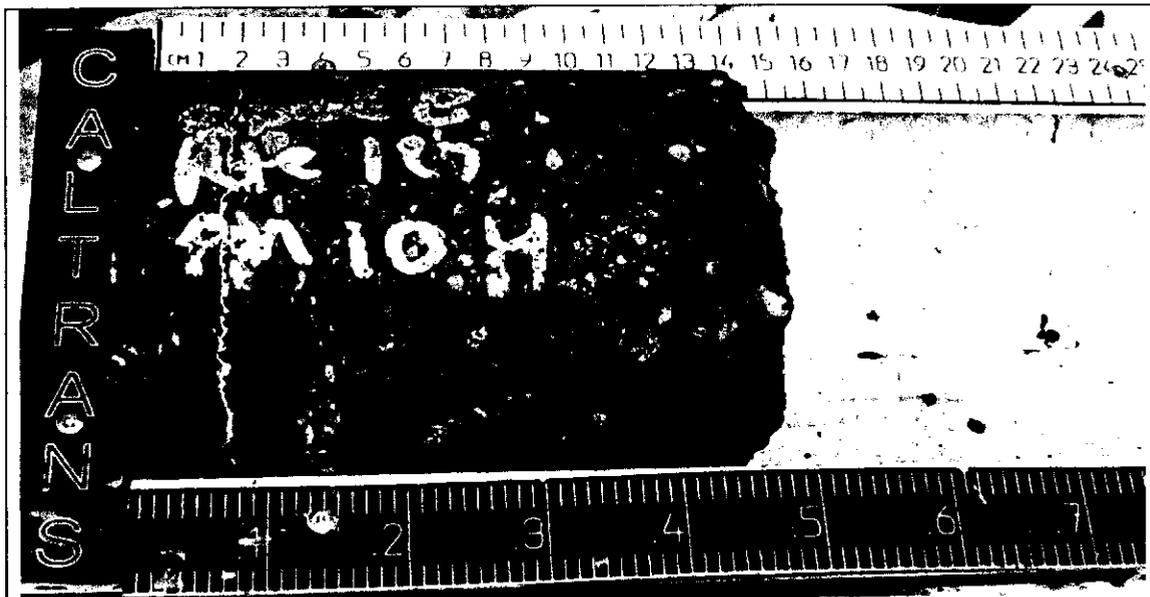
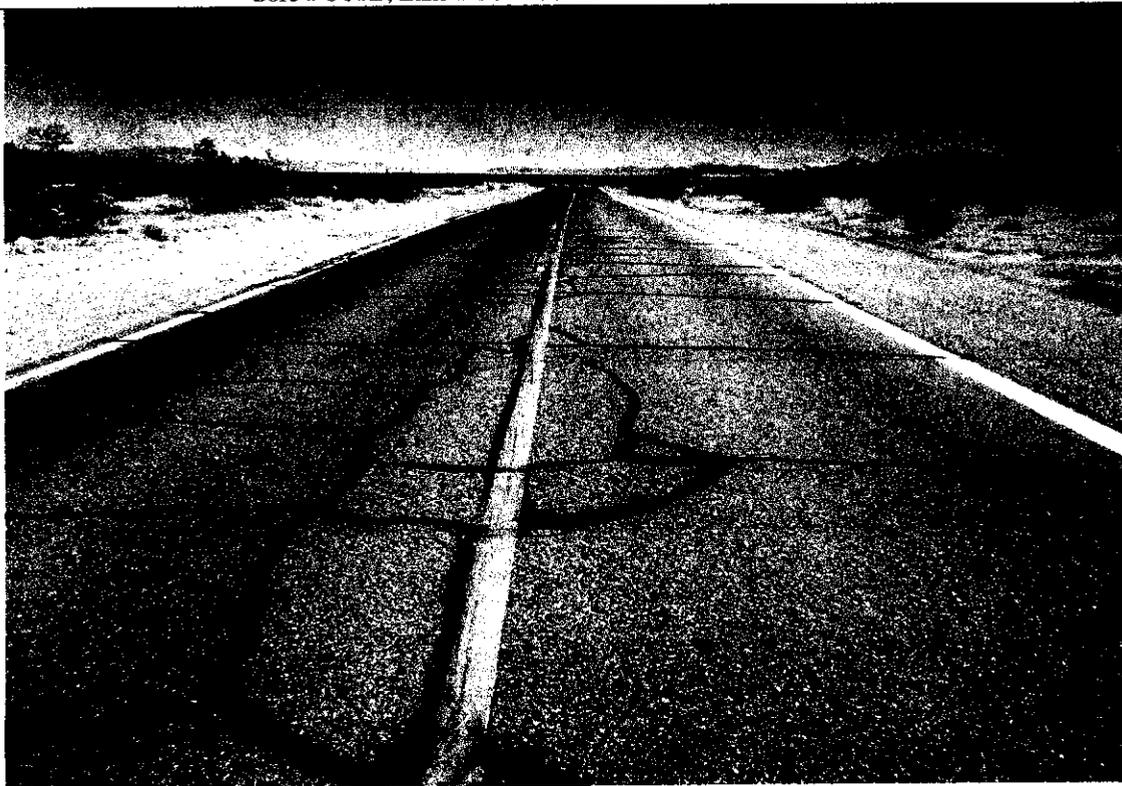
Core # 8 N/B, Lane # 1 PM 10.40

10.40	N/B, Lane # 1	Core 8	0.47' DG			NAT	0.47'	
37.75	N/B, Lane # 1	Core 9	0.26' DG	0.18' RM		NAT	0.44'	Core shows rubber material. Core delaminated.
38.70	N/B, Lane # 1	Core 10	0.60' DG	0.29' RM		NAT	0.89'

Total Thickness 0.47'

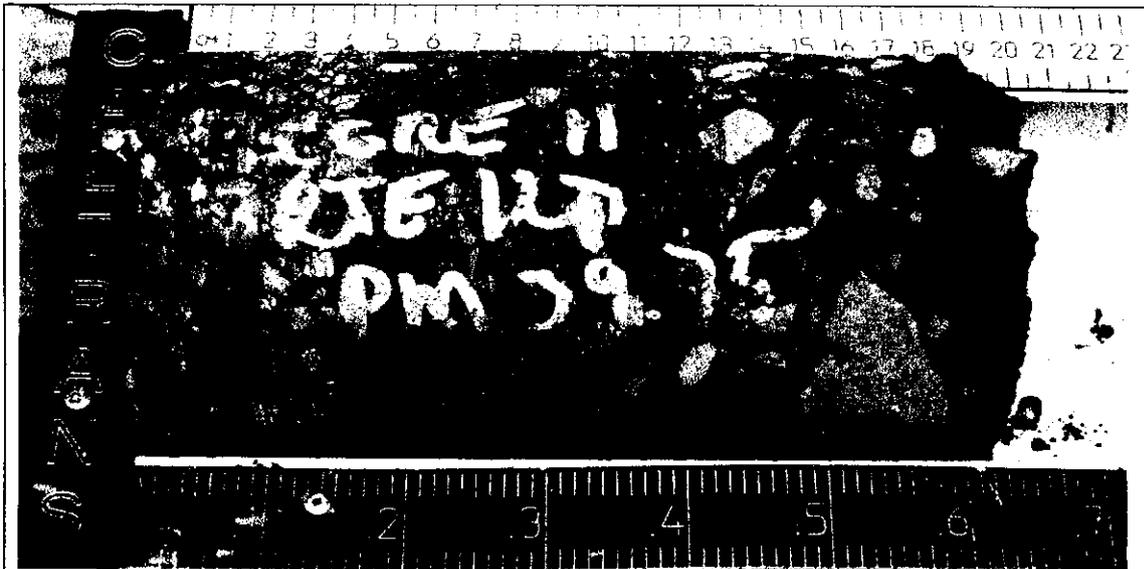
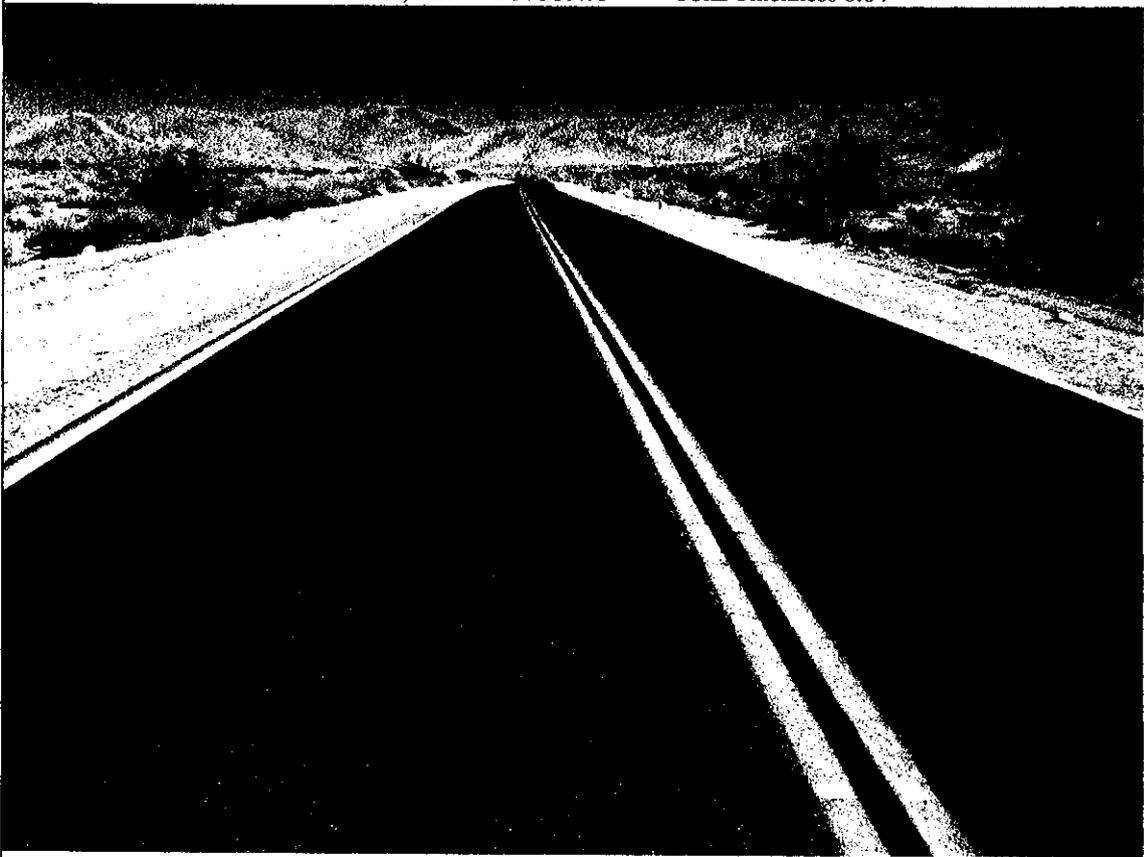
Core # 11 S/B, Lane # 1 PM 39.75 Total Thickness 0.64'

39.75	S/B, Lane # 1	Core 11	0.06' OG	0.40' DG	0.18' RM	NAT	0.64'	Core shows rubber material.
40.75	N/B, Lane # 1	Core 12	0.04' OG	0.36' DG		NAT	0.40'	Core shows rubber material.

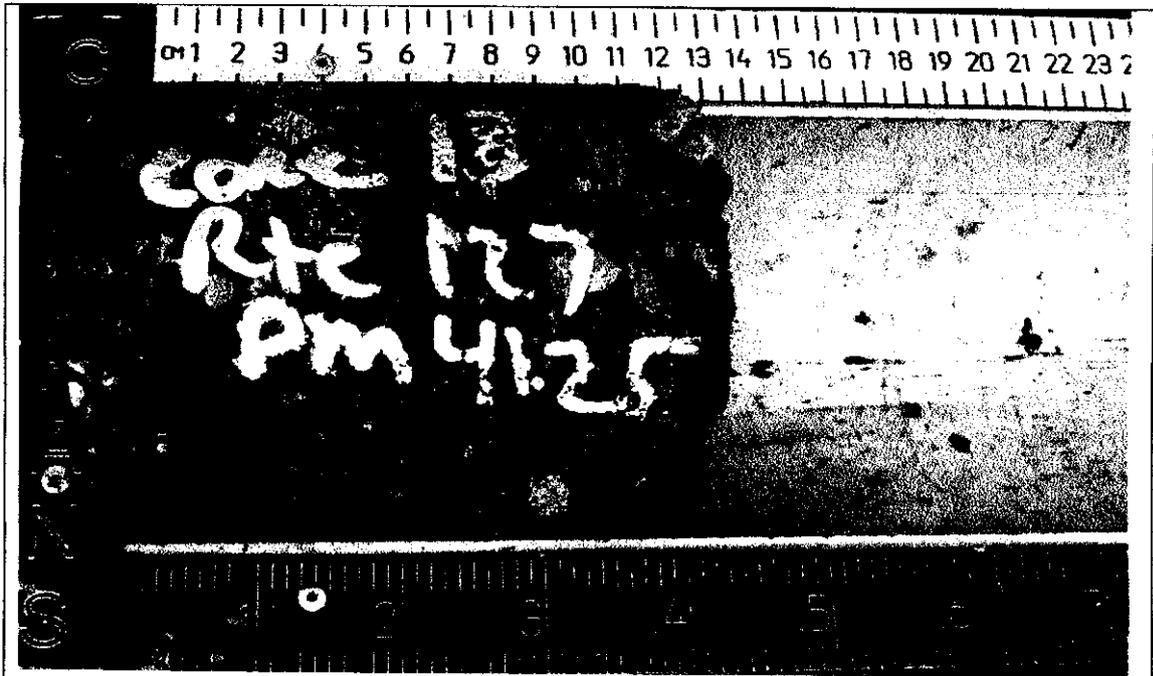
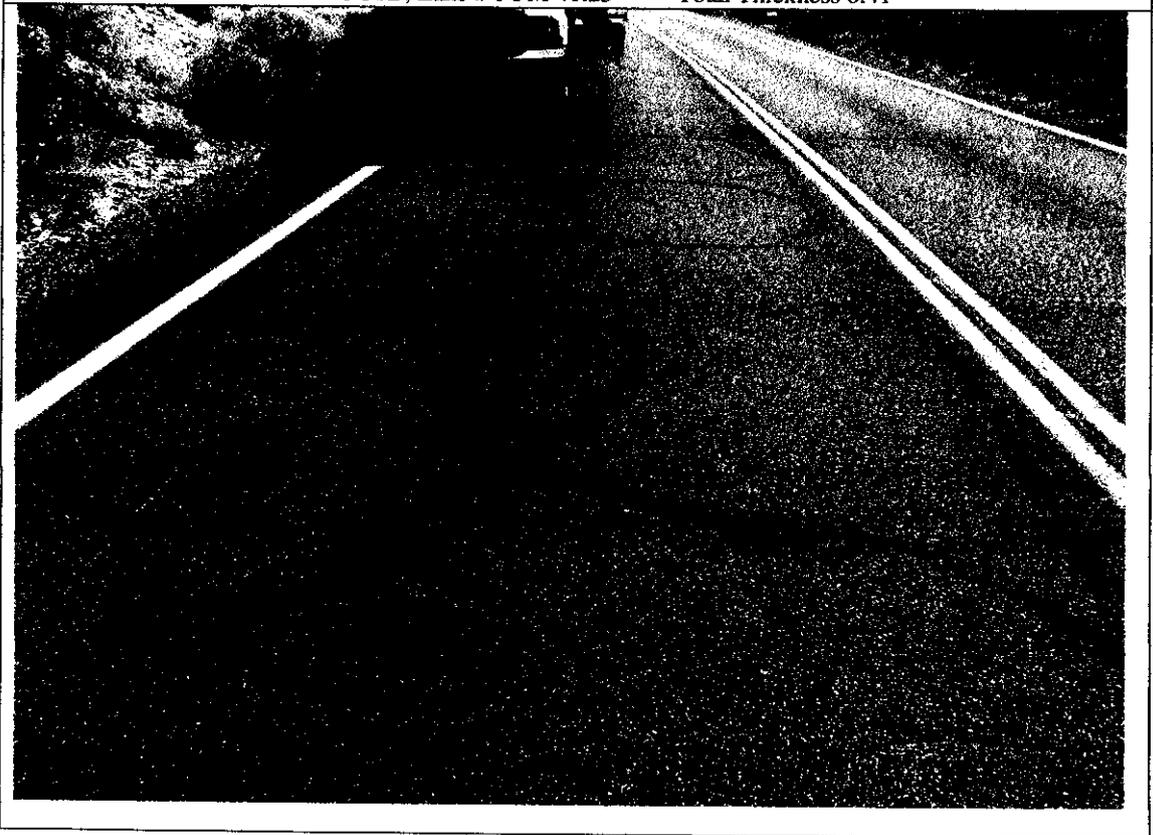
Core # 13 N/B, Lane # 1 PM 41.25

41.25	N/B, Lane # 1	Core 13	0.06' OG	0.35' DG		NAT	0.41'	Core shows rubber material.
								NAT = Native Material. Coarse Grained Sand, Silt & Clay
								SC = Seal Coat
								DG = Dense graded AC
								OG = Open Graded AC
								RM = Road Mix

Total Thickness 0.41'
