Alkali-Aggregate Reaction With Low-Alkali Cement

State of California
Department of Public Works
Division of Highways
Materials and Research Department

December 30, 1960

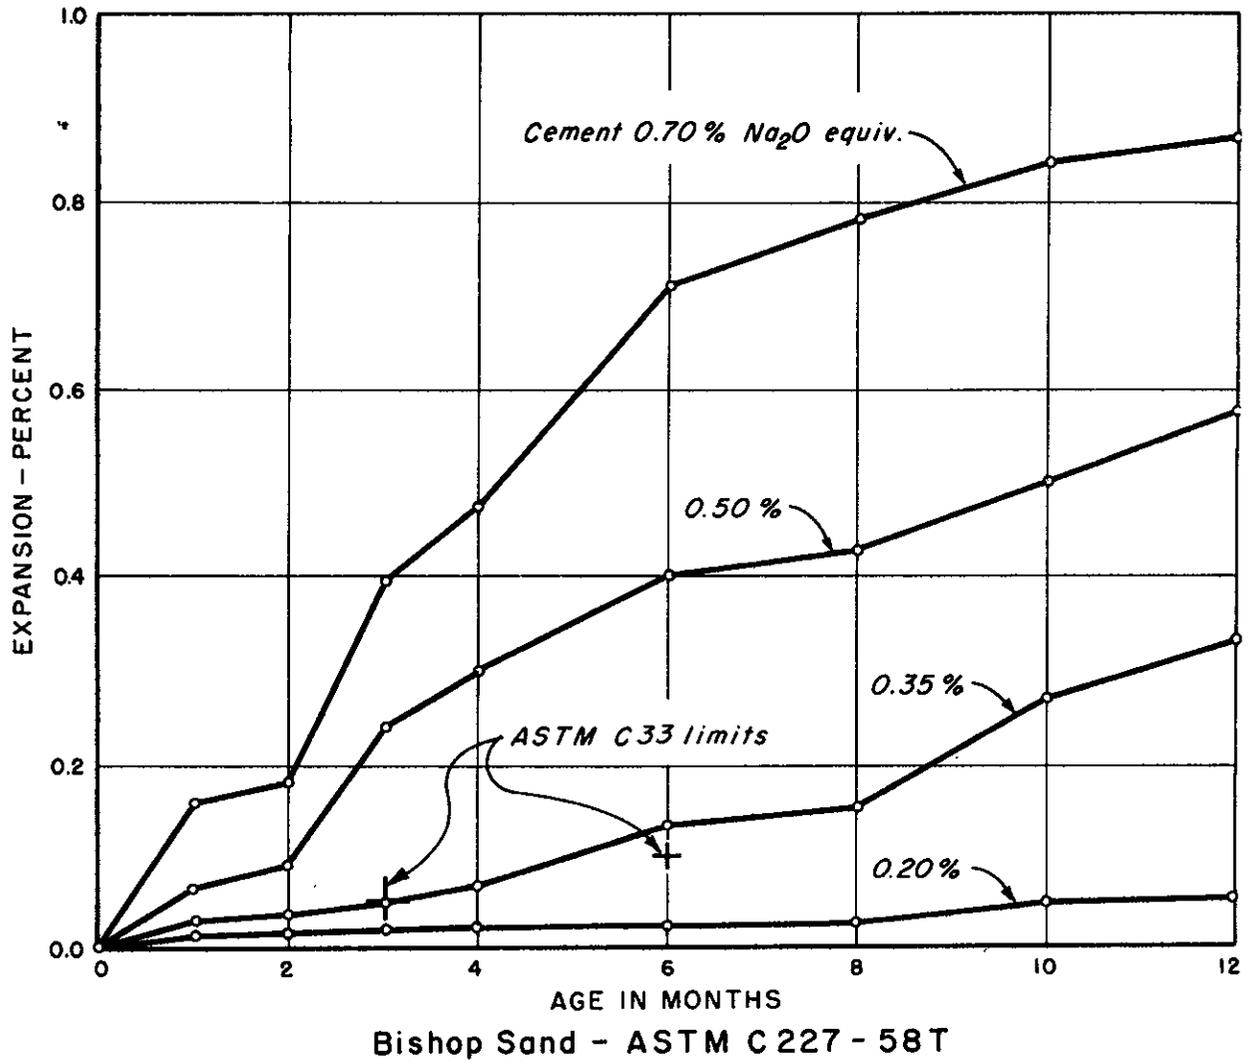
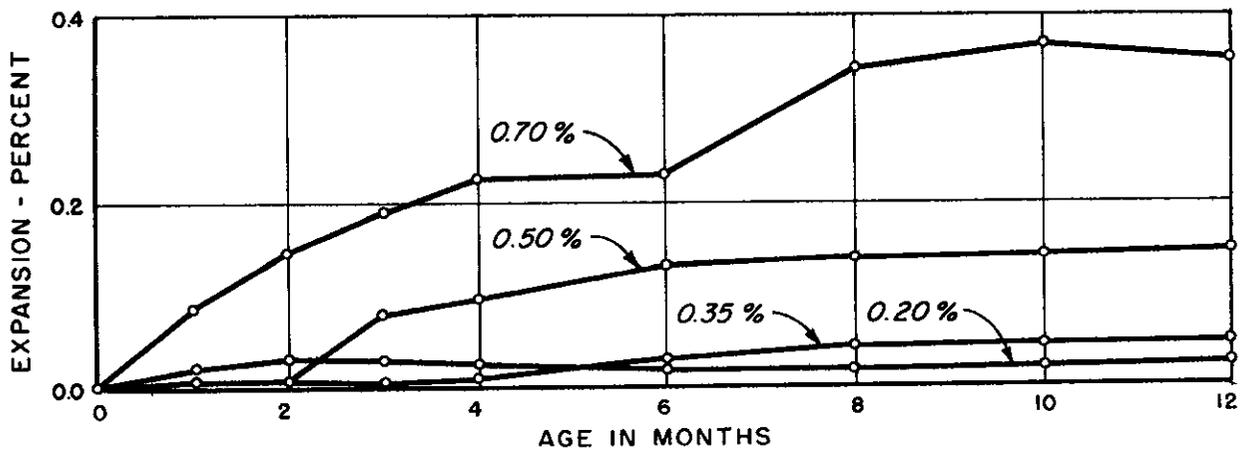
Figure 1

The maximum expansion of any of the cements with the Adams sand up to the age of 1 year is 0.017 percent. The effect of alkali content on expansion of the Bishop sand is pronounced and is shown graphically in Figure 1. The results indicate that an alkali content of less than 0.35 percent is necessary to meet the criteria given in ASTM Designation: C 33-57.

The results are shown in Figure 1.

The expansion of the concrete bars was less than that of the mortar bars. Presumably, had a higher cement factor been used in the concrete, the expansions would have been greater. The order of performance of the cements in the concrete bars was the same as in the mortar bars. With 0.50 percent alkalis, the concrete bars expanded more than 0.05 percent at 3 months and more than 0.10 percent at 6 months. The expansion with 0.35 percent alkalis was less than these values. In contrast the sand mortar bars with 0.35 percent alkalis exceeded the limit at 6 months.

The evidence seems conclusive that the Bishop aggregates have reacted deleteriously when used with cement containing alkalis slightly less than 0.60 percent. Laboratory tests indicate that the maximum safe content of alkalis (Na_2O equivalent) that can be used with these aggregates is about 0.30 percent.
