FORESTER/ARBORIST REPORT

**"Ruby 1" and "Ruby 2",
"Patrick Creek Narrows 2",
and "Washington Curve"**

197/199 Safe STAA Access

July 2012

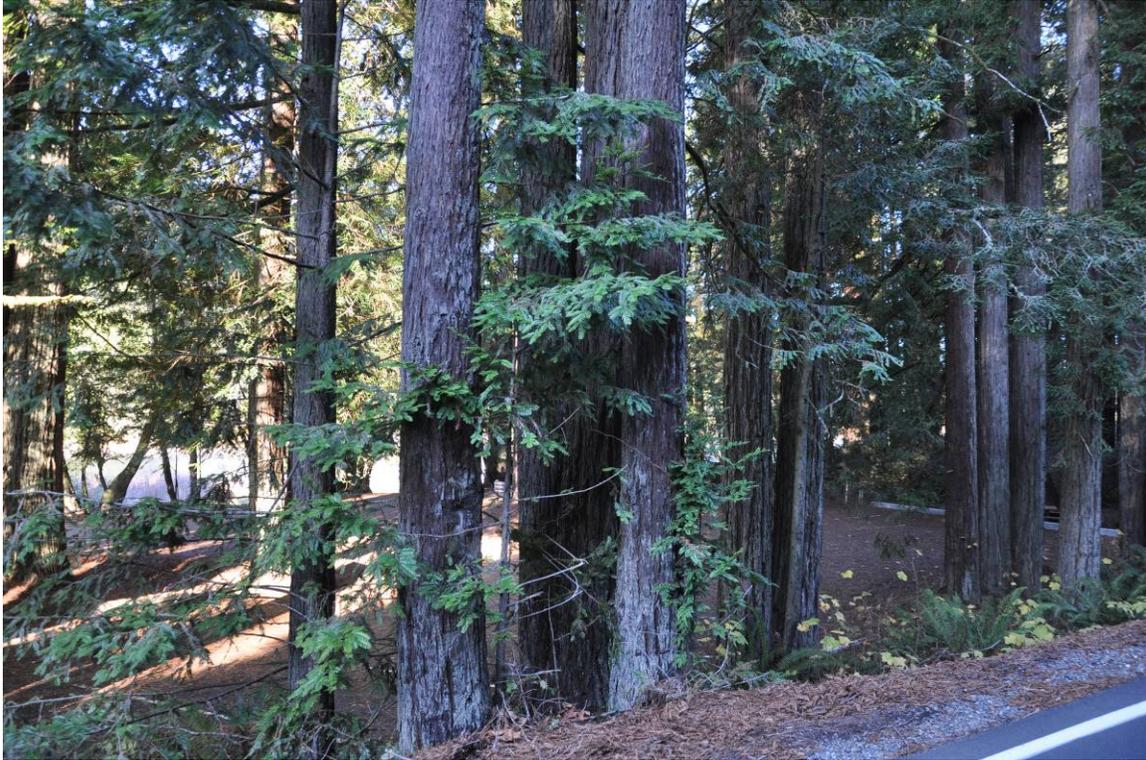
Figure 2. Ruby 1 at Ruby van Deventer Camping Area is Characterized by a Harvested Forest that Re-Sprouted

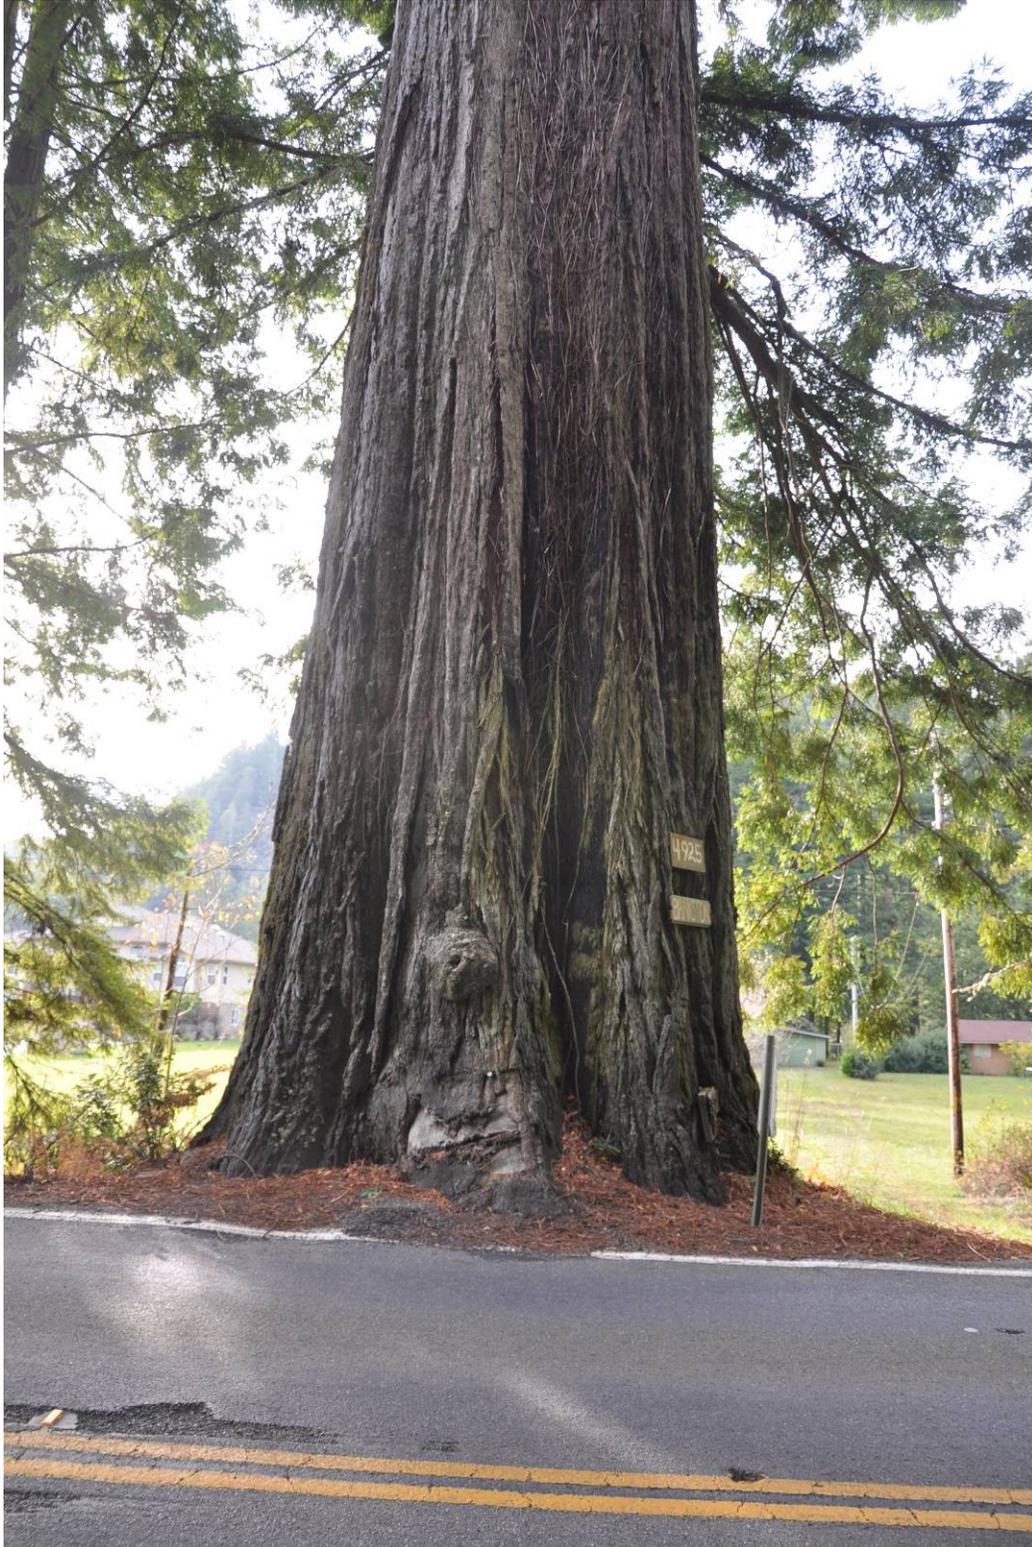
Figure 10. Large Old Remnant Redwood Trees are alongside SR 197 at Ruby 2

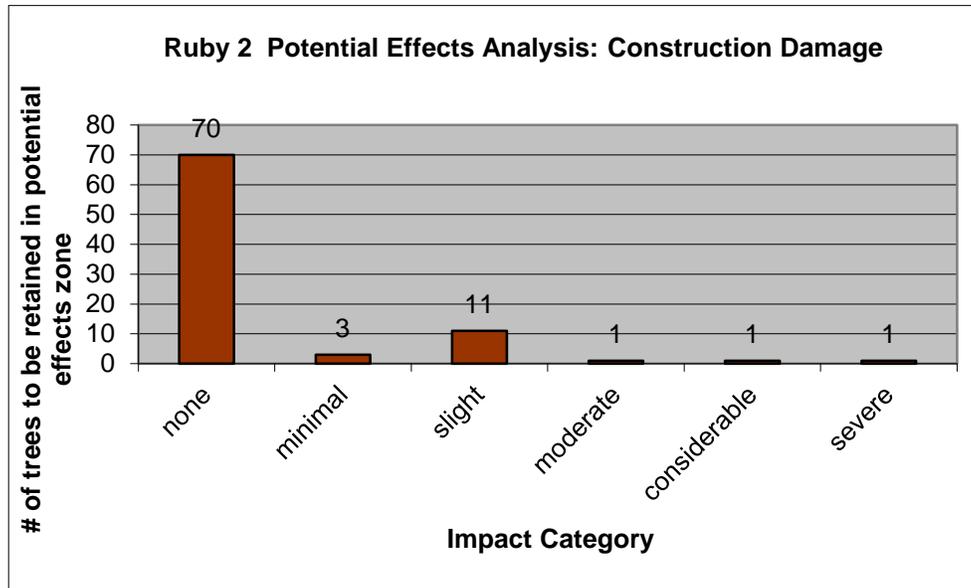
Construction damage potential is mostly “none” although it is slight for a small number of trees. One big leaf maple hanging over the road may have moderate or considerable effects, because it appears structurally unsound at this time.

Figure 17. Construction Damage Effects Analysis

The evaluation team noted “Severe” effect potential from wind throw for a single 22” big leaf maple (R2_1075) which already hangs severely over the road way. We would recommend removal of that tree. Another big leaf maple (R2_1285), with a double 16” stem, had severe potential effects due to removal of an adjacent tree and the potential for construction effects. A stump (that will be removed) supports that tree and we recommend removal of the tree also. Nearby we noted considerable effects to an 11” redwood (R2_1287) that would have 40% of its root zone affected. That tree is presently in poor condition and may require removal.

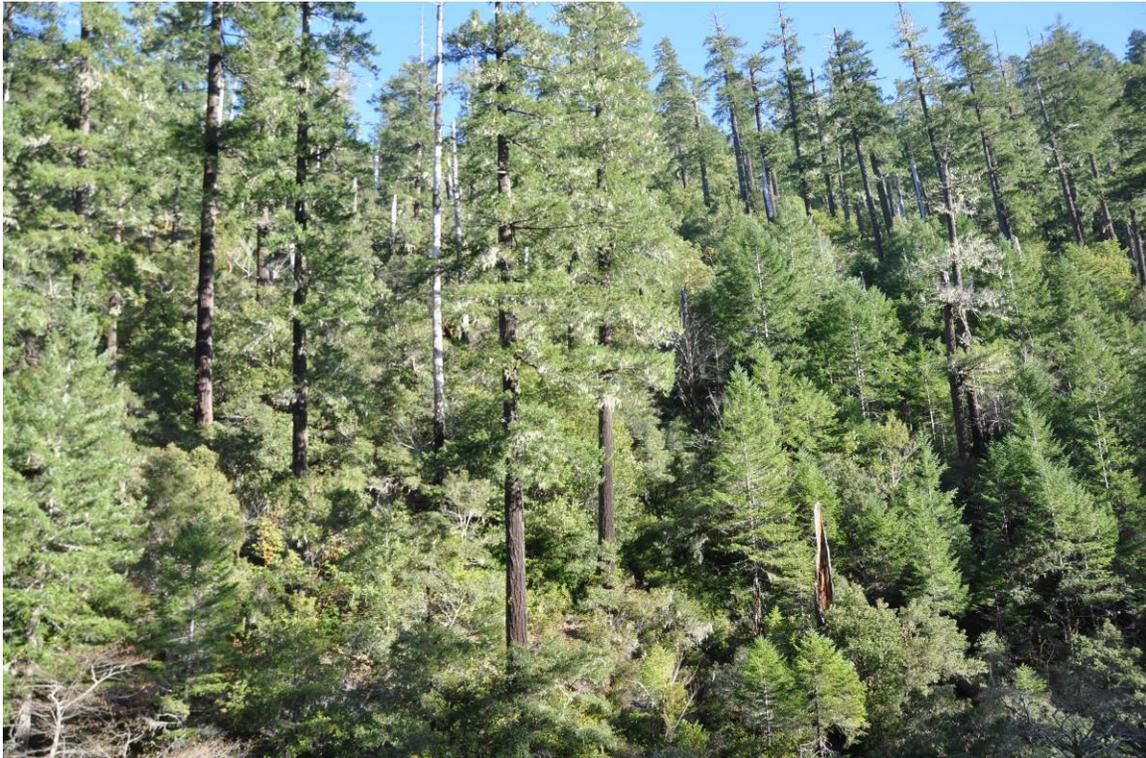
Figure 19. "Old Growth" Douglas-Fir Stand Looking East at the North Side of the Proposed New Bridge

Trees 16, 23 & 30 will be protected. These are Douglas-fir trees 51", 40" and 29" trees.

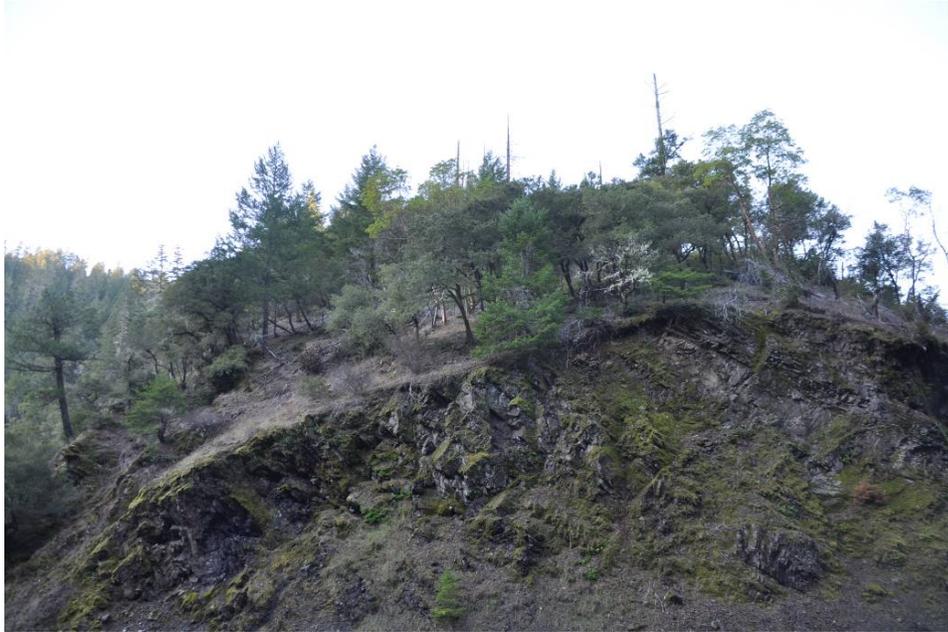
Patrick Creek Narrows Location 2 Road Cut: Caltrans also plans to reduce the angle of the curve at the southern approach to the bridge. This would require a major road cut in the location shown inside the green line in Figure 22 below. The area of the road cut is characterized as a recently burned, dry, low site, southern exposure mixed hardwood forest type with scattered Douglas-fir. Most of the larger (15–24") Douglas-fir succumbed to the fire, as evidenced by logs on the hillside. The road cut would result in the removal of 76 hardwood tree stems including 2 canyon live oak trees with 15 stems each. Also 4 Douglas-fir trees would be removed in the area with estimated diameters of 8, 24, 15 and 21 inches. The arborist/forester team also estimated that a Douglas-fir, two 10" madrones, and 3 tanoaks (10", 13" & 16") within the effect zone, but outside of the road cut, will survive following construction. Essentially all other nearby hillside trees are presently standing dead as a result of recent wildfire, and so trees to be retained are not otherwise reported.

Figure 21. The Existing Road Cut at Patrick Creek Narrows Location 2 Will be Enlarged

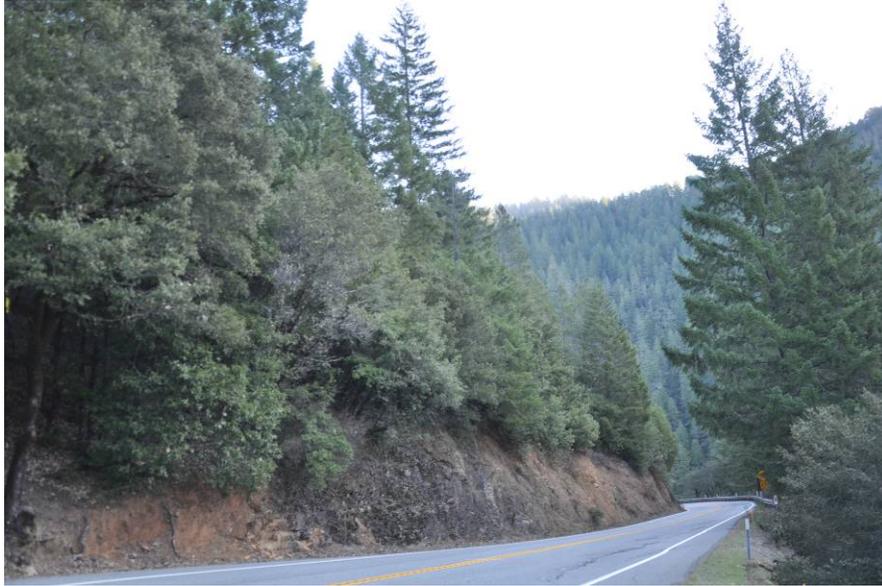
**Figure 24. The Proposed Washington Curve Road Cut
(shown on the left side of the road)**

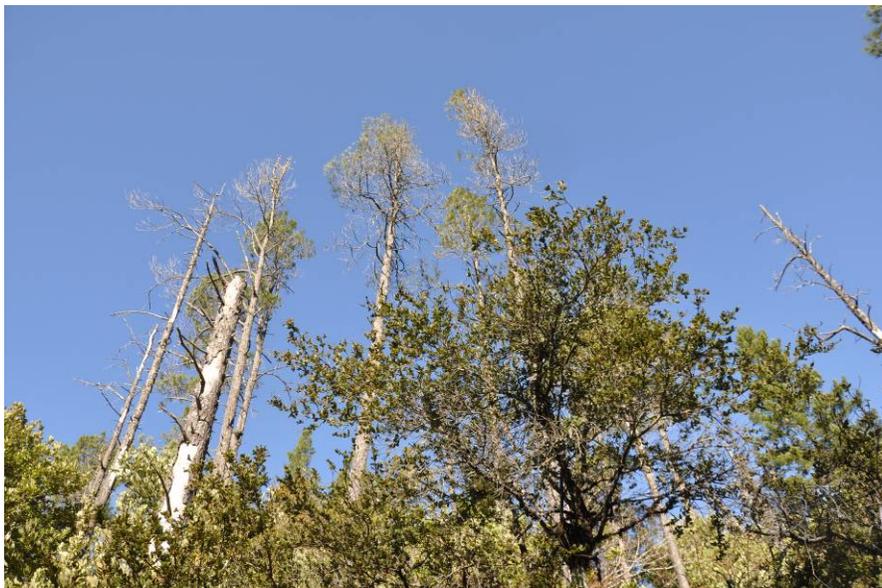
**Figure 25. Declining Knobcone Pine and Hardwood at
Washington Curve Road Cut**
