Appendix H Assessment of Erosion Sites on
Offsite Mitigation Parcels in Little
Lake Valley

Willits Bypass Project

Technical Memorandum: Assessment of Erosion Sites On Offsite Mitigation Parcels in Little Lake Valley

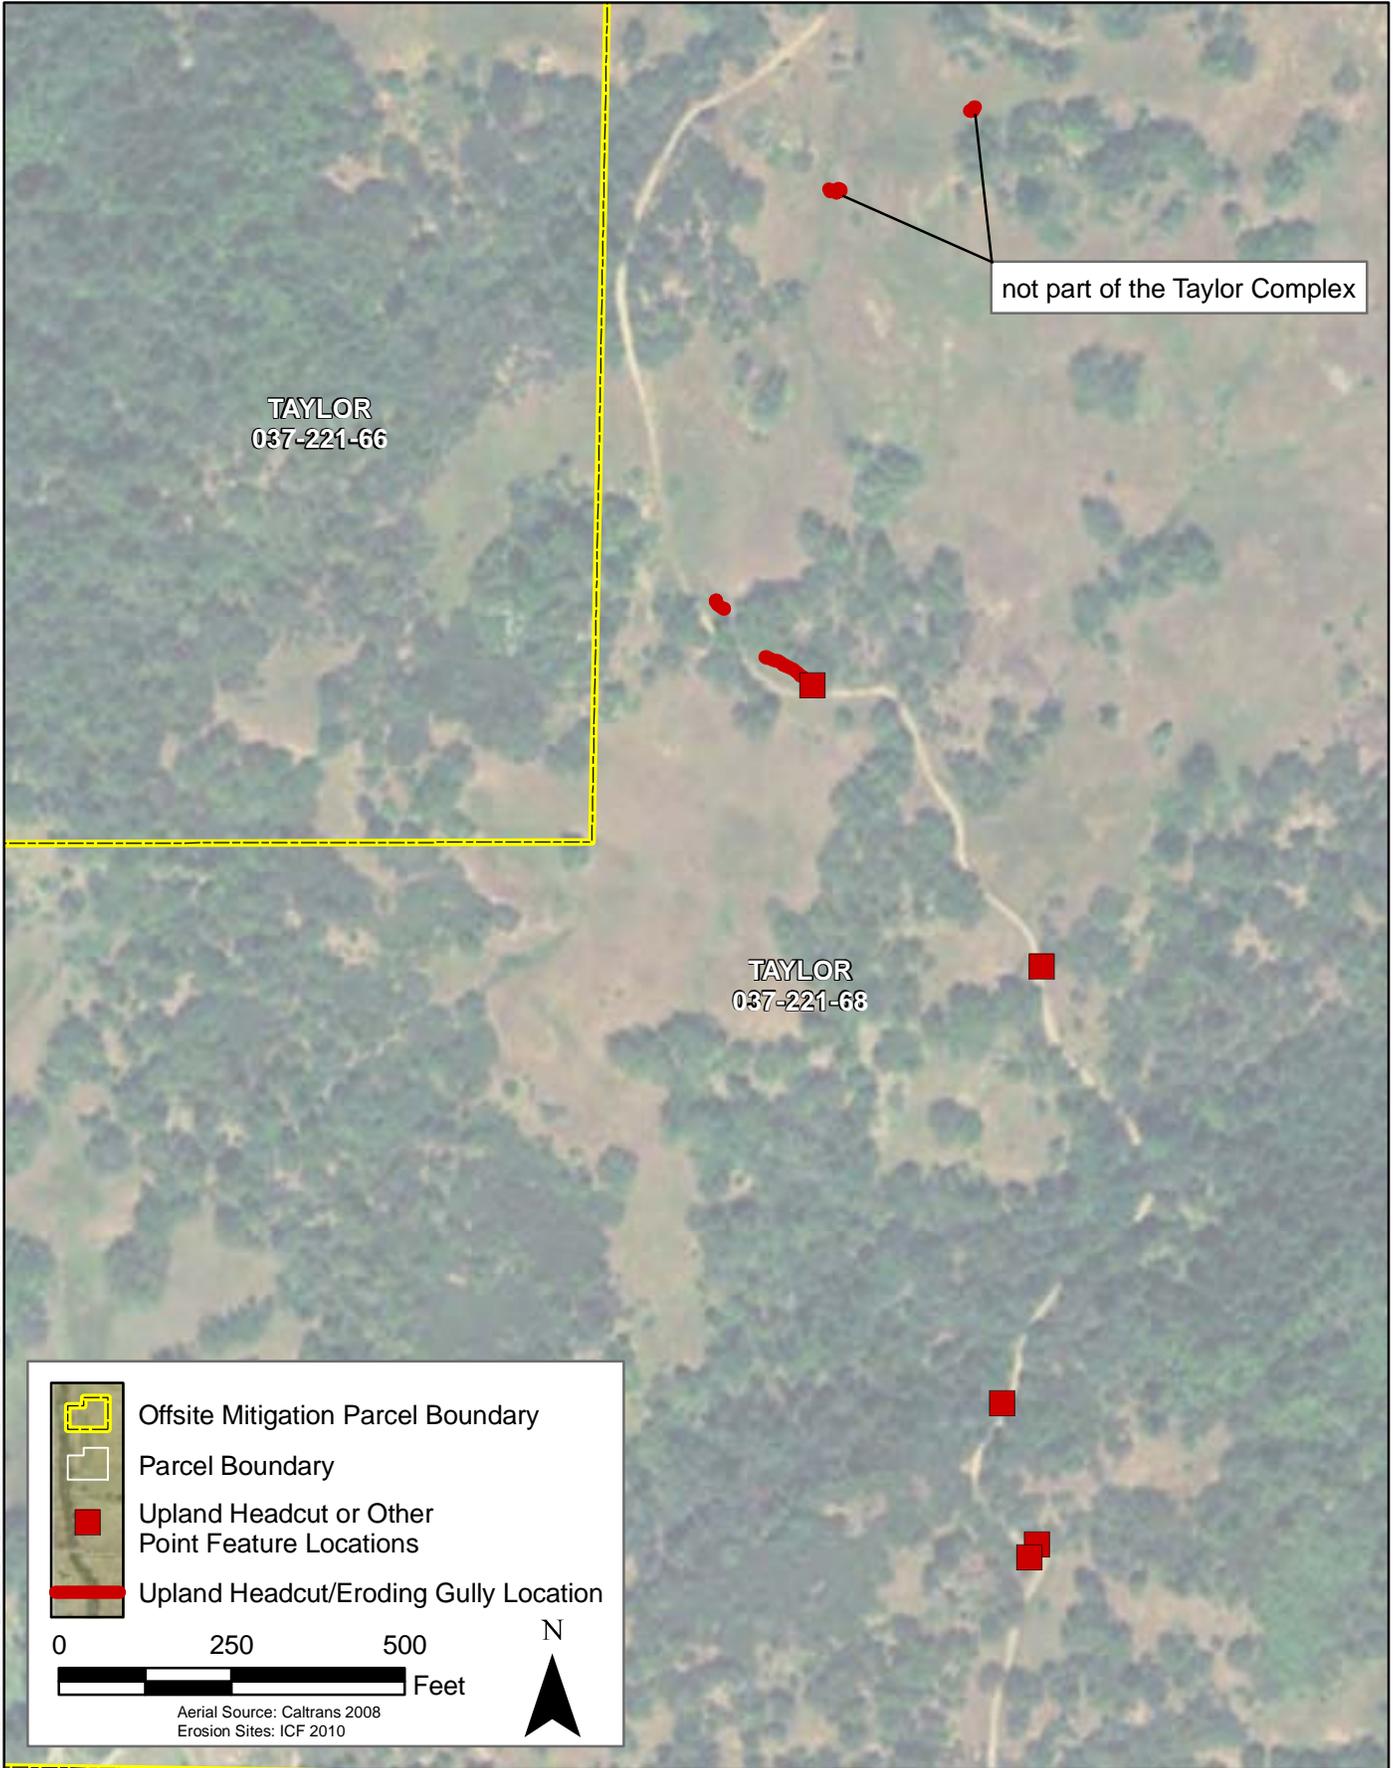
Figure 3-2
Taylor (APN 037-221-68) Complex
Erosion Site Locations

The Taylor 037-221-68 parcel has nine erosion sites (Table 3-1, Figure 3-1, Appendix A), the first seven of which are collectively referred to as the “Taylor Complex” (Figure 3-2). All erosion sites are located in upland and are typified by headcuts, scour areas, and/or eroding gullies with headcuts. All erosion sites are located in the north-central portion of the parcel (Figures 3-1 and 3-2). Since the cause of all erosion sites within the Taylor Complex is the presence of the access road with its associated culvert crossings (and to a lesser extent direct trampling by livestock), the Taylor Complex (as well 037-221-68_8 and 037-221-68_9) are discussed further in Chapter 4.

Any associated sediment derived from these erosion sites enters unnamed tributaries that eventually connect to the lowlands (i.e., Little Lake Valley) below. However, all observed erosion sites are high up in the watershed and contribute a relatively small fraction of sediment to downstream receiving channels. Furthermore, any sediment that is eroded and transported most likely gets deposited and stored in the high-gradient unnamed tributaries as a sediment source and is only transported further downstream in slugs during large storm events. Finally, if the sediment is carried to the Valley floor, it would end up in an unnamed alluvial fan channel that eventually drains onto the Watson parcels. However, approximately one mile separates the Taylor 037-221-68 parcel and the Watson parcels and presumably much of the sediment load from upstream sources gets deposited in this reach of the alluvial fan channel as it is a low-gradient “response” reach, adjusting its channel bed to both water and delivered sediment. This channel on the Watson parcel does not have a noticeable hydrologic connection to any named channel, such as Berry Creek; rather, its terminus is a large existing wetland complex (on the eastern portion of Watson 037-221-30 and the western portion of Watson 037-250-05).

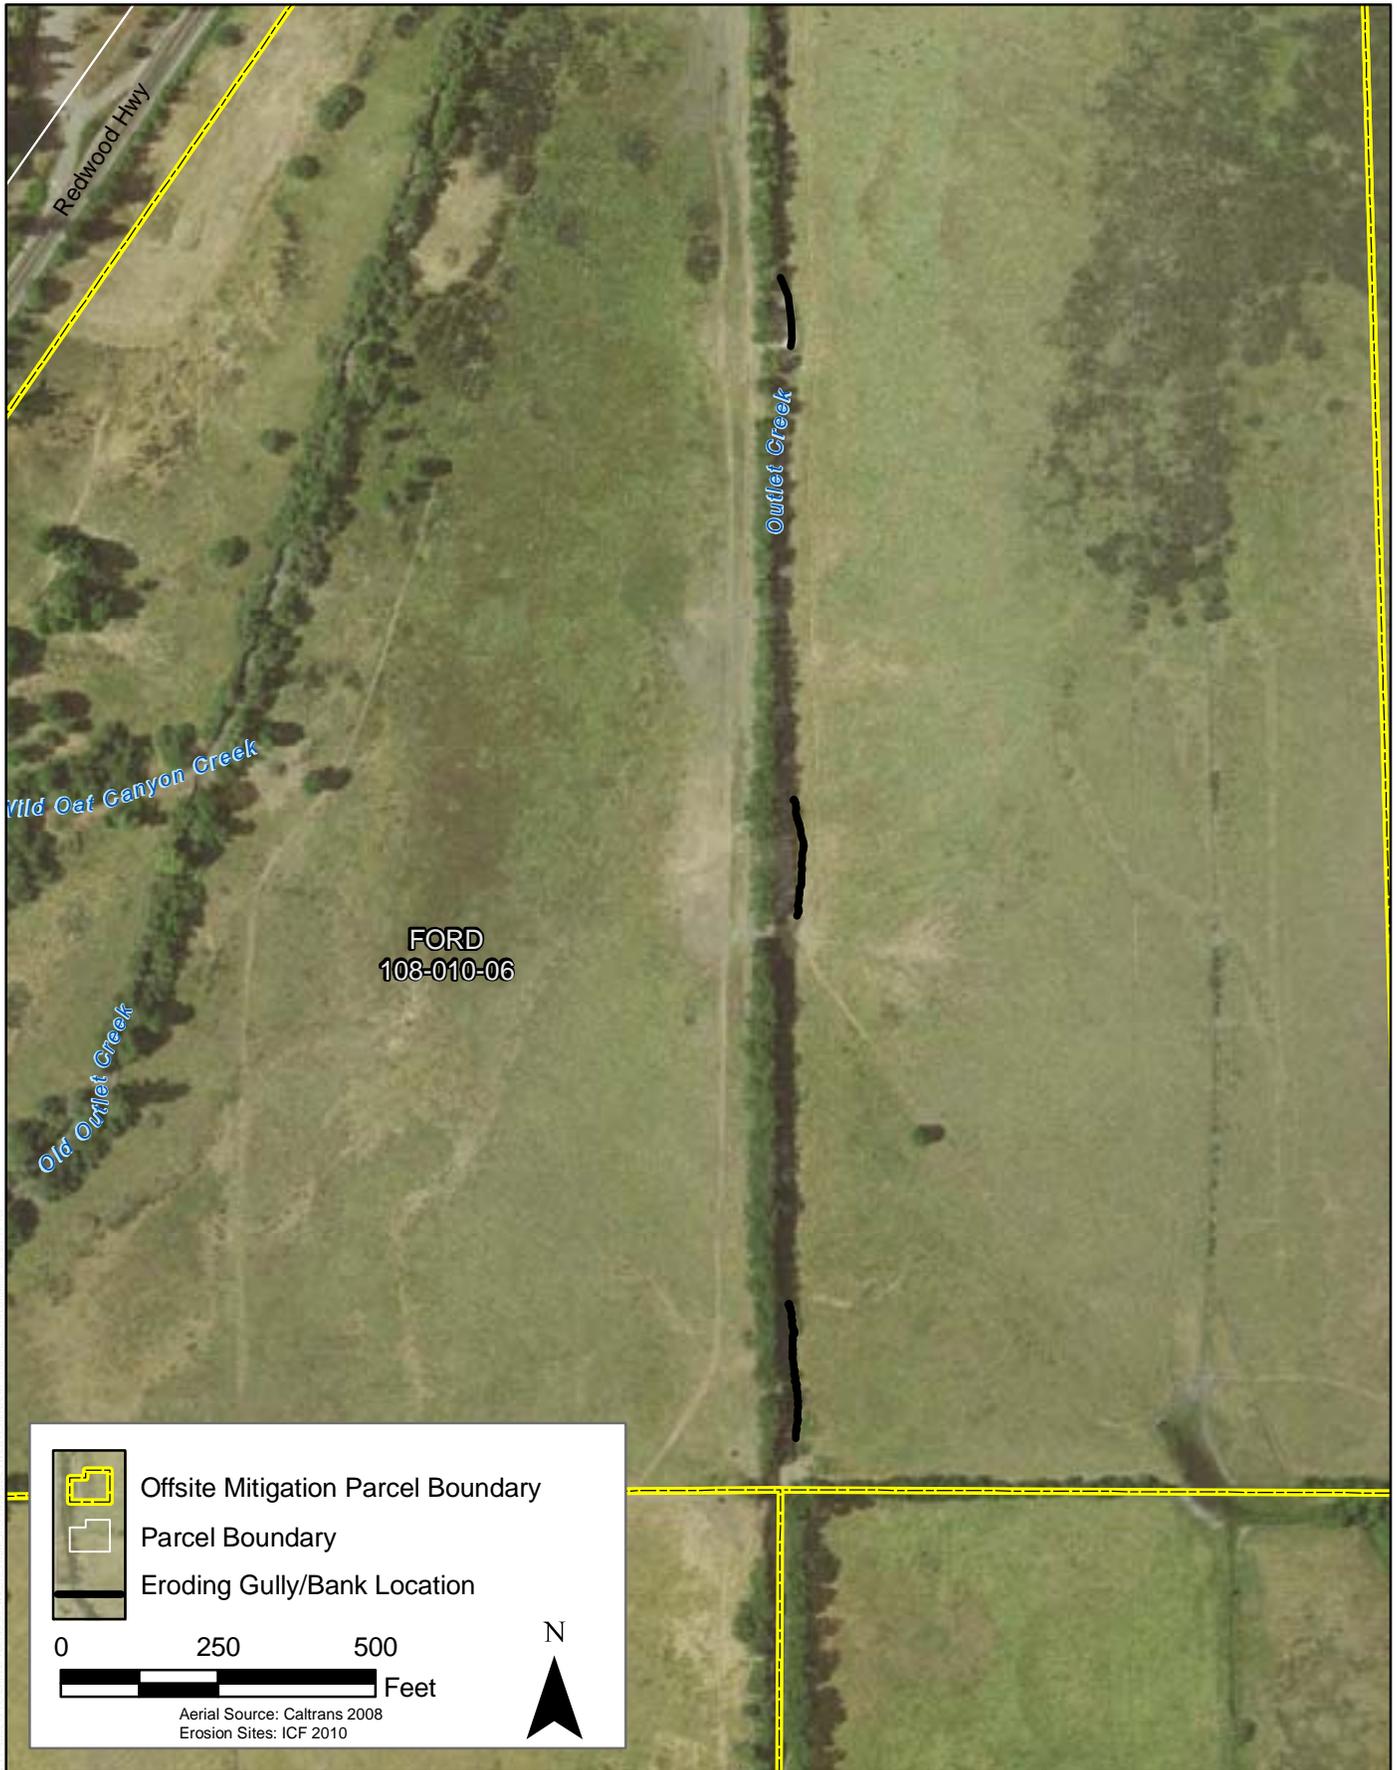
Figure 4-1
Ford (APN 108-010-06)
Erosion Site Locations

All three erosion sites (Figure 4-1) are contributing excessive sediment and causing water quality degradation in Outlet Creek. Lawler (1992) groups unstable banks into three categories:

weakening, fluvial erosion, and mass-failure processes. Weakening processes erode or prepare banks for further erosion (e.g., storm events that dislodge individual particles on the banks). Fluvial erosion processes (i.e., erosion by water) are related to the energy of flow (i.e., boundary shear stress). Mass-failure processes cause gravitational collapse of all or part of the bank. Weakening, fluvial, and mass-failure processes are acting together at these sites on the Ford 108-010-06 parcel.

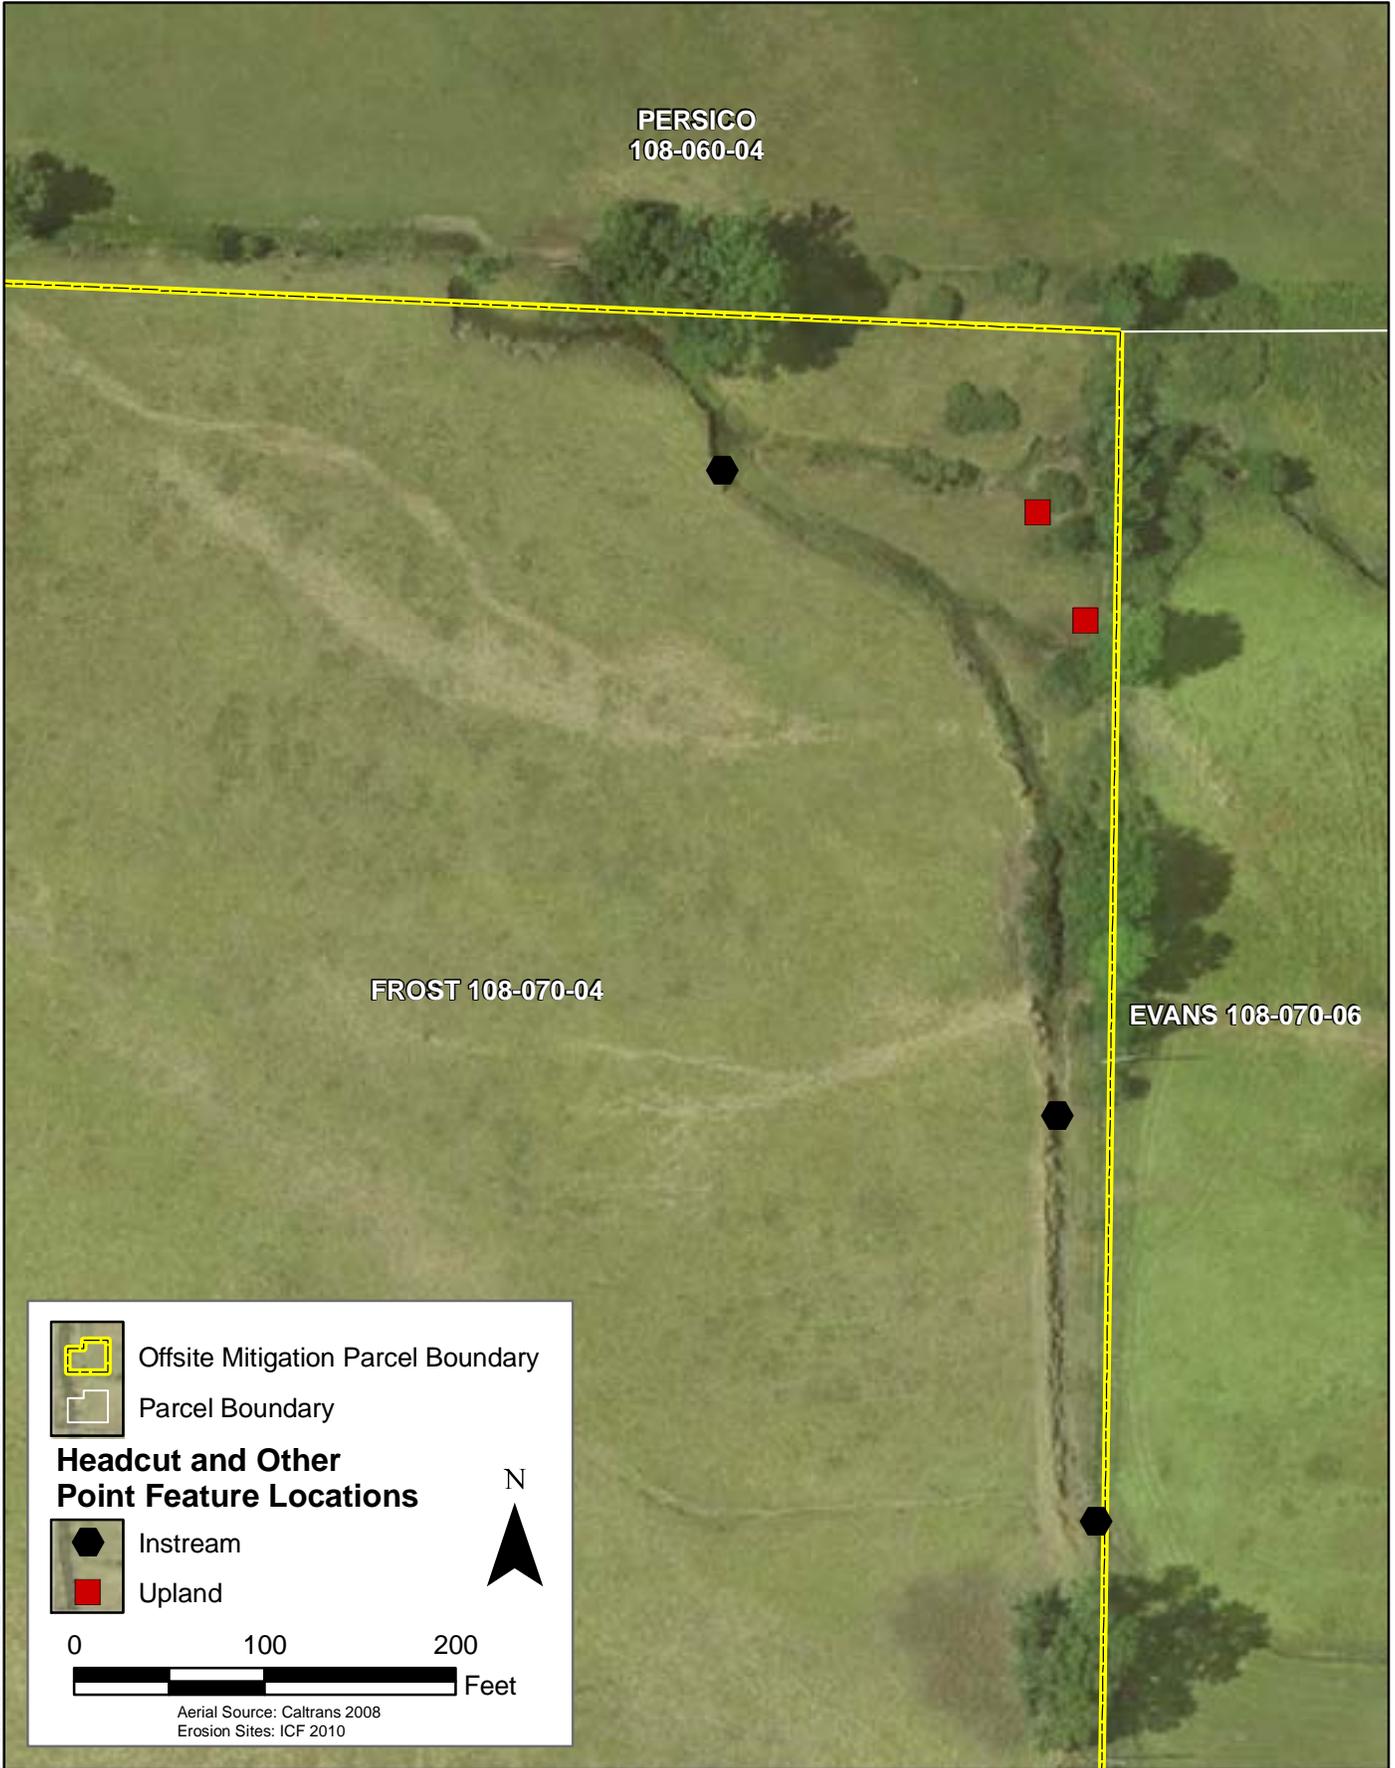
Figure 4-2
Frost (APN 108-070-04) Complex
Erosion Site Locations

The Frost 108-070-04 parcel has five erosion sites (Table 3-1, Figure 4-2, Appendix A), collectively referred to as the “Frost Complex” (Figure 3-2). There are three instream headcut sites (108-070-04_1, 108-070-04_2, and 108-070-04_5) and two upland headcut sites (108-070-04_3 and 108-070-04_4), each located in the northeast corner of the parcel (Figures 3-1 and 3-2). These are some one of the larger headcuts observed during the course of the assessment and are discussed further in Chapter 4.

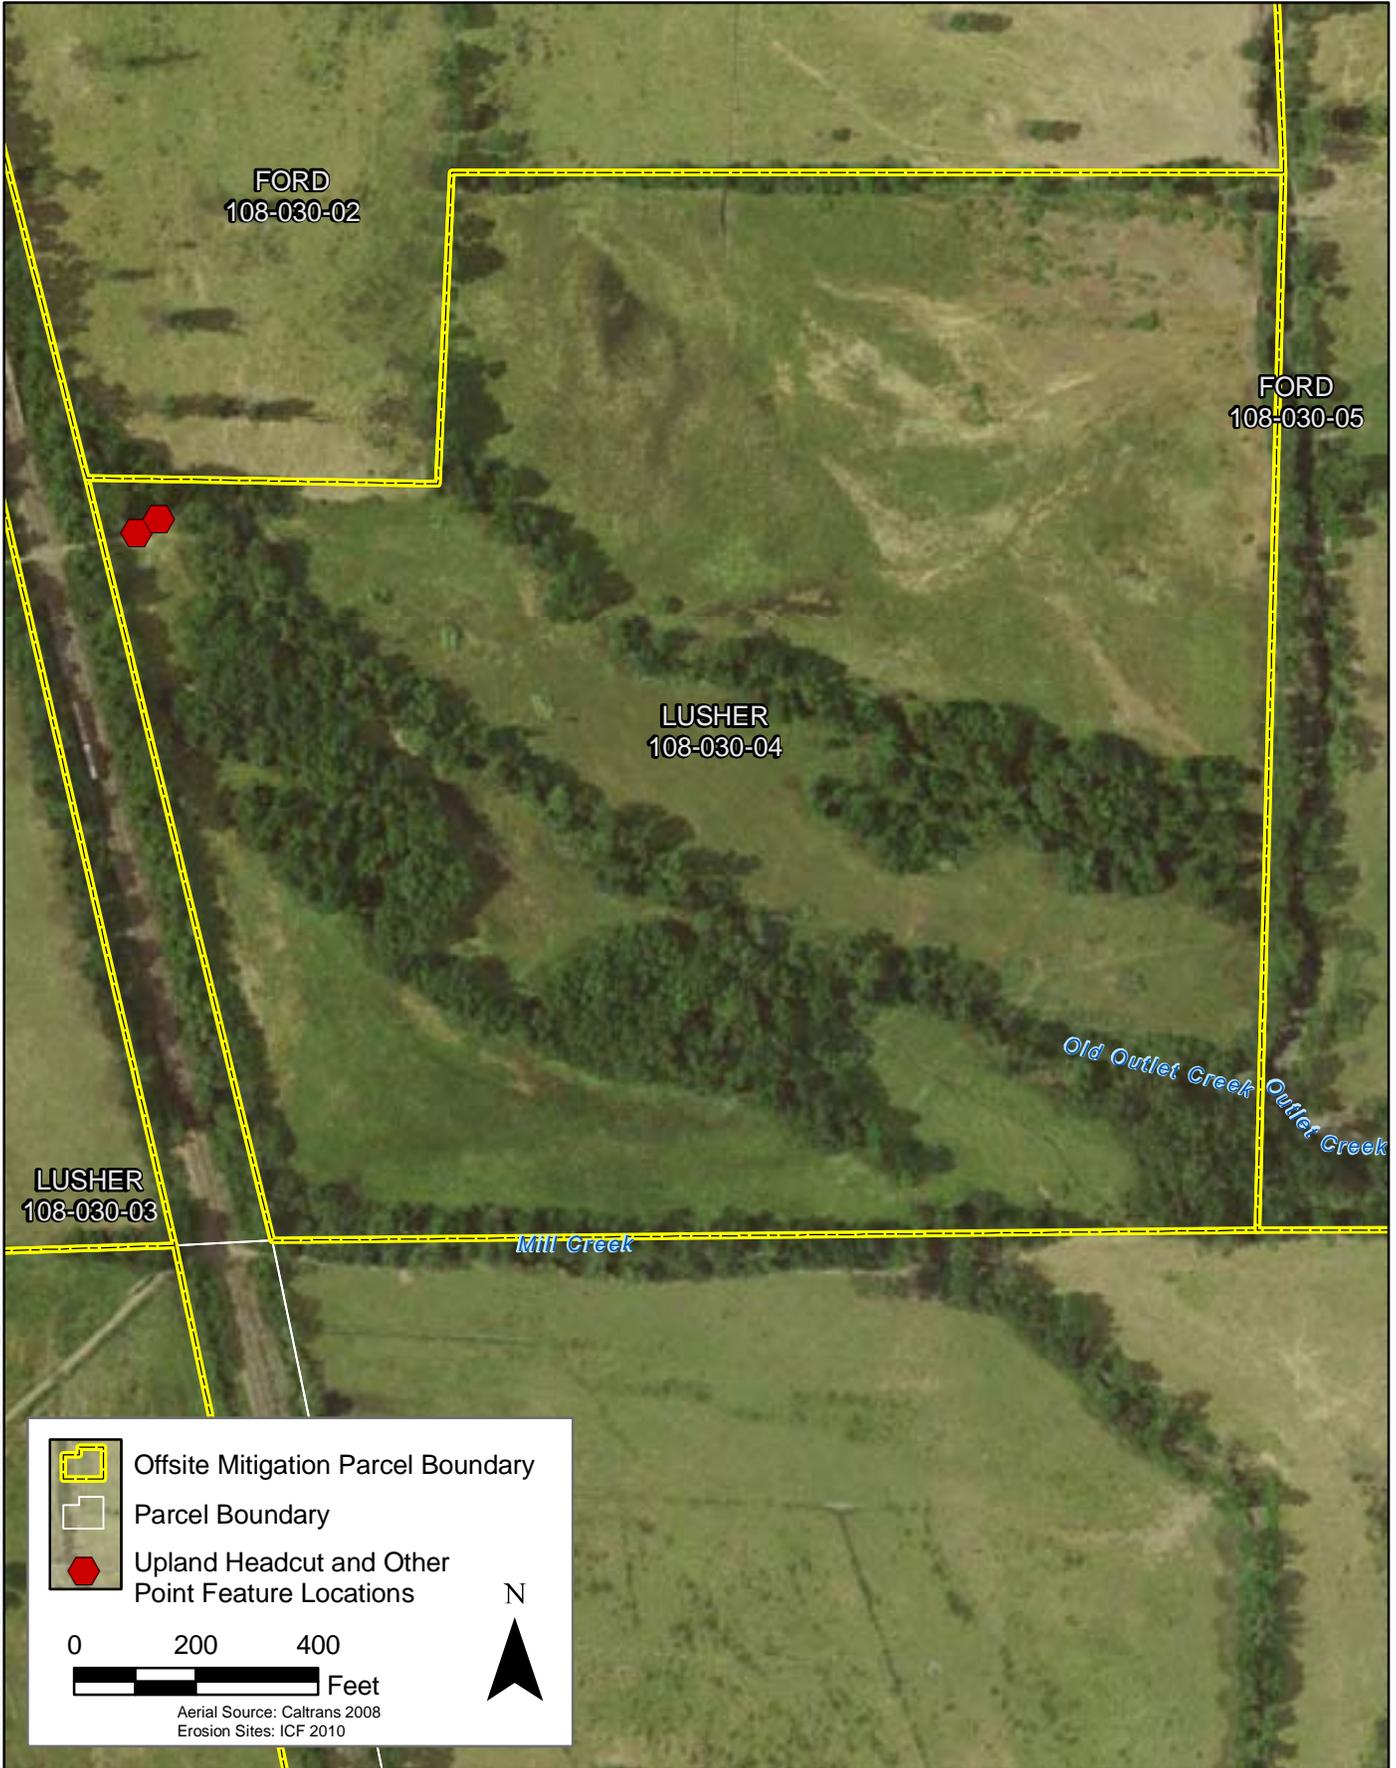
Figure 4-3
Lusher (APN 108-030-04)
Erosion Site Locations

The Lusher 108-030-04 parcel has three erosion sites (Table 3-1, Figure 3-1, Appendix A). There is one instream depressional wetland site (108-030-04_1) and two instream headcut sites (108-030-04_2 and 108-030-04_3), each located on the northern boundary of the parcel (Figure 3-1). The depressional wetland is located on a swale and has slumping banks; however, it does not have a headcut associated with it and is not undergoing headward migration in either direction. The instream headcuts, however, are two of the larger headcuts observed during the erosion site assessment and are discussed further in Chapter 4.

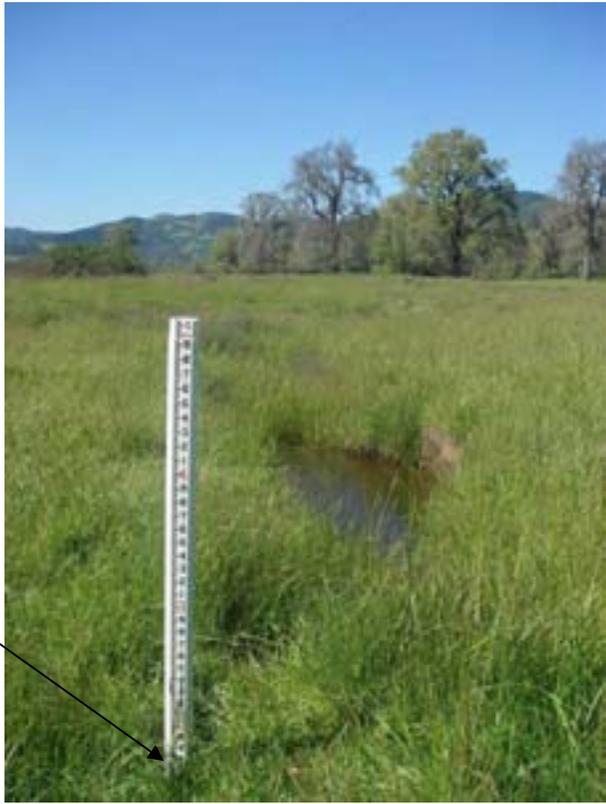
pothole

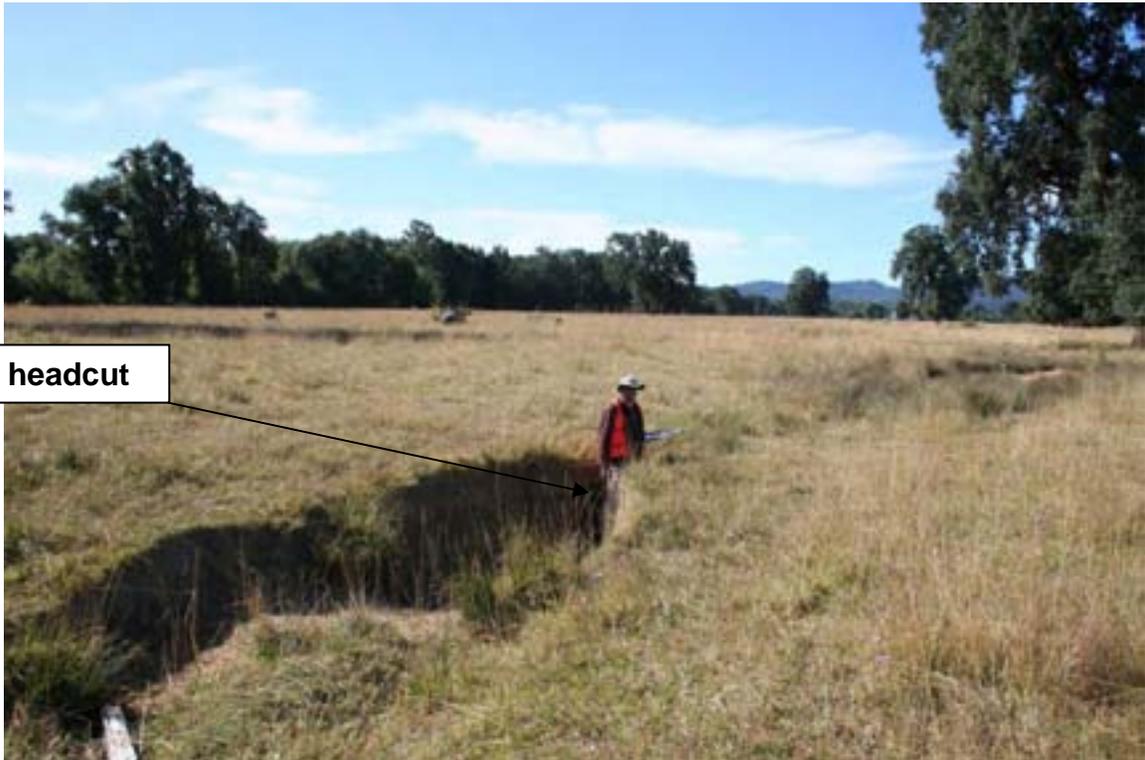
headcut

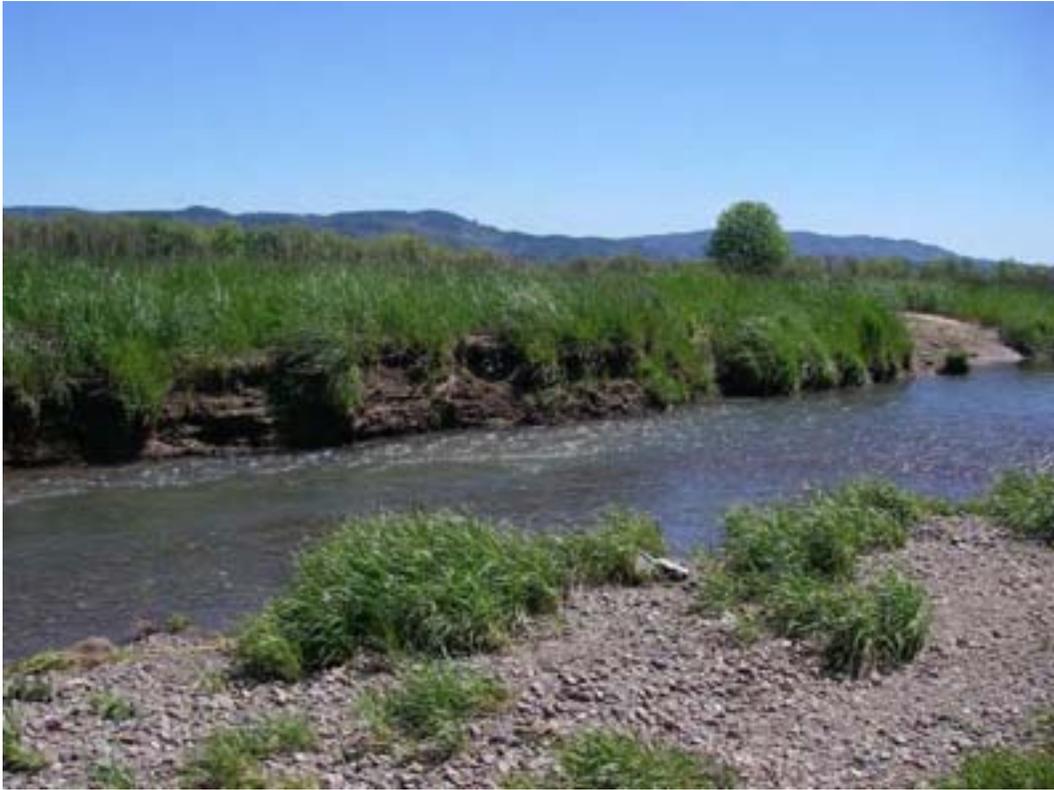
active slumping

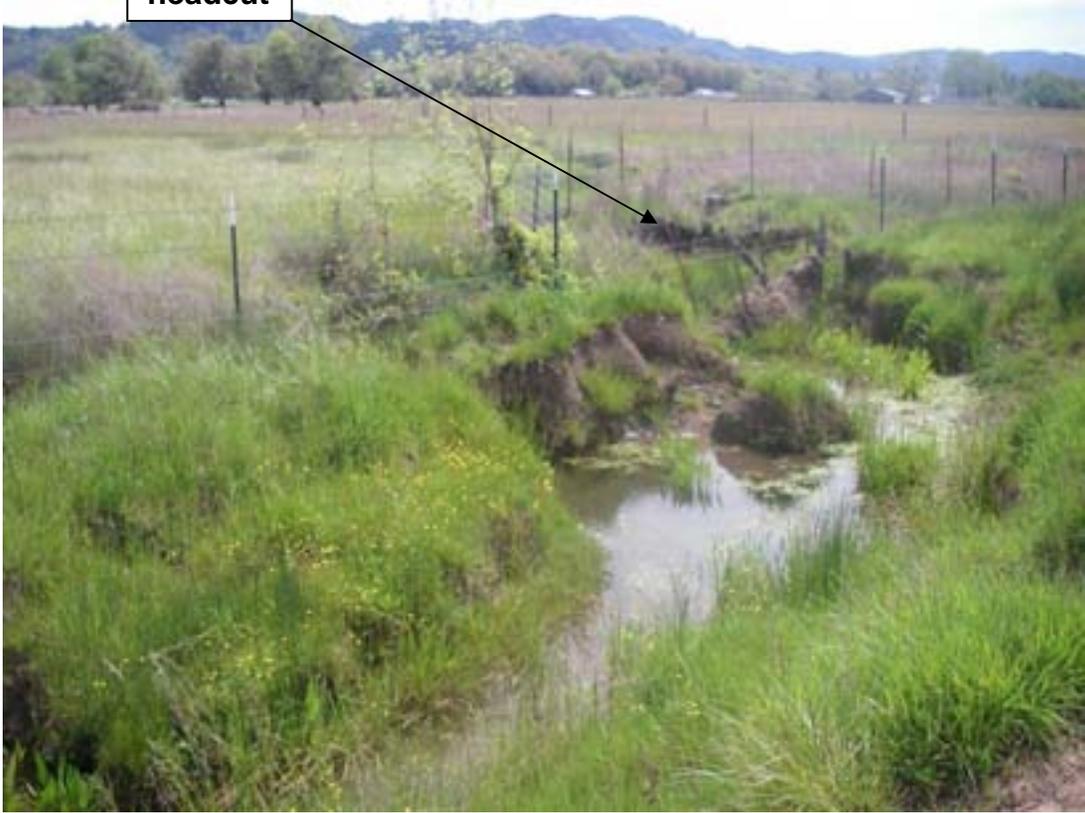
headcut

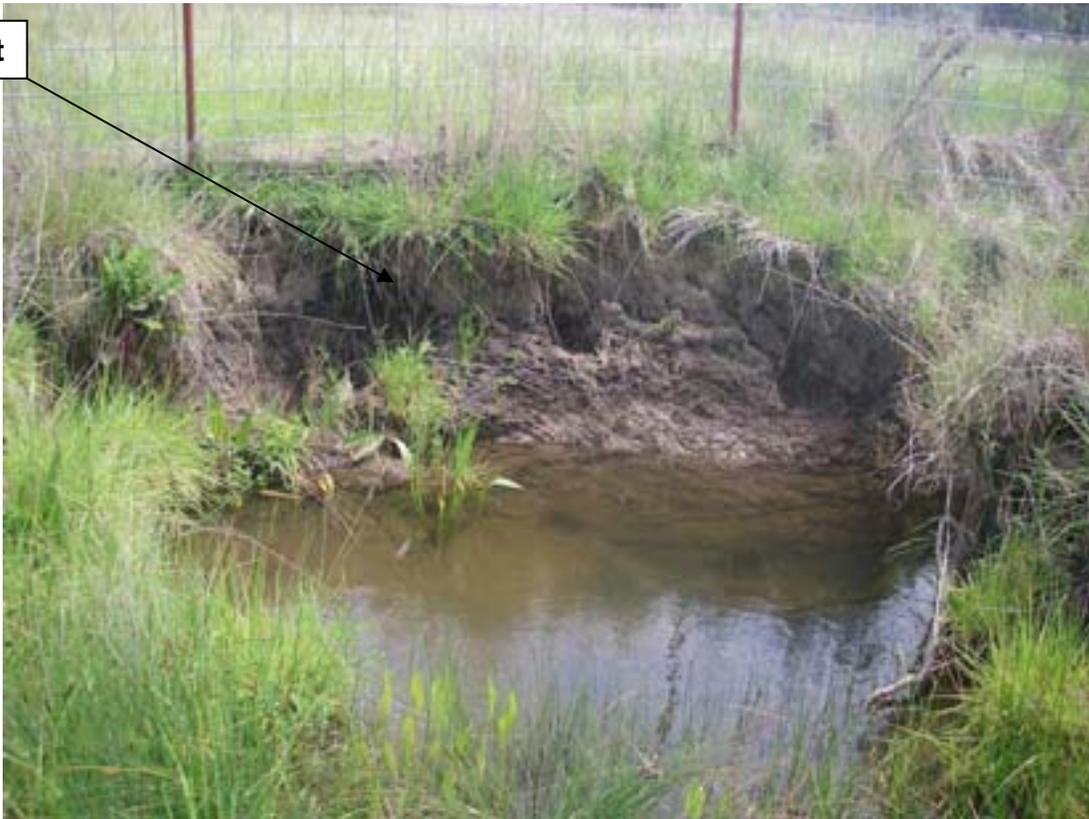
headcut

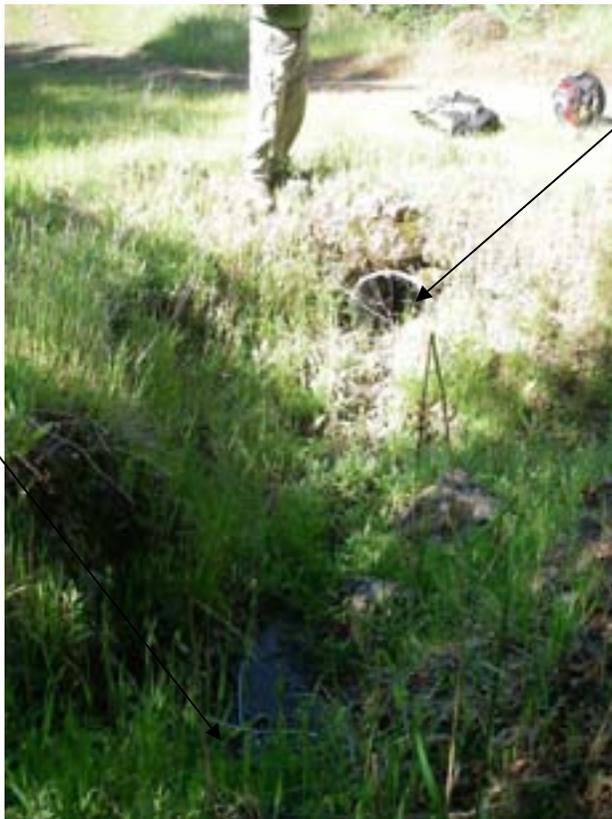
headcut

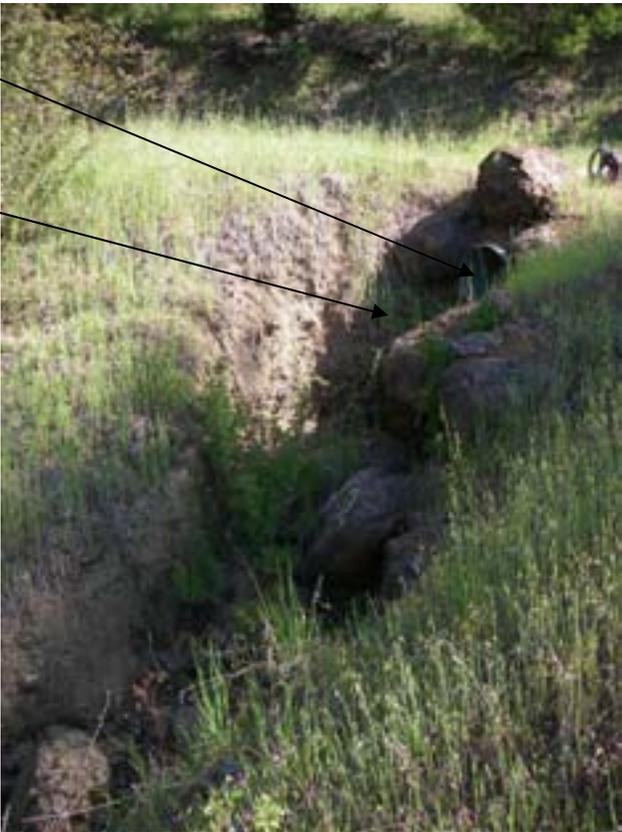
scour area

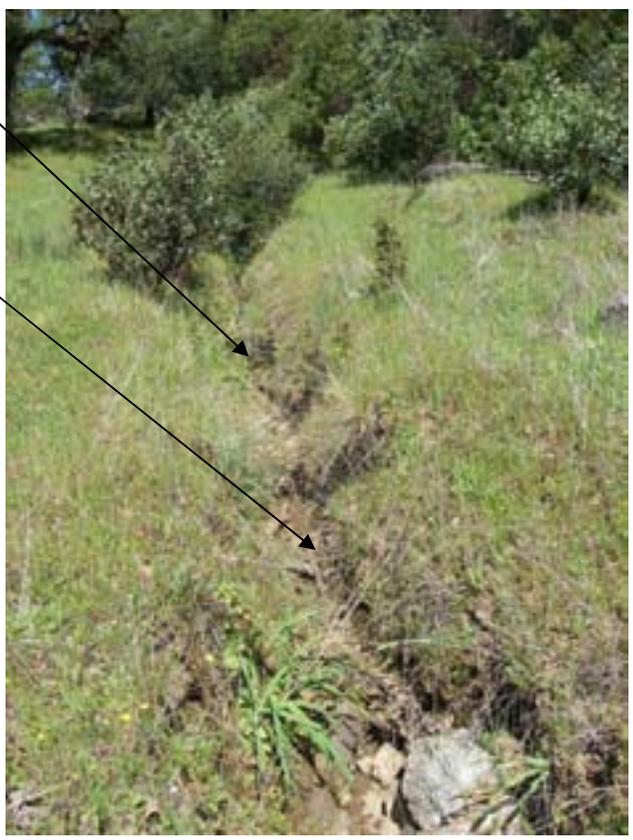
eroding
gully

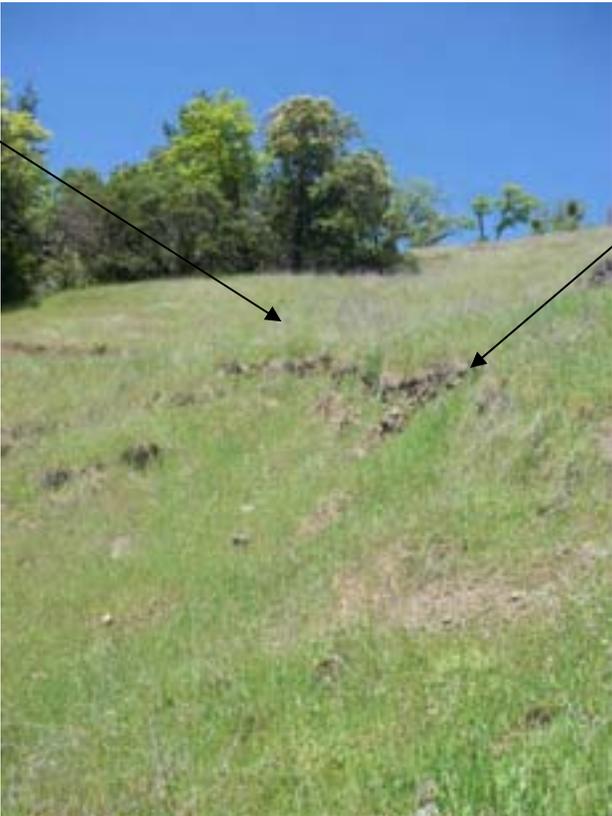
**slump/
headcut**

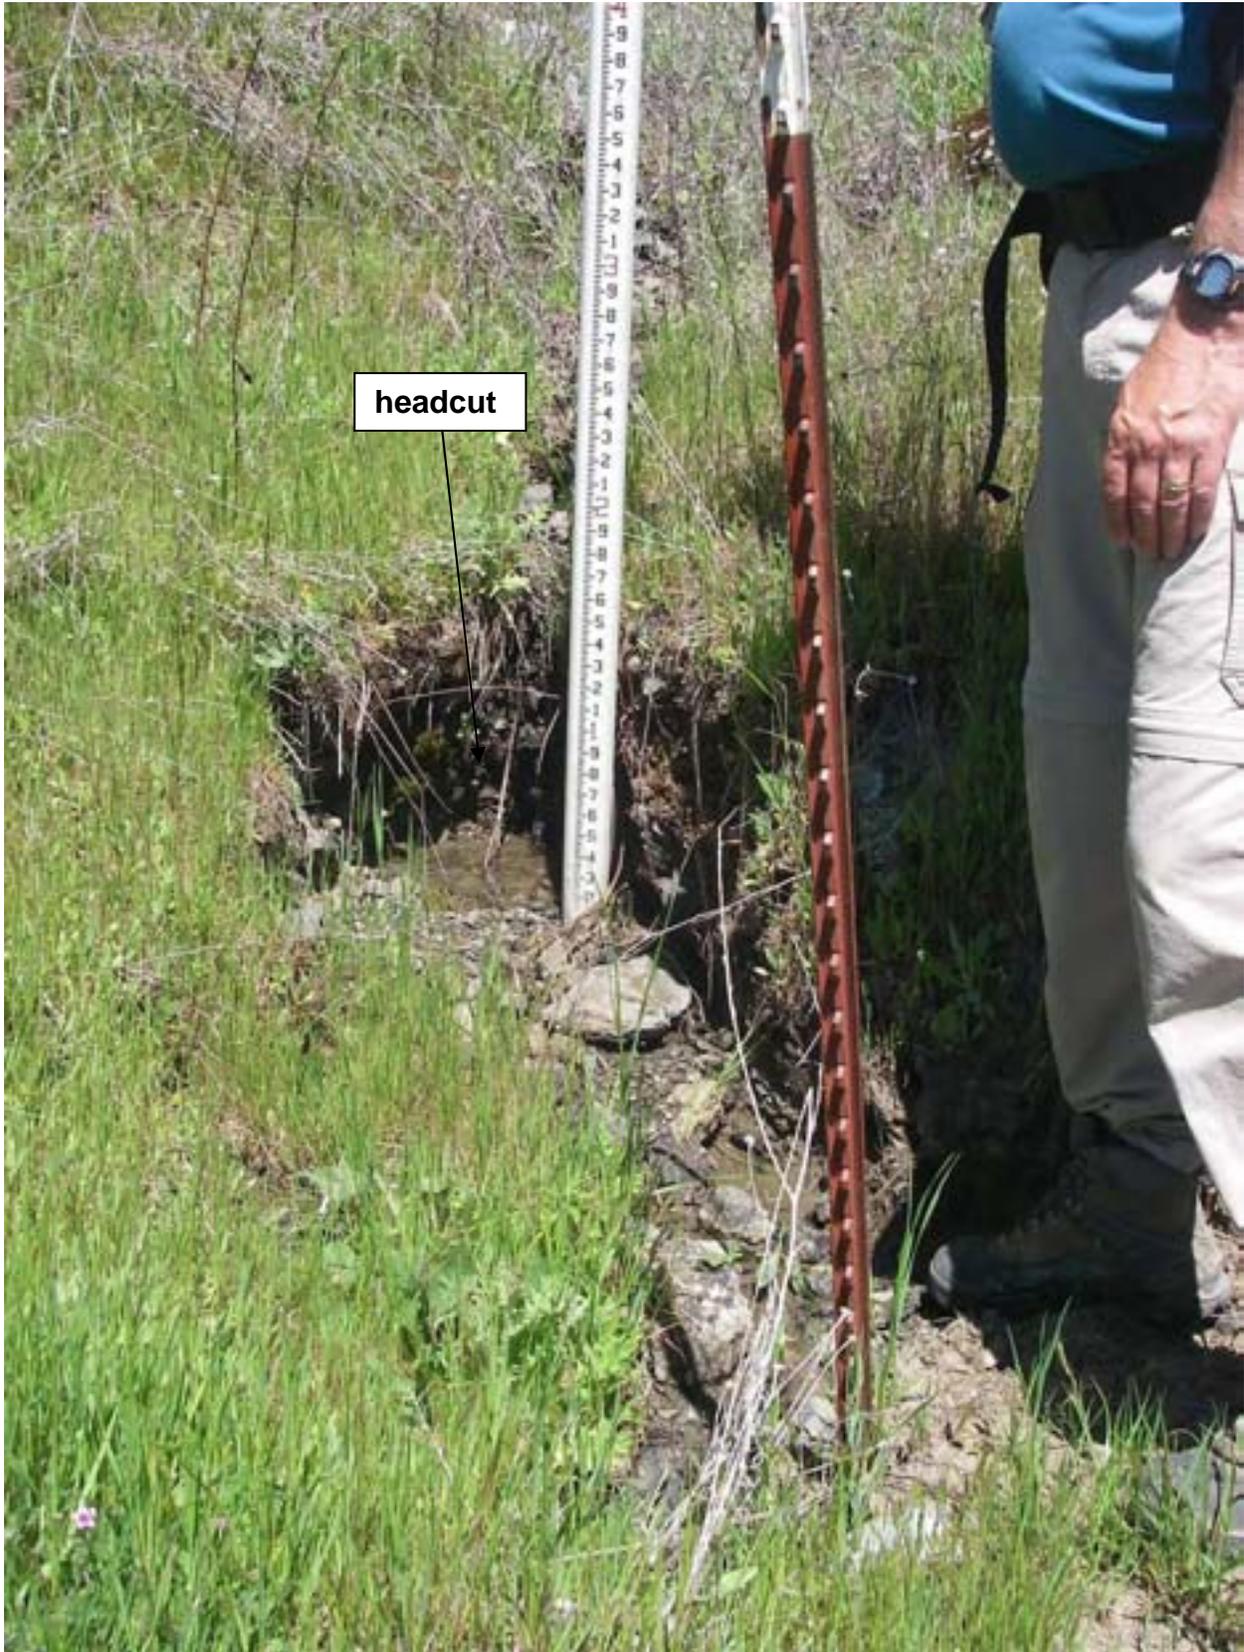
headcut
