Preliminary Investigation

Caltrans Division of Research and Innovation

Compliance Crash Testing of Side Mounted Bridge Rail

March 6, 2013

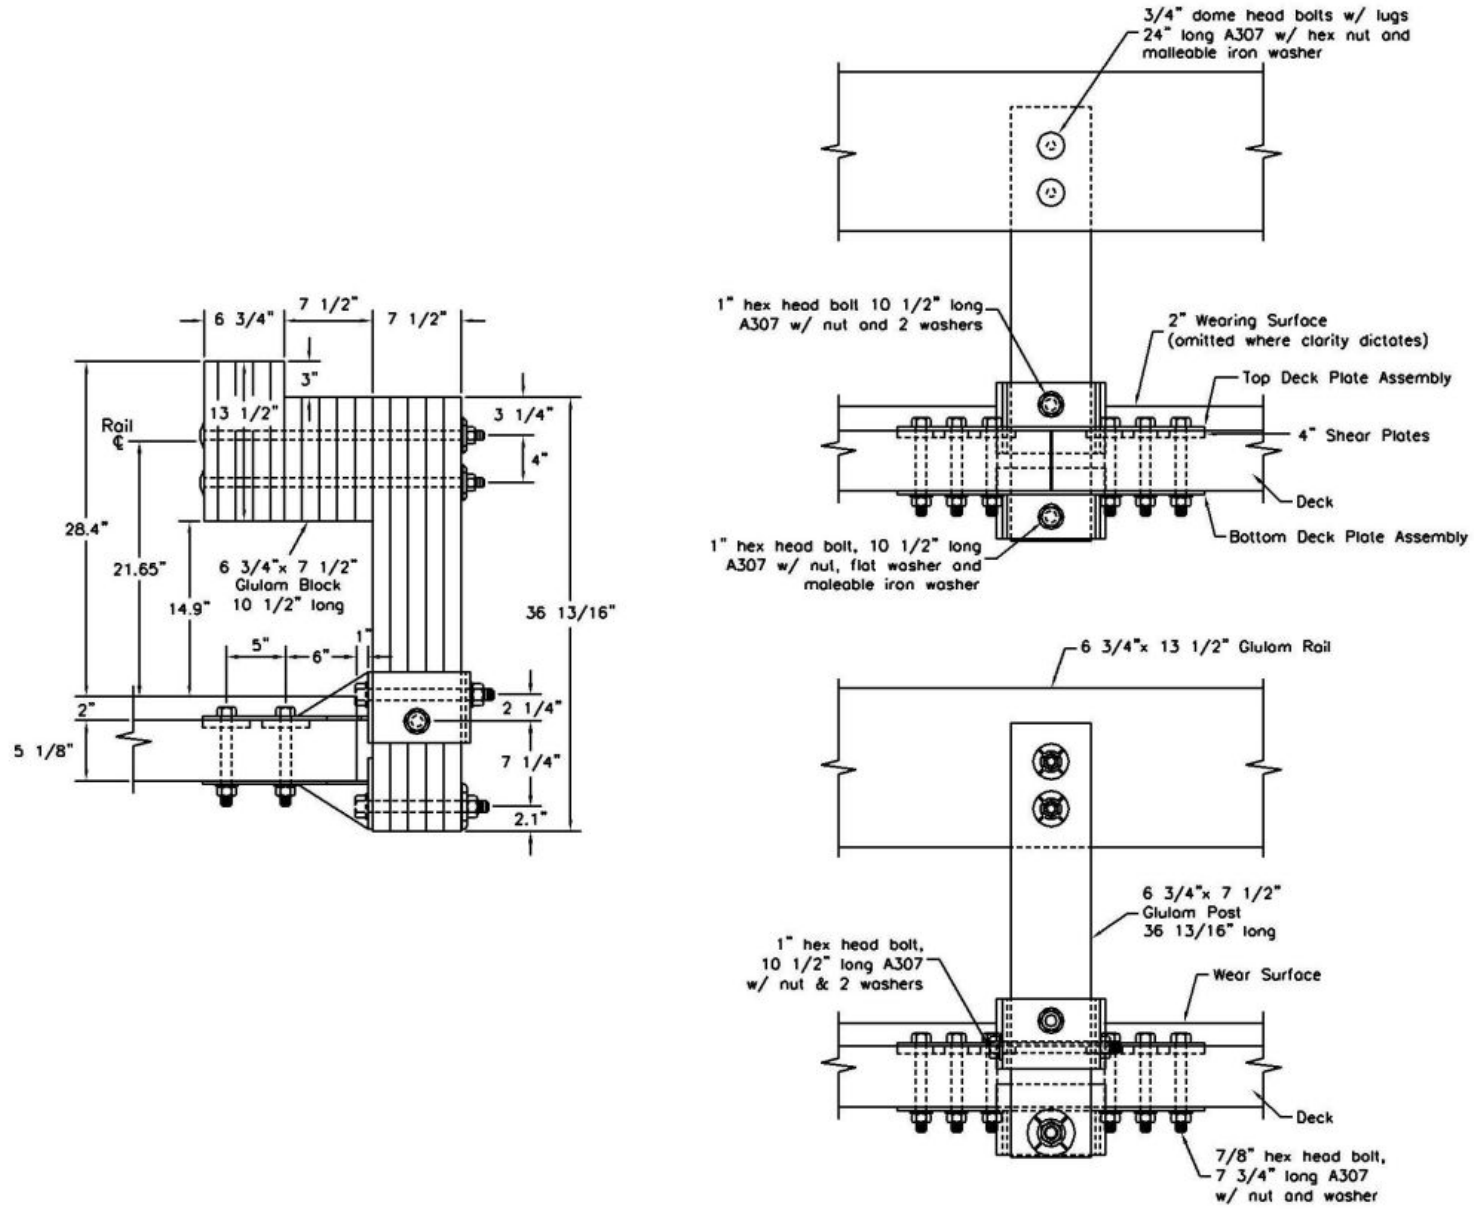
Figure 91. Bridge Railing Design Details - Wood System

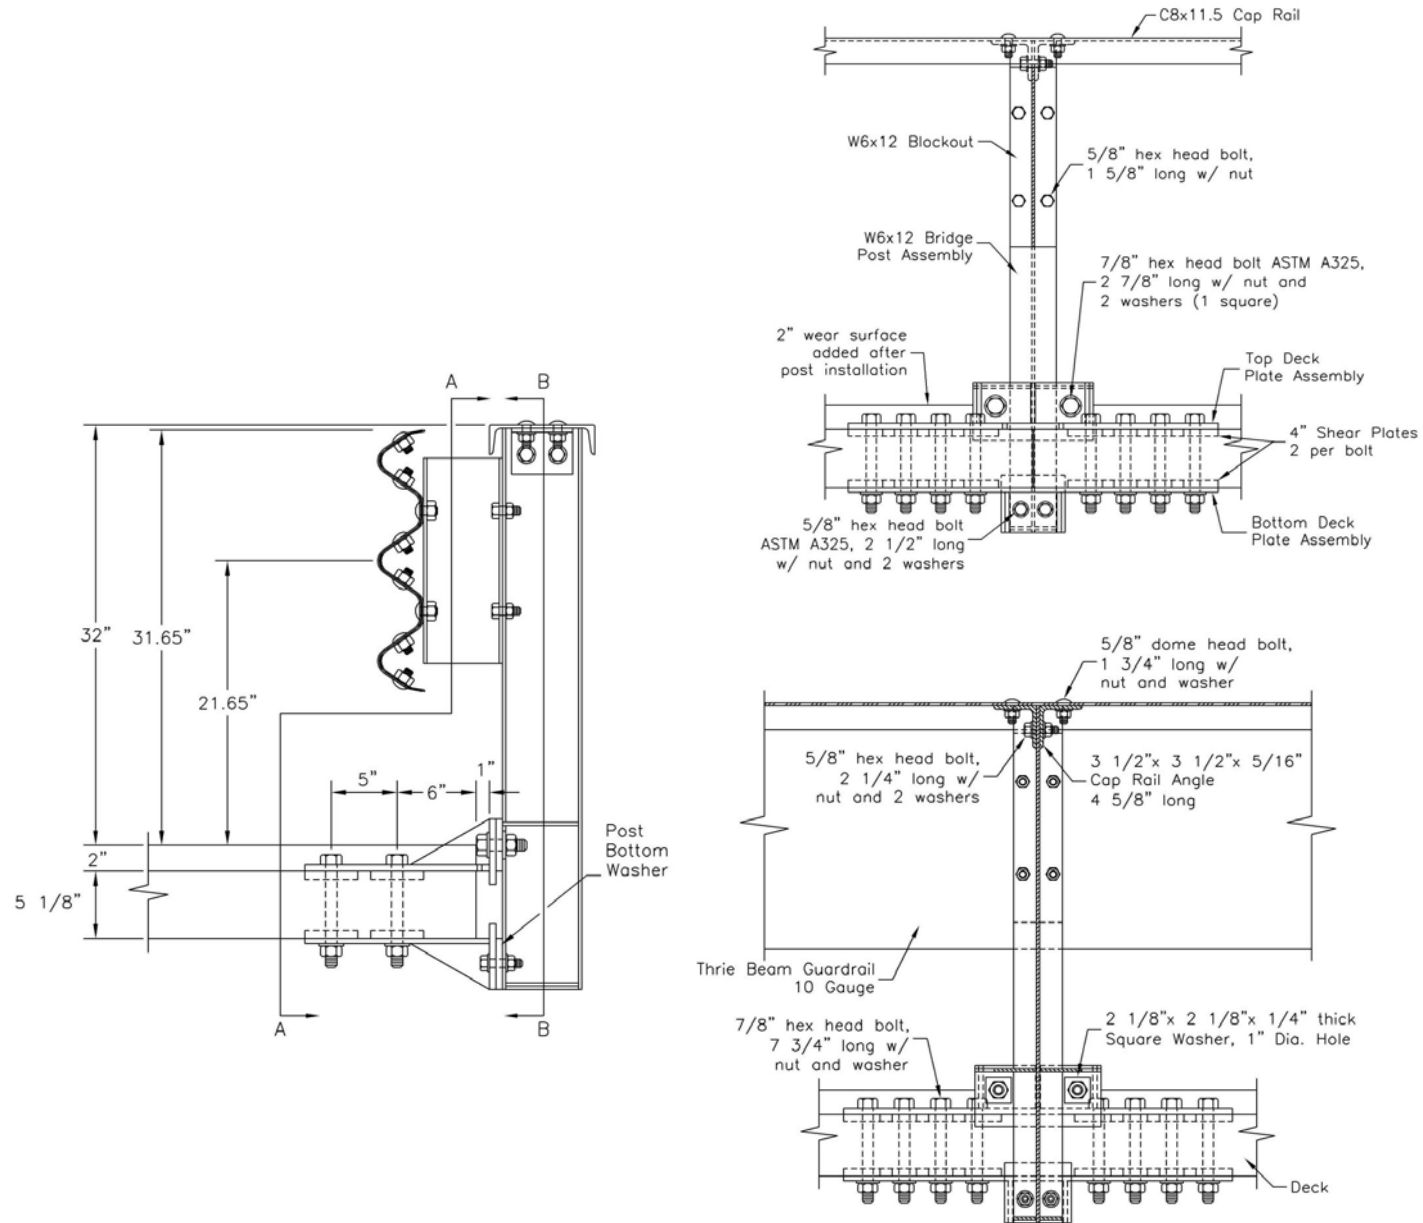
Figure 33. Bridge Railing Design Details - Steel System

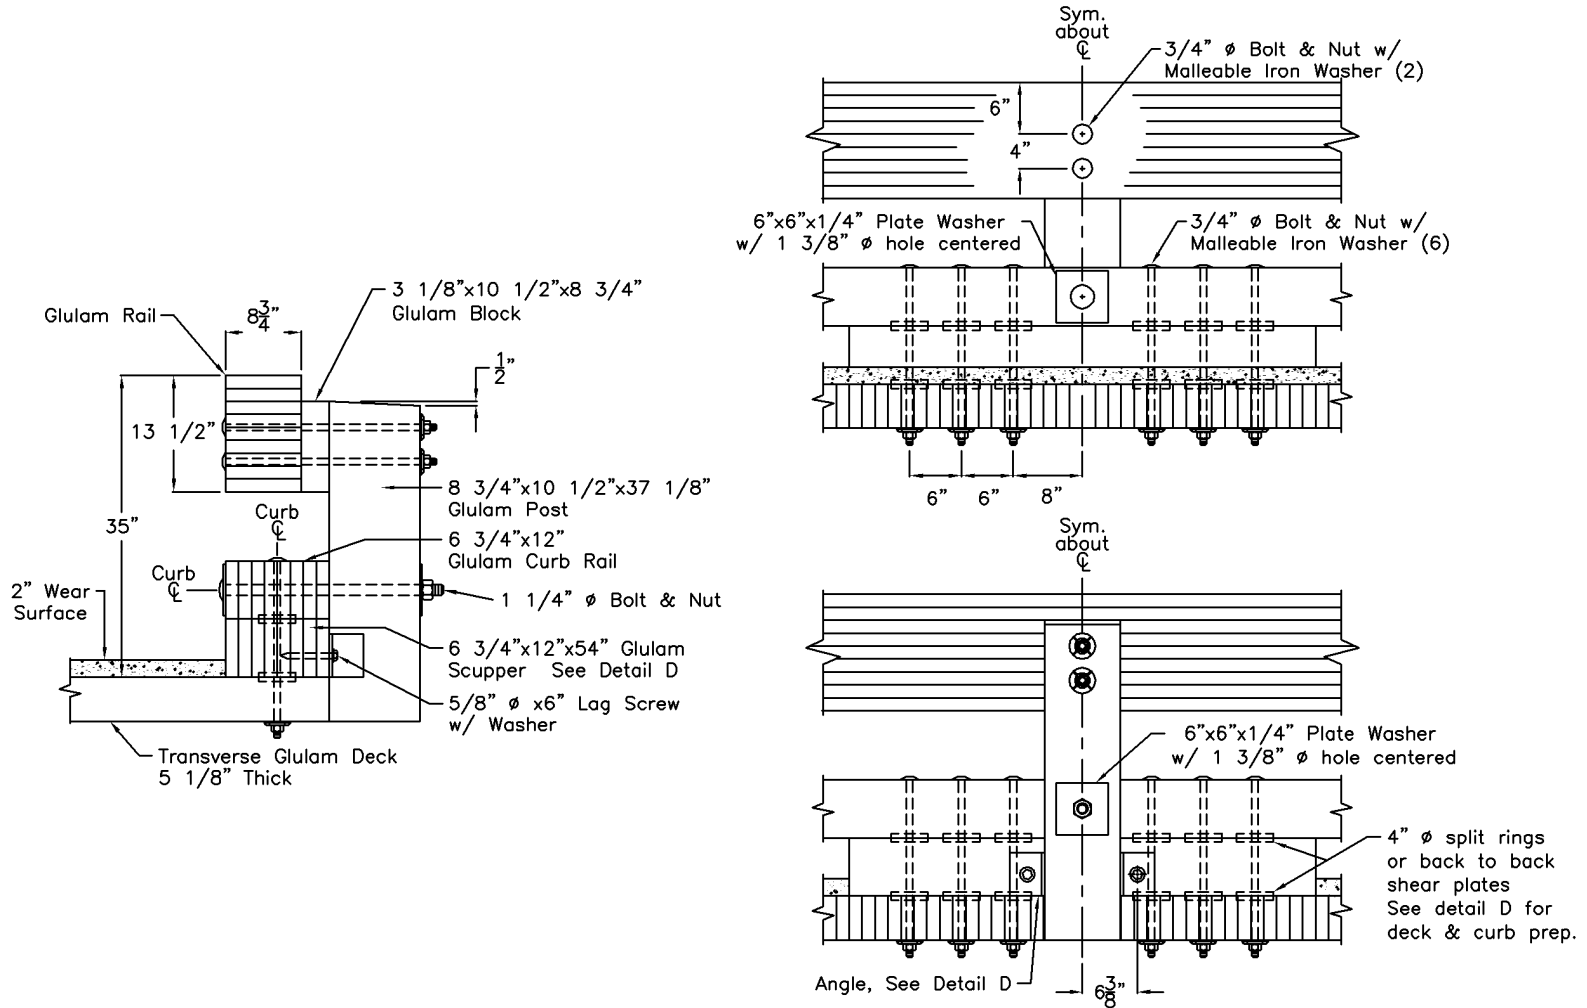
Figure 52. Bridge Railing Design Details - Wood System

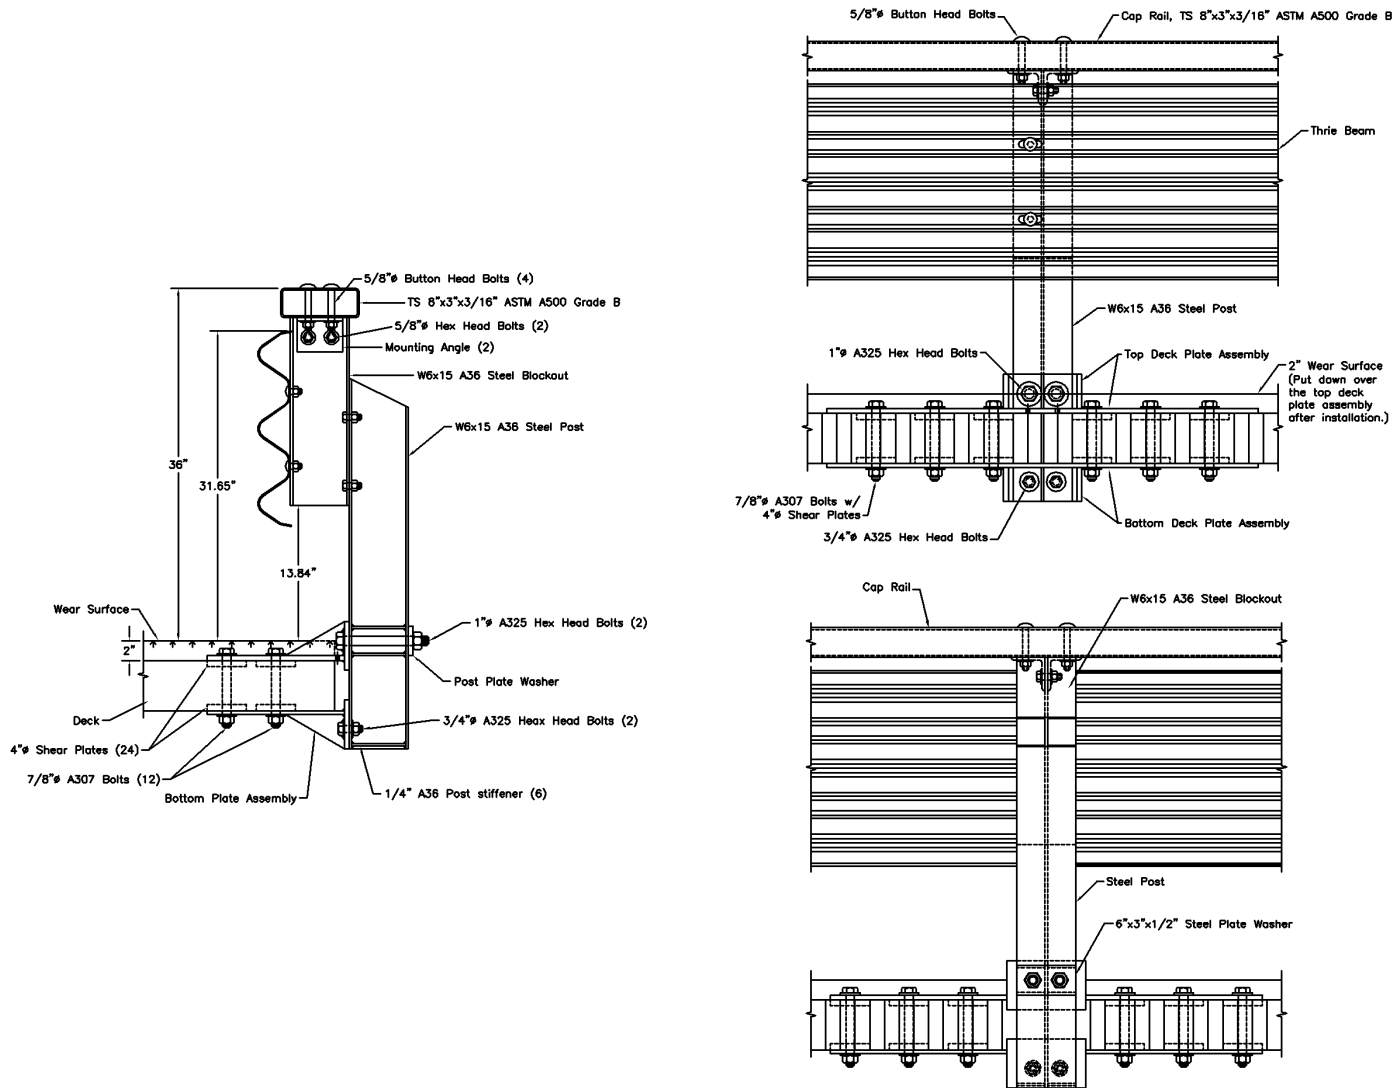
Figure 121. Bridge Railing Design Details - Steel System

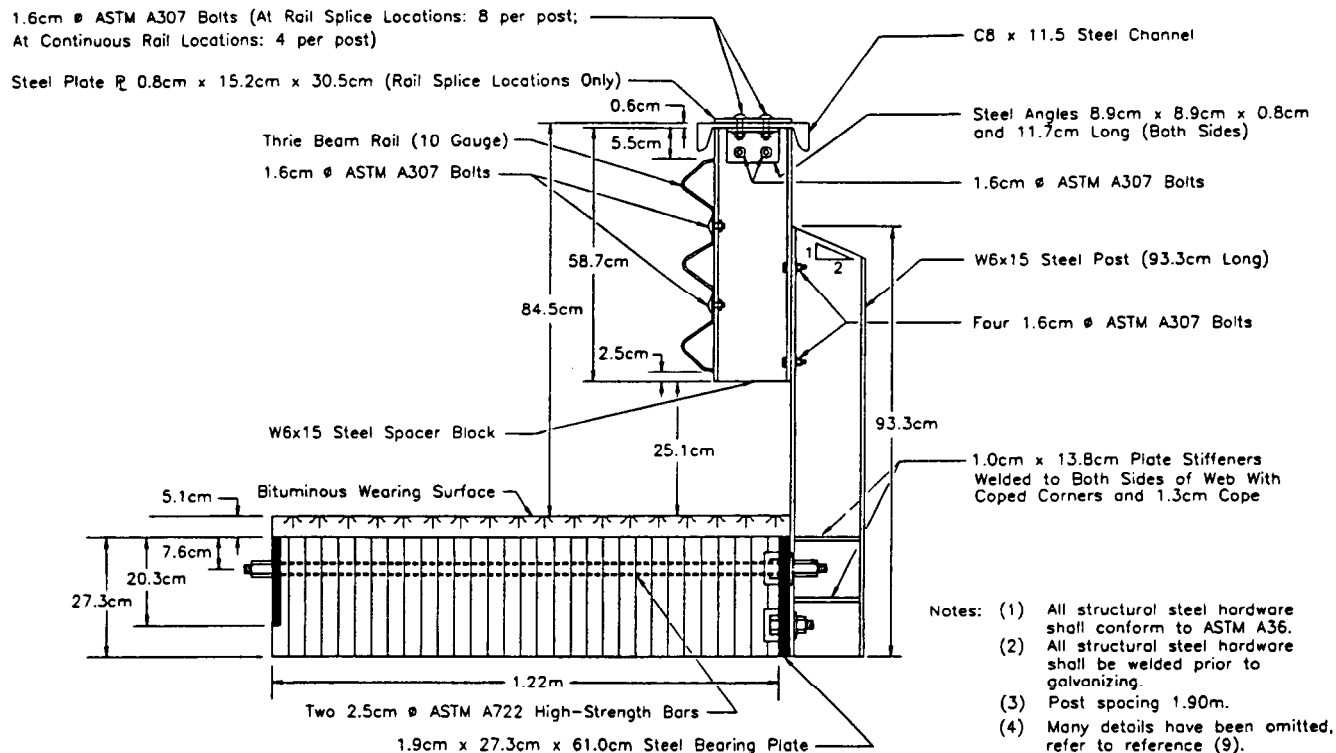
FIGURE 1 Thrie-beam with channel bridge railing (TBC-8000).

The TBC-8000 bridge railing consists of four major components: (a) structural steel posts and spacer blocks; (b) steel thrie-beam rail; (c) structural steel channel rail; and (d) structural steel mounting plates. An illustration of the TBC-8000 bridge railing is shown in Figure 1.

Fifteen galvanized ASTM A36 W6 × 15 structural steel posts 93.3 cm (3 ft 3¼ in.) long were used to support the steel railing. The steel posts were attached to the longitudinal glulam timber deck with ASTM A36 structural steel mounting plates. Fifteen steel mounting plates 1.9 cm (3/4 in.) thick, 27.3 cm (10¼ in.) deep, and 61.0 cm (24 in.) long were attached to the deck with two ASTM A722 high-strength bars 2.5 cm (1 in.) in diameter and 1.37 m (4 ft 6 in.) long, spaced at 40.6 cm (16 in.) and located 7.6 cm (3 in.) below the top surface of the deck. Design details for the bearing plates located at the other end of the rods are included in a study by Ritter et al. (6). Each steel post was bolted to a steel mounting plate with four 2.2 cm (7/8 in.) diameter ASTM A325 galvanized hex head bolts. Four recessed holes were cut into the edge of the timber deck so the steel mounting plates would bolt flush against the vertical deck surface. The lower rail consisted of a 10-gauge thrie-beam mounted 78.4 cm (2 ft 6⅞ in.) above the timber deck surface. The thrie-beam rail was offset 15.2 cm (6 in.) away from the posts with galvanized ASTM A36 W6 × 15 structural steel spacer blocks 58.7 cm (1 ft 11 ⅞ in.) long. The upper rail consisted of galvanized ASTM A36 C8 × 11.5 structural steel channel sections attached to the top of the steel spacer blocks. The top of the channel rail was 84.5 cm (2 ft 9¼ in.) above the asphalt surface. The channel rail sections were attached to the spacer blocks with 3½ × 3½ × ⅞ ASTM A36 structural steel angles. Each channel rail section was spliced together with ASTM A36 structural steel splice plates.

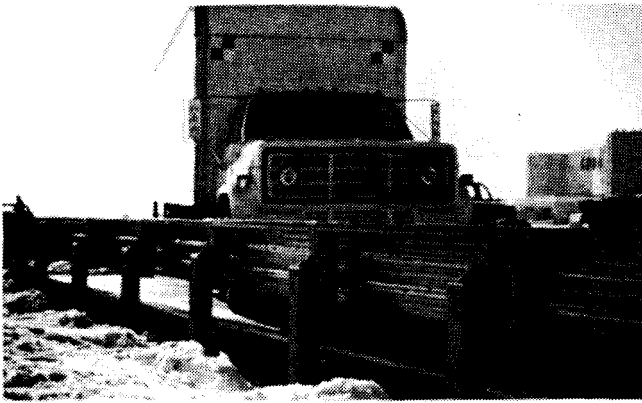
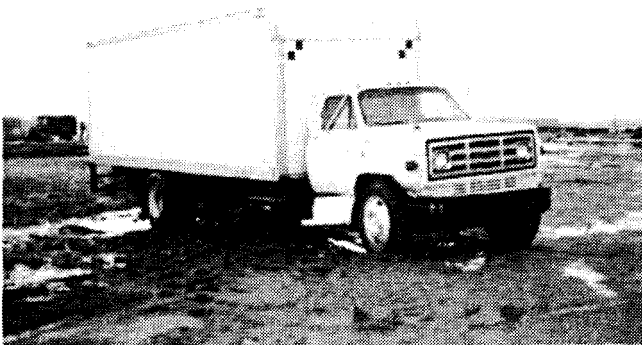
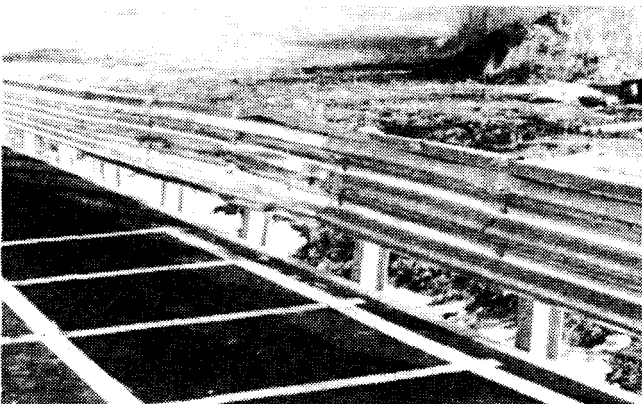
FIGURE 2 Impact location, vehicle damage, and bridge rail damage, Test FSTC-1.

Test FSTC- 1 [8, 165-kg (18,000-lb), 76.3 km/hr (47.4 mph), 16.1 degrees] struck the bridge railing at Post No. 4 (Figure 2). A summary of the test results and the sequential photographs is presented in Figure 3.

Vehicle damage was relatively minor and was limited to the right-front corner of the truck cab, box, and front bumper (Figure 2). The bridge rail damage was moderate, consisting mostly of deformed thrie-beam sections, C-rail sections, and steel posts (Figure 2). Examination of the top and bottom surfaces of the timber deck laminations revealed no physical damage or separation.

The length of vehicle contact along the top of the C-rail was approximately 11.4 m (37 ft 6 in.). Physical evidence revealed that lateral buckling of the C-rail occurred between Post Nos. 4 and 5 (Figure 2). The physical damage to the thrie-beam rail revealed that approximately 7.6 m (25 ft) of rail was damaged. The maximum permanent set deflections of the C-rail and thrie-beam rail were 19.3 cm (7.6 in.) and 20.8 cm (8.2 in.), respectively.

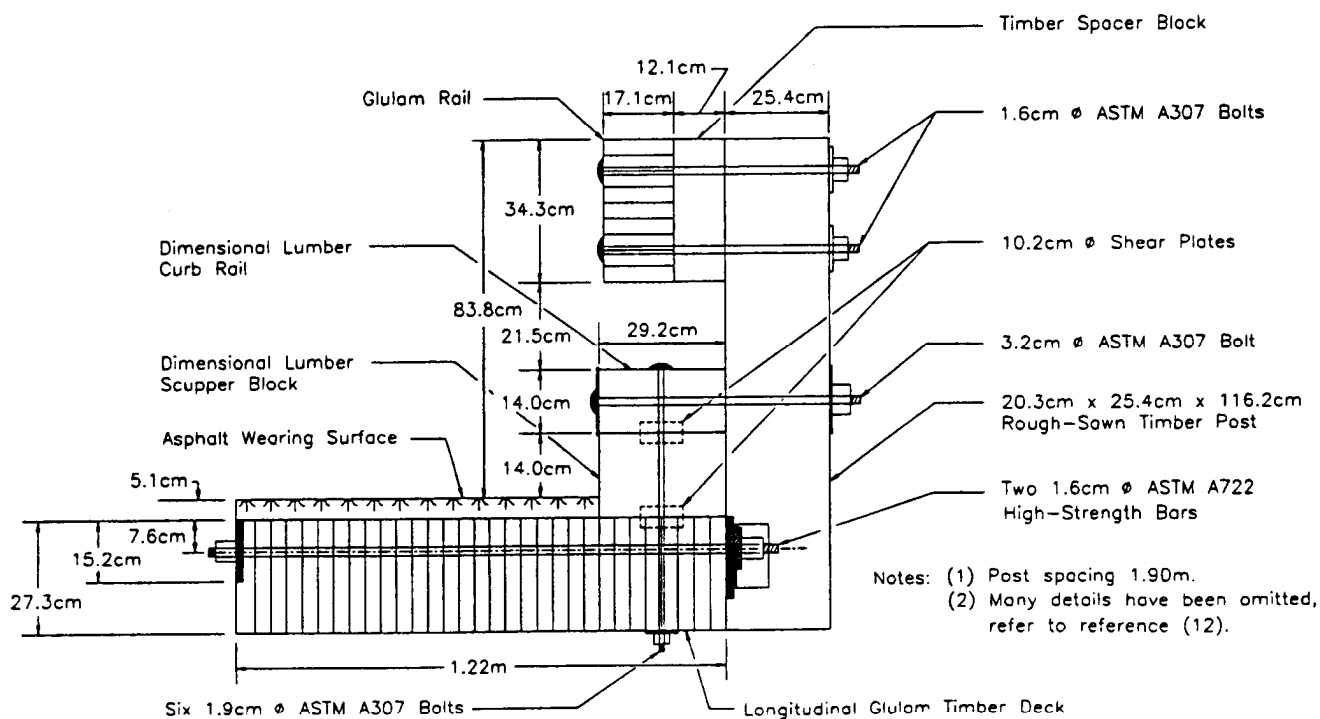
FIGURE 4 Glulam timber with curb bridge railing (GC-8000).

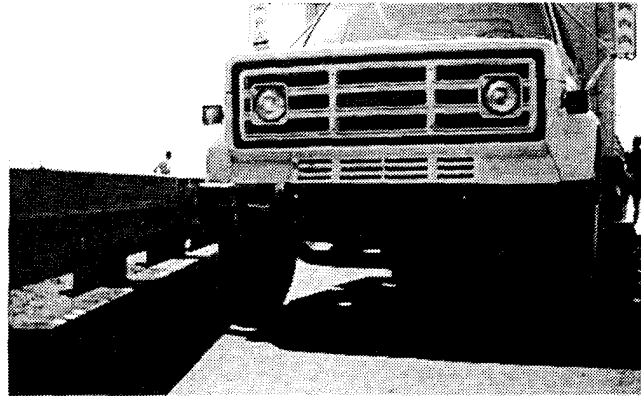
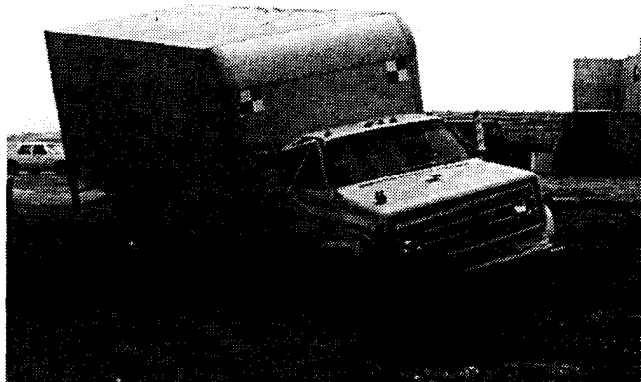
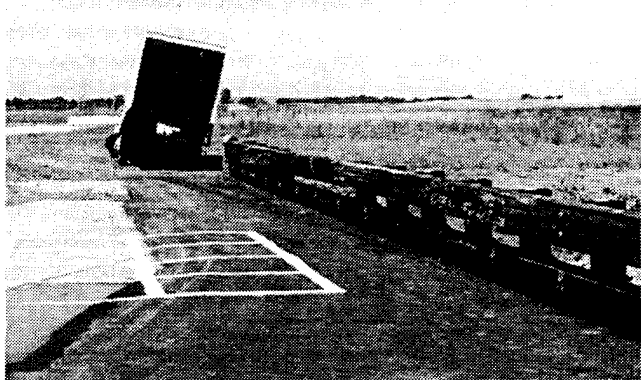
FIGURE 5 Impact location, vehicle damage, and bridge rail damage. Test FSCR-1.

upstream from Post No. 4 (Figure 5). A summary of the test results and the sequential photographs are presented in Figure 6.

Exterior vehicle damage was moderate (Figure 5). Vehicle damage occurred to several body locations, including the door and quar-

The moderate bridge railing damage near the impact area is shown in Figure 5. The downstream end of the glulam rail adjacent to Post No. 4 was fractured on the lower part of the rail. The curb rail received significant gouging between Post Nos. 4 and 5. Deep gouges and scrapes occurred to the top of the glulam rail from Post Nos. 7-14. Nine timber bridge posts, Post Nos. 7-15, were damaged during the crash test, as shown in Figure 5. The glulam timber bridge deck received some superficial surface cracks near Post No. 4. The crack width ranged between 1.6 to 3.2 mm (1/16 and 1/8 in.).

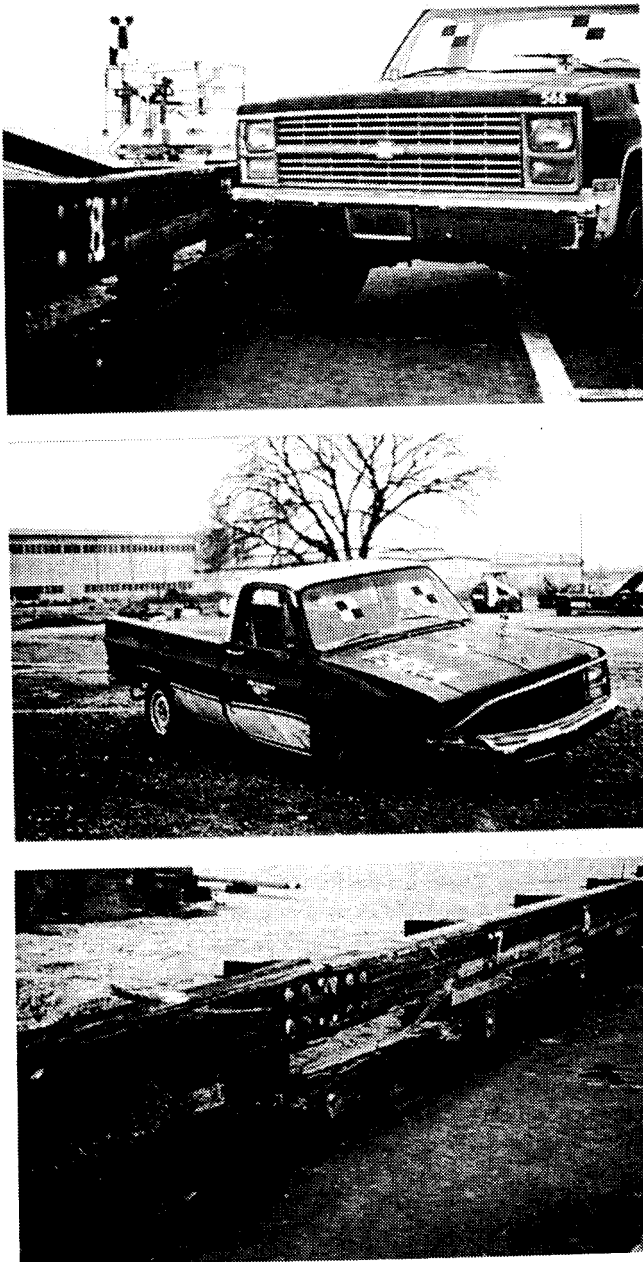
FIGURE 7 Impact location, vehicle damage, and bridge rail damage, Test FSCR-4

Test FSCR-4 [2,087-kg (4,600-lb), 98.0 km/hr (60.9 mph), 24.9 degrees] impacted the bridge rail at approximately 1.76 m (5.77 ft) upstream from Post No. 8 (Figure 7). A summary of the test results and the sequential photographs are presented in Figure 8.

Exterior vehicle damage was moderate (see Figure 7). Vehicle damage occurred to several body locations, including the door and quarter panels, front bumper, right-side tires and rims, rear bumper, engine mount, and interior floorboard. The right-front tire, was deflated and partly removed from the rim. In addition, the right-front tire, rim, and attached steering mechanism were pushed backward, and the right-side engine mount was deformed toward the engine. Interior vehicle deformation to the occupant compartment was not sufficient to cause injury to the vehicle occupants.

The minor bridge railing damage downstream from the impact location is shown in Figure 7. Scrapes and gouging occurred to the upper glulam timber and sawed lumber curb rails. Significant tire and rim contact on the curb rail was evident from the downstream side of Post No. 7 to the downstream side of Post No. 8. Longitudinal cracking occurred toward the bottom traffic-side face of the glulam rail at Post No. 8. The downstream-side of the glulam rail splice located at Post No. 8 was fractured. The flexural failure occurred in the tension region of the glulam rail (or the backside of the vertical saw-cut section) and near the downstream end of the steel splice plate. No physical damage occurred to the timber bridge posts or spacer blocks. Additional curb rail damage consisted of cracking along a vertical plane through the longitudinal centerline of the bolts. The glulam timber bridge deck received some superficial surface cracks. The crack width ranged between 1.6 and 6.4 mm (1/16 and 1/4 in.).

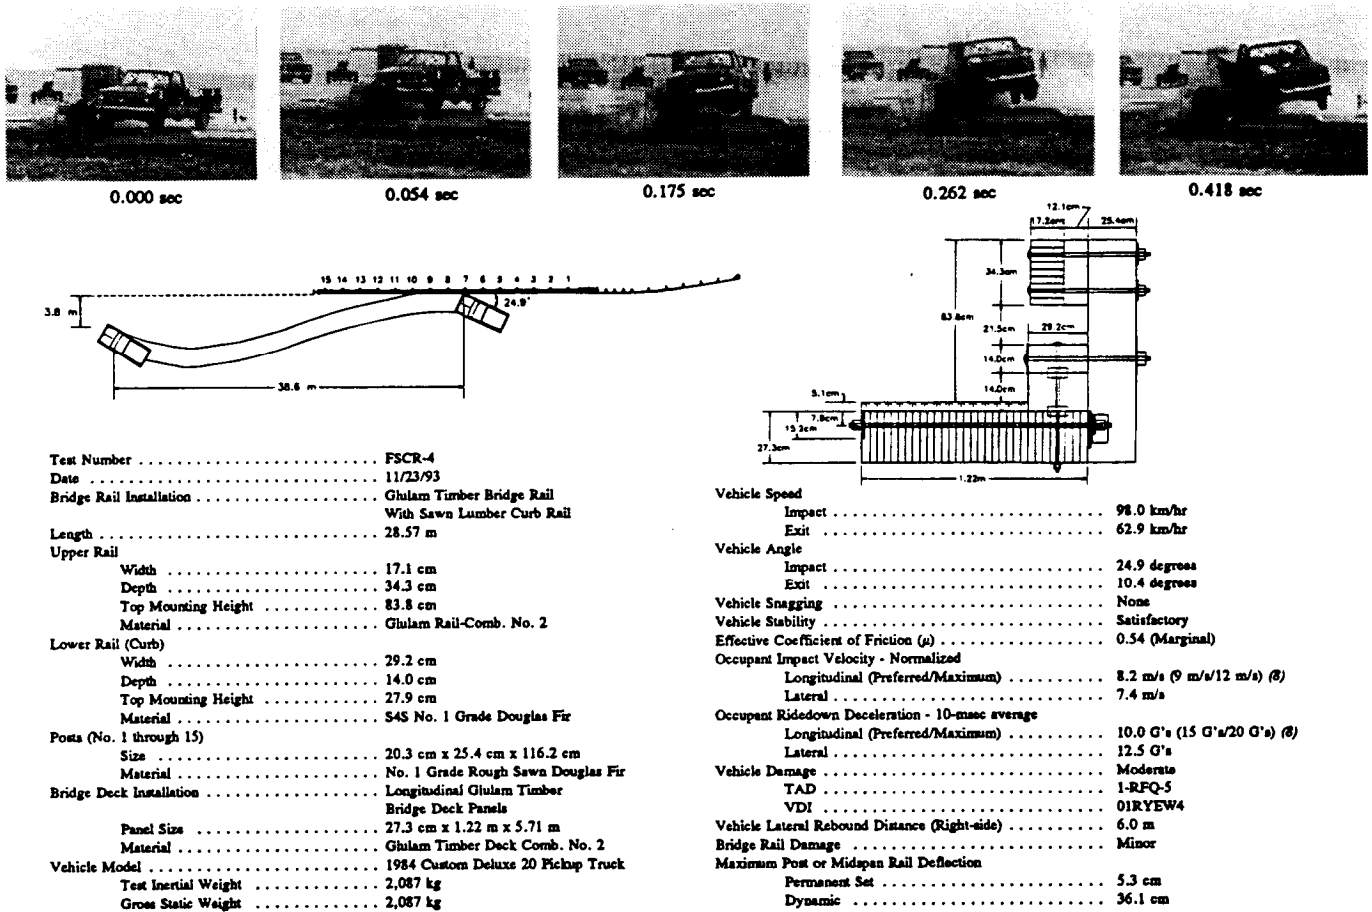
FIGURE 8 Summary of test results and sequential photographs, Test FSCR-4.

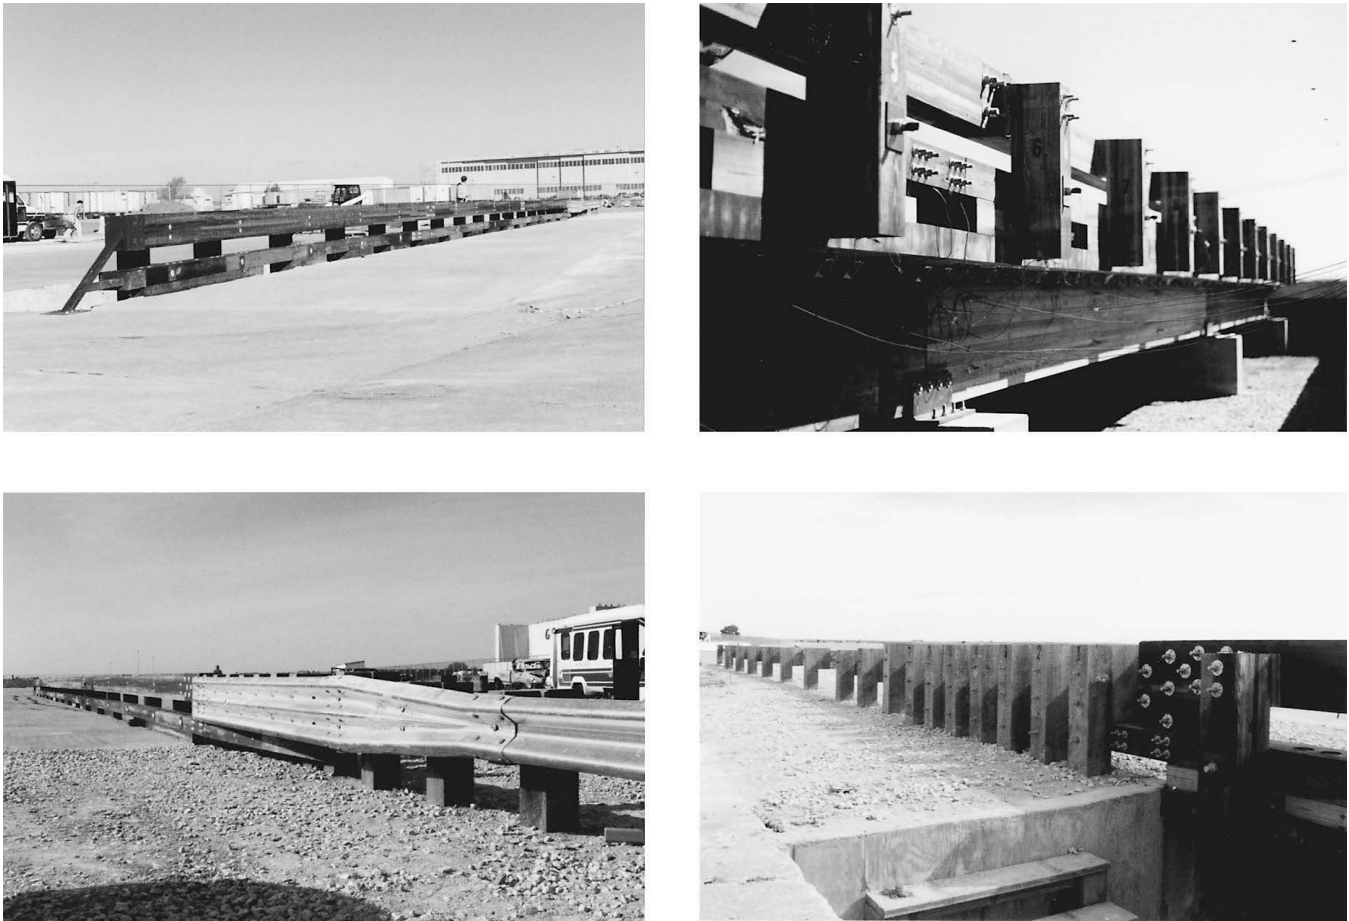
FIGURE 1 System No. 1: glulam rail with curb bridge railing (*top*) and thrie beam with curb transition (*bottom*).

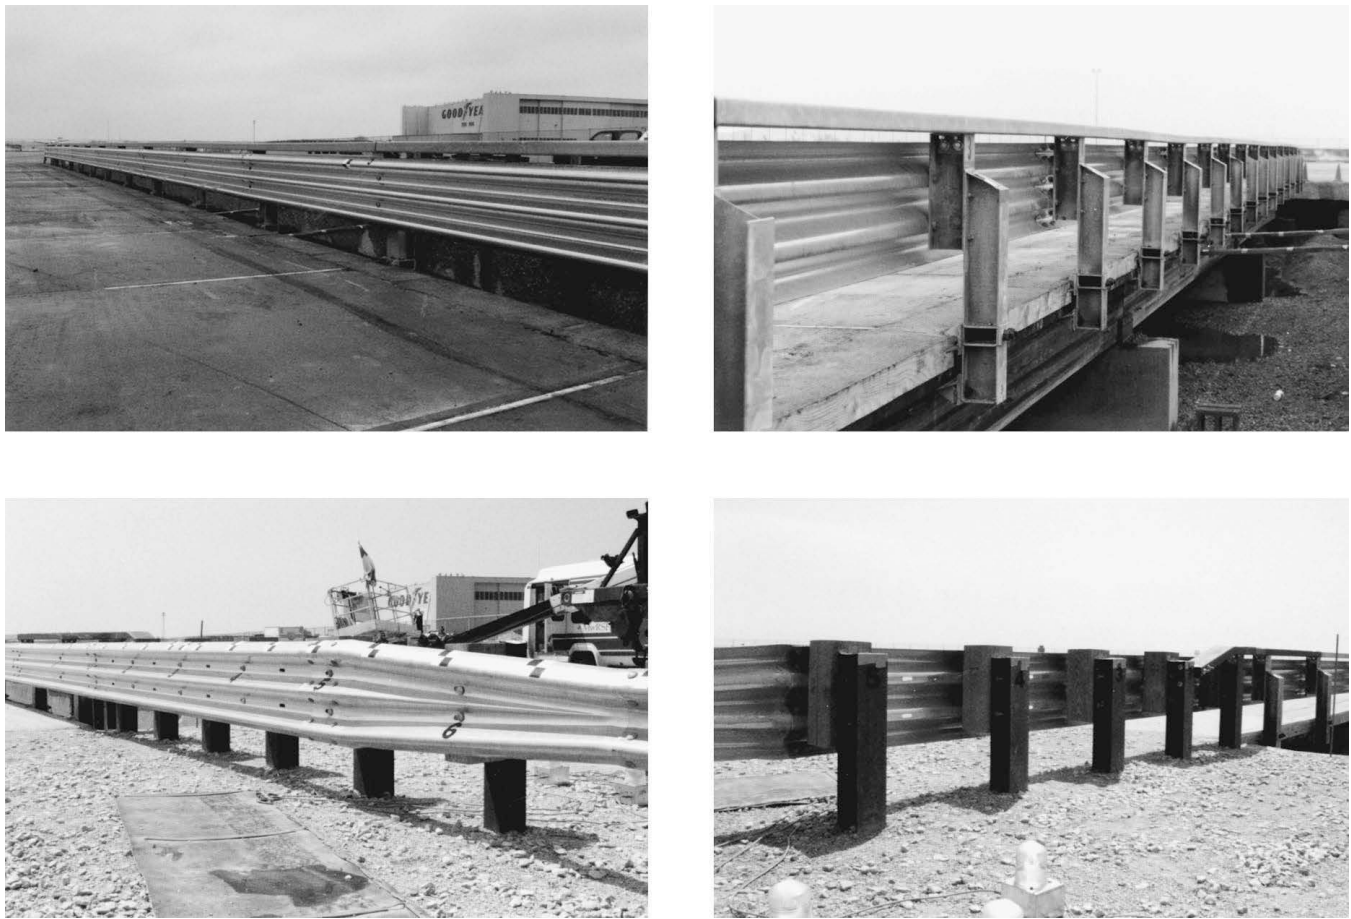
FIGURE 2 System No. 2: steel thrie beam with tube bridge railing (*top*) and thrie beam with tube transition (*bottom*).

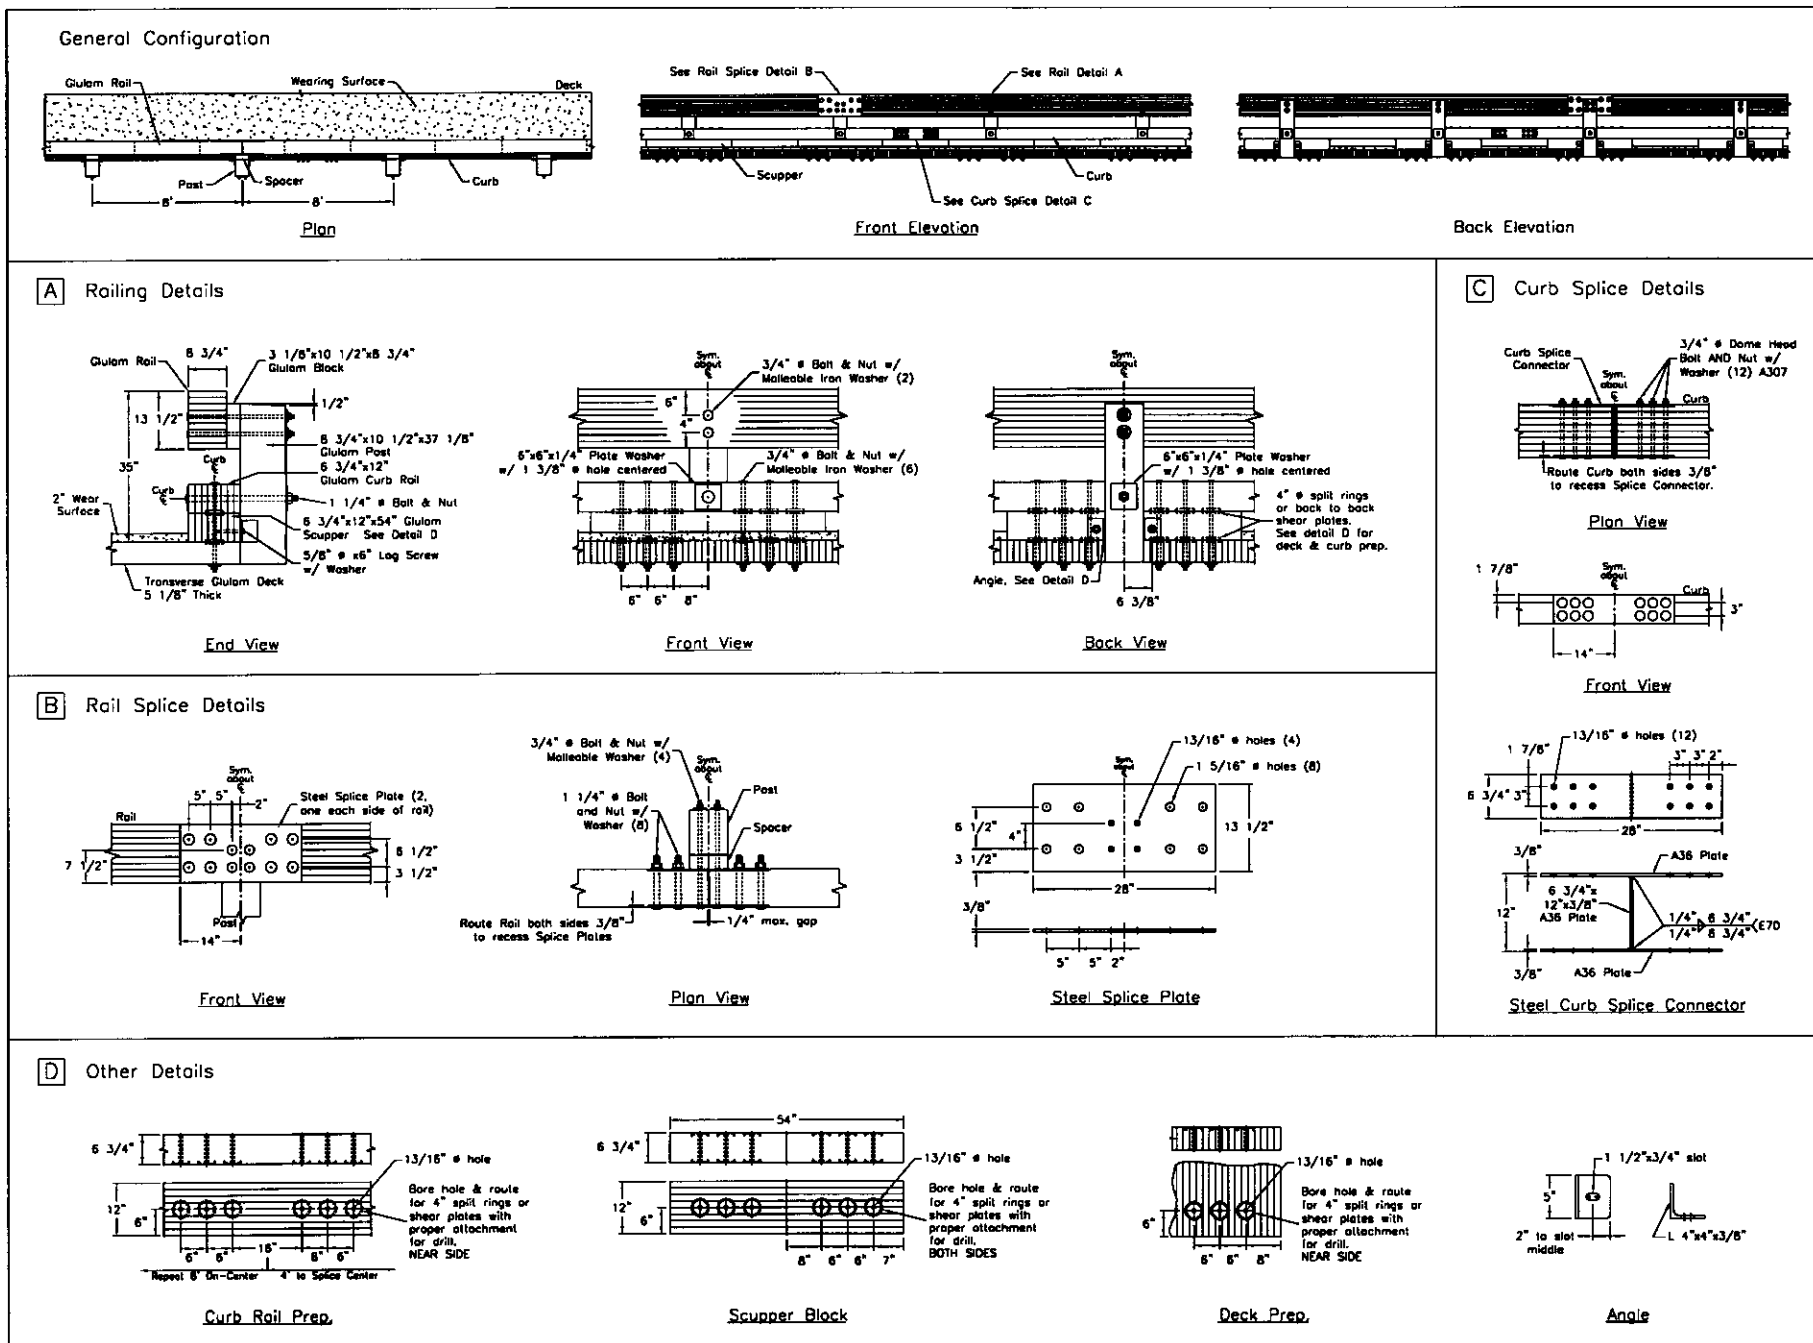
FIGURE 3 System No. 1: wood bridge railing design details (1 in. = 25.4 mm).

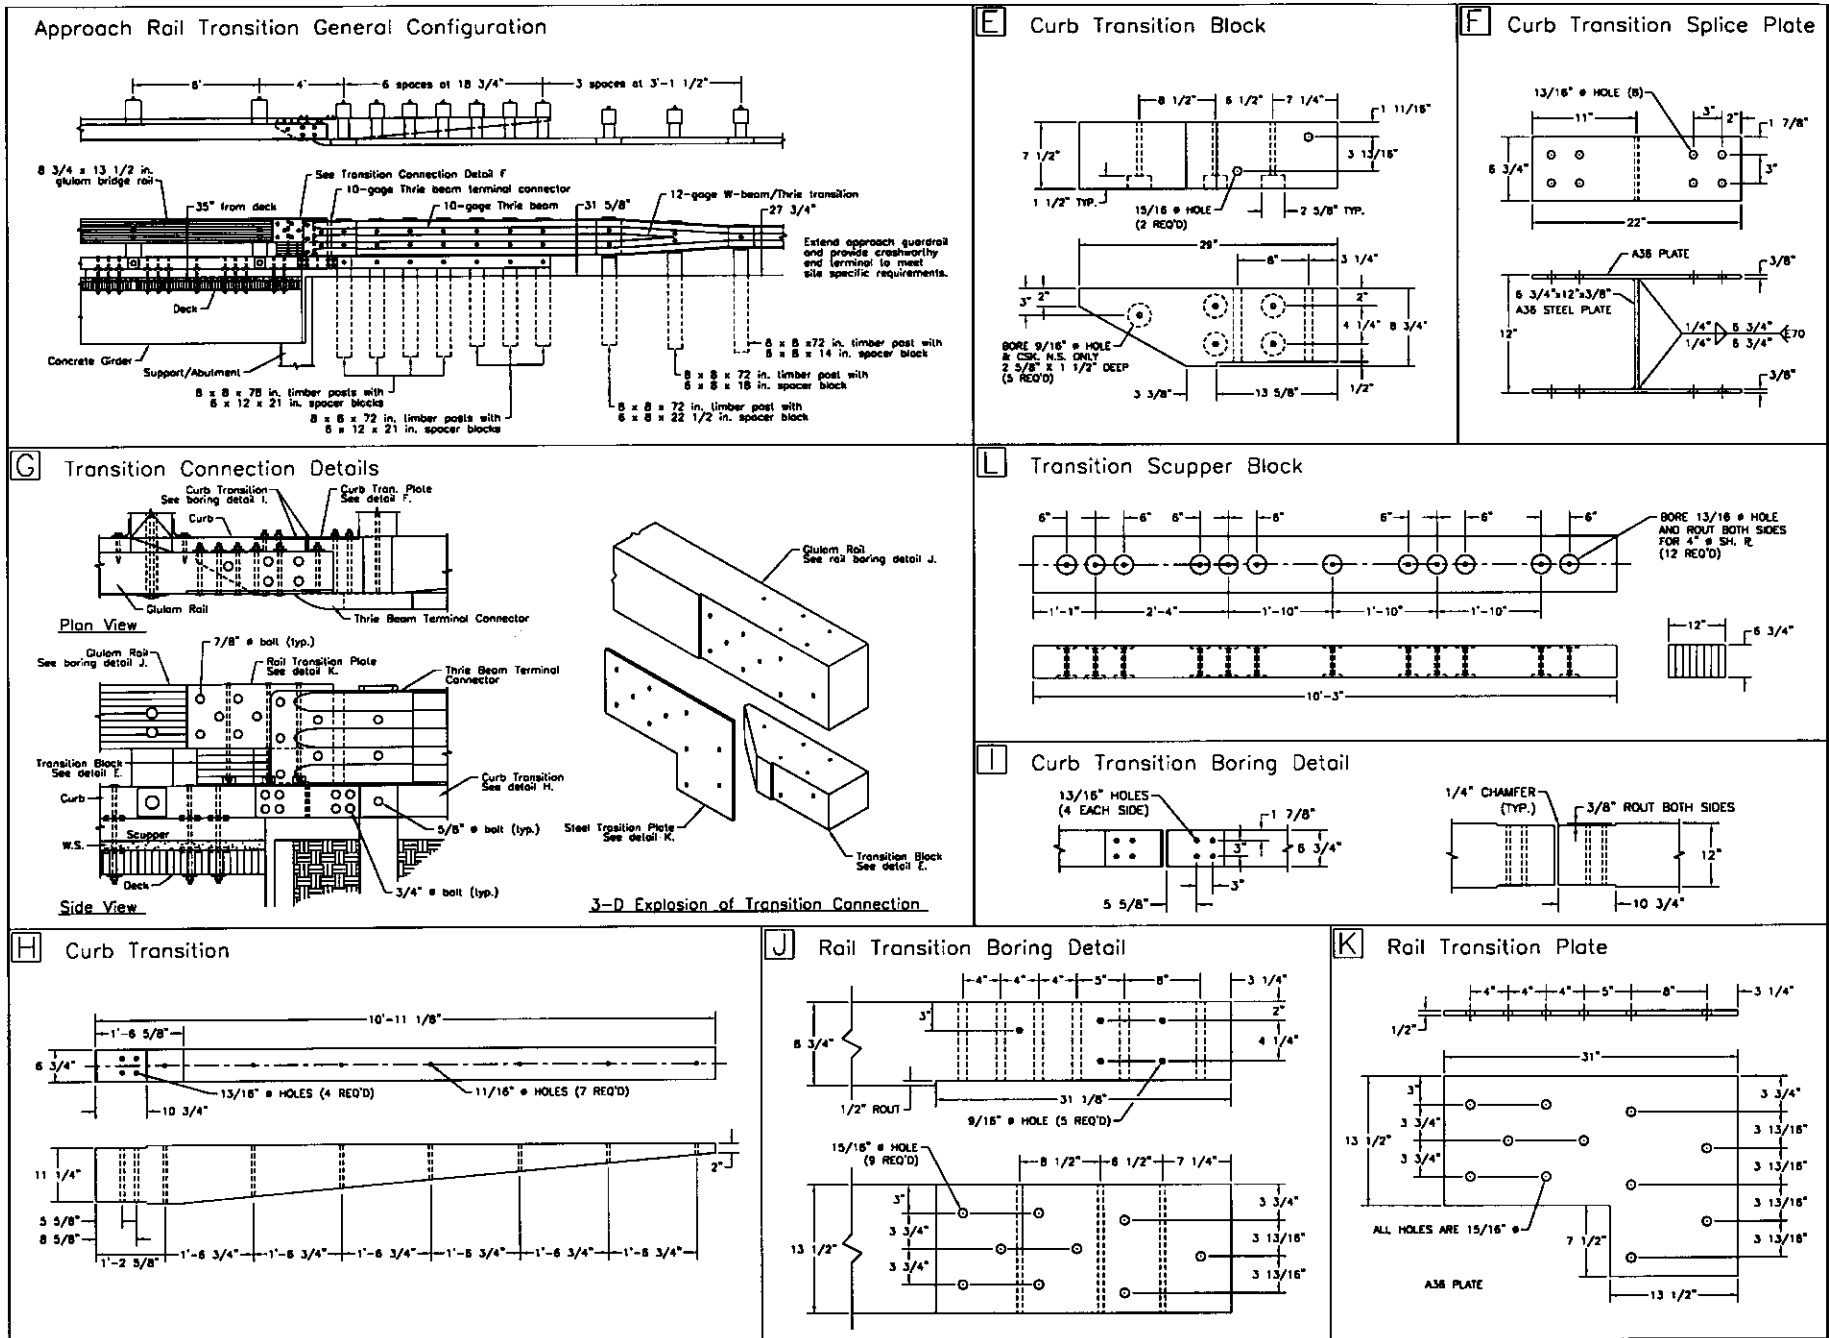
FIGURE 4 System No. 1: approach guardrail transition design details (1 in. = 25.4 mm).

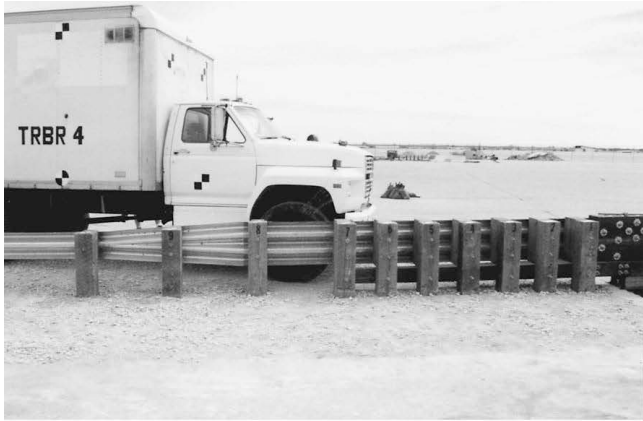
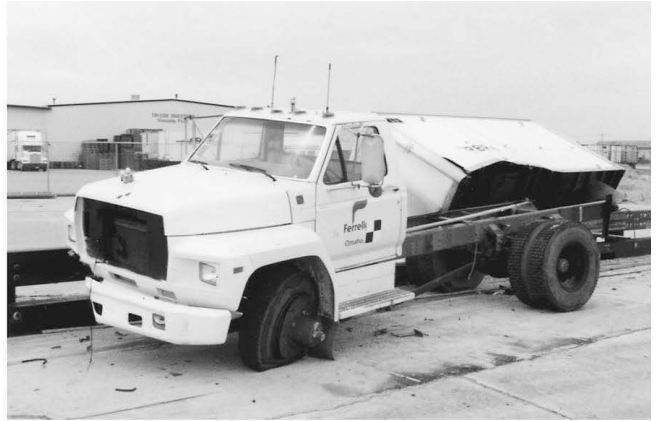
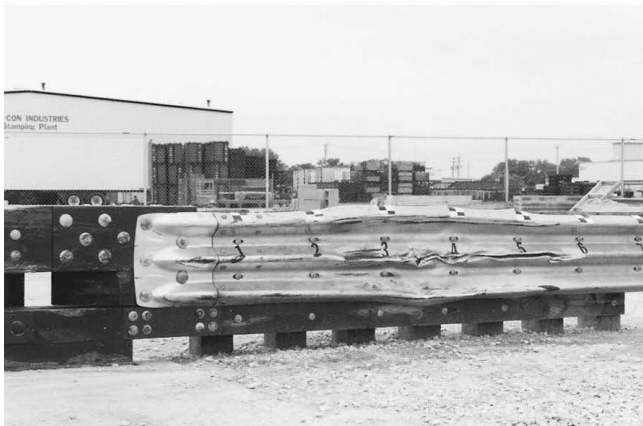
FIGURE 8 Test TRBR-4: (a) impact location, (b) vehicle damage, and (c) approach guardrail transition damage.

The second crash test, Test TRBR-4, was successfully performed with a 1988 Ford F-700 Series, single-unit truck with a test inertial mass of 8003 kg and at impact conditions of 82.5 km/h and at an angle of 13.7 degrees. During impact, the vehicle exited the transition system at a speed of 25.3 km/h and at an angle of less than 1 degree. The maximum lateral permanent set deflection and the dynamic rail deflection were observed to be 49 and 124 mm, respectively. The location of vehicle impact with the approach guardrail transition, vehicle damage, and barrier damage are shown in Figure 8.

During the impact event, a failure occurred in the connection hardware between the truck box and the steel frame that caused the box to release from the frame and travel over the bridge railing. From an analysis of the high-speed photographs, it was evident that this failure occurred after the truck had reached the bridge railing region and was not a result from any specific contact with components of the approach guardrail transition. Because a single-unit truck had successfully performed on the bridge railing system and no vehicle snagging had occurred in the transition region, the researchers determined that a retest was not required. Further investigation revealed that the release of the truck box resulted from an inadequate number and size of steel connection hardware.
