Preliminary Investigation

Caltrans Division of Research and Innovation

Compliance Crash Testing of Side Mounted Bridge Rail

March 6, 2013

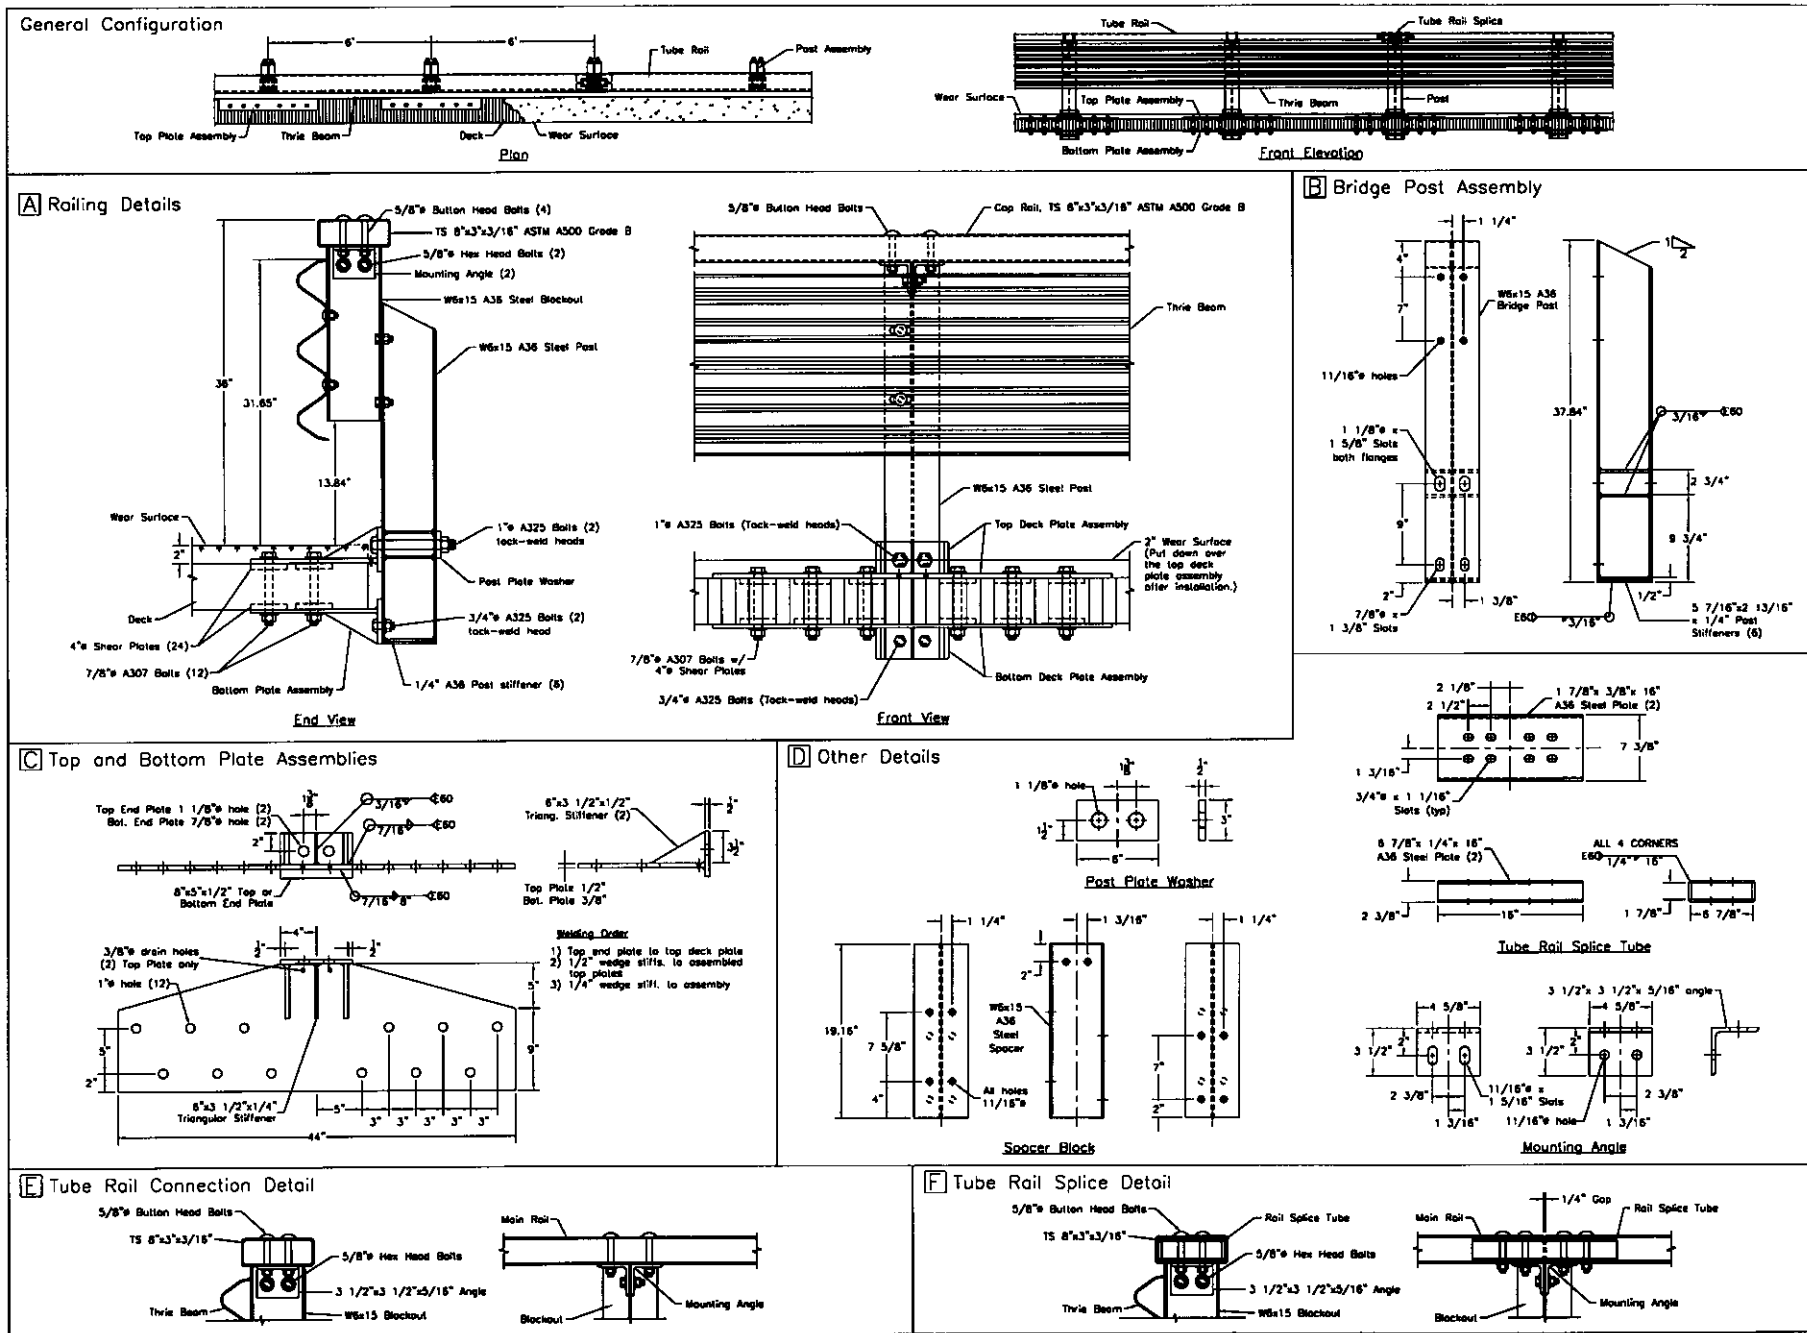
FIGURE 9 System No. 2: steel bridge railing design details (1 in. = 25.4 mm).

The second bridge railing system was designed as an all-steel system. This system was constructed with a thrie-beam rail, an upper structural tube rail, wide flange bridge posts and rail blockouts, and deck-mounting plates. Specific details of this system are provided in Figure 9. For the steel system, a 10-gauge, thrie-beam rail was blocked from the wide flange posts with wide flange spacers. A structural tube rail was then attached to the top of the spacer blocks. The lower end of each post was bolted to two steel plates that were connected to the top and bottom surfaces of the bridge deck with vertical bolts.

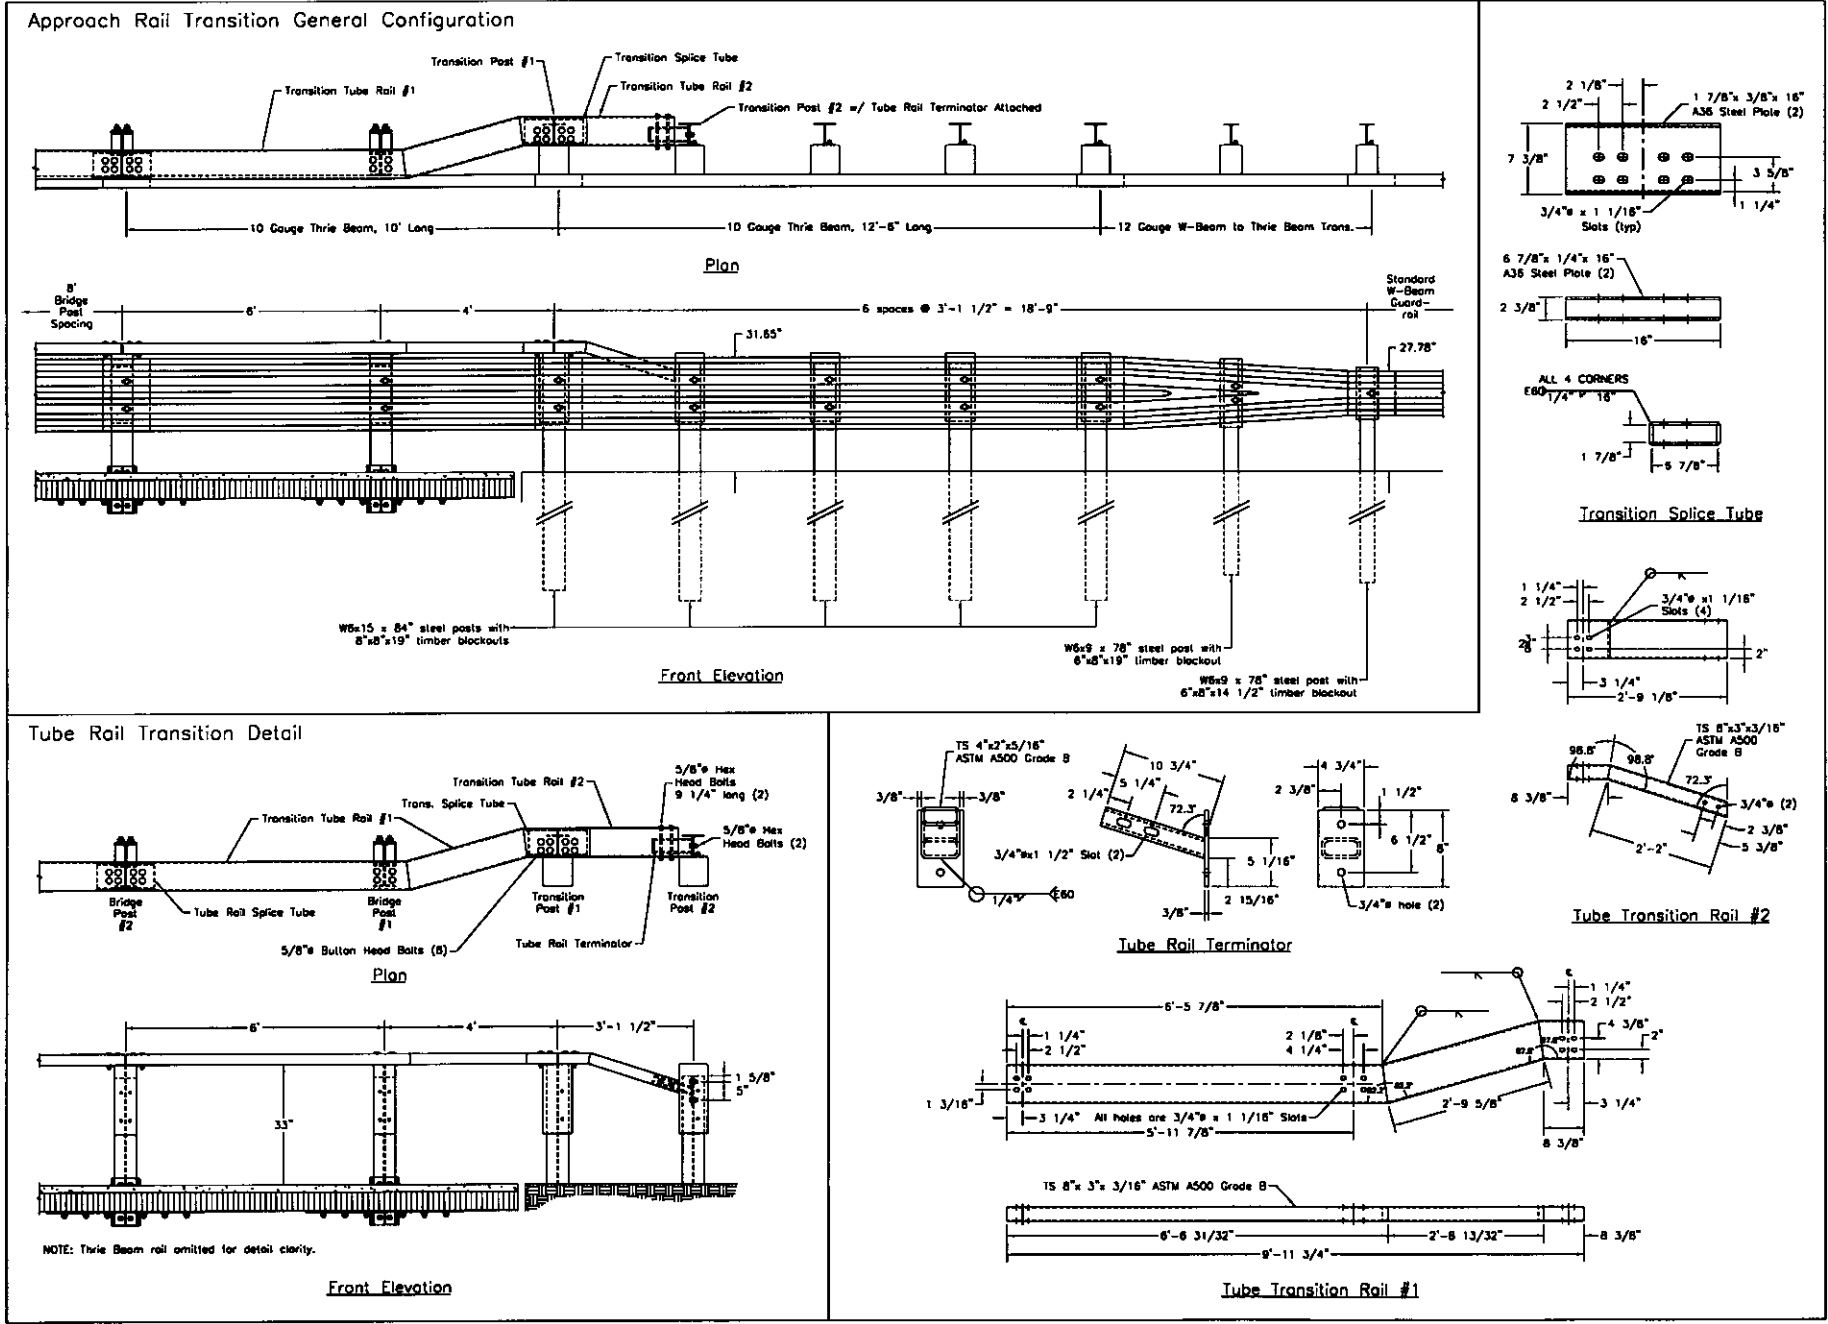
FIGURE 10 System No. 2: approach guardrail transition design details (1 in. = 25.4 mm).

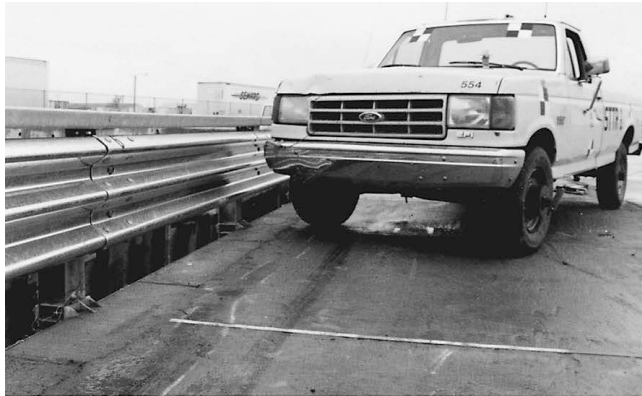
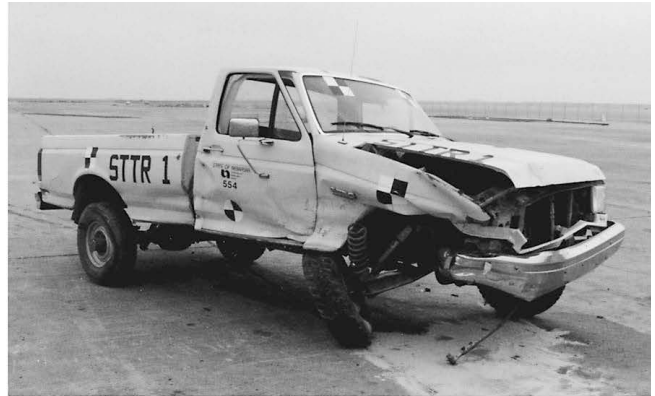
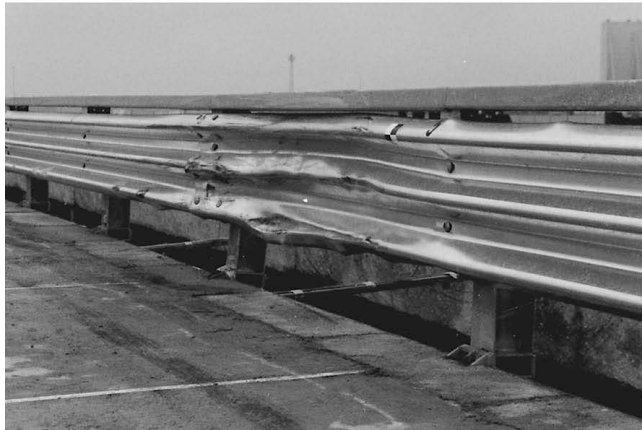
FIGURE 11 Test STTR-1: (a) impact location, (b) vehicle damage, and (c) bridge railing damage.

The first crash test, Test STTR-1, was successfully performed with a 1990 Ford F-250, $\frac{3}{4}$ -ton pickup truck with a test inertial mass of 1994 kg and at impact conditions of 93.7 km/h and at an angle of 25.5 degrees. During impact, the vehicle exited the railing system at a speed of 62.3 km/h and at an angle of 1.5 degrees. The maximum lateral permanent set deflection and the dynamic rail deflection were observed to be 92 and 137 mm, respectively. The location of vehicle impact with the bridge railing, vehicle damage, and barrier damage are shown in Figure 11.

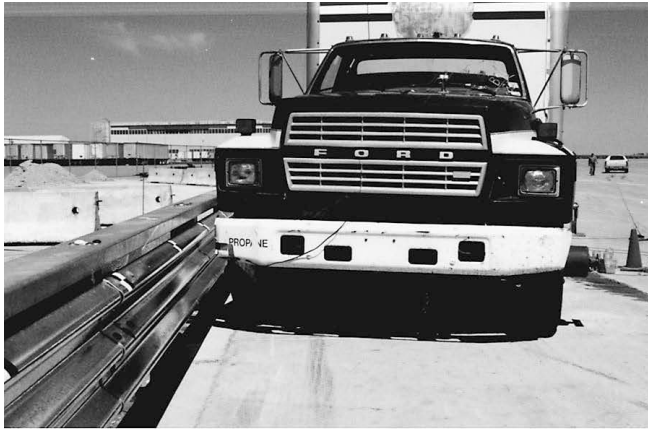
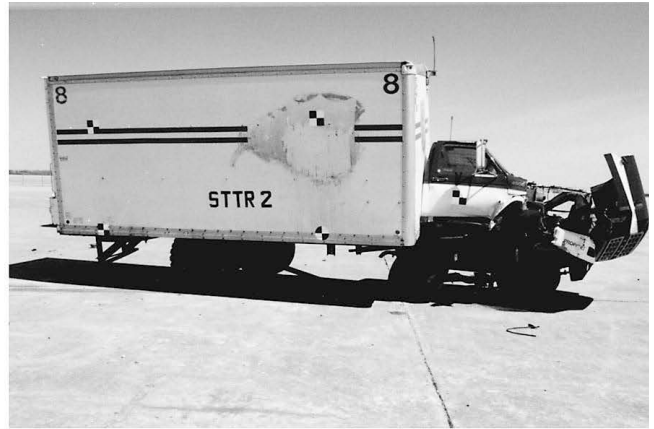
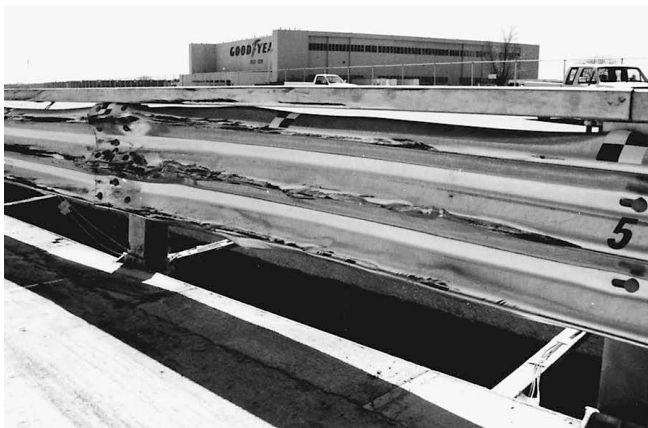
FIGURE 12 Test STTR-2: (a) impact location, (b) vehicle damage, and (c) bridge railing damage.

The second crash test, Test STTR-2, was successfully performed with a 1985 Ford F-800 Series, single-unit truck with a test inertial mass of 8067 kg and at impact conditions of 76.4 km/h and at angle of 14.6 degrees. During the impact, the vehicle exited the railing system at a speed of 63.6 km/h and at an angle of less than 1 degree. The deflection of the maximum lateral permanent set rail was observed to be 136 mm. The location of the vehicle impact with the bridge railing, vehicle damage, and barrier damage are shown in Figure 12.

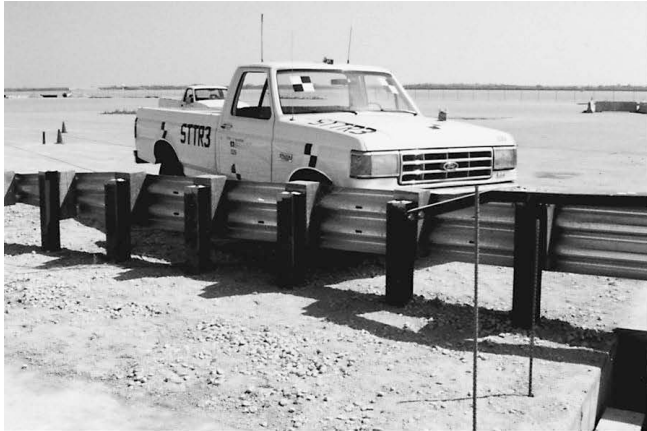
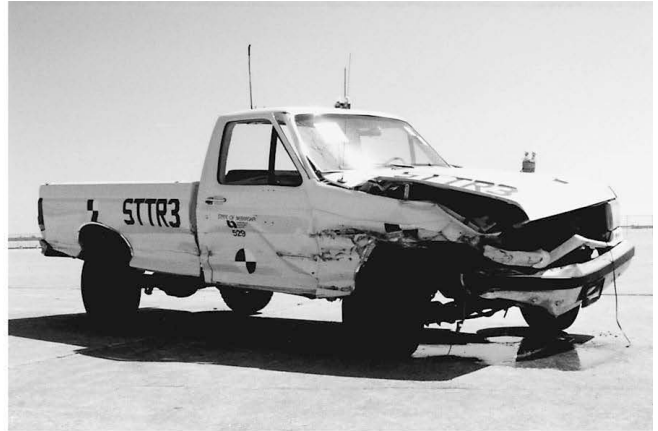
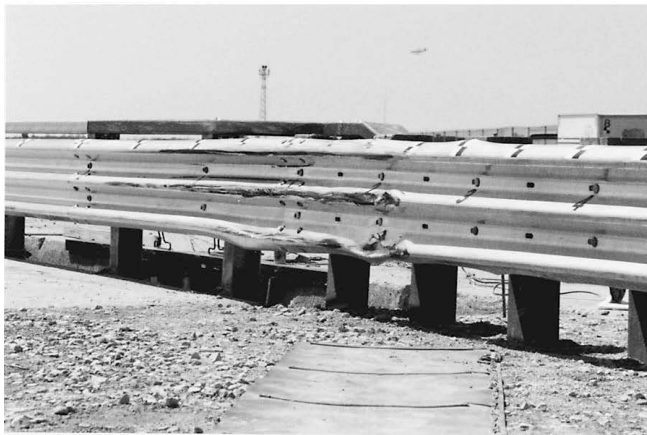
FIGURE 13 Test STTR-3: (a) impact location, (b) vehicle damage, and (c) approach guardrail transition damage.

The first crash test, Test STTR-3, was successfully performed with a 1988 Ford F-250, $\frac{3}{4}$ -ton pickup truck with a test inertial mass of 1997 kg and at impact conditions of 101 km/h and at an angle of 25.6 degrees. During impact, the vehicle exited the transition system at a speed of 73.5 km/h and at an angle of 4.9 degrees. The maximum lateral permanent set deflection and the dynamic rail deflection were observed to be 67 and 143 mm, respectively. The location of vehicle impact with the approach guardrail transition, vehicle damage, and barrier damage are shown in Figure 13.

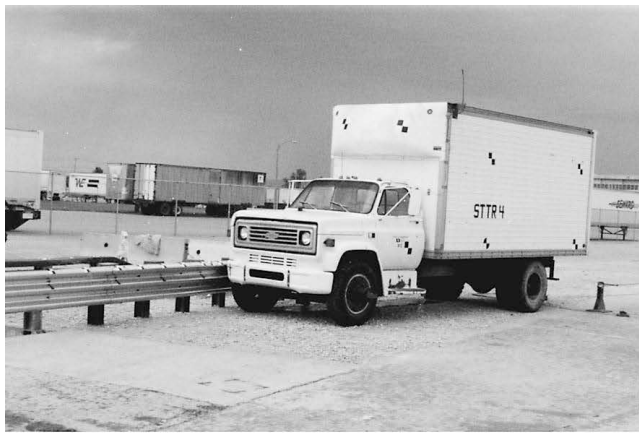
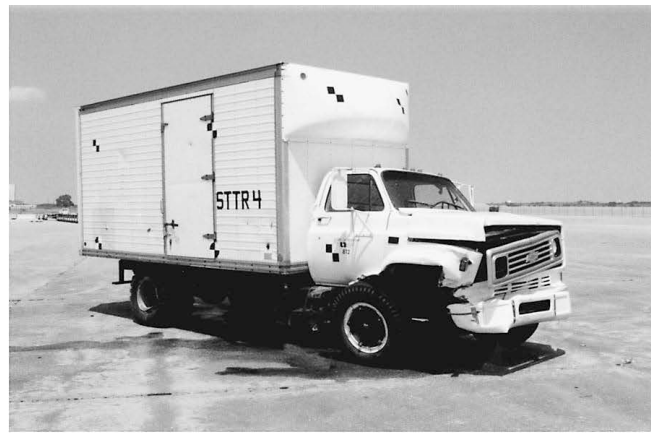
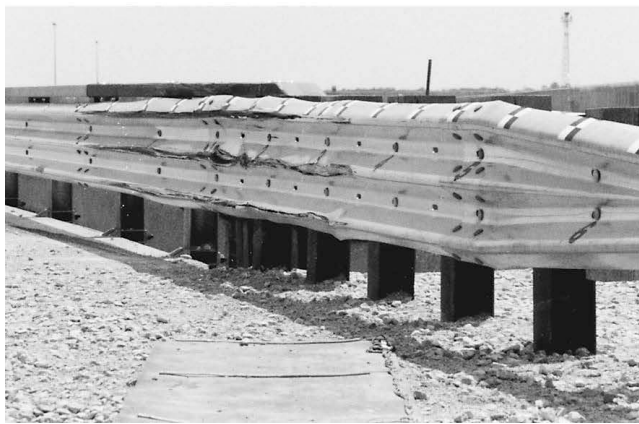
FIGURE 14 Test STTR-4: (a) impact location, (b) vehicle damage, and (c) approach guardrail transition damage.
