Chapter 5 Baseline Information

5.1 Valleywide Hydrology, Geology, and Geomorphology

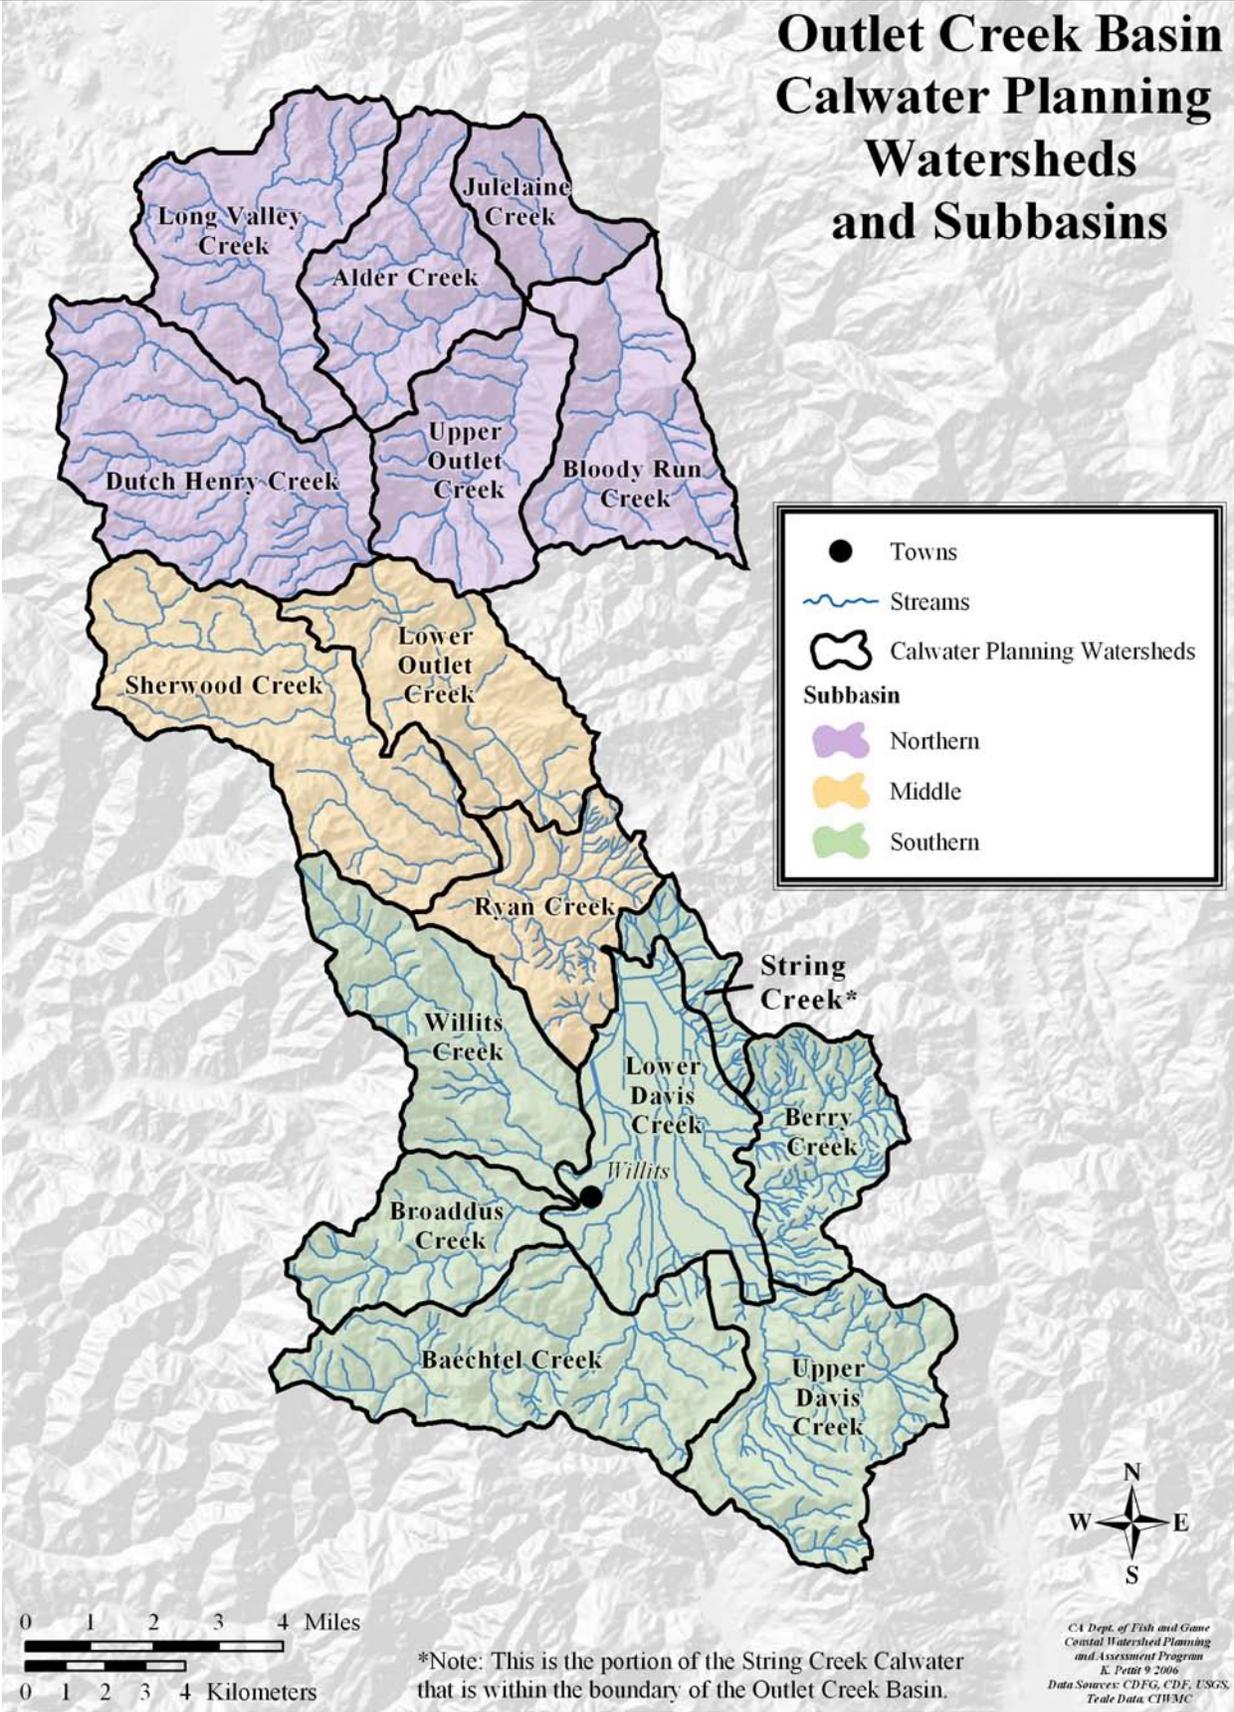
**Figure 5-2
Outlet Creek Subbasins and CalWater2.2a Planning Watersheds**

Outlet Creek Basin has been divided into three separate subbasins for assessment and analyses purposes as described in the Outlet Creek Basin Assessment Report (LeDoux-Bloom and Downie 2008): the Northern, Middle, and Southern subbasins. The onsite mitigation area and offsite mitigation properties are in the Southern subbasin (Figure 5-2). Although the following description of geologic and geomorphic conditions covers the entire Outlet Creek Basin, its main focus is the Southern subbasin (and area of 64 mi^2 [40,960 acres]).

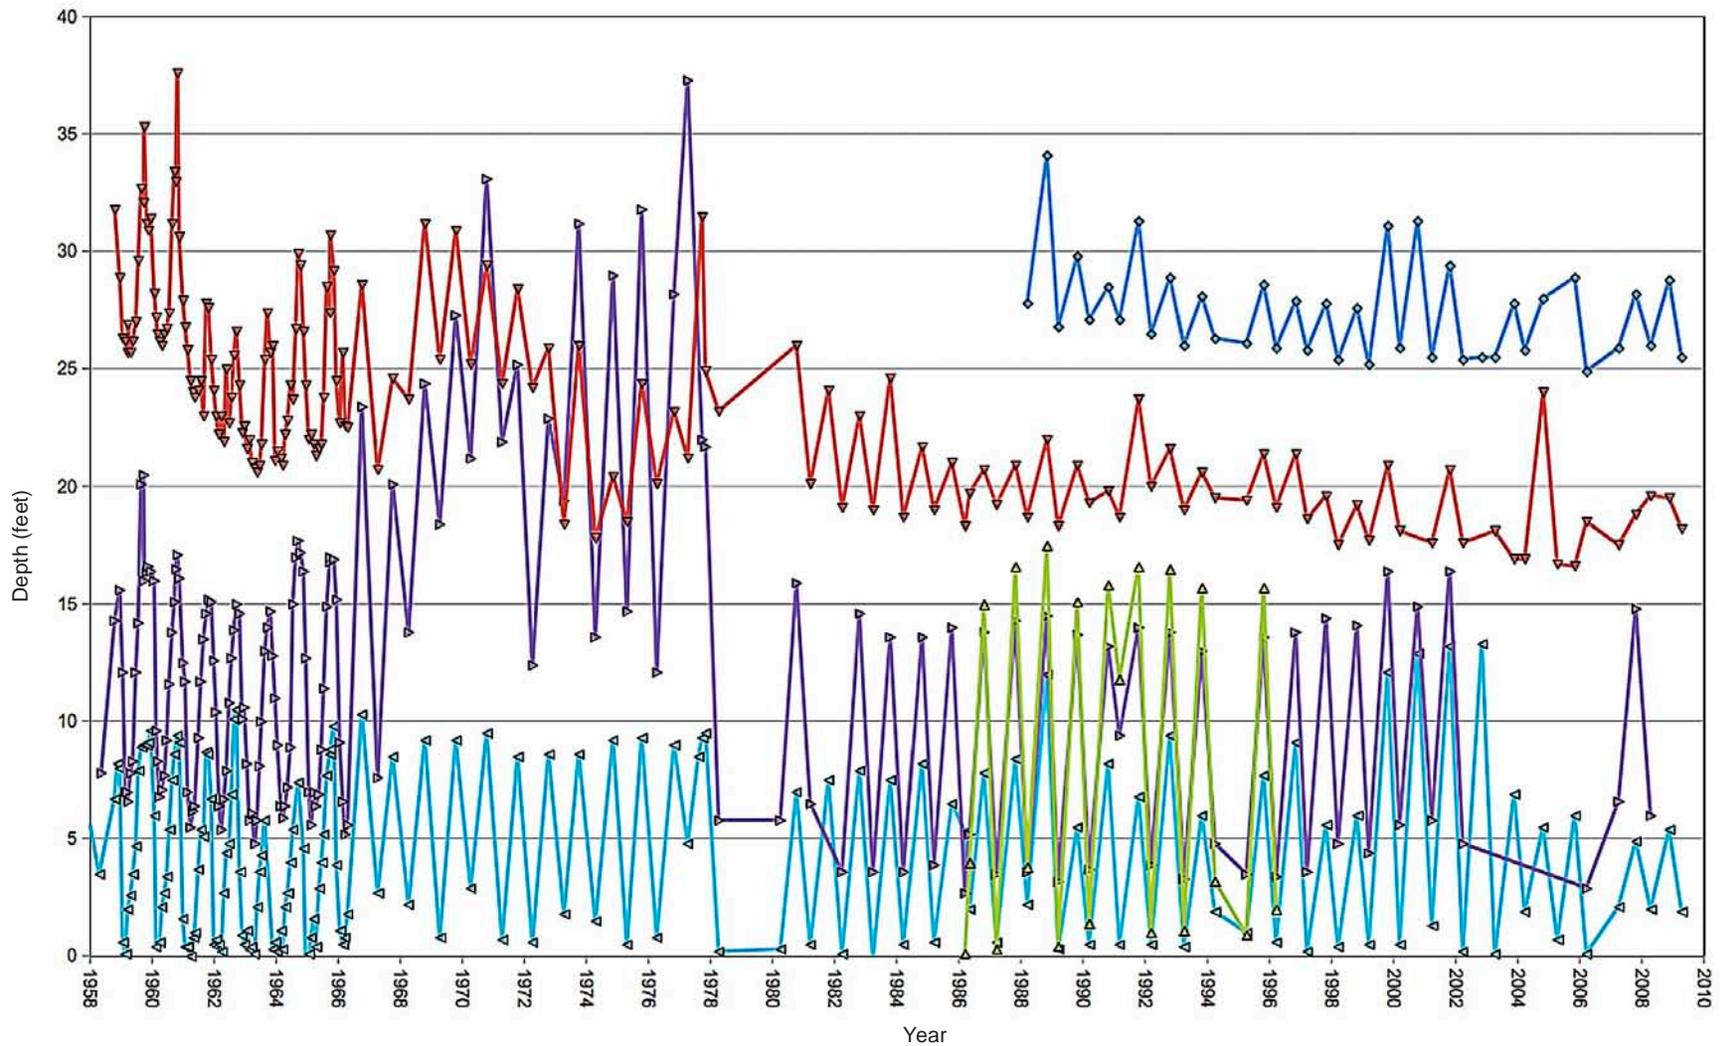
The California Department of Water Resources (DWR) reports well depth and elevation measurements from five wells in Little Lake Valley (California Department of Water Resources 2010; Figure 5-3). Wells 1 and 2 are near Willits adjacent to the mountains on the west side of Little Lake Valley. Wells 3, 4, and 5 are toward the center of Little Lake Valley, to the southeast, east, and northeast of Willits, respectively. Measurements from these wells indicate that groundwater could be close to the ground surface (i.e., shallow), particularly in the wells located away from the edges of Little Lake Valley (i.e., wells 3, 4, and 5). This shallow groundwater supports many depressional wetlands that occur throughout Little Lake Valley.

Groundwater levels measured in wells represent piezometric water surface levels. For an unconfined aquifer, the well elevations are roughly the same as the elevation of the top of the aquifer, but for confined aquifers, well elevations can be higher than the elevation at the top of the aquifer. As a result, it is difficult to determine with certainty whether the groundwater supporting wetlands in Little Lake Valley is perched on impermeable layers above the main aquifer or whether it represents the top portion of the main aquifer. Regardless of the mechanism
