# Chapter 3      Site Selection Criteria

Proposed Willits Bypass Project

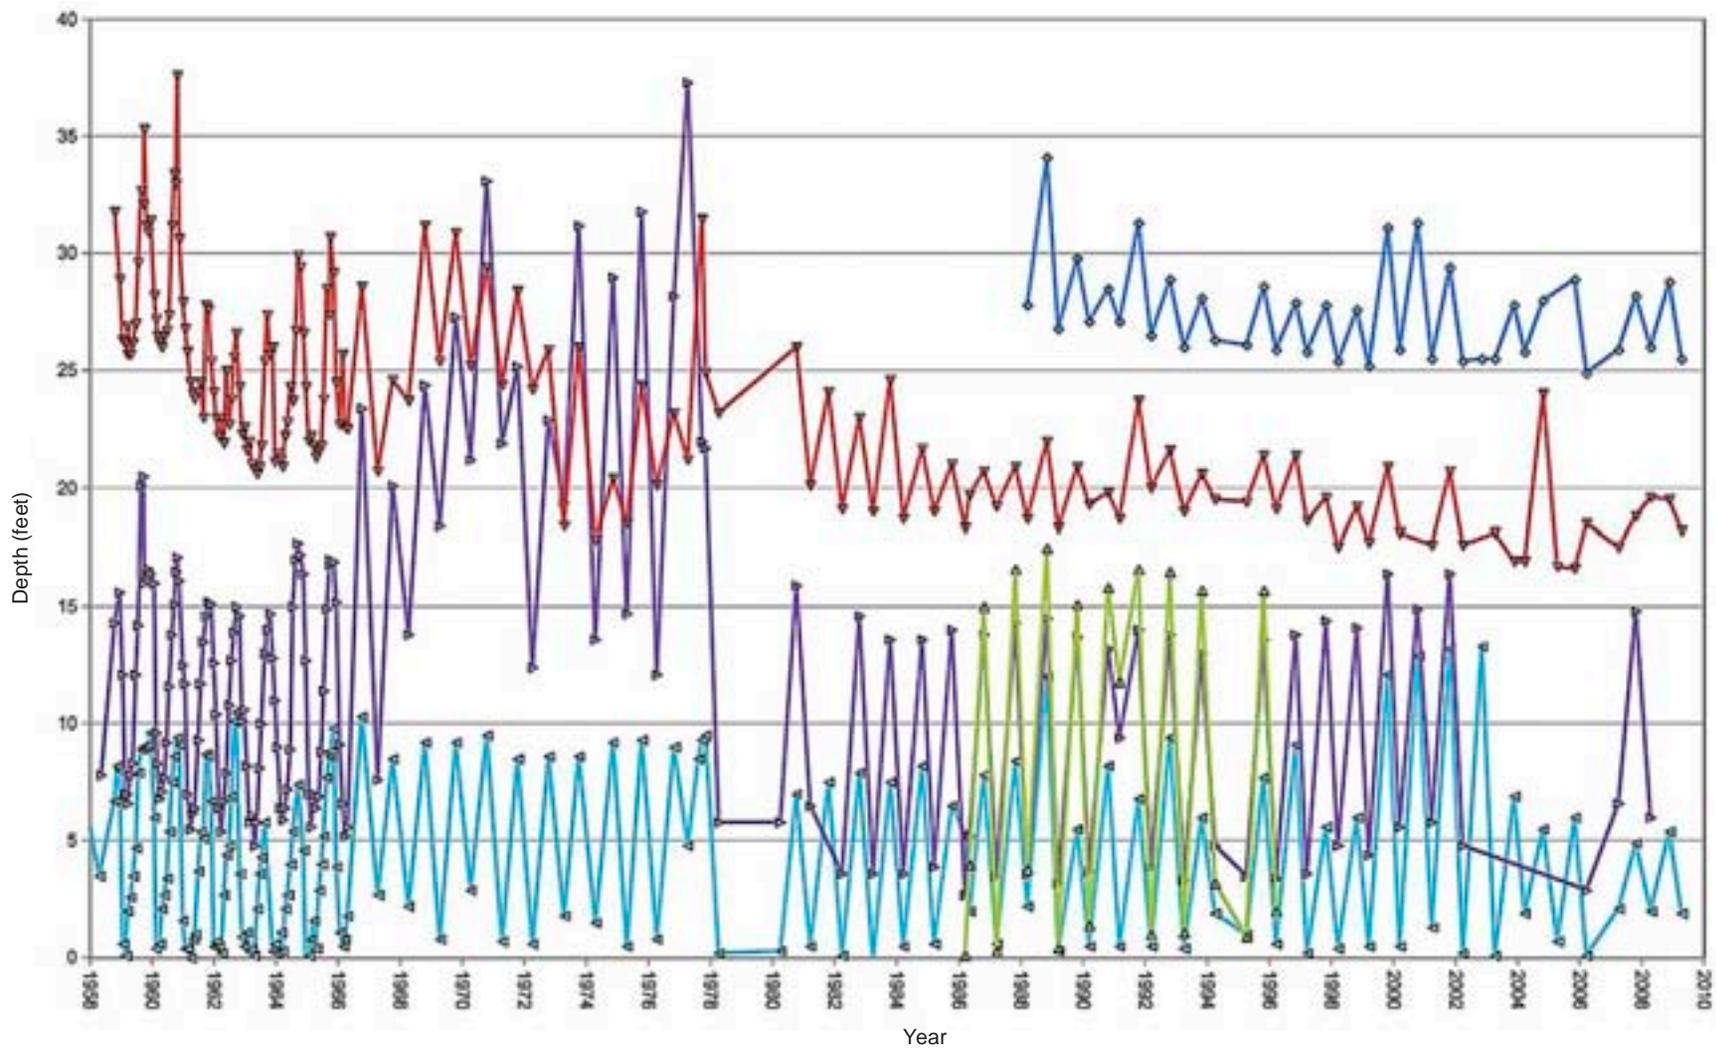
The DWR well data indicate that groundwater elevations can fluctuate seasonally from 5 to 15 ft (California Department of Water Resources 2010) (Figure 5-3). Seasonal fluctuations in groundwater level result primarily from pumping and precipitation (Farrar 1986), although other factors such as groundwater movement to and from streams, evapotranspiration, and recharge from irrigation play a role. Wells 2, 3, and 4 are no longer in use, so the fluctuations in their levels (Figure 5-3) are not a result of pumping of these wells, although pumping at other wells could be affecting the levels in wells 2, 3, and 4. The well data also indicate that groundwater levels in Little Lake Valley can decrease slightly during periods of drought. For example, well-

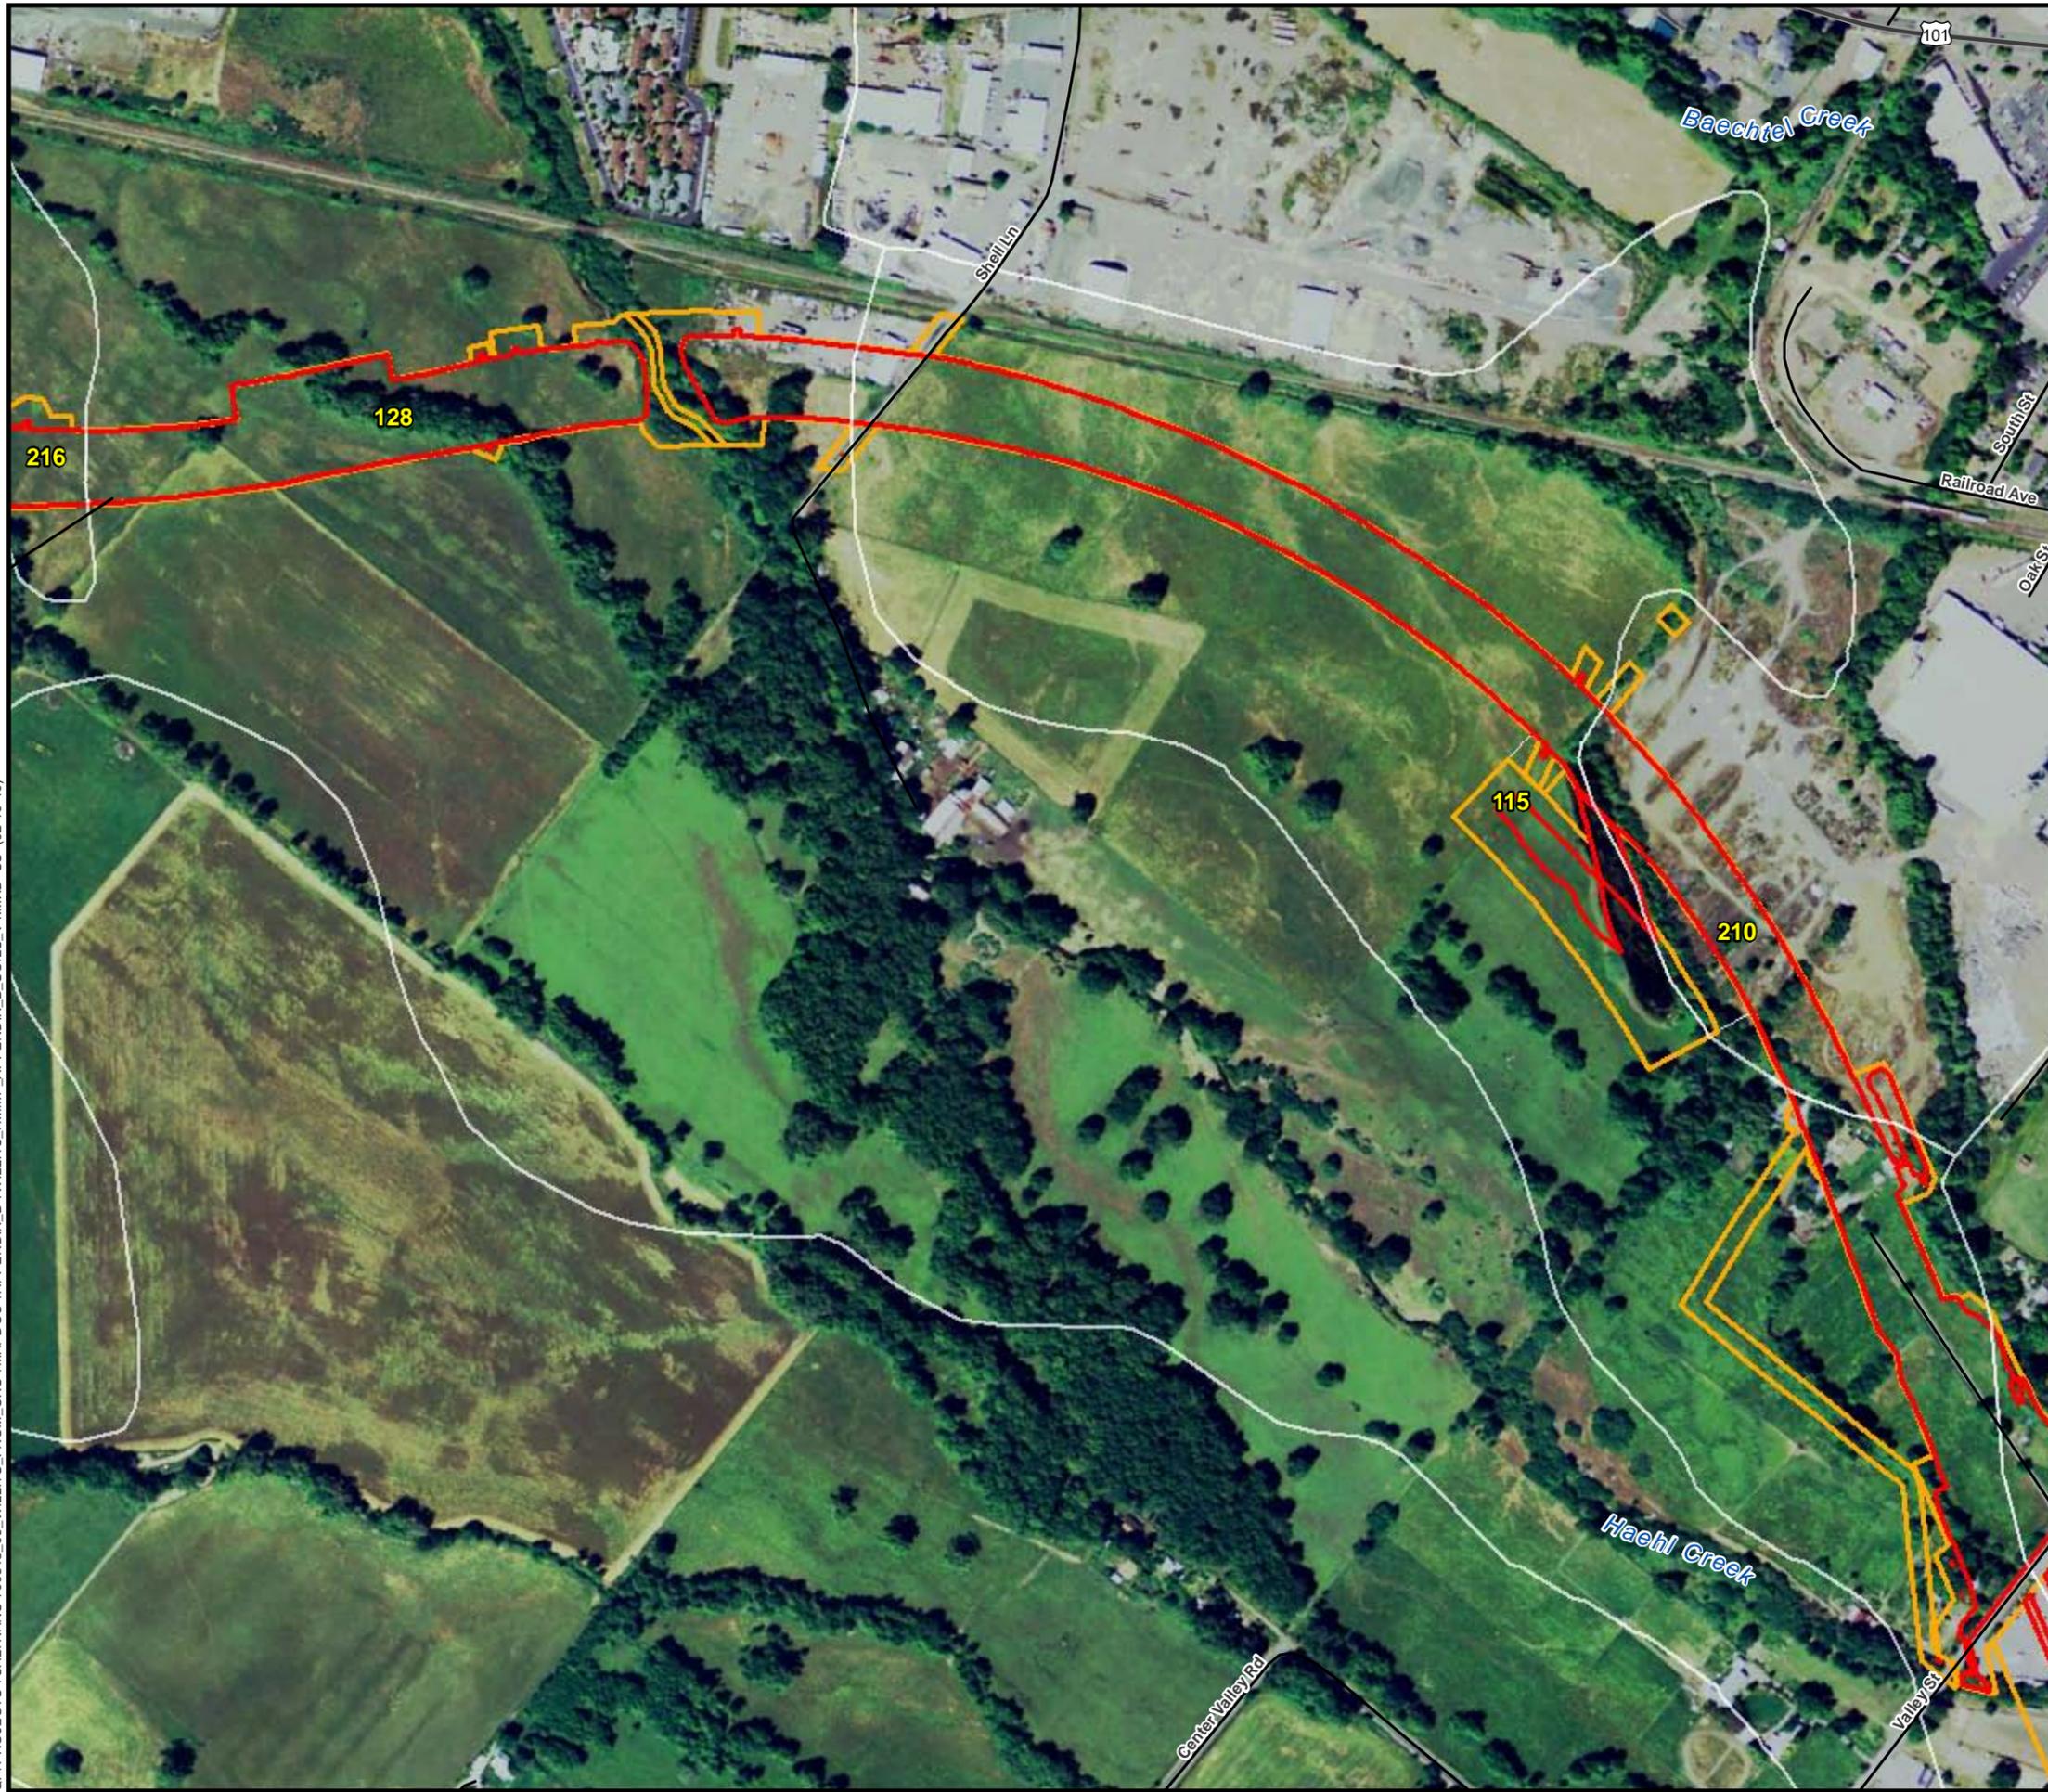
**Figure 5-4c**  
**Soil Types within the Proposed Bypass Project Footprint**  
 Proposed Willits Bypass Project

SSURGO Map Unit  
 Permanent Impact Boundary  
 Temporary Impact Boundary  
 Road

The Natural Resources Conservation Service (NRCS) *Eastern Mendocino County Soils Survey* was used to analyze soils in the bypass alignment footprint (Figures 5-4a through 5-4h). Hydric status for map units ranged from nonhydric to partially hydric, while the dominant drainage class ranged from very poorly drained to well-drained.

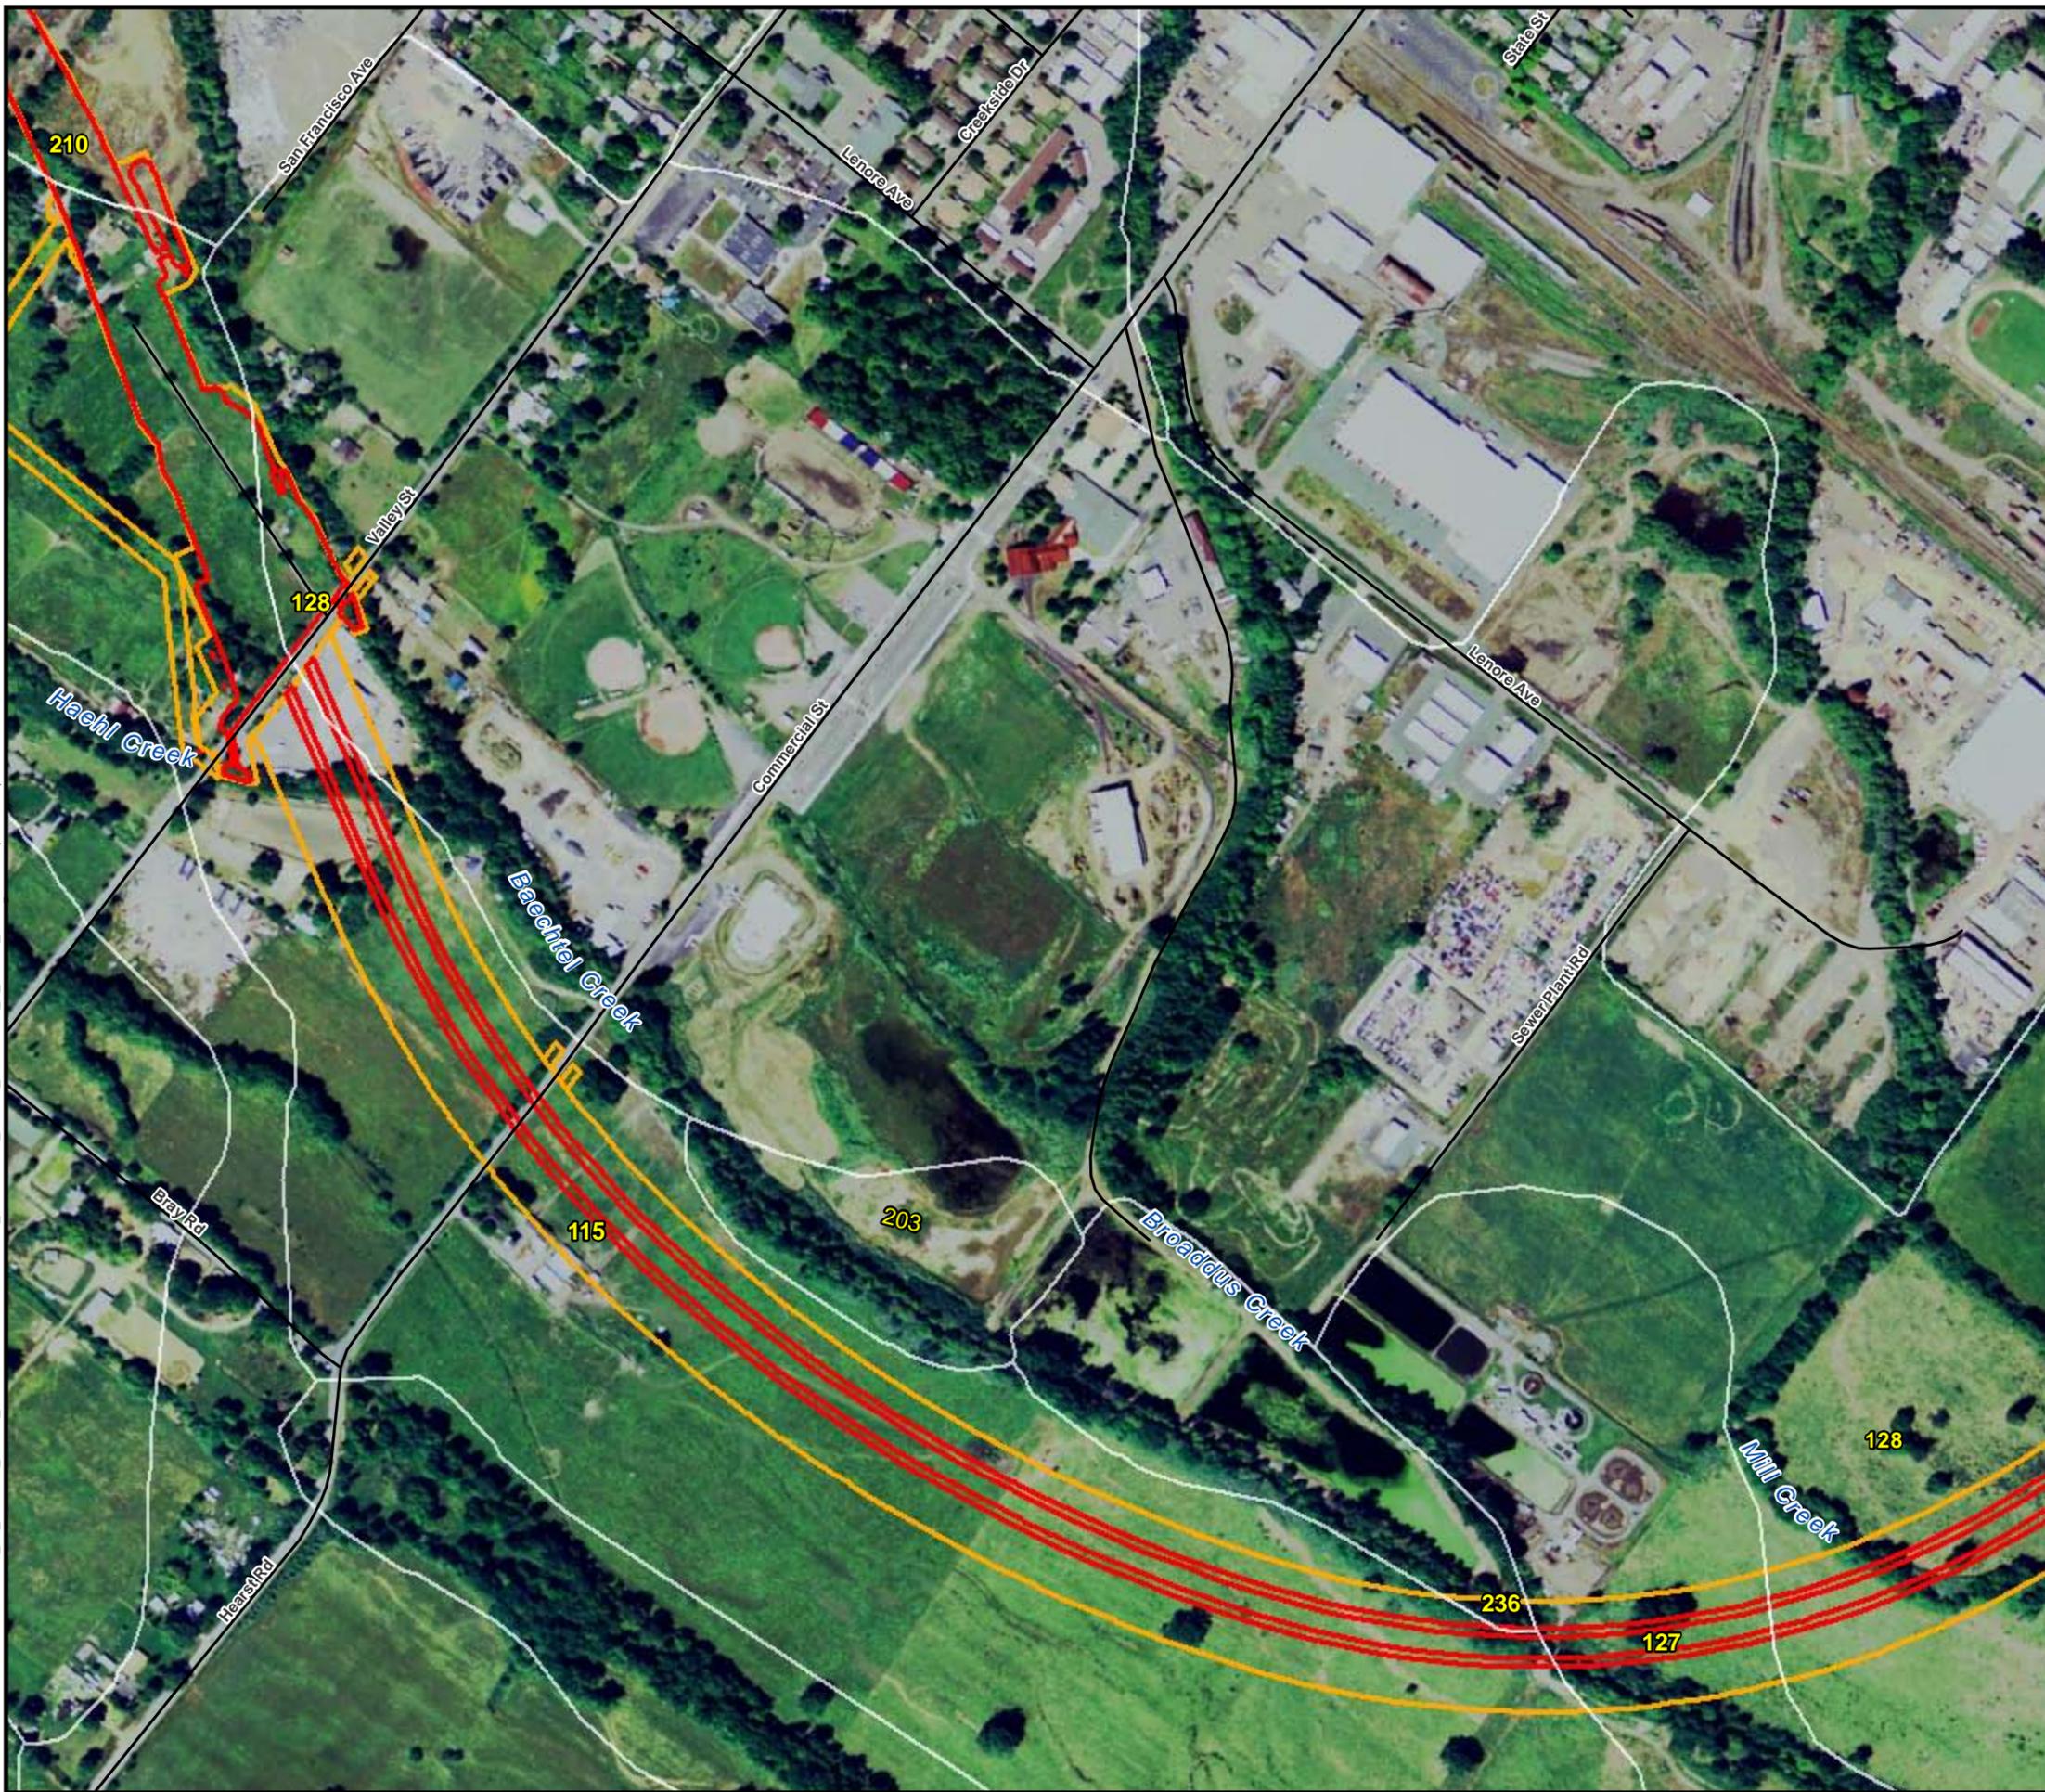
**Figure 5-4d**

SSURGO Map Unit  
 Permanent Impact Boundary  
 Temporary Impact Boundary  
 Road

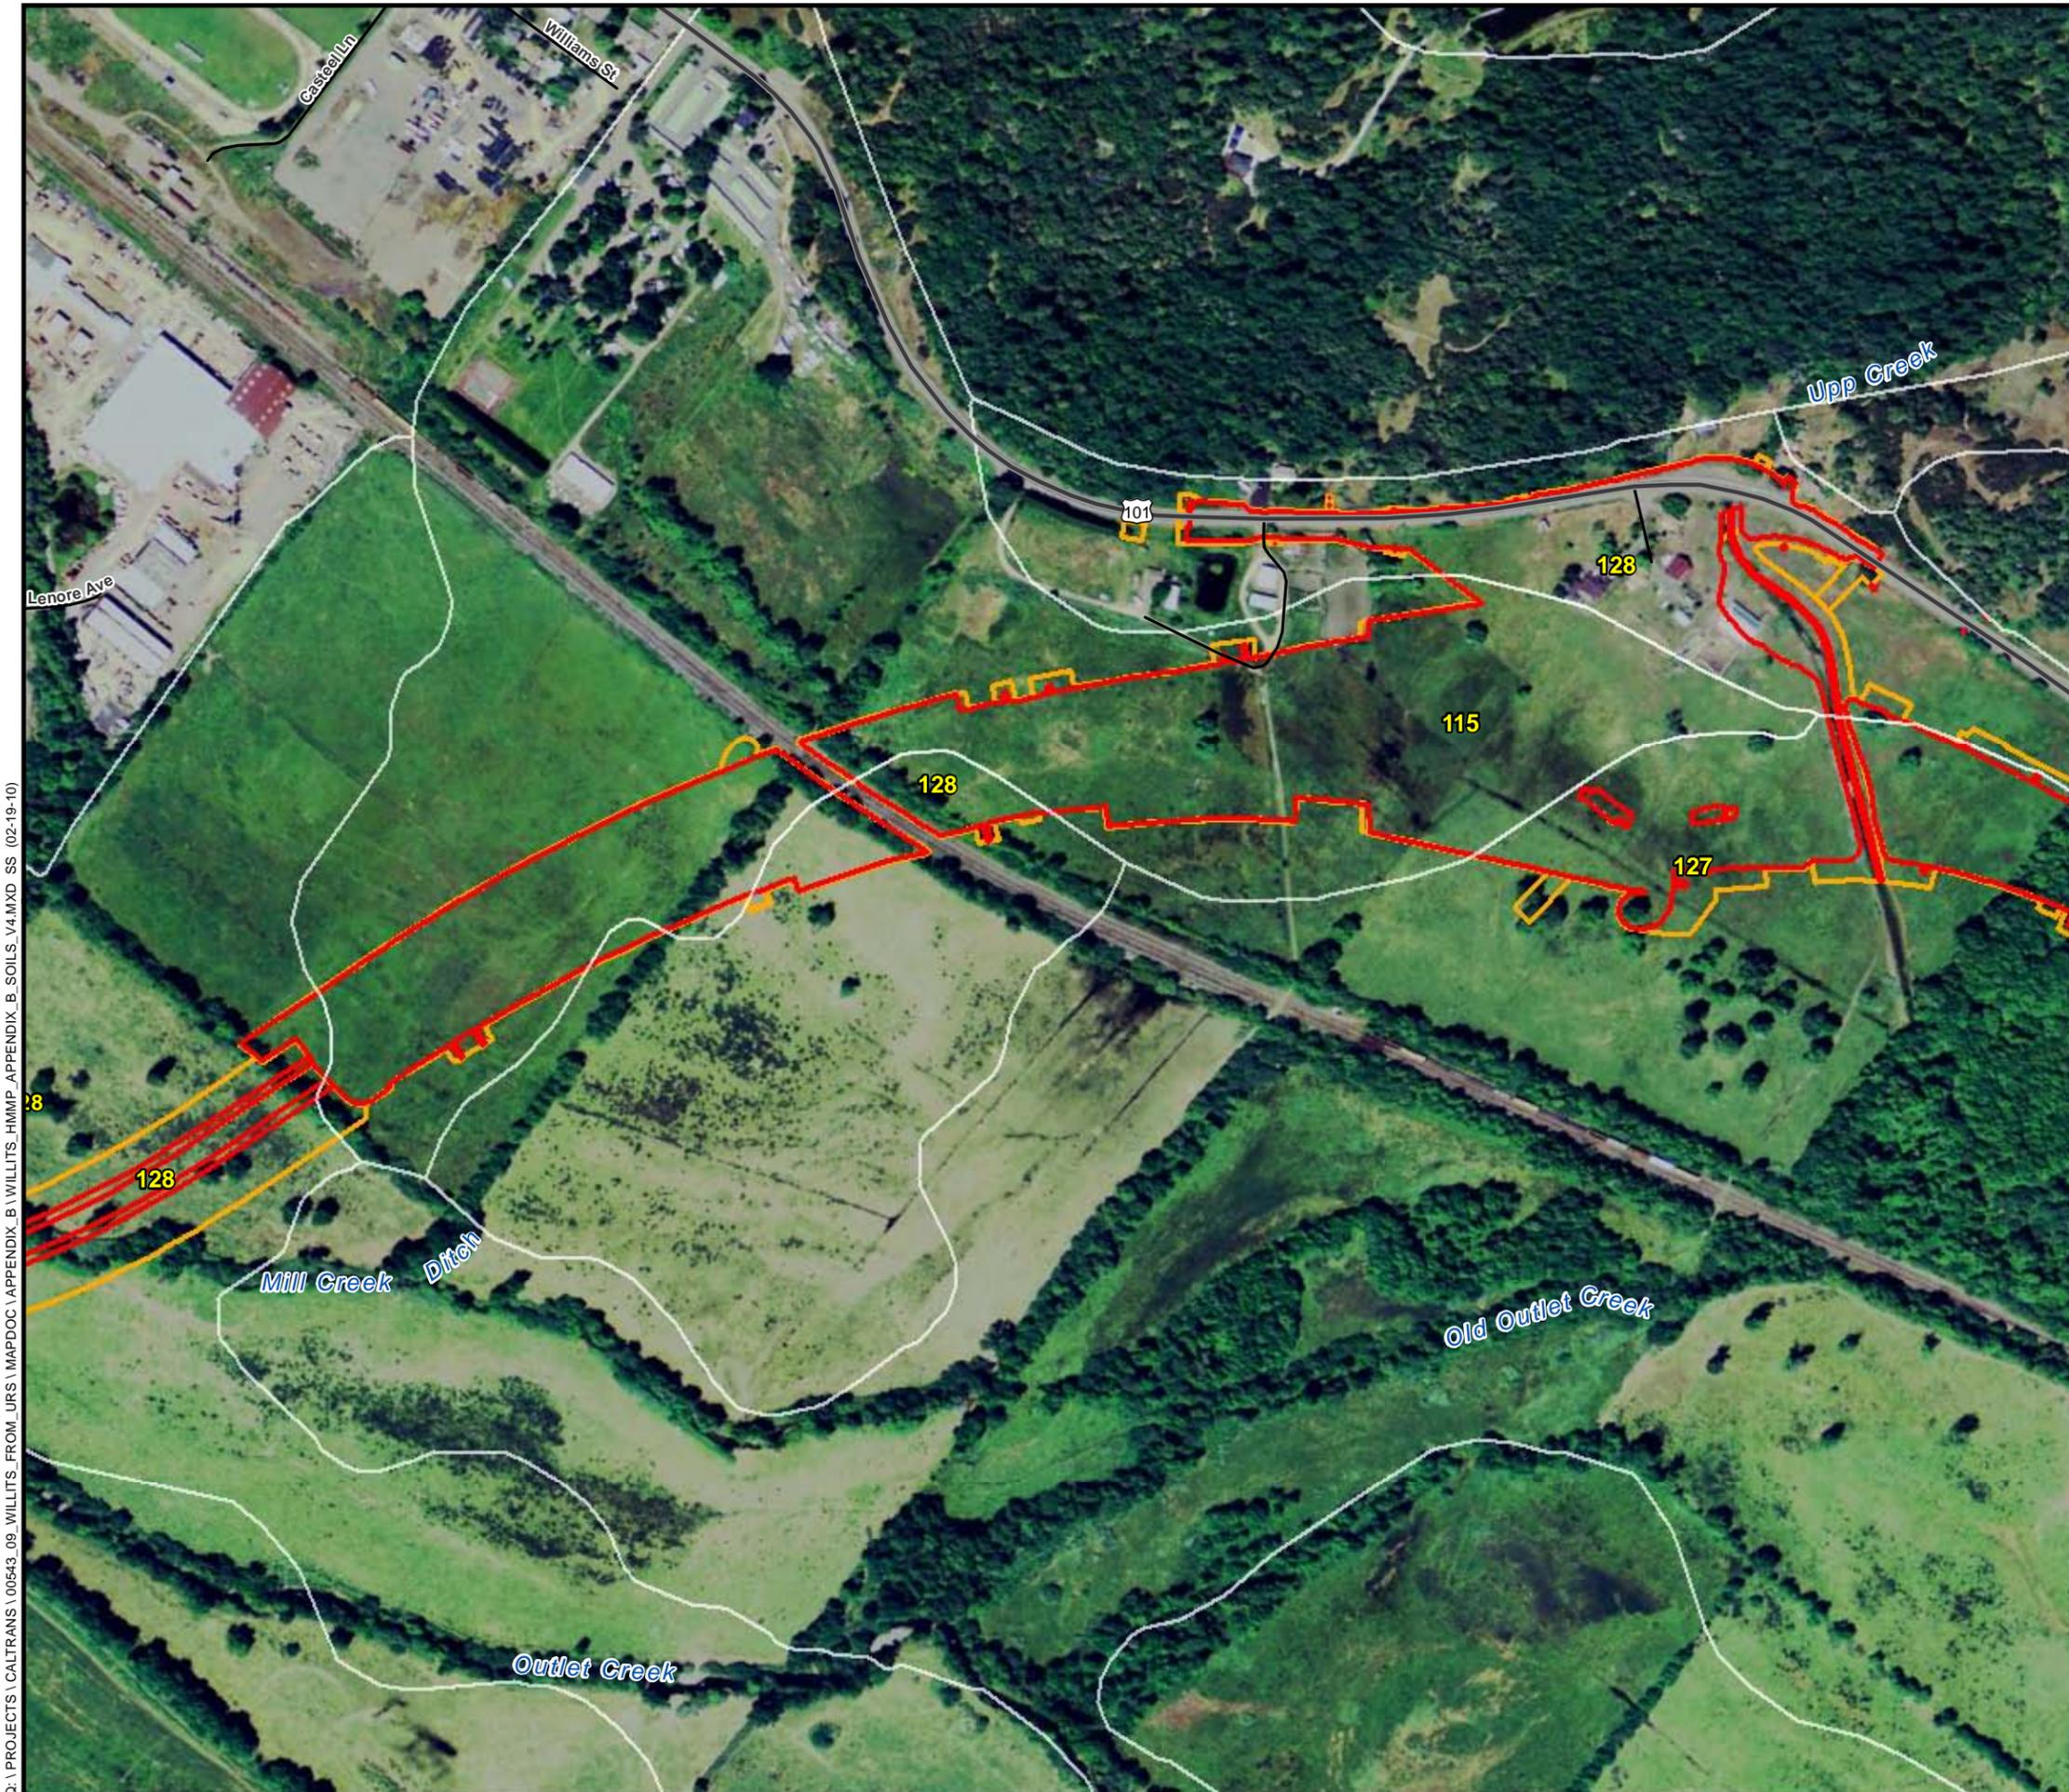
**Figure 5-4e**  
**Soil Types within the Proposed Bypass Project Footprint**  
 Proposed Willits Bypass Project

SSURGO Map Unit  
 Permanent Impact Boundary  
 Temporary Impact Boundary  
 Road

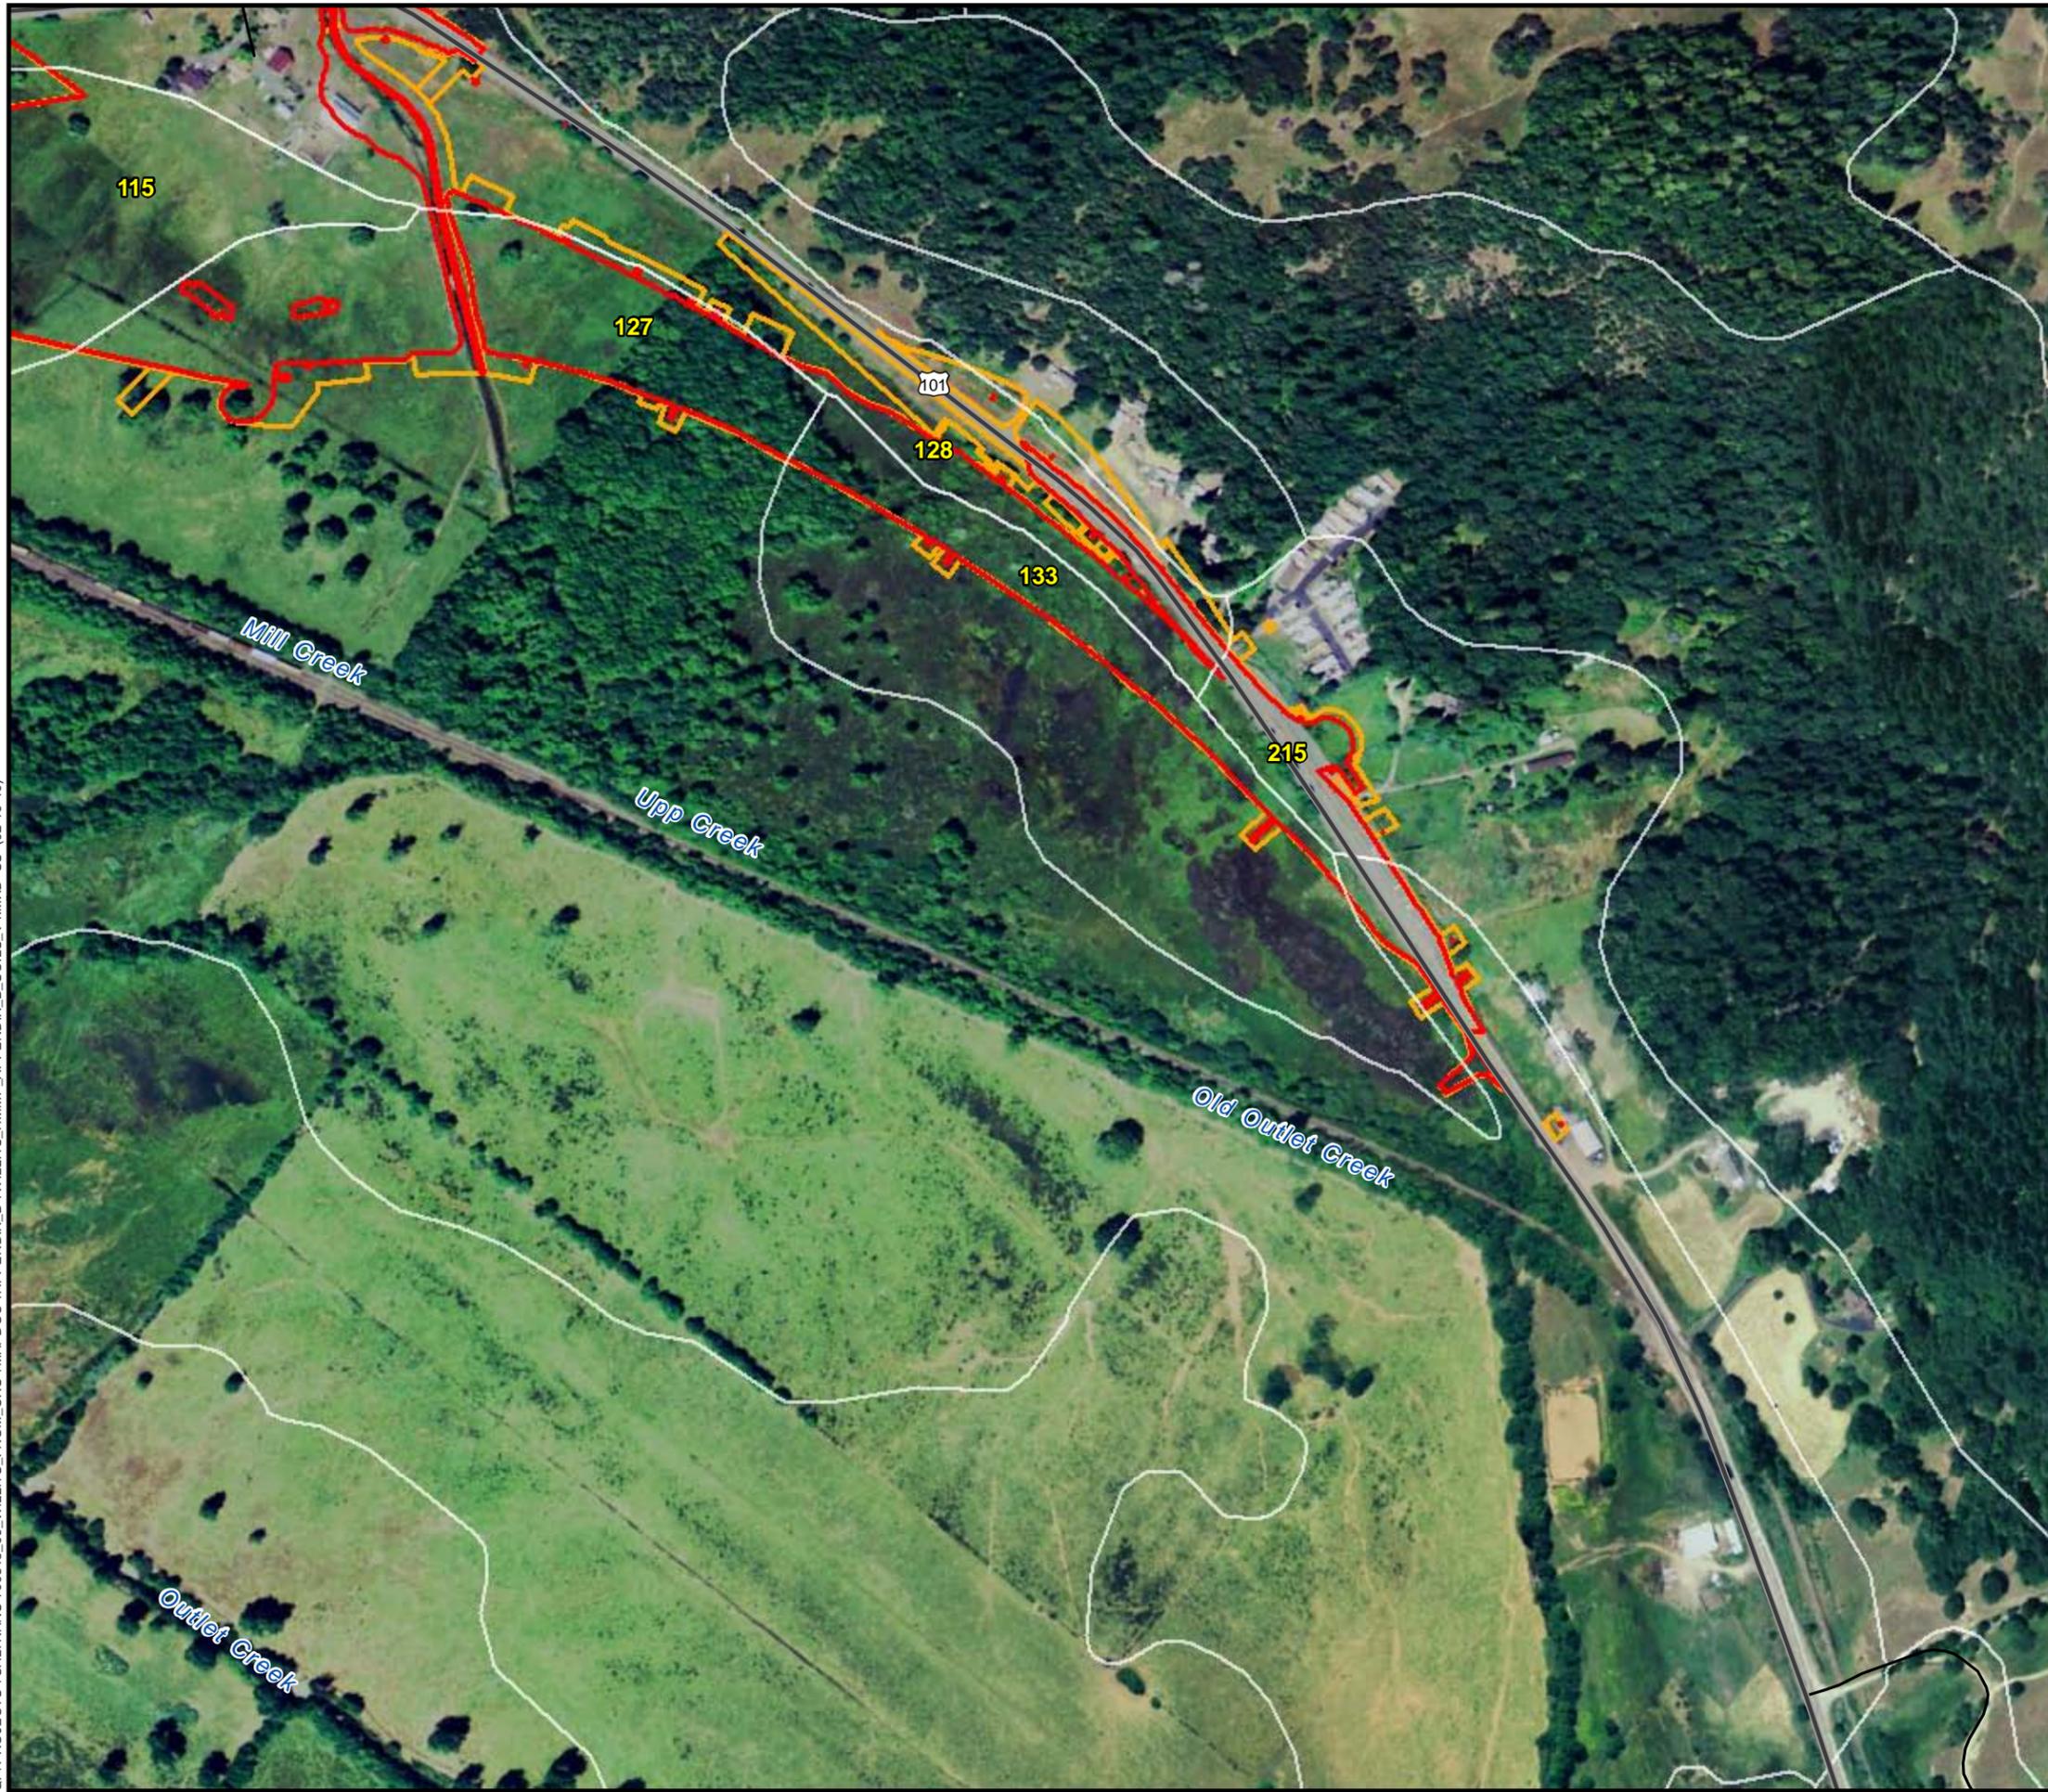
**Figure 5-4f**  
**Soil Types within the Proposed Bypass Project Footprint**  
 Proposed Willits Bypass Project

SSURGO Map Unit  
 Permanent Impact Boundary  
 Temporary Impact Boundary  
 Road

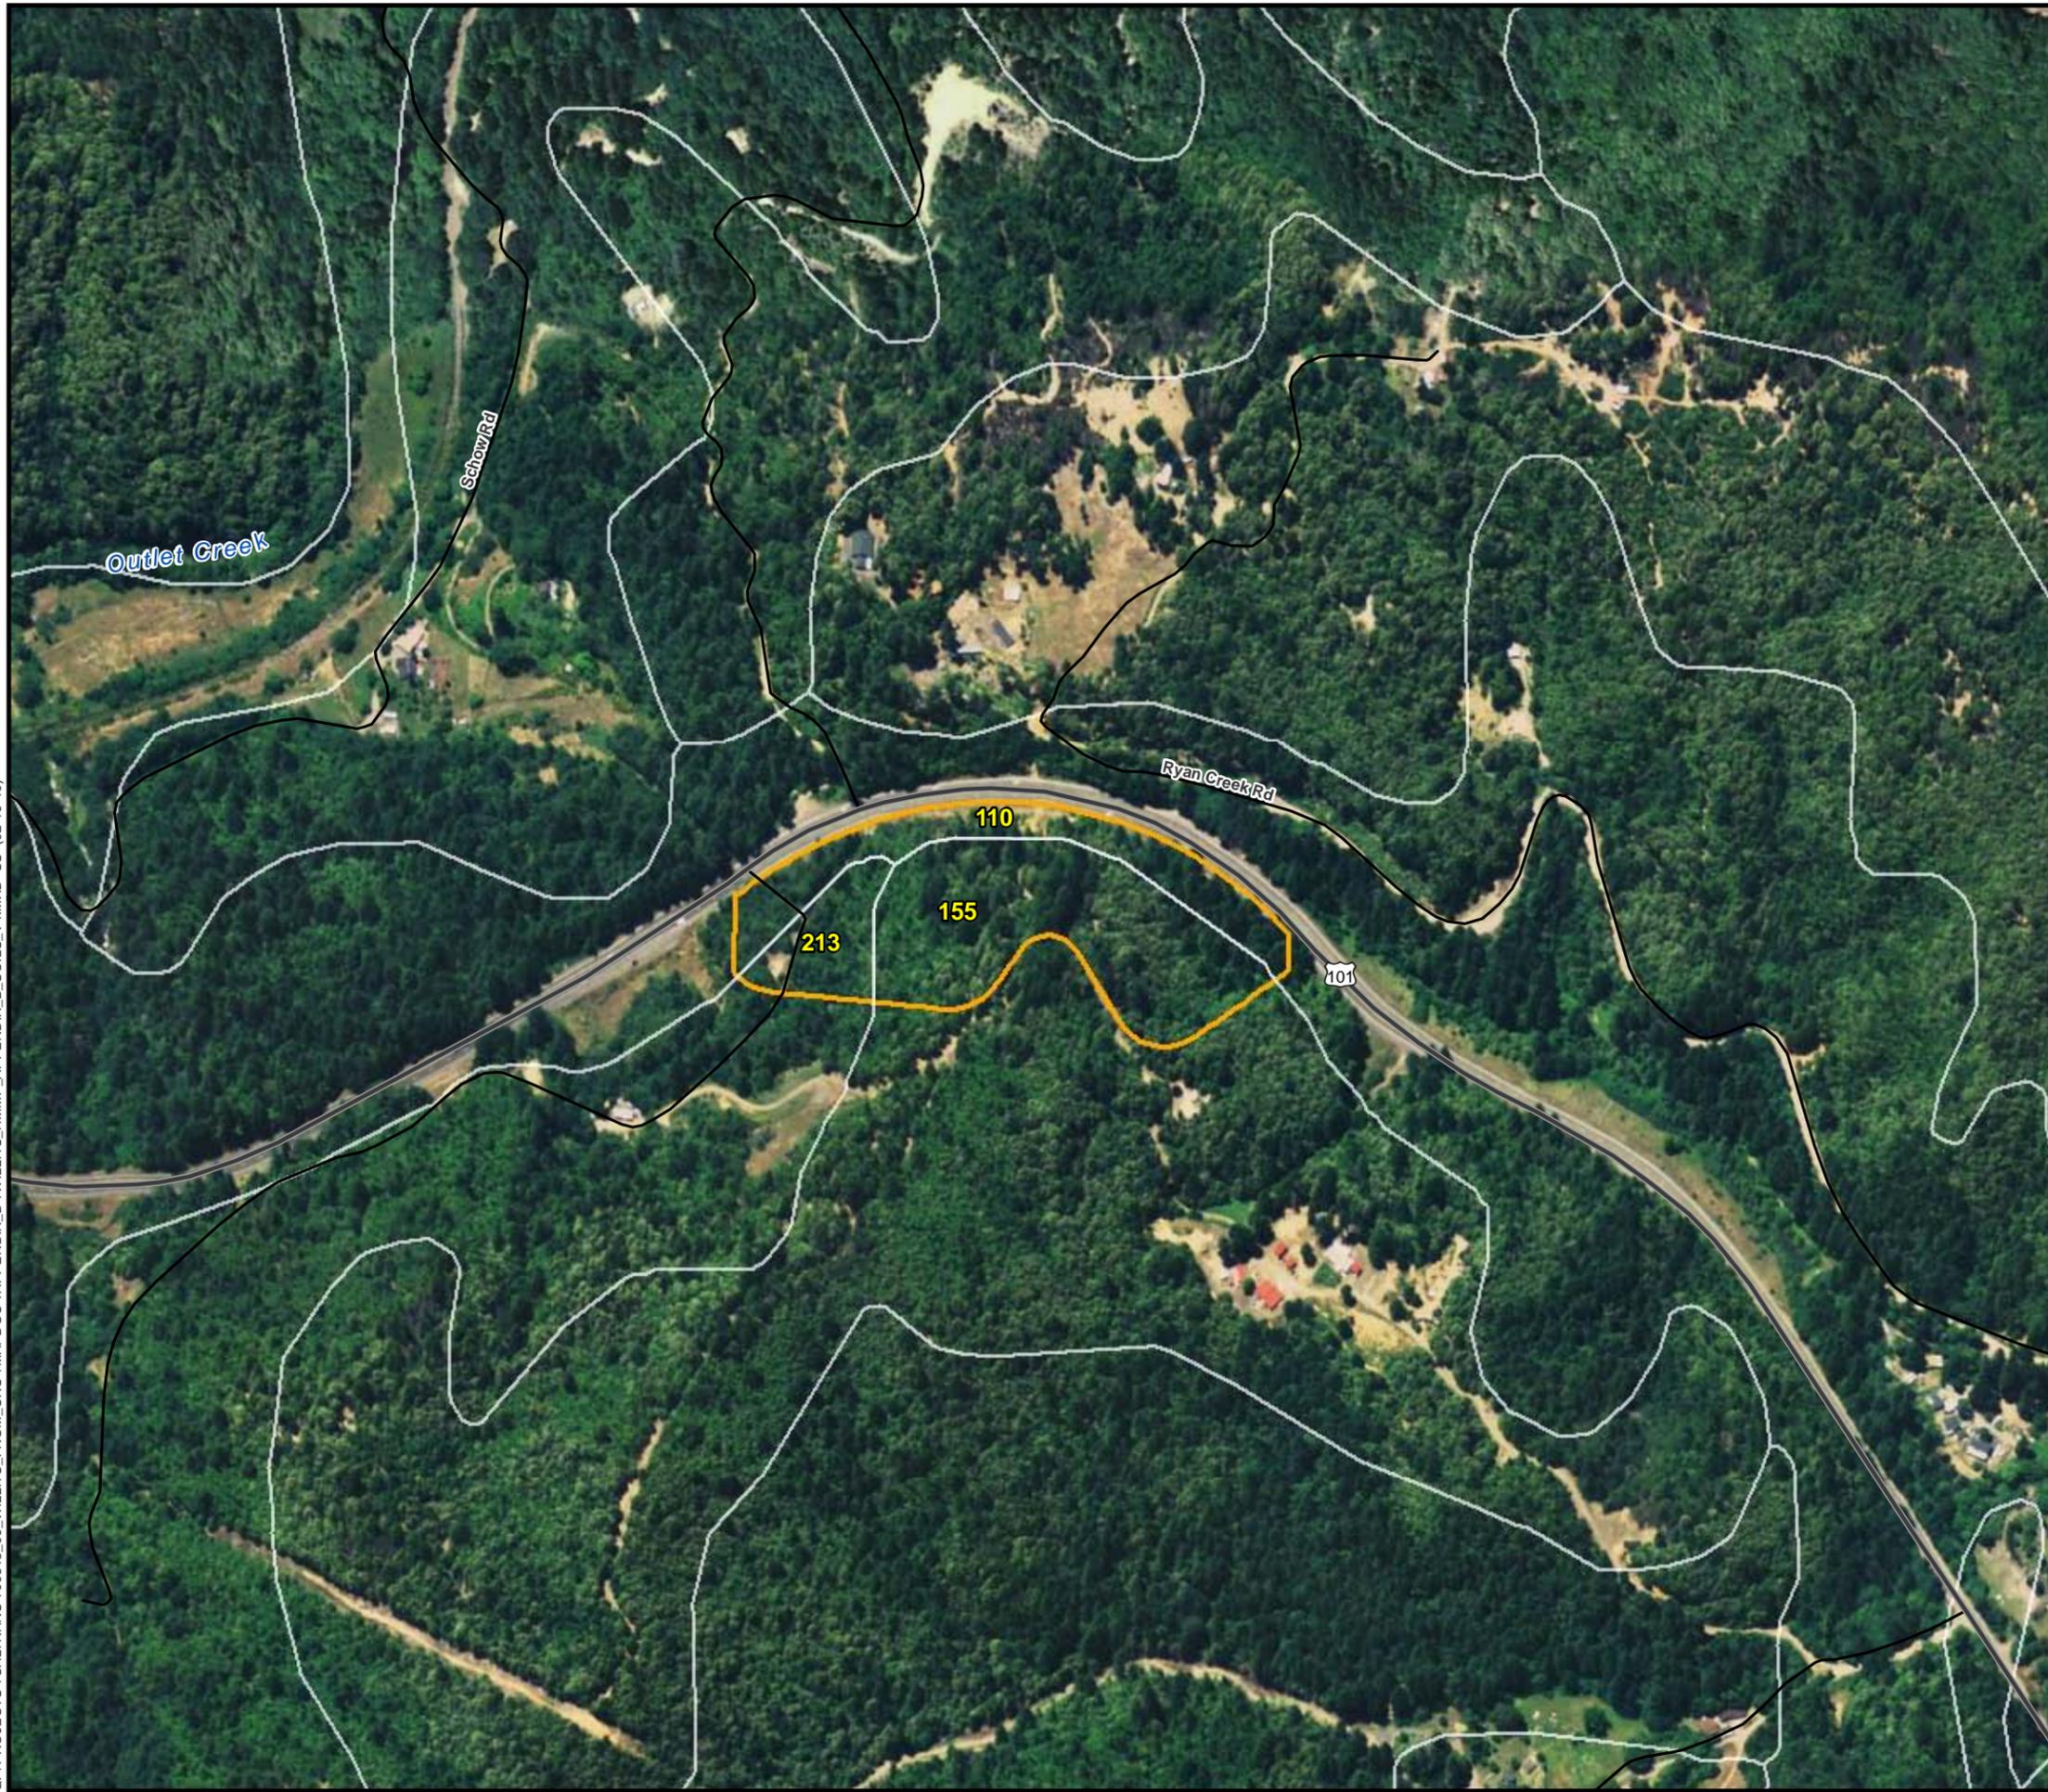
**Figure 5-4g**  
**Soil Types within the Proposed Bypass Project Footprint**  
 Proposed Willits Bypass Project

SSURGO Map Unit  
 Permanent Impact Boundary  
 Temporary Impact Boundary  
 Road
