**FOR CONTRACT No.: 03-4M0104
PROJECT ID: 0300001132**

**NATURALLY OCCURRING ASBESTOS PRELIMINARY SITE INVESTIGATION REPORT
STATE ROUTE 49, NEVADA AND SIERRA COUNTIES, CALIFORNIA**

**TASK ORDER No. 03-4A4401-DV
GEOCON PROJECT No. S8475-06-82
MARCH 2004**

ROUTE: 03-Yub, Sie-49-Var

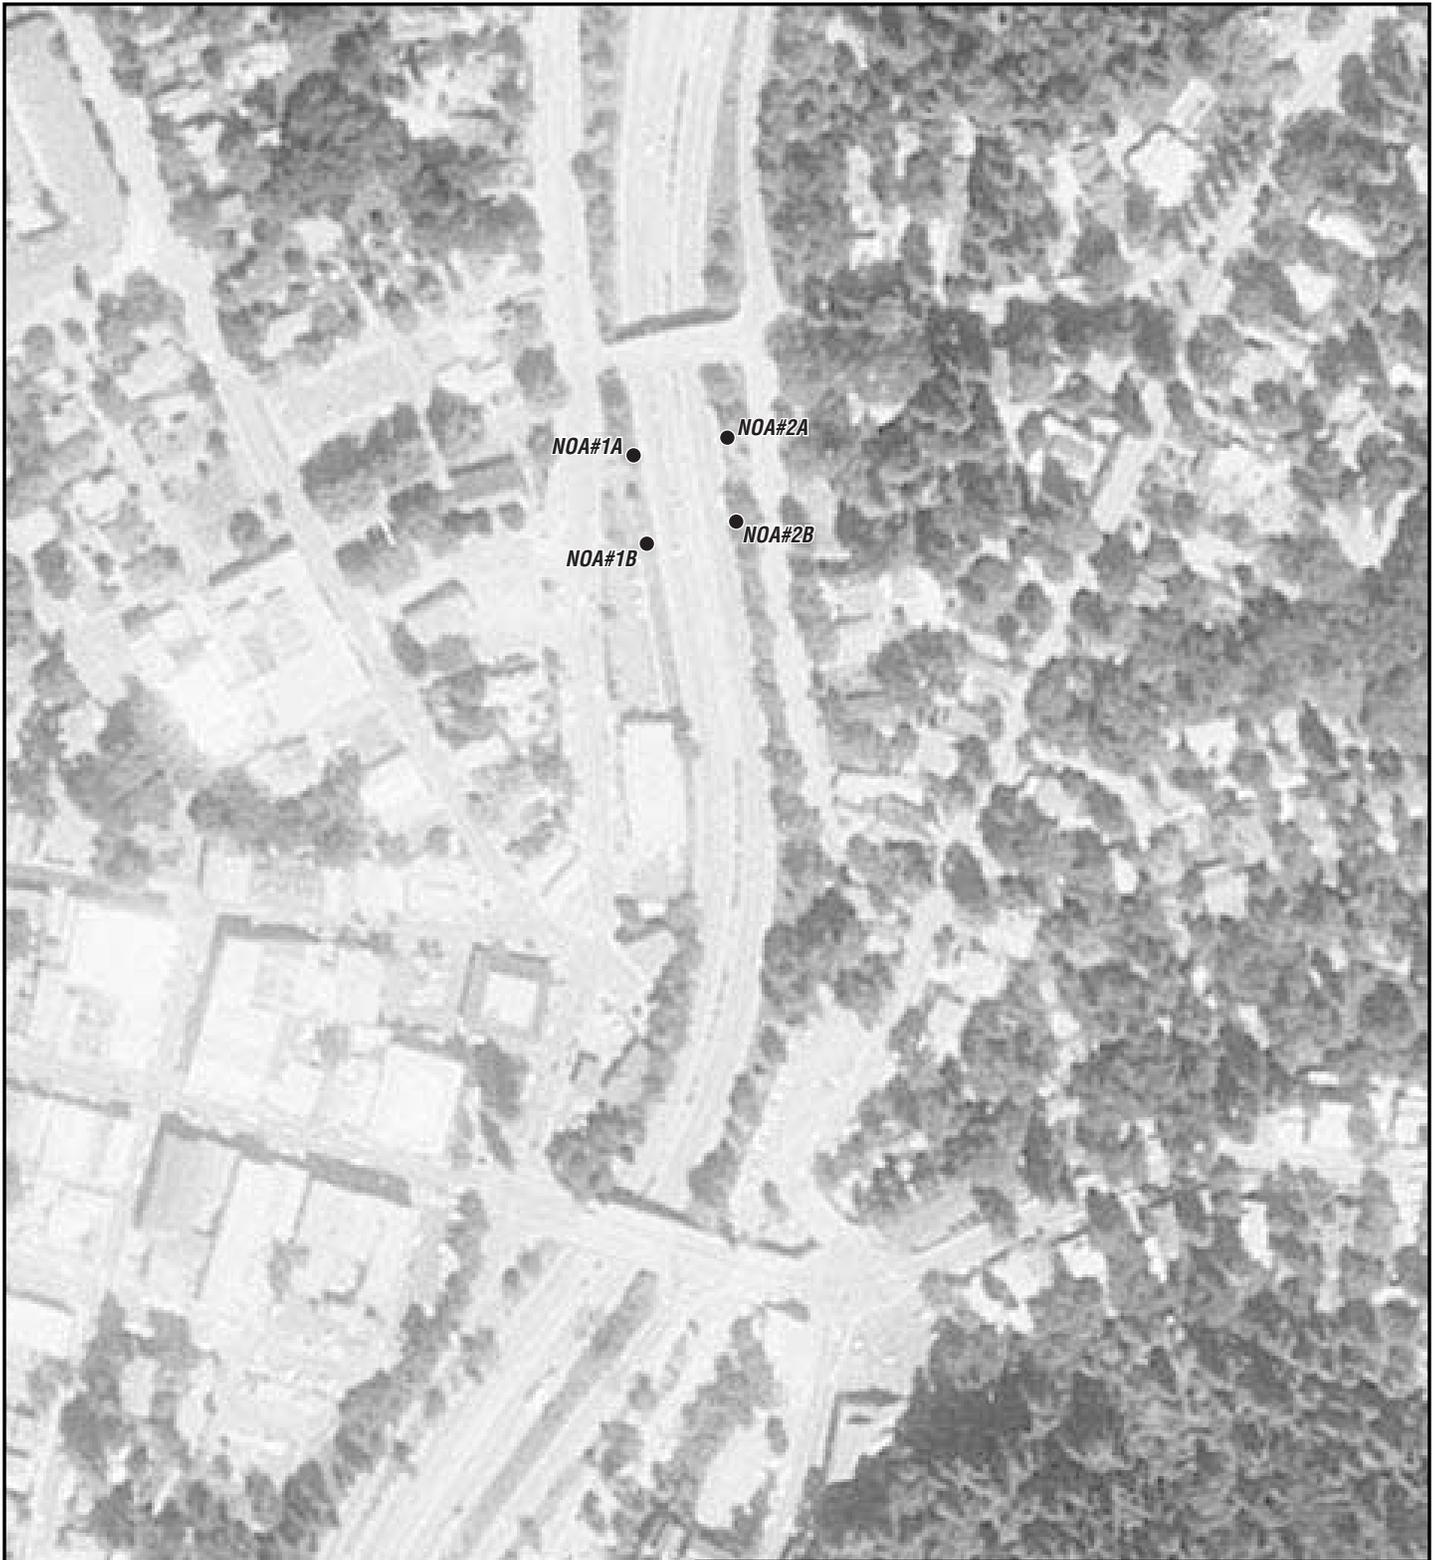
Figure 2A

Two composite samples, NOA #1 and NOA #2, were collected from the soil at the edge of the roadway between KP 24.14 and KP 24.62 in Nevada County, each comprised of two soil samples collected along the shoulder of the southbound and northbound lanes respectively. Samples were collected by scraping off the upper five to ten centimeters (cm) of soil and organic matter from the surface and collecting an approximately 500-gram sample with a soil scoop. Two scoops were collected for each sample from what appeared to be representative soil types at the designated location. The two scoops were field composited into one sample. The soil scoop was decontaminated between each sample using dry decontamination procedures. The sampling area and approximate sample locations between KP 24.14 and KP 24.62 in Nevada County are depicted on the Site Plan, Figure 2A.

NOA#1A ● Approximate Soil Sample Location

SITE PLAN

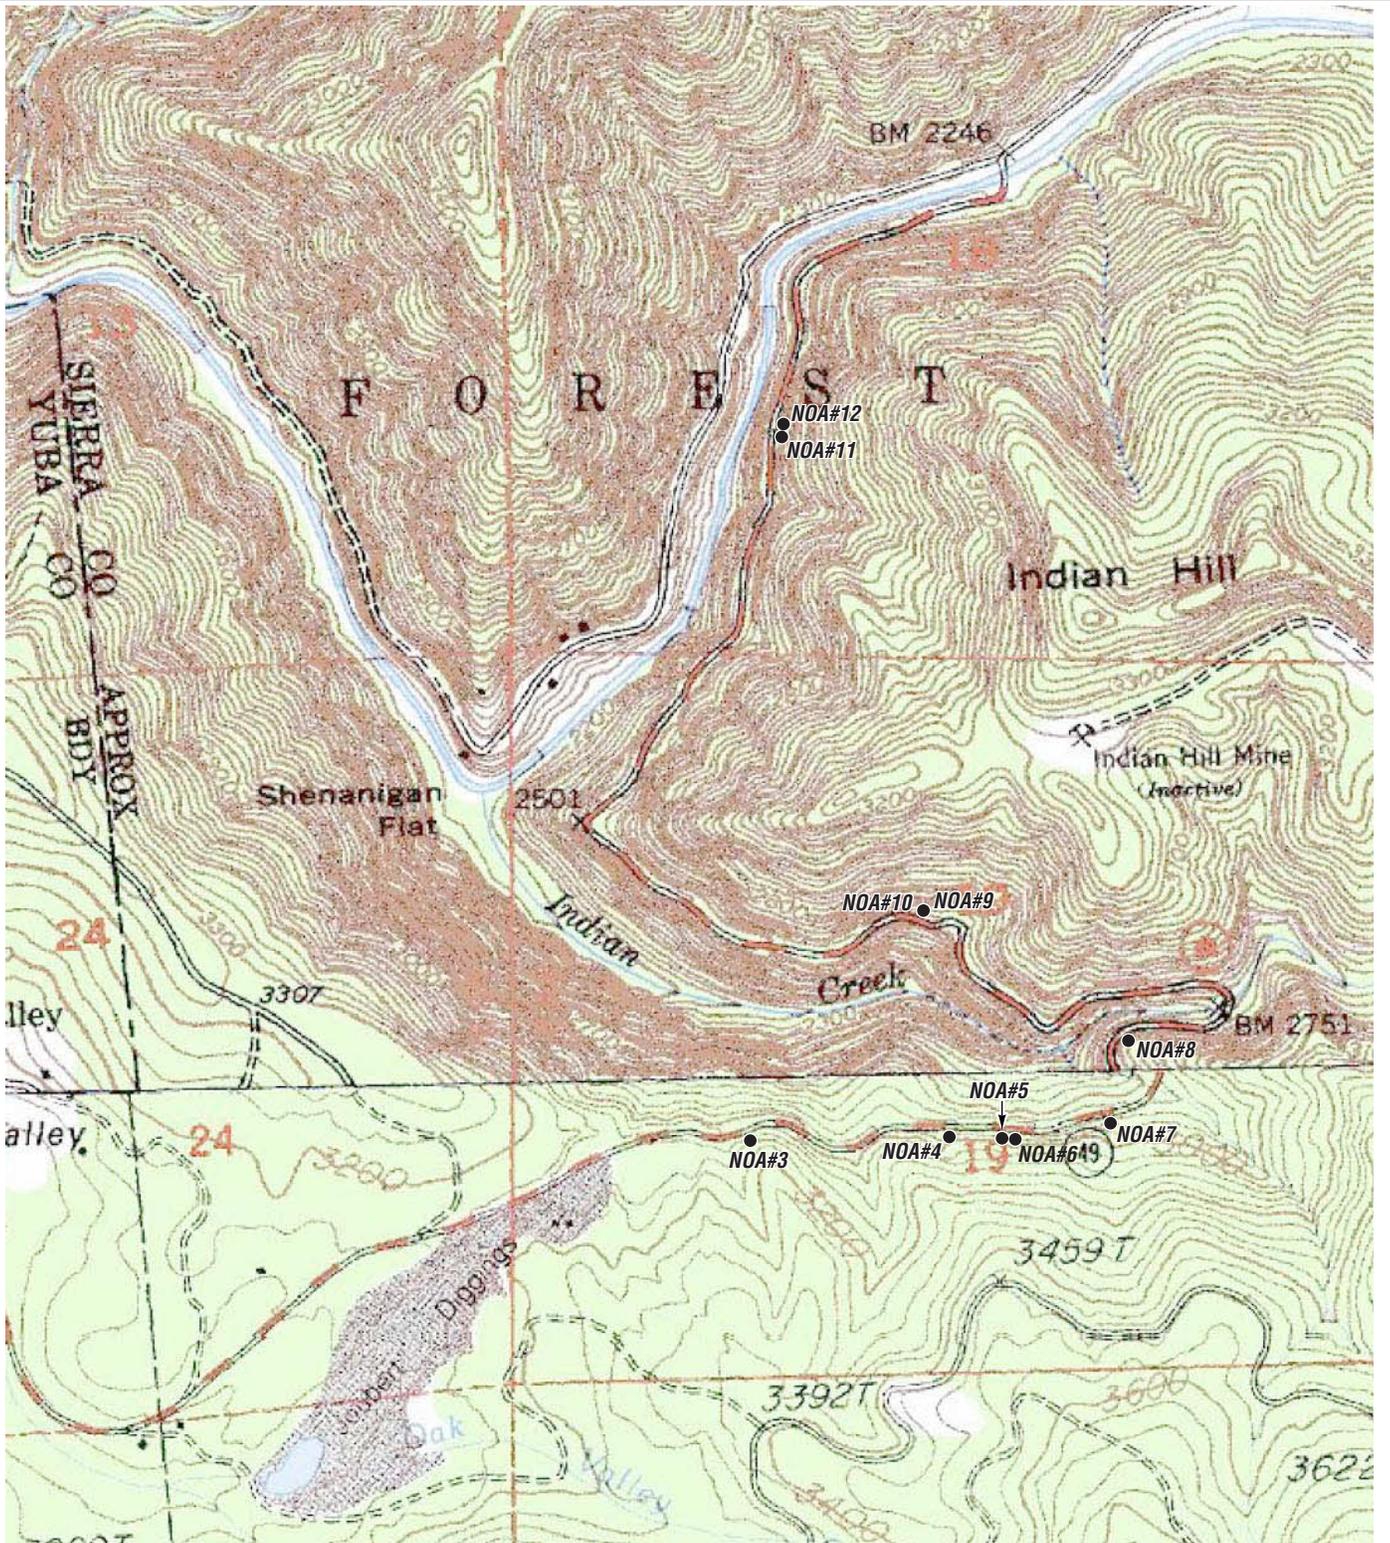
Figure 2B

The soil and rock samples collected were placed into Zip-Lock® plastic bags for storage and were subsequently shipped to EMSL for asbestos analysis under standard chain-of-custody procedure. Each sample bag was marked with a sample identification number, date, time and highway number and post mile distance. The sampling area and approximate sample locations between KP 1.01 and KP 5.95 in Sierra County are depicted on the Site Plan, Figure 2B.

NOA#3 ● Approximate Rock Sample Location

SITE PLAN

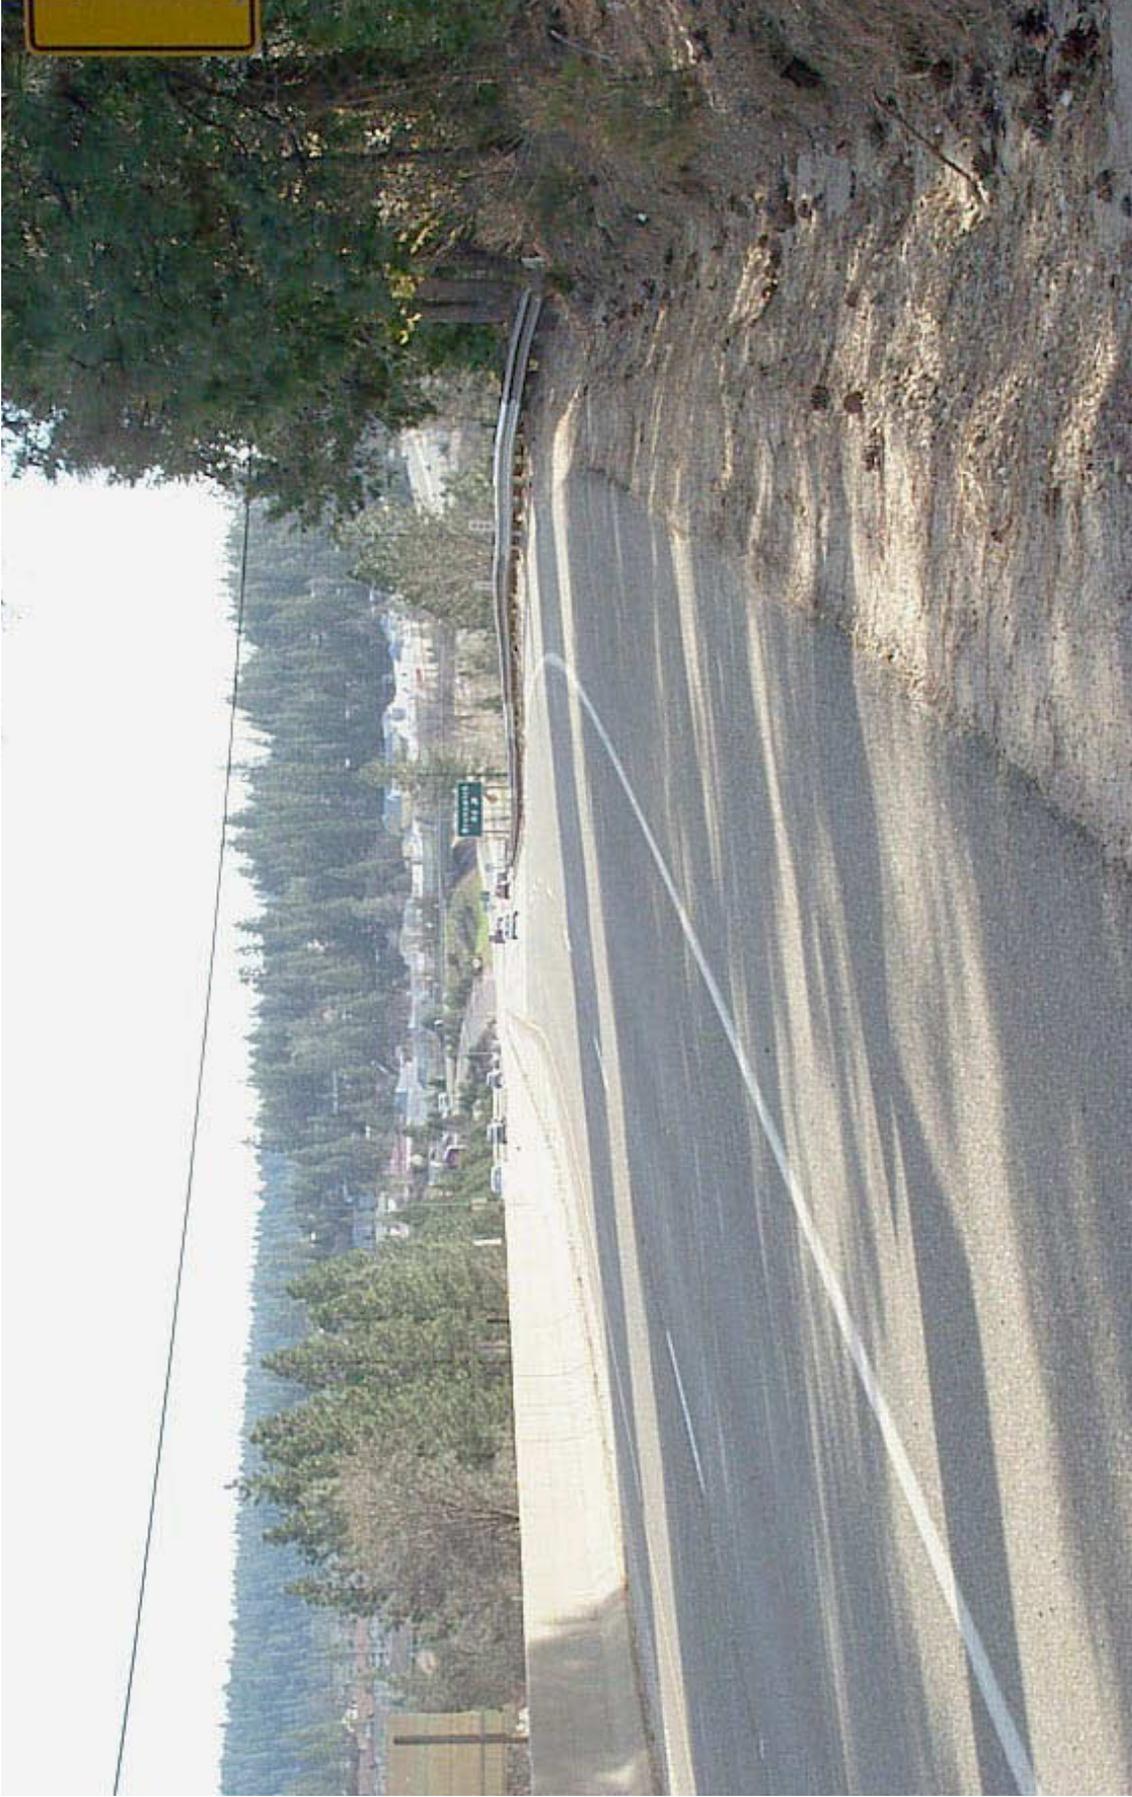
Figure 3a

Soils encountered within 20 cm of the surface at the edge of the roadway between KP 24.14 and KP 24.62 in Nevada County are composed primarily of native soil and fill. The native soil encountered is loose, medium grayish brown sandy silt with weathered rock fragments (ML to SM) adjacent to the in-place rock outcrops. The fill encountered is loose, dark grayish brown, silty sand (SM) with abundant organic debris.

Photo No. 1 Nevada County KP 24.14 - 24.62 (NOA #1)

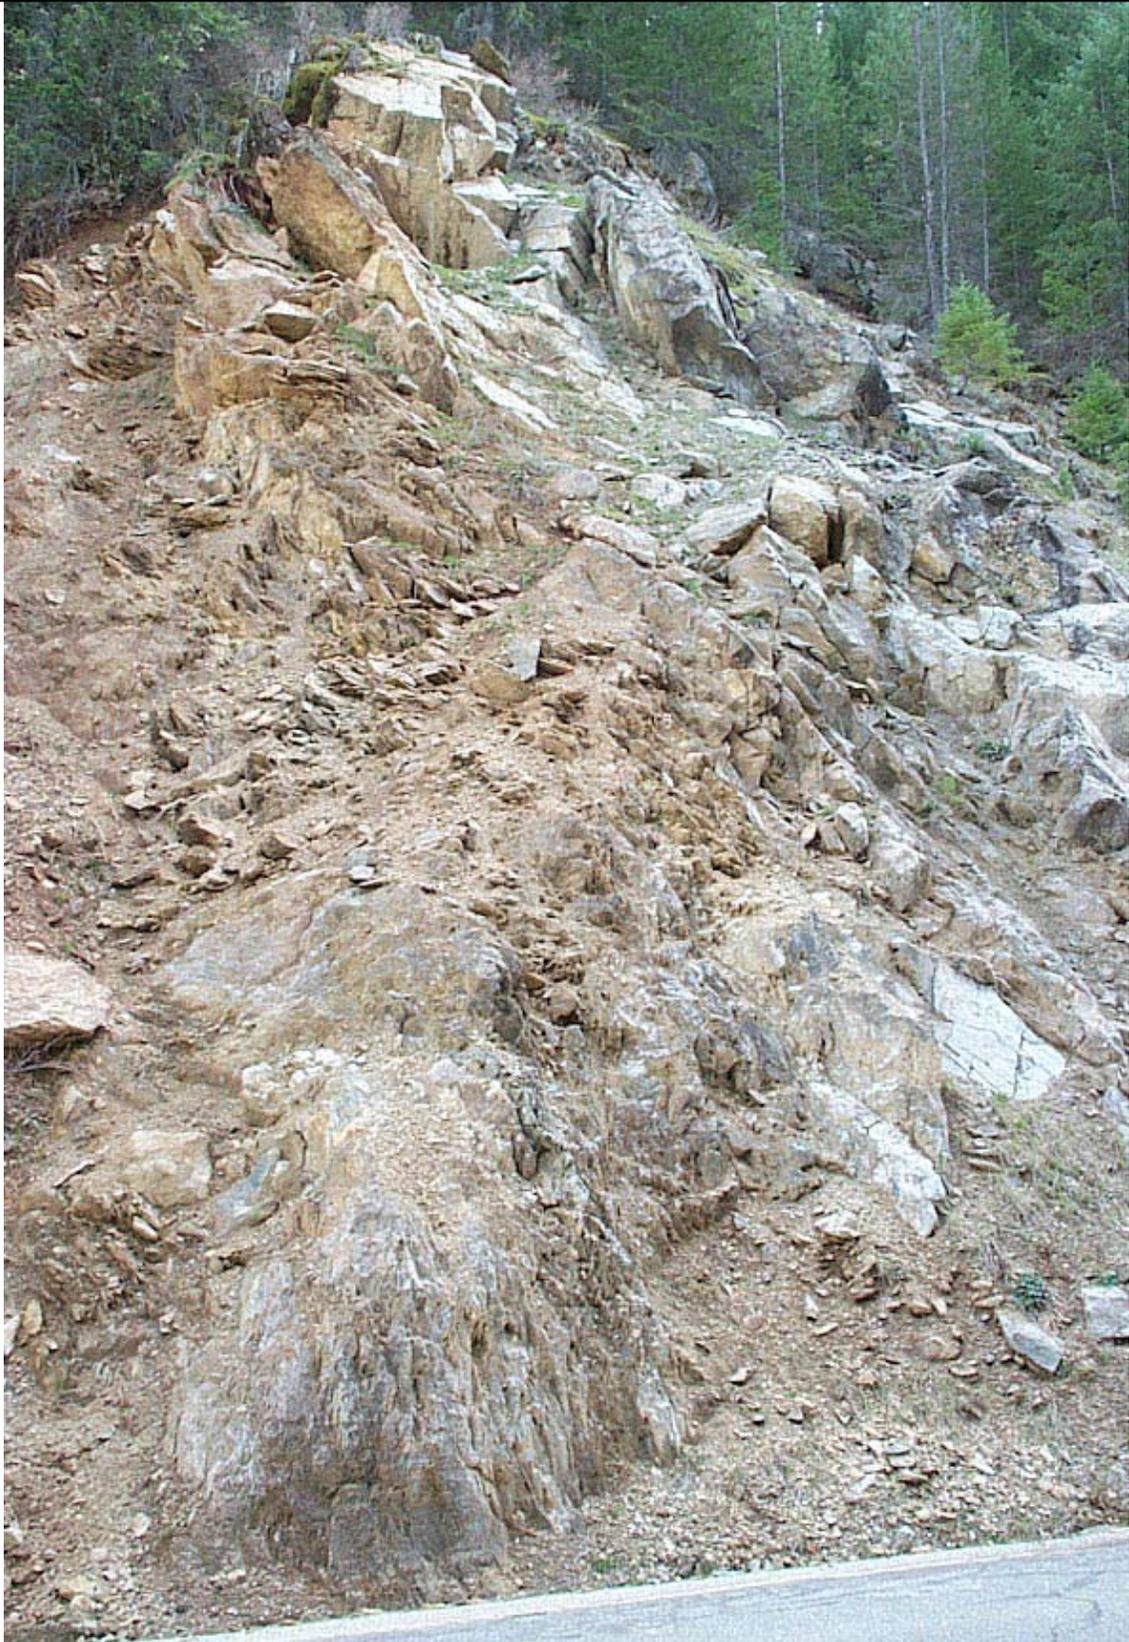
Figure 3b

Photo No. 2 Sierra County KP 1.88 - 1.89 (NOA #5 and NOA #6)

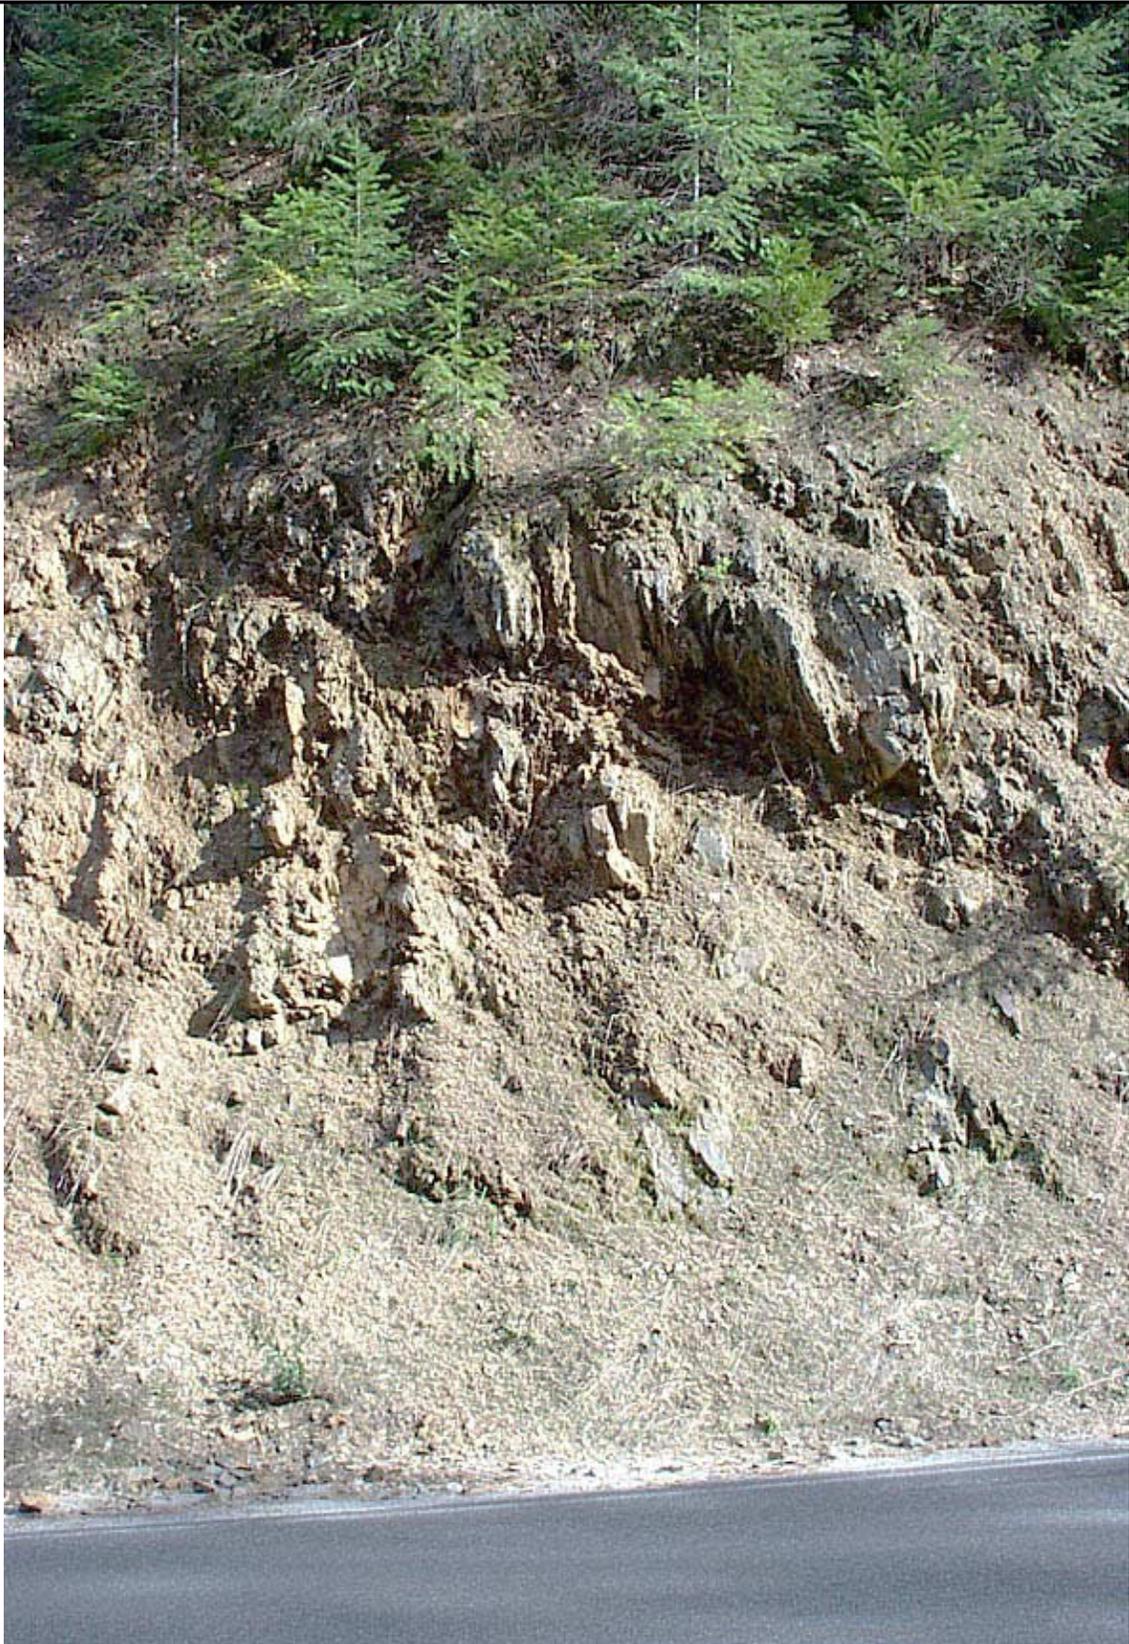
Figure 3c

The rock outcrops observed during the geological reconnaissance between KP 1.01 and KP 5.95 in Sierra County include a mixture of metamorphosed sedimentary and volcanic rocks typical of those found within the western Sierra geologic complex. Metamorphosed sedimentary rocks observed included meta-graywacke, slates, and massive phyllitic rocks. The metamorphosed volcanic rocks observed included meta-andesites, greenstones, and pods of apparently serpentinized rock. While NOA minerals can occur in each of the metamorphosed volcanic rock types observed, they are most common in the serpentinized rock. The metamorphosed sedimentary rocks would not generally contain NOA minerals except in certain instances where they are in contact with magnesium rich volcanic rocks. Within the site boundaries, two rock types were observed that commonly contain NOA minerals; serpentine rock which can contain chrysotile and talc schist which can contain amphibole asbestos minerals. One rock sample was collected from the meta-andesite at KP1.33, and a second was collected from greenstone at KP 1.76 to determine whether disseminated NOA was present in the apparently un-serpentinized metamorphosed volcanic rock. Eight rock samples were collected from five outcrop locations that were observed to be comprised of serpentine and/or talc schist. Bodies of apparently serpentinized rock associated with talc schists were observed at Sierra County KP 1.88, KP 3.46, and KP 5.13. Serpentine was also observed at Sierra County KP 2.41. Talc schist was noted at Sierra County KP 2.09 that was not observed to be in contact with a serpentine body. Fractured serpentinite with what appeared to be cross-fiber vein fillings was observed and sampled at two locations, Sierra County KP 2.41 and Sierra County KP 3.46.

Photo No. 3 Sierra County KP 2.41 (NOA #8)

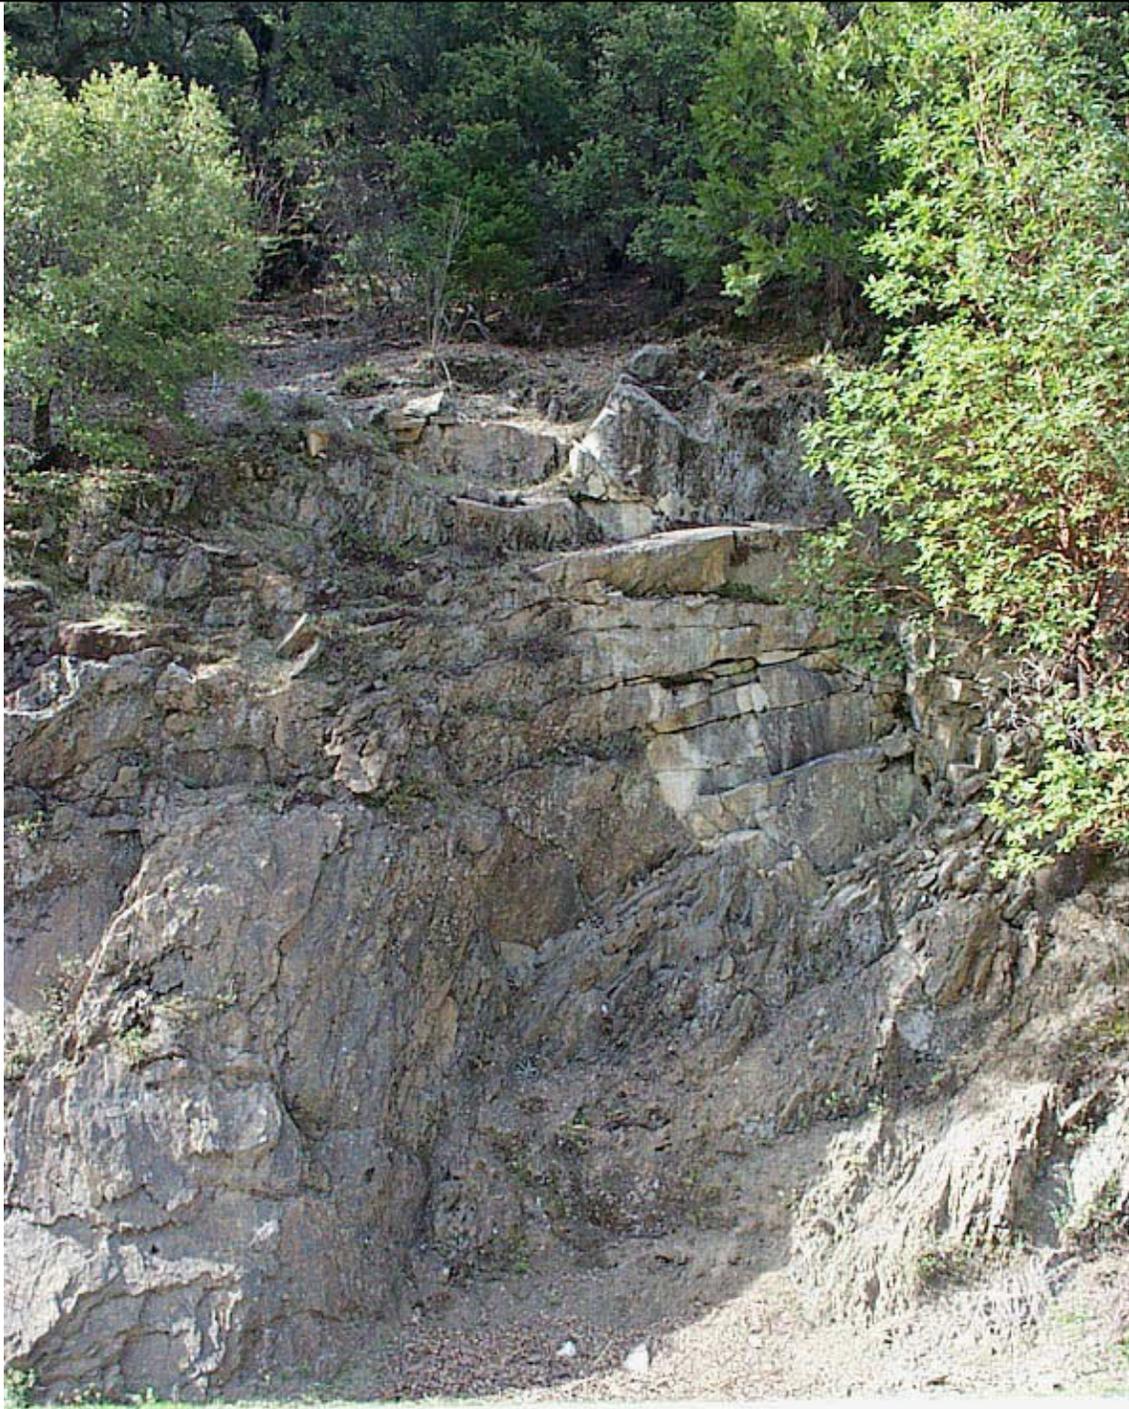
Figure 3d

Photo No. 4 Sierra County KP 3.46 (NOA #9 and NOA #10))

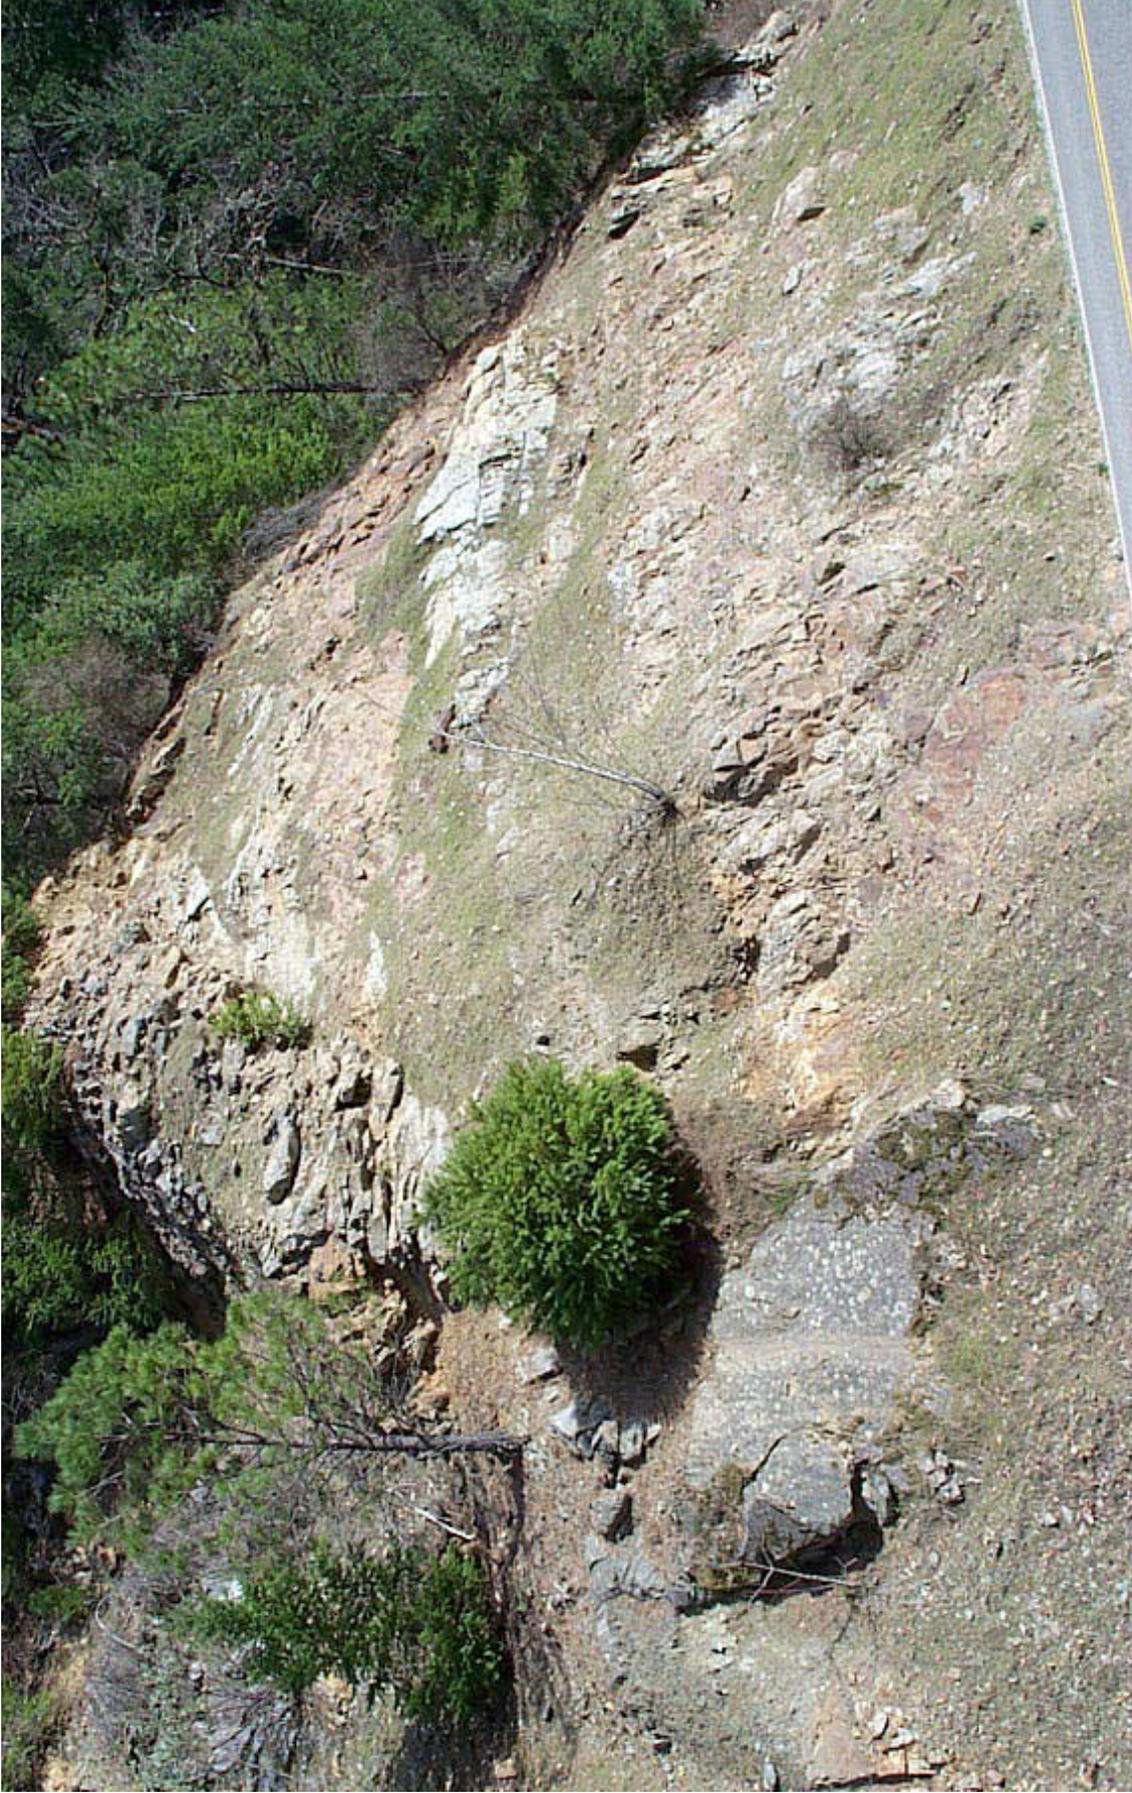
Figure 3e

Photo No. 5 Sierra County KP 5.13 - 5.15 (NOA #11 and NOA #12)
