I-215 Corridor System Management Plan (CSMP)

Draft Final Comprehensive Performance Assessment And Causality Report

**Kimley-Horn
and Associates, Inc.**

June 23, 2009
097473002

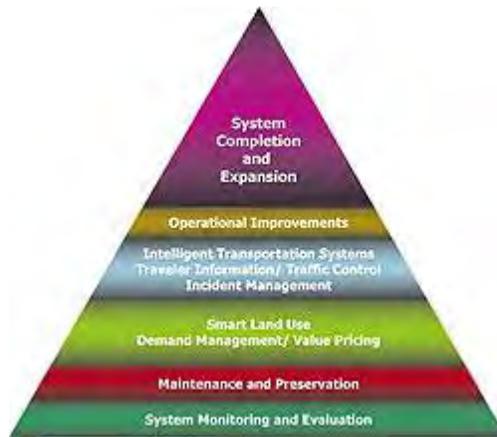
Figure 1-2: System Management Pyramid

The goal of a CSMP is to define how a travel corridor is performing, understand why it is performing that way, and recommend system management strategies to address problems within the context of a long-range planning vision. Guided by the system management pyramid (**Figure 1-2**), a CSMP seeks to incorporate operational analysis into more traditional transportation planning processes at the corridor level. This is accomplished by conducting comprehensive performance assessments, analysis and evaluations leading to recommending system management strategies for the corridor.

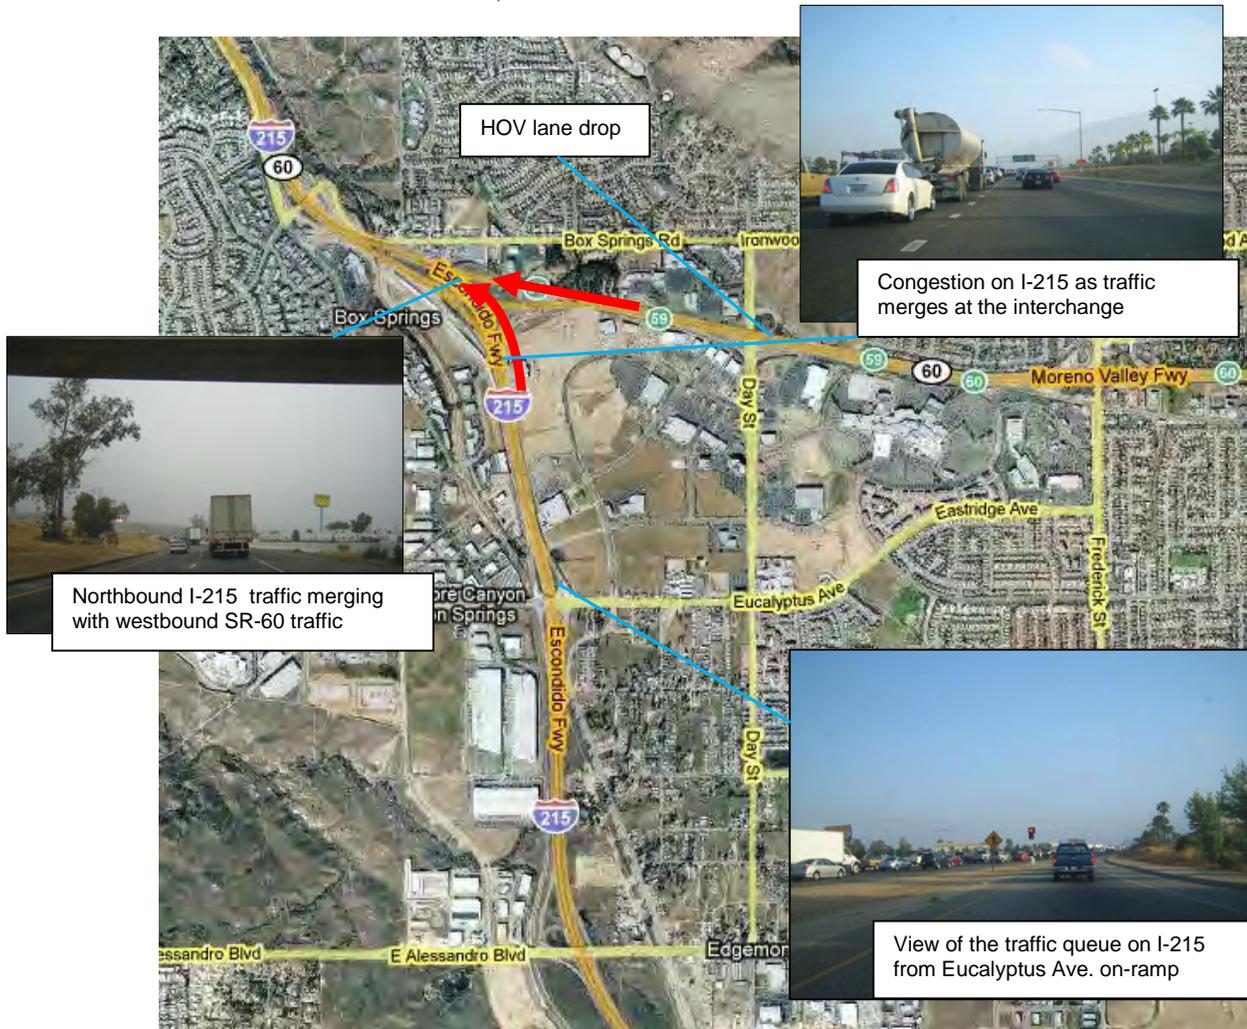
Figure 5-2: Bottleneck #1

In the AM peak period in the northbound direction, a bottleneck is identified at the SR-60/I-215 freeway interchange. The congestion is caused by traffic merging from westbound SR-60, causing queues to form on northbound I-215 south to Alessandro Boulevard. A bottleneck also exists on westbound SR-60 caused by the HOV lane drop that reduces freeway capacity from two general-purpose lanes and one HOV lane to two general-purpose lanes. On northbound I-215, three general-purpose lanes are reduced to two mixed flow lanes at the SR-60/I-215 Interchange.

Congestion at this bottleneck exists from approximately 7:30 AM to 9:00 AM along SR-60 and from approximately 6:40 AM to 9:00 AM along NB I-215. Also in the AM peak period in the northbound direction, pockets of reduced speed occur between Box Springs Road and Martin Luther King Boulevard. The reduced traffic flow is likely caused by hilly terrain and weaving segments between Box Springs Road/Fair Isle Drive and Central Avenue/Watkins Drive and Martin Luther King Drive and University Avenue. Congestion at this location occurs from approximately 7:30 AM to 8:30 AM.
