## Development and Crash Testing of a See-Through Steel Bridge Rail

**RESULTS:** A see-through steel bridge rail (Type California ST-20) was developed and tested. As tested, ST-20 was at the limits of NCHRP Report 350 TL-4 test matrix, and also met the requirements established by AASHTO Bridge Design Specifications for use as a bicycle rail, and is considered an aesthetically pleasing see-through bridge rail. Results from the test and computer modeling indicate that ST-20 passed NCHRP Report 350. However, the level of hood snagging demonstrated that the ST-20 pushed the limits of acceptability. In order to decrease the level of hood snagging, ST-20 was redesigned with deeper rail elements and given the new designation ST-20s.\* Because ST-20s resisted hood snagging more than ST-20, California ST-20s was recommended (and approved) on California Highways requiring TL-4 bridge rails without further testing.

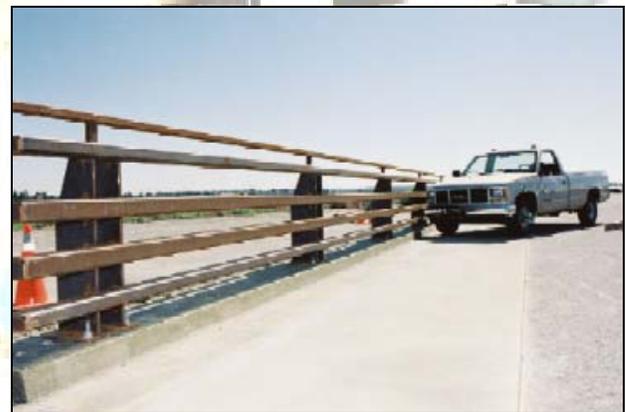
Figure 1 – Completed ST-20 Barrier Prior to Testing

Test barrier for the ST-20 was constructed at the north end of the Caltrans Dynamic Test Facility. The asphalt was cut away and the underlying earth was removed to allow for placement of an anchor block and a simulated bridge deck. The concrete was placed in three phases: the anchor block, the overhang deck, and the curb for the ST-20. Once the formwork for the anchor block was complete, the reinforcing steel was positioned. Holes were drilled in the forms where some of the connection steel passes between the anchor block and the overhang. In order to protect the structural integrity of the concrete, no vehicles were allowed on the anchor block during work on the overhang and curb sections.

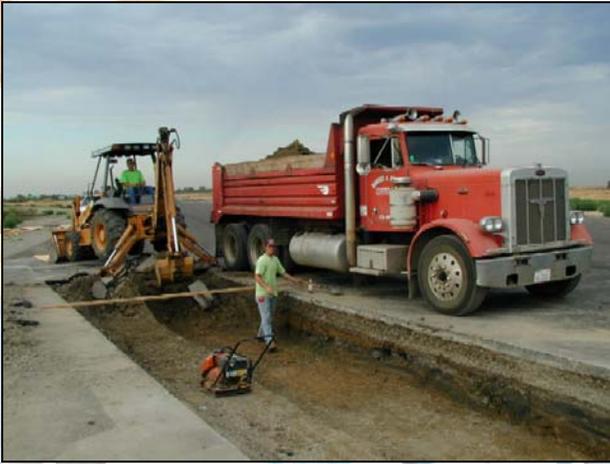
Figure 2 – Site Excavation

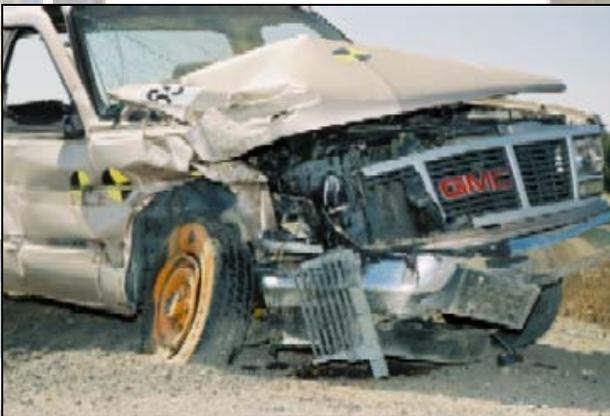
Figure 3 – Test 651 Vehicle Damage, Front Right Corner

One full-scale crash test was performed and evaluated in accordance with Report 350. Applied Research Associates, Inc. (ARA) performed computer modeling to determine the critical impact point. Because the computer modeling indicated a potential for hood snagging, it was determined that the critical impact point would be mid-span between posts. The resulting hood snagging led to a redesign, which was also evaluated by ARA.

NCHRP Report 350 stipulates that crash test performance is assessed according to three evaluation factors: 1) Structural Adequacy, 2) Occupant Risk, and 3) Vehicle Trajectory. For Structural Adequacy, the vehicle was contained and smoothly redirected. For Occupant Risk, there were minor amounts of rail scraping and concrete spalling created during impact. Also, the hood rotated back toward the windshield putting the ST-20 at the limits of acceptability. Regarding Vehicle Trajectory, the test vehicle remained relatively straight after exiting the barrier. The exit angle and rate of return into traffic were minimal. Consequently, the California ST-20 as tested was not recommended for approval. A modified version of the ST-20 (designated the California ST-20s) with rail element 50mm deeper than the version tested was recommended (and later approved) for use as a TL-4 bridge rail. The approved version was later renamed the California ST-20.

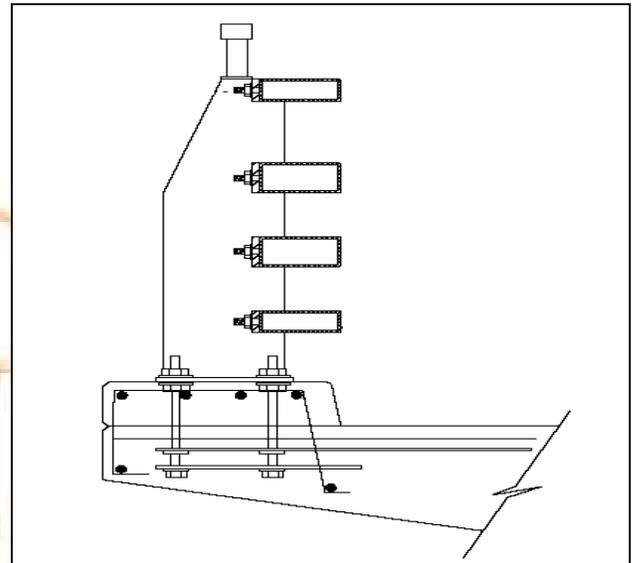
Figure 4 – California ST-20S (Approved)

\* For simplicity, the final "approved" version of the ST-20 had the "s" dropped from the name.
