**SUBJECT: Experiment Status Report  
CTCDC Item 11-4 (Round Rapid Flashing Beacon)  
FHWA Item 4(09)-8(E) Circular Rapid Flashing Beacons – Santa  
Monica, CA**

## **1. Milestones**

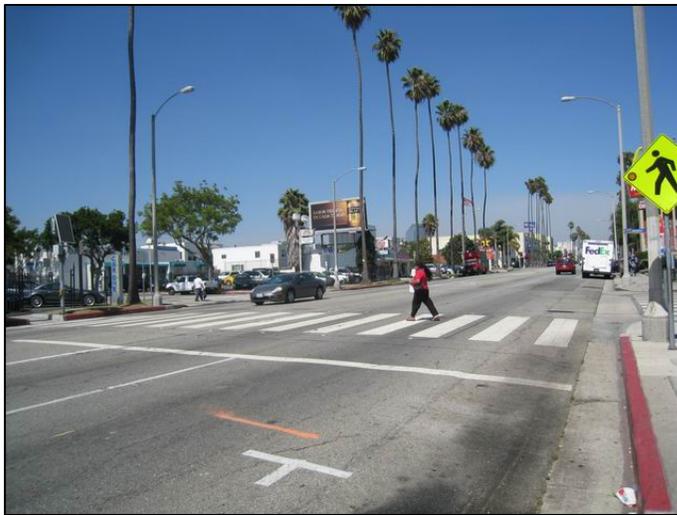
#### *Santa Monica Boulevard/Princeton Street*

The Santa Monica Boulevard/Princeton Street test site consists of a marked crosswalk on Santa Monica Boulevard across the uncontrolled eastern leg of the intersection. Santa Monica Boulevard is a Principal Arterial. Stop controls are provided on Princeton Street, the minor side street approaches to Santa Monica Boulevard. The intersection is offset, with the segment of Princeton Street south of Santa Monica Boulevard located approximately 30 feet west of the segment to the north.

*Lane Geometrics, Width, and Striping* – In the vicinity of the test site, Santa Monica Boulevard has a curb-to-curb width of approximately 68 feet, with five travel lanes (two travel lanes in each direction and a center two-way left turn lane) and two eight-foot parking lanes.

*Crossing Enhancements* – A high visibility “continental” pattern crosswalk is marked across Santa Monica Boulevard. There are advance “Ped Xing” pavement markings to the east and west of the crossing as well as advance stop bars on both approaches to the crosswalk. On the eastbound approach, the stop bar is located approximately ten feet from the crosswalk. On the westbound approach, due to the offset configuration of the intersection, the stop bar is located approximately 65 feet from the crosswalk. Overhead street lights located on each side of the crosswalk, provide illumination of the crossing at night.

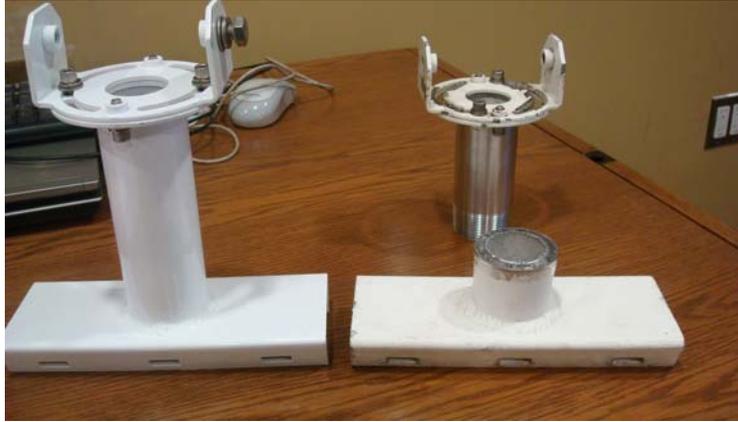
The City of Santa Monica made many after-market modifications to the RRFB device as provided by the manufacturer. The RRFB housings were initially designed to be attached to a pole directly. City staff created modified mounts for the housing using video detection equipment mounts.

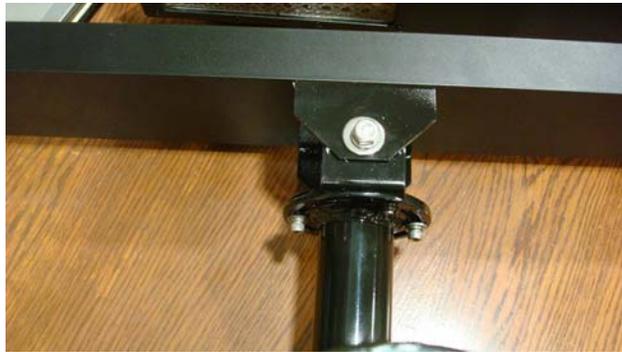
The modified mounts are affixed to a standard terminal block, and allow the RRFB housings to be angled towards or away from the roadway, and rotated from top to bottom.

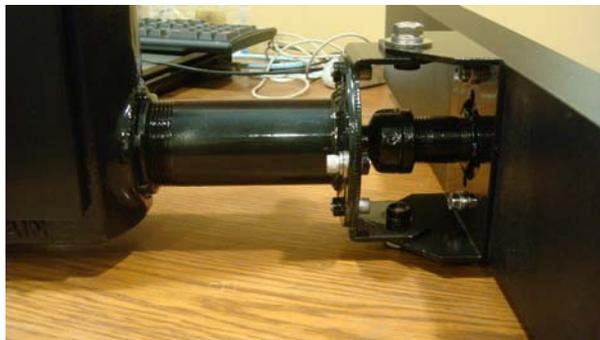
Here is another view of the RRFB housing mounts, showing the adjustable angle of the RRFB. This mounting ensures that once the RRFB is affixed to the pole, the RRFB housing can be angled to point directly at the path of travel of oncoming vehicles.

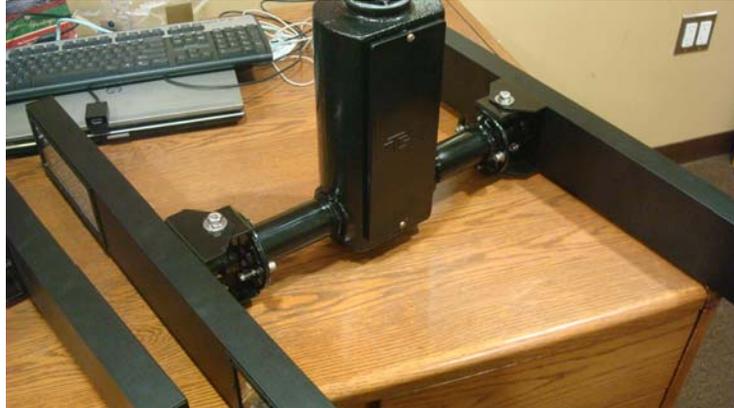
Below is an image of the finished modification, with the terminal block holding two RRFB housings, to face each direction of oncoming traffic.

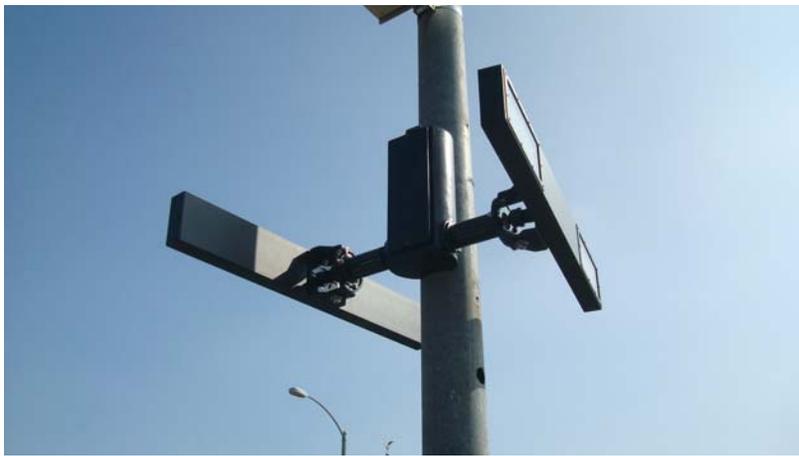
Last is an image of the finished devices mounted to a pole. Once mounted, the fully adjustable mounting allowed for optimal adjustment to aim the flashing beacons at oncoming traffic.

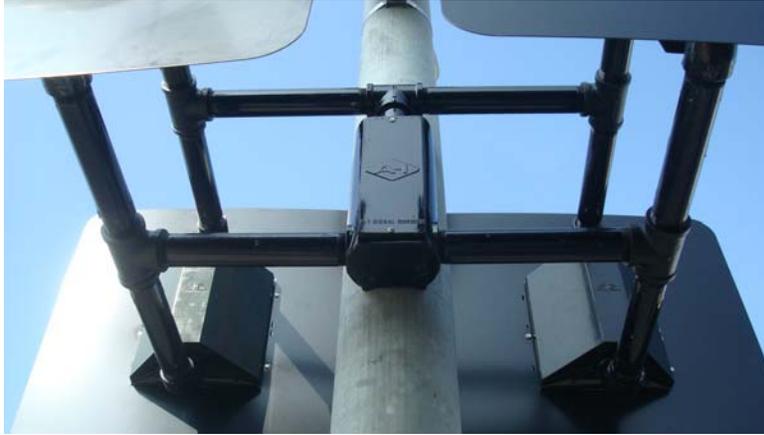
Similar modifications were made to the CRFB device. Each of the circular indications was mounted on standard traffic signal installation housings, and attached to the pole via a terminal block.

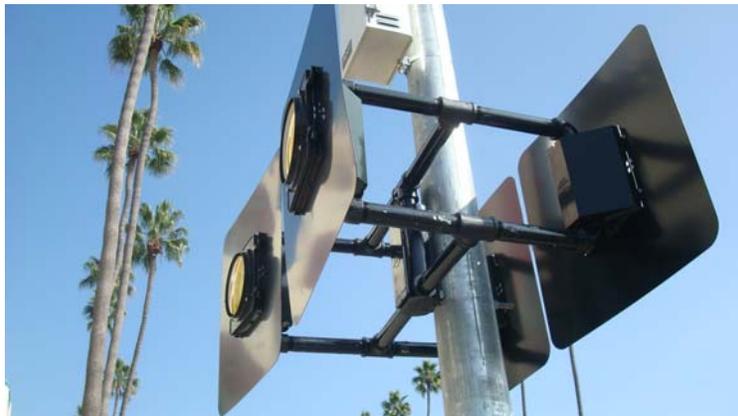
The modifications allowed each of the circular indications of the CRFB to be directed towards oncoming traffic.

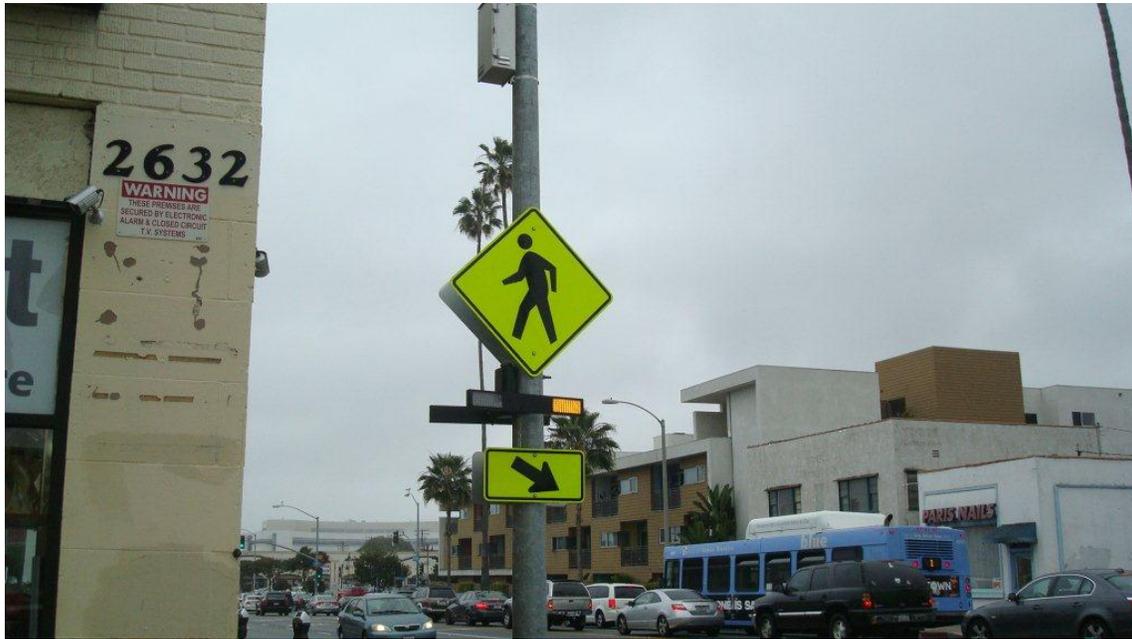
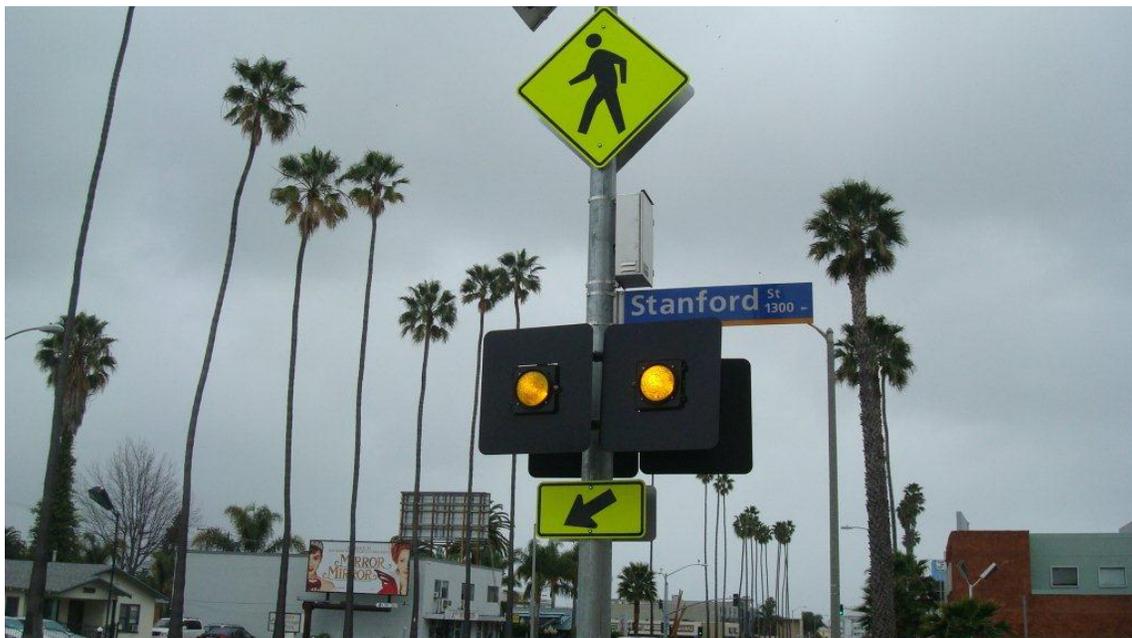
The photos below show the flashing beacon systems as installed. The first photo shows the RRFB at the intersection of Santa Monica Boulevard/Princeton Street, while the second photo shows the CRFB at the intersection of Santa Monica Boulevard/Stanford Street.
