**Final Report  
FHWA Item 4(09)-8(E)  
Circular Rapid Flashing Beacons – Santa Monica, CA  
April 24, 2013**

The City of Santa Monica was granted permission by the California Traffic Control Devices Committee (CTCDC) to experiment with both a Rectangular Rapid Flashing Beacon (RRFB) device and a Circular Rapid Flashing Beacon (CRFB) in March 2011. The experiment with the CRFB was also approved by the Federal Highway Administration (FHWA) on March 11, 2011. Pursuant to the original requests for experimentation, the City is providing this progress report documenting the performance of both devices.

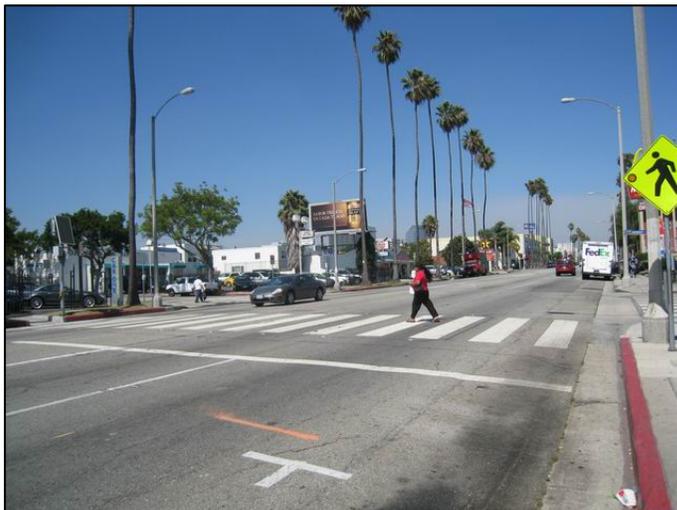
#### *Santa Monica Boulevard/Princeton Street*

The Santa Monica Boulevard/Princeton Street test site consists of a marked crosswalk on Santa Monica Boulevard across the uncontrolled eastern leg of the intersection. Santa Monica Boulevard is a Principal Arterial. Stop controls are provided on Princeton Street, the minor side street approaches to Santa Monica Boulevard. The

intersection is offset, with the segment of Princeton Street south of Santa Monica Boulevard located approximately 30 feet west of the segment to the north.

*Crossing Enhancements* – A high visibility “continental” pattern crosswalk is marked across Santa Monica Boulevard. There are advance “Ped Xing” pavement markings to the east and west of the crossing as well as advance stop bars on both approaches to the crosswalk. On the eastbound approach, the stop bar is located approximately ten feet from the crosswalk. On the westbound approach, due to the offset configuration of the intersection, the stop bar is located approximately 65 feet from the crosswalk. Overhead street lights located on each side of the crosswalk, provide illumination of the crossing at night.

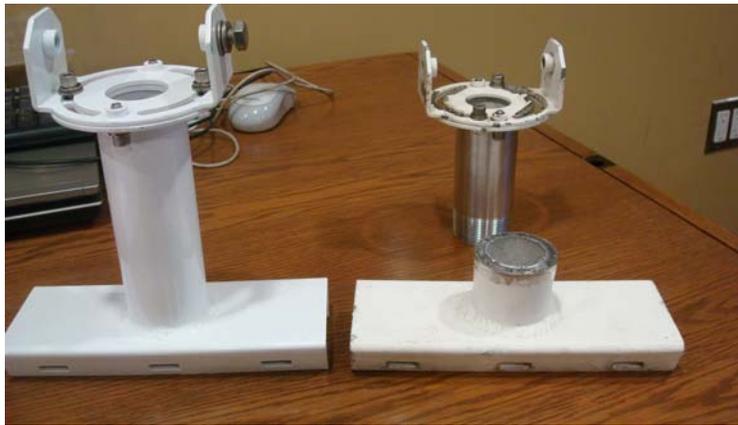
The City of Santa Monica made many after-market modifications to the RRFB device as provided by the manufacturer. The RRFB housings were initially designed to be attached to a pole directly. City staff created modified mounts for the housing using video detection equipment mounts.

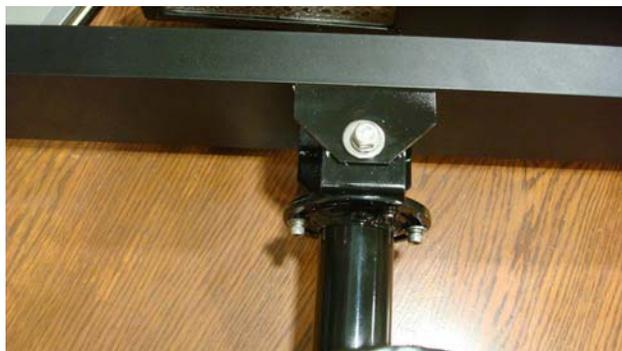
The modified mounts are affixed to a standard terminal block, and allow the RRFB housings to be angled towards or away from the roadway, and rotated from top to bottom.

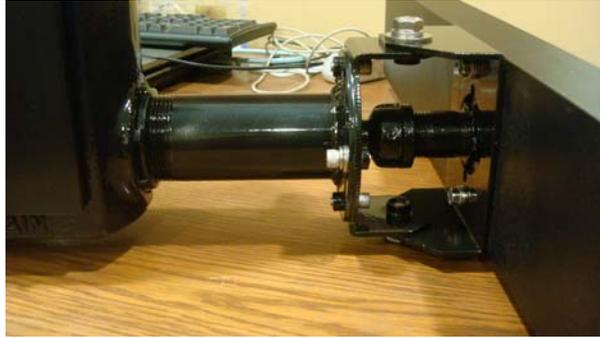
Here is another view of the RRFB housing mounts, showing the adjustable angle of the RRFB. This mounting ensures that once the RRFB is affixed to the pole, the RRFB housing can be angled to point directly at the path of travel of oncoming vehicles.

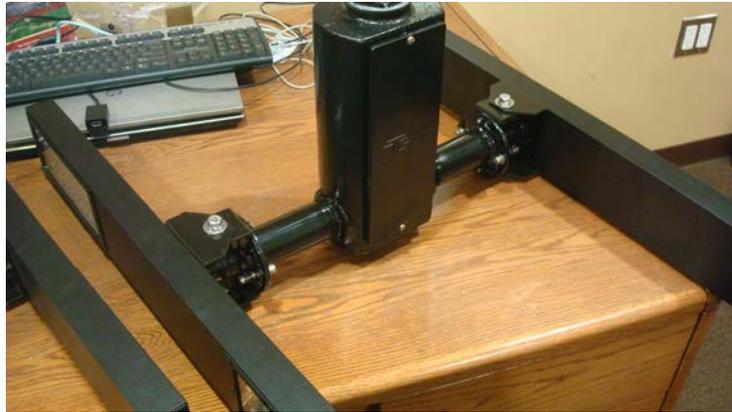
Below is an image of the finished modification, with the terminal block holding two RRFB housings, to face each direction of oncoming traffic.

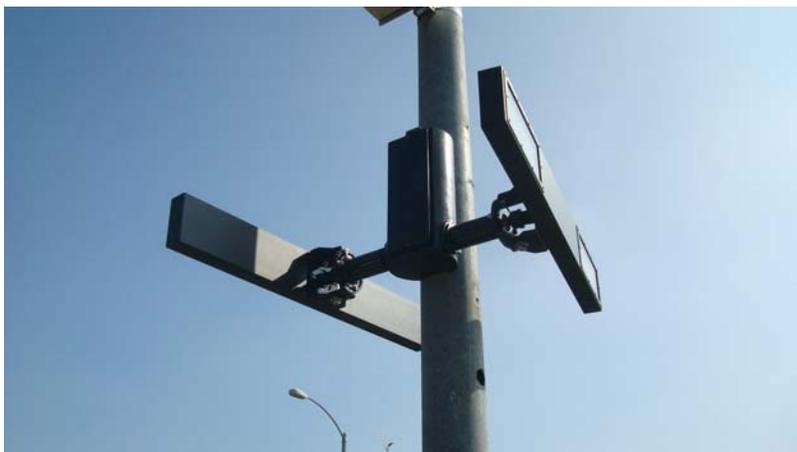
Last is an image of the finished devices mounted to a pole. Once mounted, the fully adjustable mounting allowed for optimal adjustment to aim the flashing beacons at oncoming traffic.

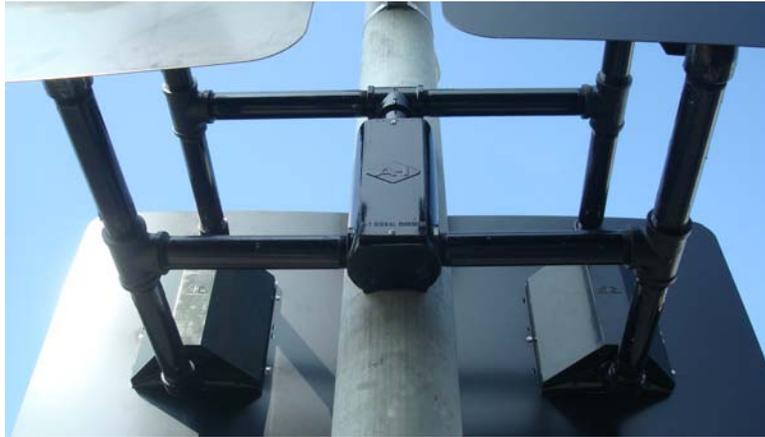
Similar modifications were made to the CRFB device. Each of the circular indications was mounted on standard traffic signal installation housings, and attached to the pole via a terminal block.

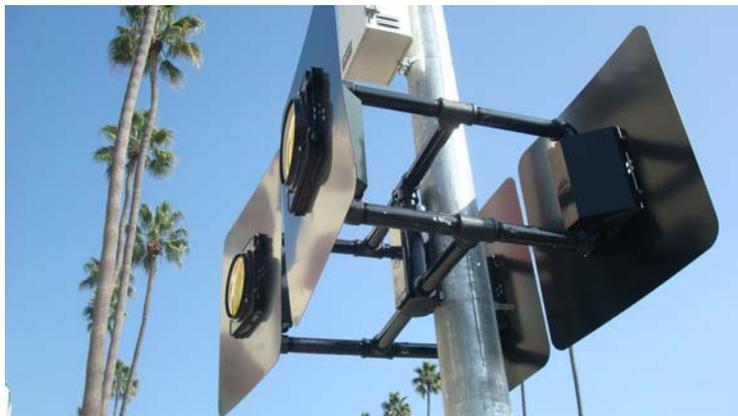
The modifications allowed each of the circular indications of the CRFB to be directed towards oncoming traffic.

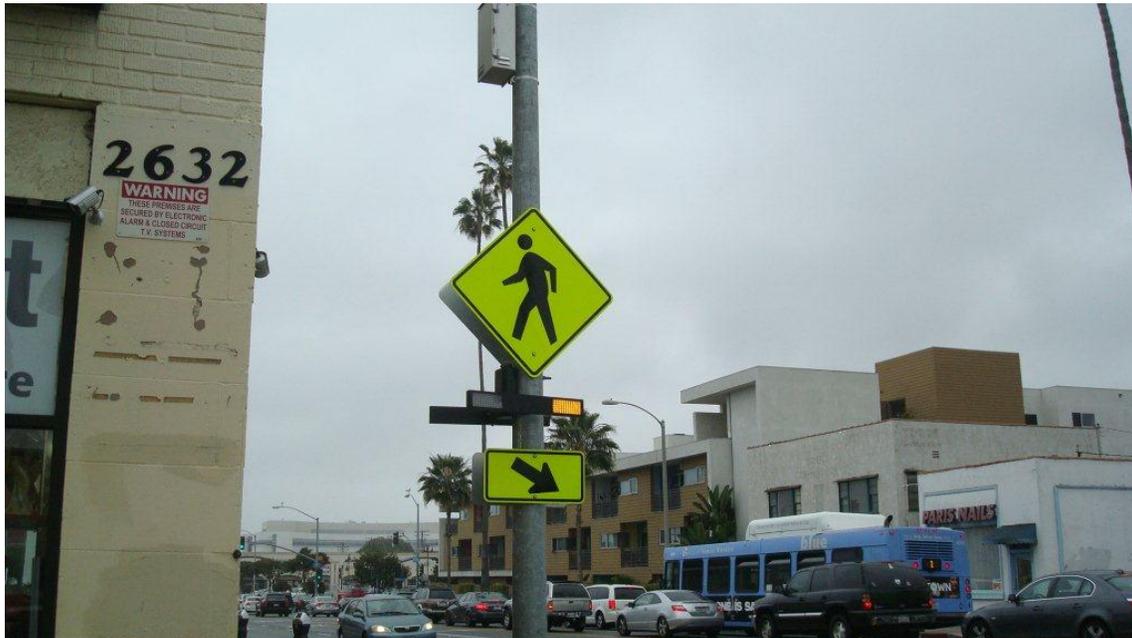
The photos below show the flashing beacon systems as installed. The first photo shows the RRFB at the intersection of Santa Monica Boulevard/Princeton Street, while the second photo shows the CRFB at the intersection of Santa Monica Boulevard/Stanford Street.

In May 2012 the locations of the two devices were swapped, with the RRFB moved to Santa Monica Boulevard/Stanford Street and the CRFB moved to Santa Monica Boulevard/Princeton Street.

In November 2012 the locations of the two devices were again swapped, with the RRFB moved back to Santa Monica Boulevard/Princeton Street and the CRFB moved back to Santa Monica Boulevard/Stanford Street. At this time the back plates on the CRFB were removed and back plates were added to the RRFB.
