Yellow LED Border on Pedestrian Signal

An Evaluation to Determine the Effectiveness of Adding an Actuated Yellow LED Border to Standard Pedestrian Signals in the City of Redding, CA.

FHWA Experiment: 4(09)-13 (E) Yellow LED Border on Ped Signal – Caltrans

Prepared by:
Robert Stinger, P.E.
California Department of Transportation
District 2 – Traffic Engineering & Operations

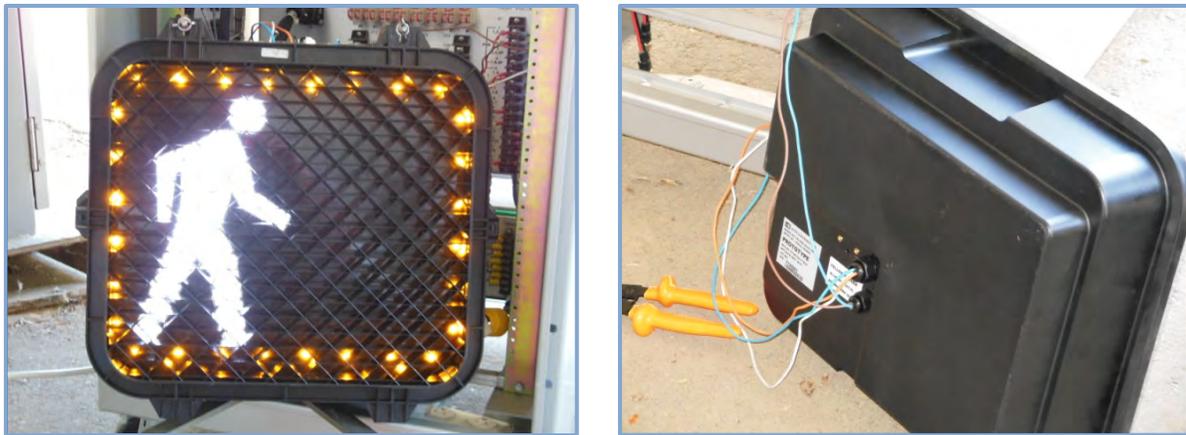
Leotek Electronics fabricated the first prototype pedestrian signal module by supplementing a standard pedestrian signal module with a ring of yellow LEDs positioned just inside the front edge. The individual LEDs were evenly spaced approximately 2 inches apart. Since no changes were made to the other components of the module, the yellow LEDs were positioned very close to the upraised hand and walking person symbols. This was determined to be acceptable for evaluating the concept because the yellow border does not impact the visibility of these symbols. However, should the YPB feature be approved for large scale production at some point the future, it would be advisable to reposition the upraised hand and walking person symbols within the module to provide more space for the yellow border.

Figure 1 – Original prototype module manufactured by Leotek Electronics USA Corp.

Two conductors were provided for activating the border lights. The wires extend out of the back of the module and can be connected to spare conductors at the signal poles for each location. This allows the YPB to be activated directly by the signal controller during the evaluation period. Ultimately, additional engineering will be required by manufacturers to develop a smart control and regulation mode to operate the YPB system from within the module. This would eliminate the need for the extra connections at the signal poles.

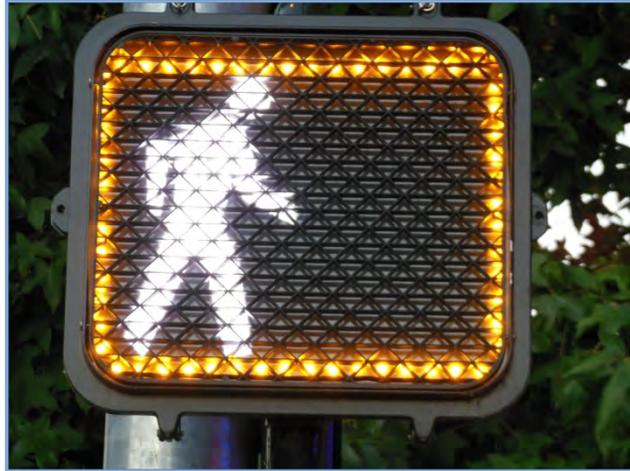
Figure 2 – Final prototype module with 1-inch LED spacing.

The process required to obtain the 16 prototype modules turned out to be a significant delay to the project. The procurement process began in August 2012 and the first modules finally arrived near the end of March 2013, nearly 8 months later.

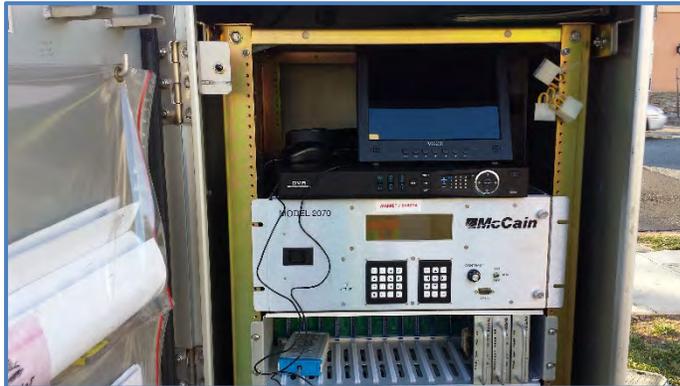
Figure 3 – DVR and monitor placed in signal controller cabinet at Location 4.

During data collection, each location was observed in the before and after condition using digital video recording equipment. Video data was recorded for seven consecutive days, 24-hours per day. As much as possible, each recording period was completed during fair weather conditions to capture the greatest amount of pedestrian activity. Also, because Location 1 is near two schools, the before/after data was collected while the schools were in session.

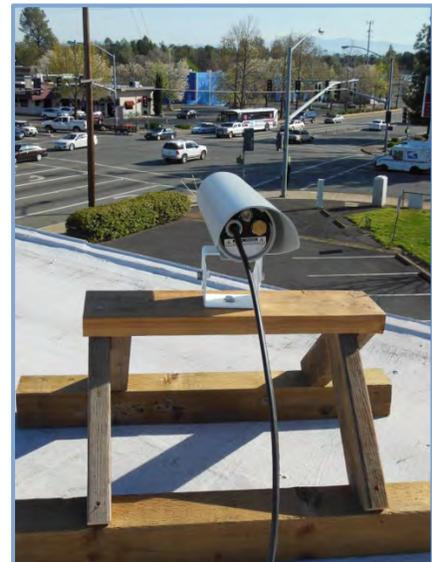
Figure 4 – Camera placement on Redding Fire Station 5.

A camera and DVR were placed on the roof of Redding Fire Station 5 near the southwest corner of the intersection. The placement of the camera offered a full view of all four crosswalks. However, due to the distance and location of the pushbuttons, observing repeated button pushes was very limited in the northeast and southeast corners of the intersection. Therefore, the results for repeated button pushes were primarily observed from the other two corners of the intersection.

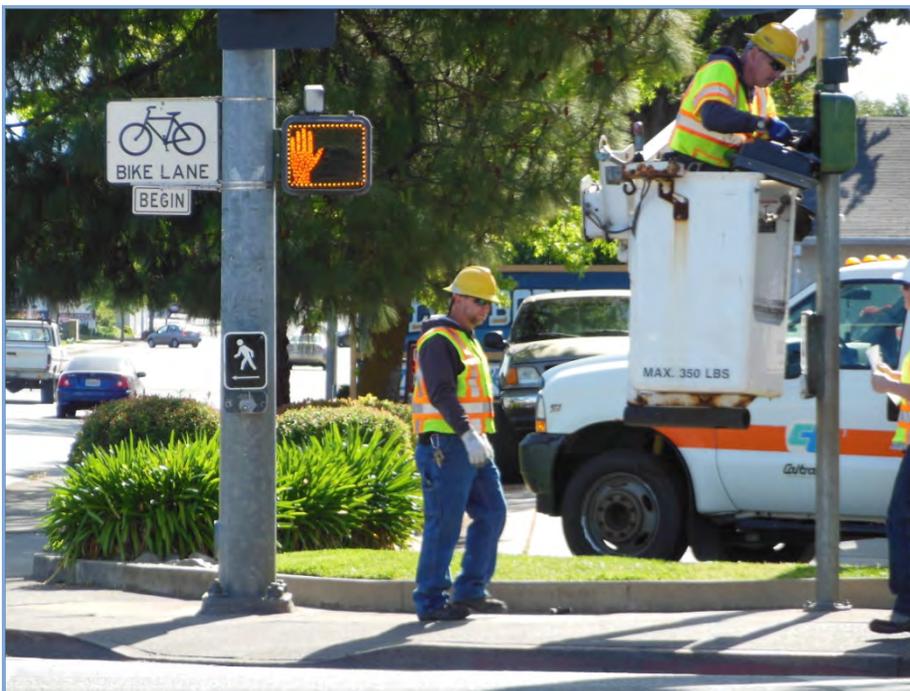
Figure 5 – Caltrans Maintenance Electrical Employees installing the YPB modules at Location 1.

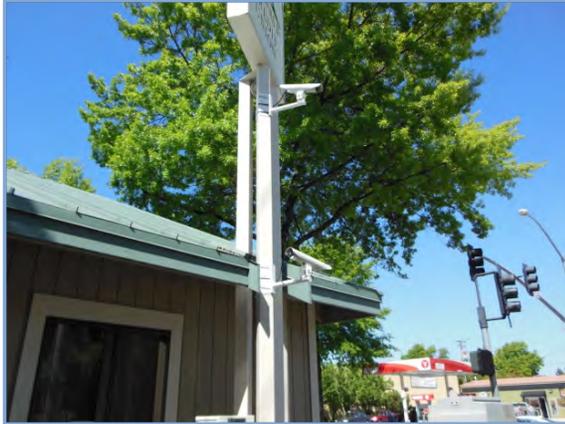
Figure 6 – Cameras placed on business sign post.

Two cameras were placed at the northwest corner of the intersection to collect video data for the two crosswalks. The cameras were mounted on a sign post for the credit union building located at the corner of the intersection. The power source and storage for the DVR was provided by the

signal controller cabinet located in the same corner of the intersection. The cameras provided excellent visibility of the two crosswalks and most of the pushbuttons. The only exception was the view of the pushbutton in the northwest corner of the intersection that is used by pedestrians heading south across Shasta Street. This part of the intersection was too close to the camera facing to the south to be included in the view.

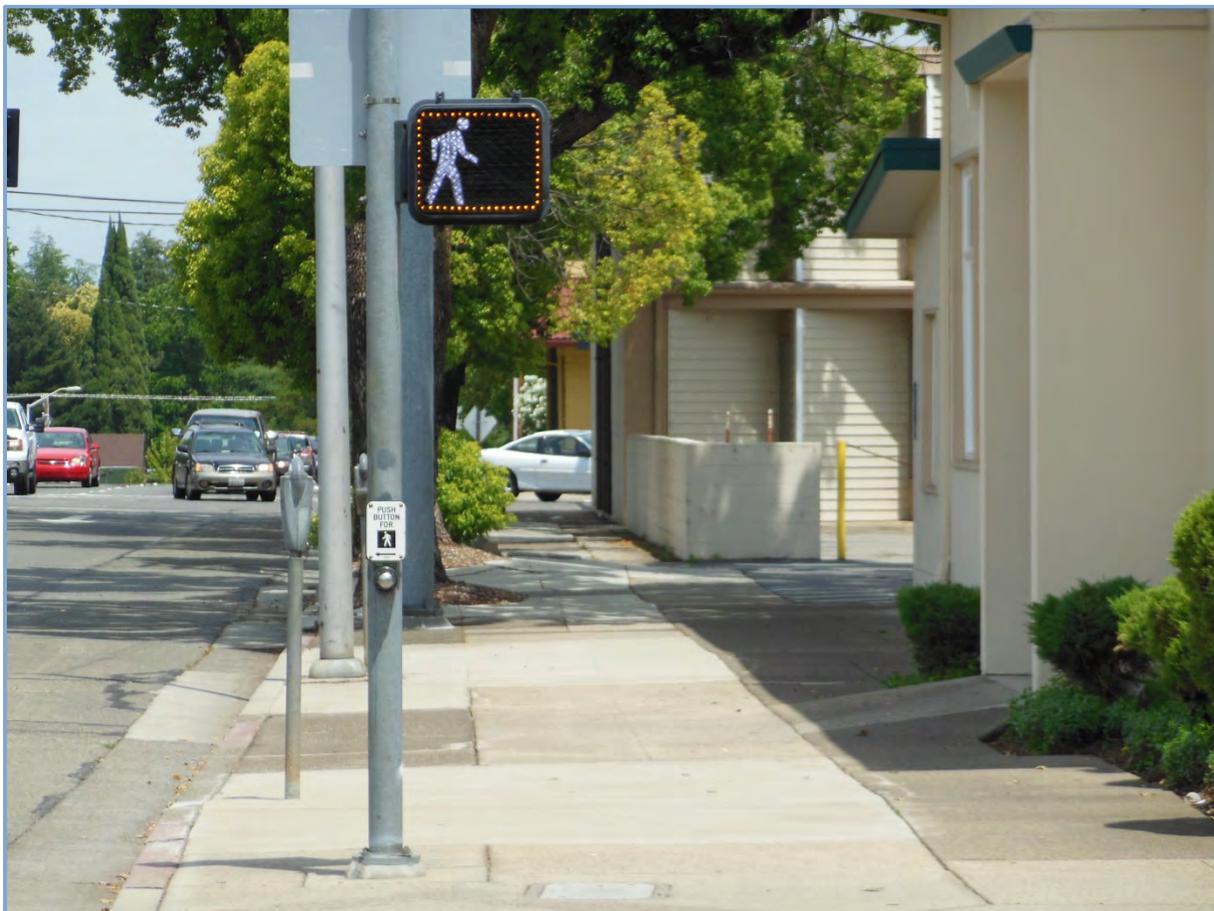
Figure 7 – YPB signal in the southeast corner of Location 2, looking east.

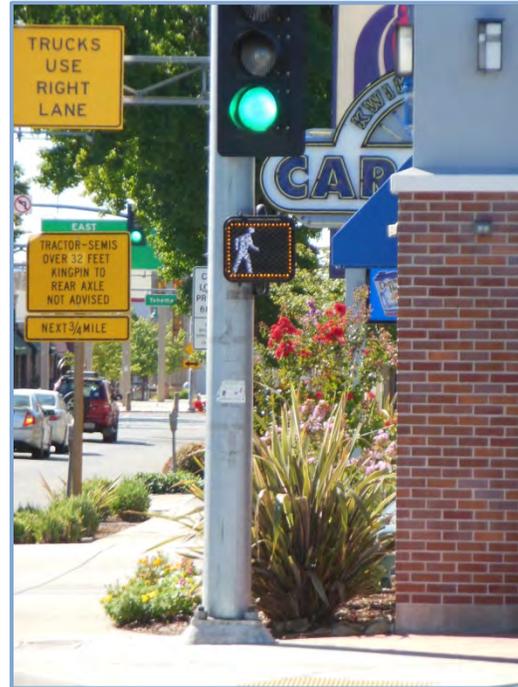
Figure 8 – YPB signal in the southwest corner of Location 3, facing south.

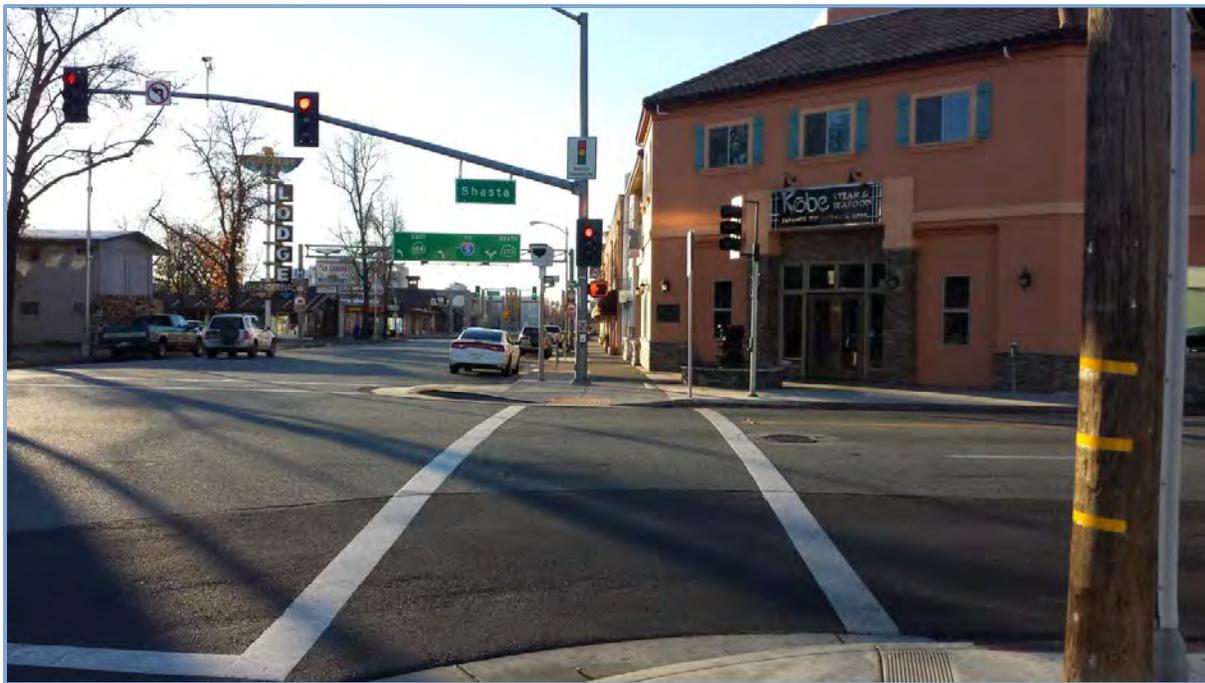
Figure 9 – Looking at the southwest corner of Location 4.

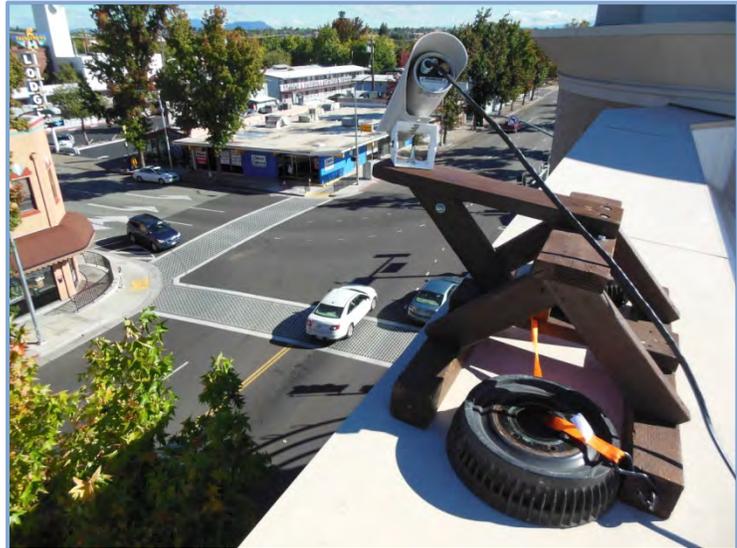
Figure 10 – Camera placement on the 2-story Downtown Health Sciences Building for Shasta College.

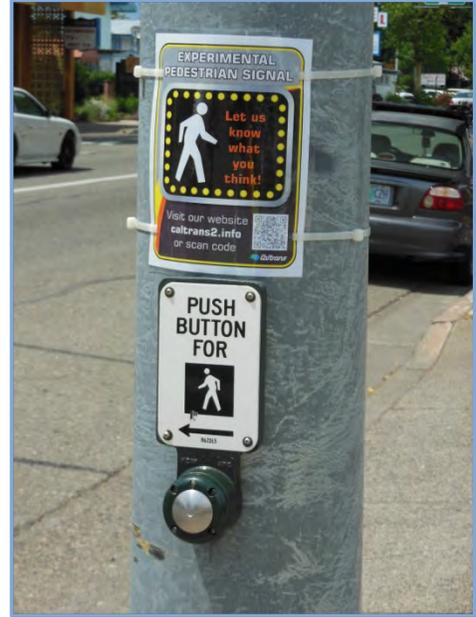
Figure 10 – Laminated flyer strapped to signal pole at Location 2.

As discussed earlier in this report, flyers were posted at each location to notify pedestrians of the experiment and to provide them with an opportunity to take an online survey. The response to the survey was fairly small given the amount of time the flyers were in place at the five locations. In total, 15 people responded to the survey and only seven provided written comments after rating the five questions.

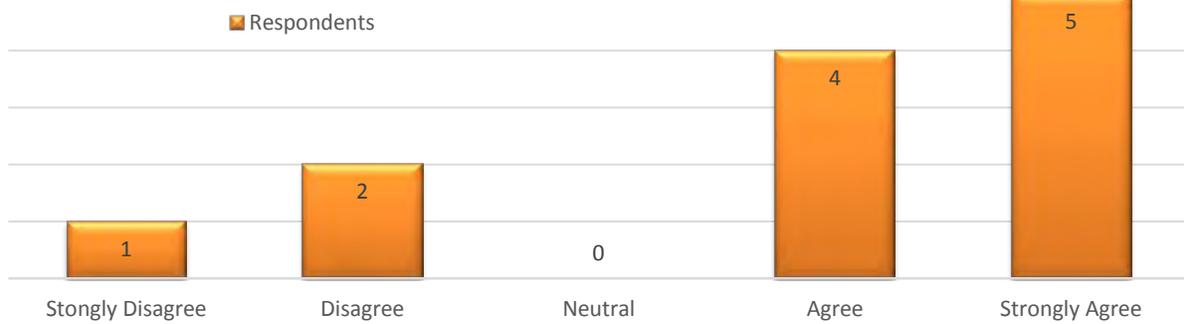
Q2: The yellow lights are effective in confirming that the pushbutton worked and that the walk symbol is coming on soon.

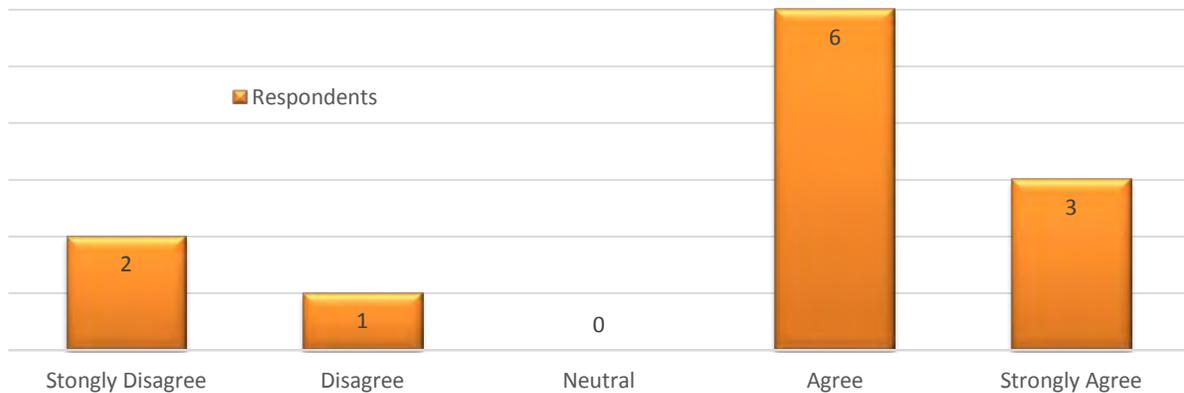
Q3: The purpose of the yellow border lights is easy to understand.

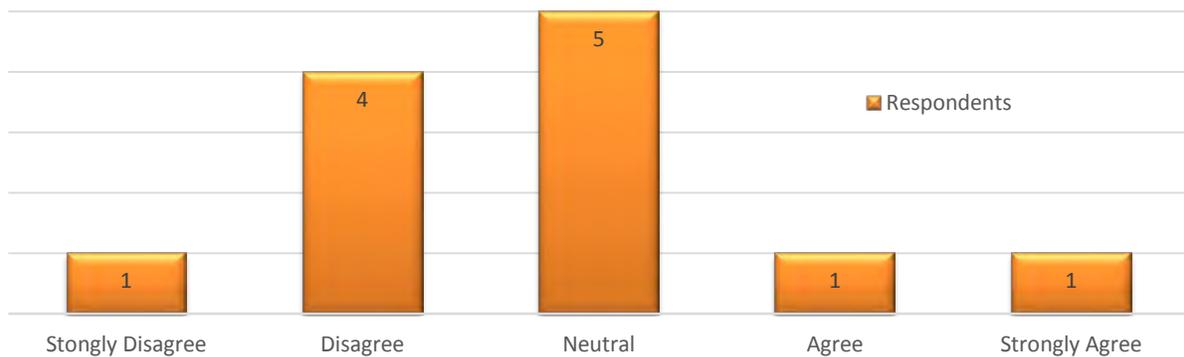
Q4: Cars notice the yellow border lights and drive more cautiously when pedestrians are crossing.
