RECENT EXPERIMENTAL PCC PAVEMENTS IN CALIFORNIA

INTERIM REPORT

CA-HY-MR-5180-1-73-01

Prepared in Cooperation with the U.S. Department of Transportation, Federal Highway Administration June, 1973

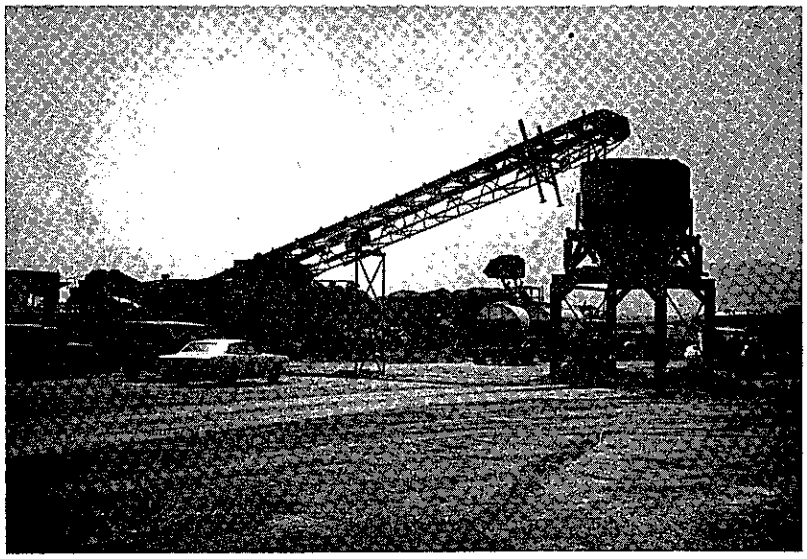
Figure 9

The Contractor, Gordon H. Ball, Inc., at his option, elected to use plant-mixed CTB in lieu of road-mixed CTB. An automatic batch plant was erected near the jobsite and used for mixing. The CTB was hauled to the roadway in bottom dump trucks and spread and brought to grade by a slipform paver. Line and grade control was provided by guide wires and electronic devices. Some compaction was obtained with a vibratory screed attached to the paver. Final compaction was achieved with a vibratory steel wheel roller, followed by a pneumatic tired roller. (See Figures 9, 10, and 11.) With this procedure, no trimming or excessive manipulation of the CTB

Plant

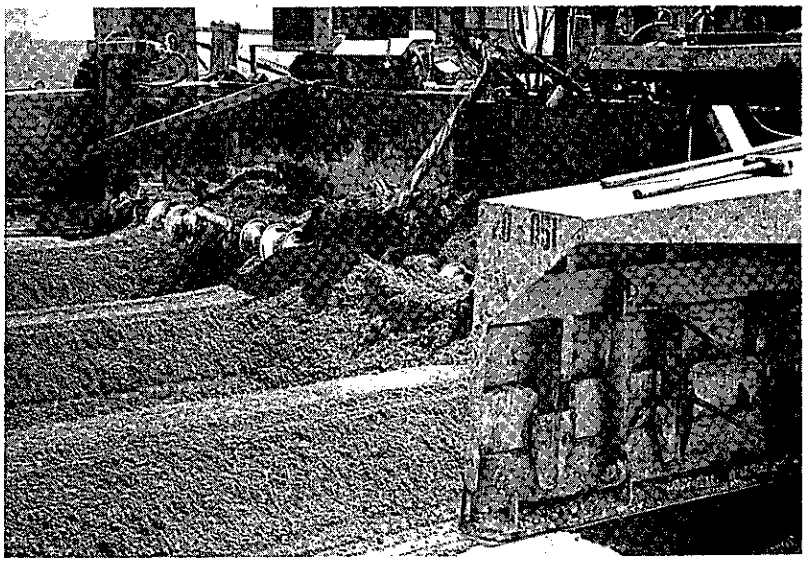
Figure 10

In windrows
at paver

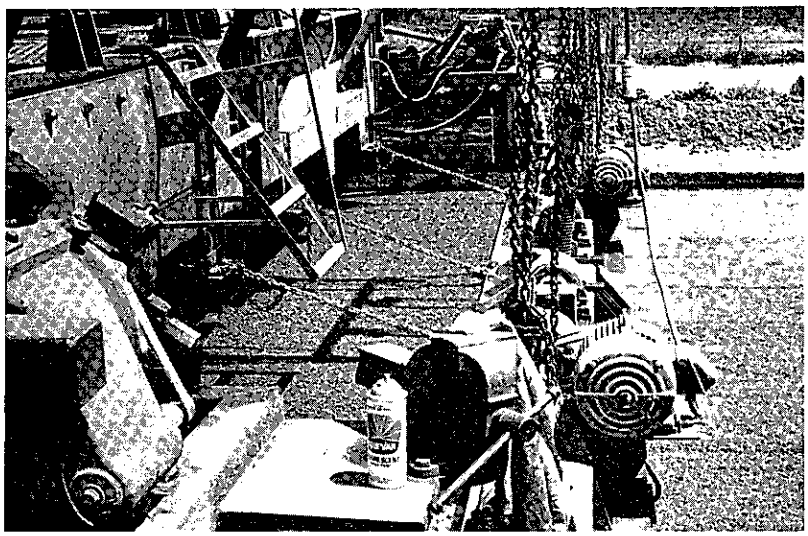
Figure 11

Behind paver

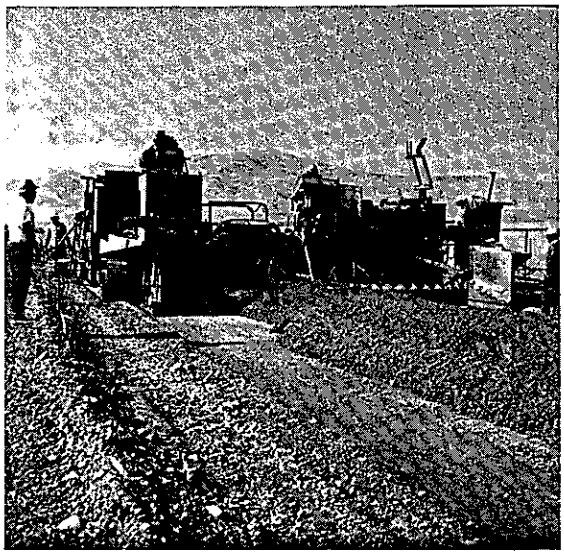
The lean concrete base in Experimental Section 5 was produced in a concrete batch plant and placed with a slipform paver. (See Figures 12, 13, and 14.) A nylon broom towed behind the paver added some texture. Few problems developed with this base operation. In a few locations, hand finishing had to be employed to remove irregularities, and occasionally shrinkage cracks occurred (see Figure 15). These were probably due to a combination of factors, such as excessive working of the surface, rapid drying conditions, and loss of water to the untreated subbase. The cracks are not considered to be harmful to the LCB surface durability.

Figure 12 In front of paver.

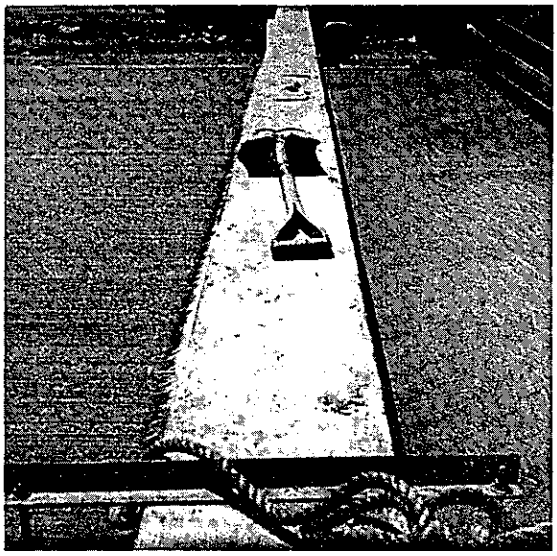
Figure 13 After paver.

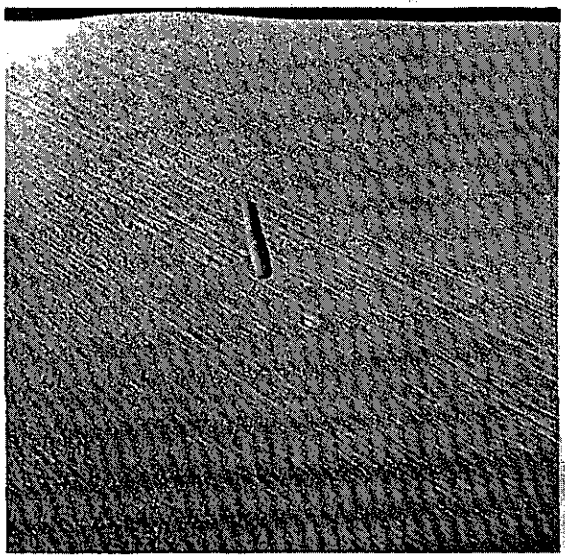
Figure 14 Texture.

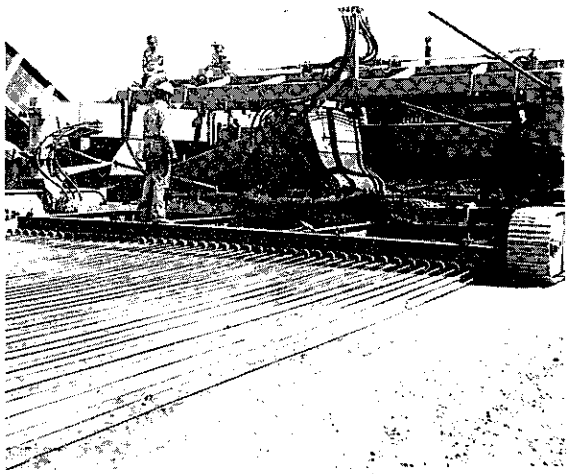
Figure 17

Paving started in the section with longitudinal steel only (no transverse steel). (See Figures 16, 17, and 18). The bars were placed on the base in approximate final location and the 20-inch laps were tied at staggered intervals across the roadbed. Pushed along on skids in the front of the placer-spreader was a frame holding forty-four 2-1/4-inch diameter metal tubes with flared ends. Bars were fed through the tubes for proper positioning in the fresh concrete. Occasionally a lap splice would catch on a metal tube resulting in a brief paving delay while a bent rebar was replaced. A few minor problems arose in the use of side delivery equipment for the concrete, but these were gradually overcome. Considerable difficulty was experienced in adjusting the metal tubes to obtain proper placement of the rebars in the concrete. Much of this section has steel well below the planned depth.

Going through tubes
at Placer-Spreader

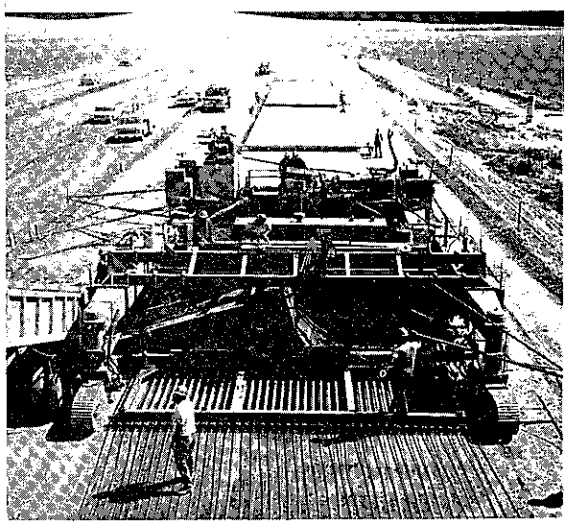
Figure 18

Paving train

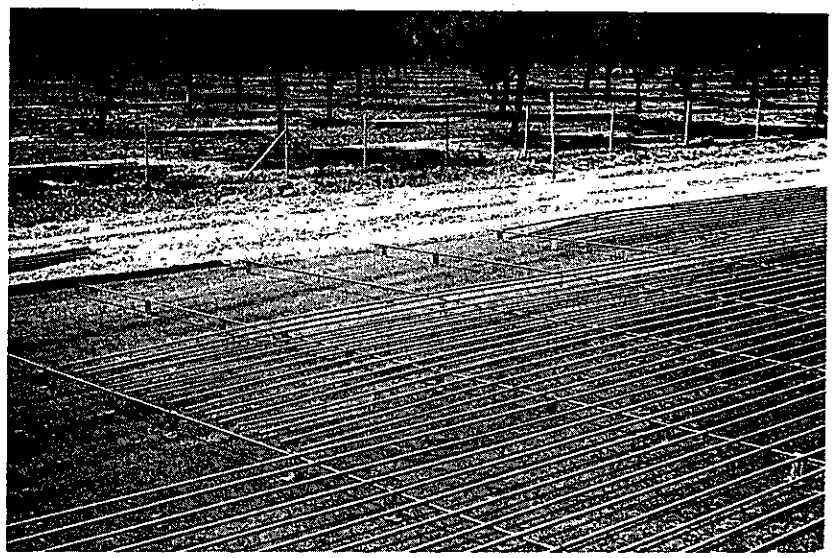
Where transverse bars were used, they were clipped to metal chairs and spaced at 60-inch intervals. Longitudinal bars were then placed on top at the proper spacing and tied to the transverse steel (see Figures 19, 20, and 21). The staggered longitudinal laps were also tied except at intervals of about 1500 feet where laps were left untied until just before paving

Figure 19 Placing on chairs

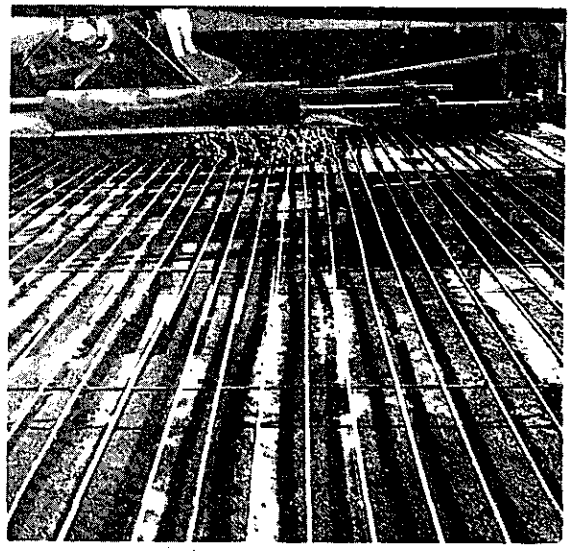
Figure 21 Placer-Spreader

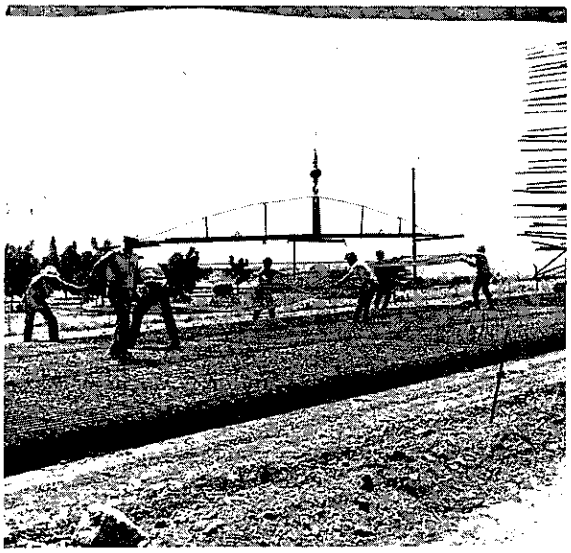
Figure 24

The welded wire fabric was prefabricated into 40-ft. long mats. Three mats were used for the 24-ft. pavement width, one of which was 7'-10" wide and two were 8'-9" wide. Concrete was deposited directly on the base and brought to approximate grade by the placer-spreader machine. The mats were then placed on the fresh concrete by a crane and laps (16-inch longitudinal and 8-inch transverse) tied by iron workers. The longitudinal laps were staggered about 4 feet across the roadway (see Figures 22, 23, 24, and 25). A mesh depressor attached to the front of the slipform paver forced the fabric into the concrete to the proper depth with vibrating vertical baffles (see Figure 26). The depressor rode on pneumatic tires and had a hydraulic system to control the height of the baffles. It was noted during construction that occasionally the depressor caught on mats breaking splices and bending the steel. This created delays while the mats were replaced and retied. As described later, several failures occurred at lap splices.

Mats placed onto concrete

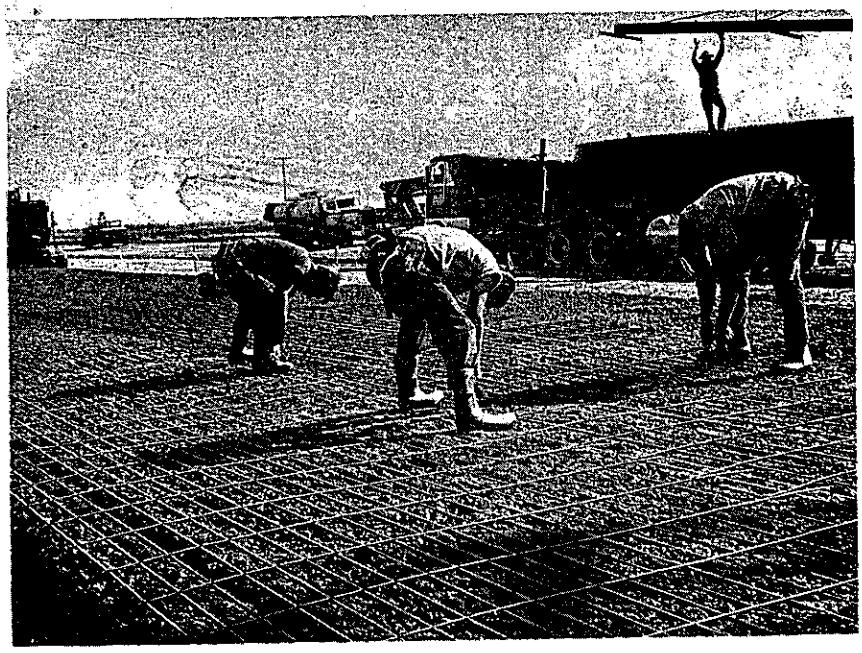
Figure 25

Laps being tied

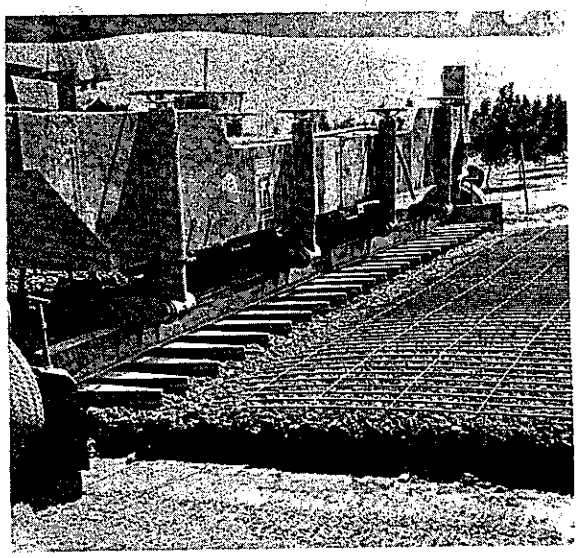
Figure 26

Mats being depressed into concrete

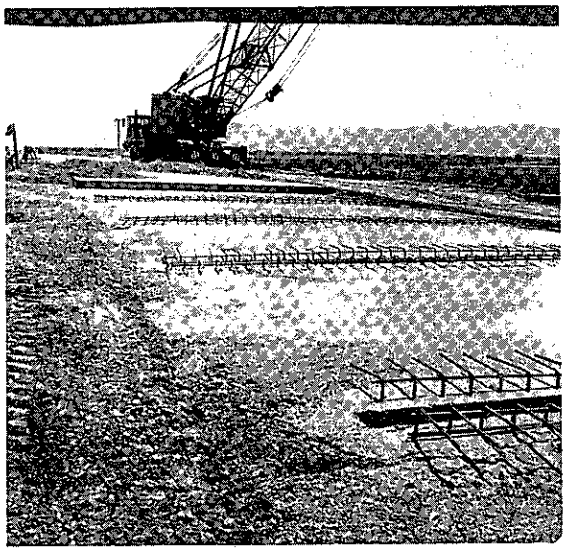
Figure 27

A series of lug type terminal anchors were designed for use before each bridge approach in the CRCP sections. The lugs were intended to restrain the movements of the slab ends to approximately the same degree that the major portion of the pavement is restrained, and prevent excessive pressure on structure abutments due to thermal expansion[16] and the growth phenomenon[4]. A lug series consisted of five 3-ft. deep by 2-ft. wide trenches excavated across the CTB 17 feet apart beginning 16 feet from the bridge approach slab. The lugs were reinforced with stirrups and continuous bars. One group of lugs was filled with concrete prior to paving (these were made with a key formed on top), and the rest were filled with concrete during the paving operation (see Figures 27 and 28).

Lug type terminal anchor

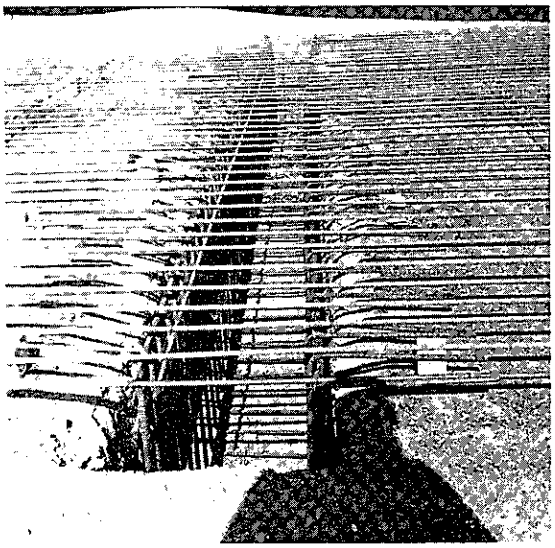
Figure 28

Reinforcement for terminal anchor lug

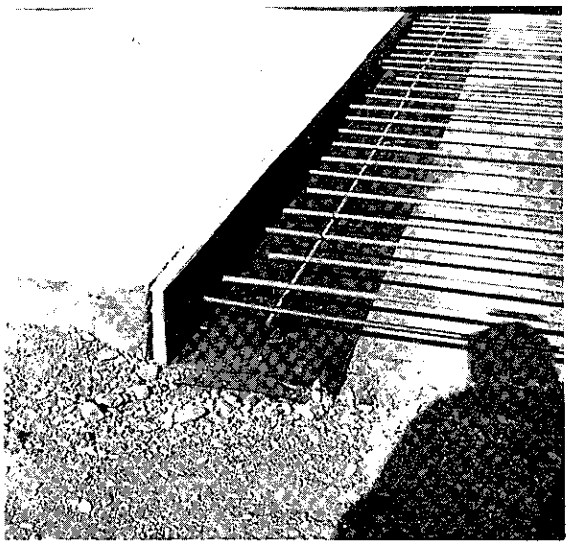
Figure 29

The end of the CRCP where it reaches the bridge approach slab rests upon half of a 2'-3" wide sleeper slab. Between the pavement slab and sleeper slab are two layers of 30-lb. roofing felt with graphite between them. The sleeper slab extended beneath the bridge approach slab also and was connected to it by reinforcement. A 1-1/4-in. sealed expansion joint was placed between the CRCP and bridge approach slab (see Figure 29). Theoretically, the lugs will restrain most of the longitudinal movement that might occur in the pavement and the 1-1/4-in. expansion joint will be more than adequate to accomodate the movement expected at the free end of the pavement.

End of CRCP reinforcement at bridge approach slab

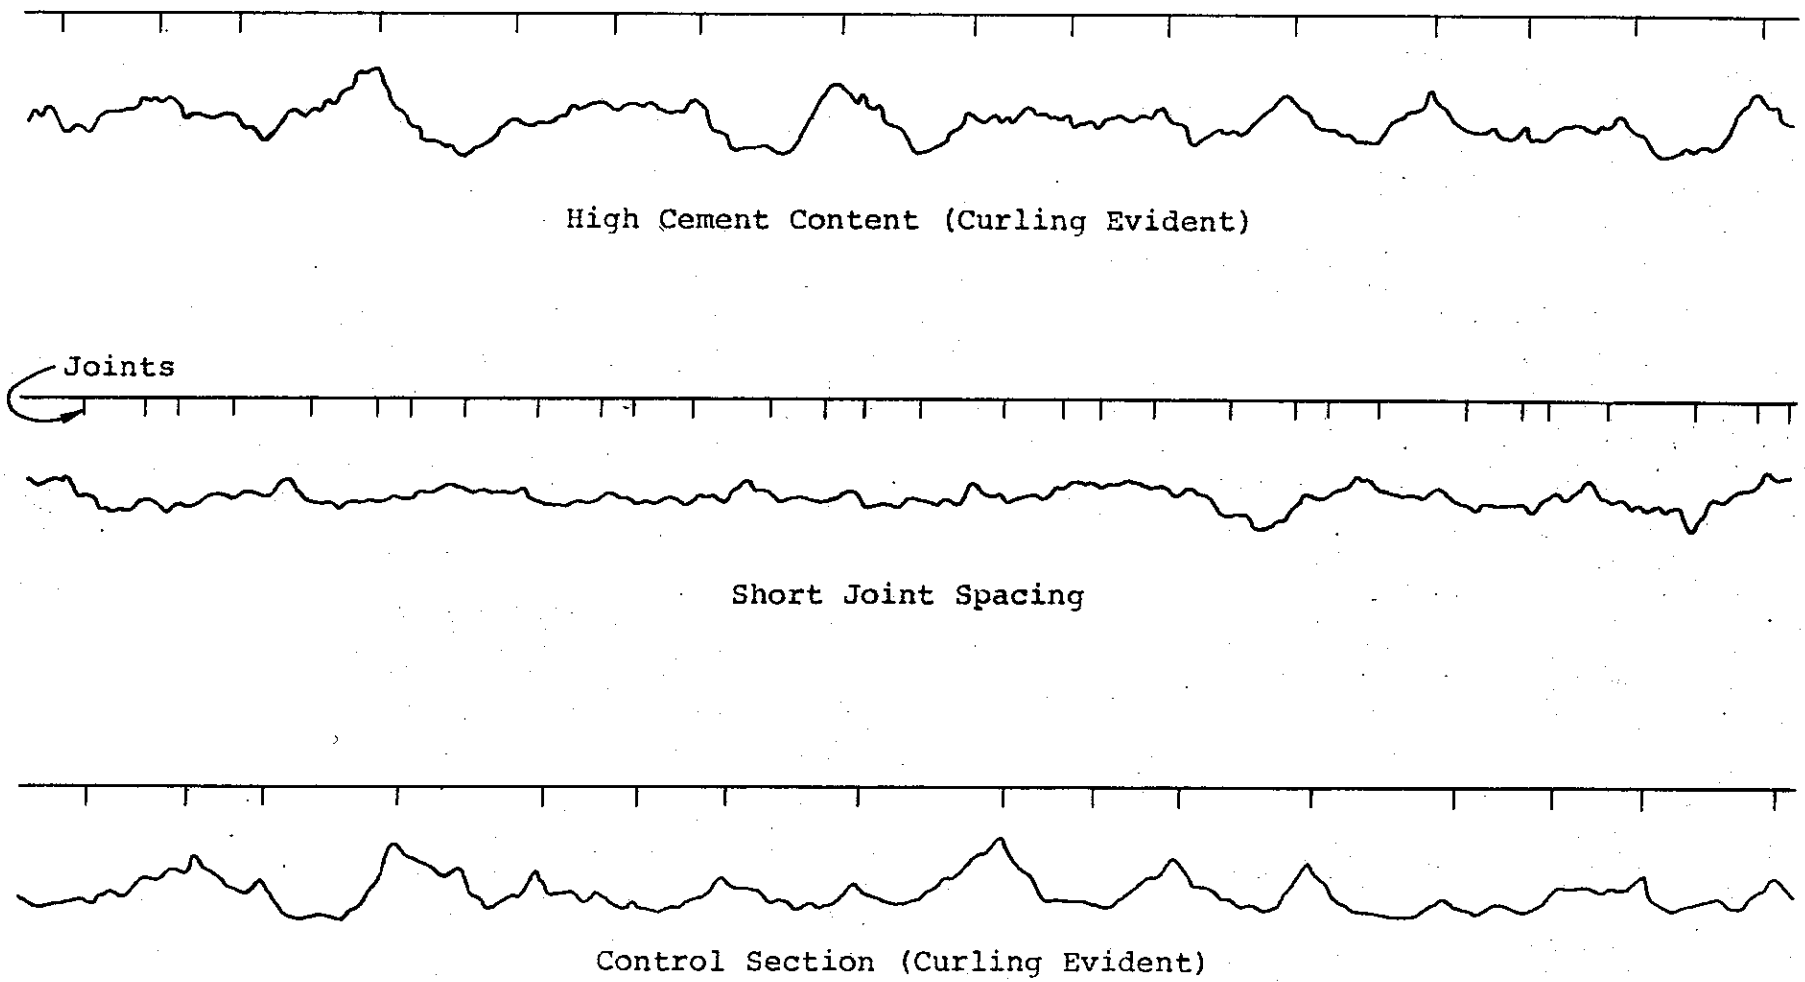
All of the experimental pavements were considered to be relatively smooth at an average age of approximately six months. Profile indices indicate significant increases in roughness of some sections at 16 months, especially in the northbound control section and the pavement with higher cement content. Profilograms show that many slabs in these sections have curled, creating greater roughness. Figure 34 depicts typical profiles of both curled and noncurled pavements.

TYPICAL PROFILOGRAMS (16 MONTHS)
