California Trials With Lean Concrete Base (LCB)

75-37

INTERIM REPORT
CA-DOT-TL-5167-3-75-37
OCTOBER 1975

Caltrans
CALIFORNIA DEPARTMENT OF TRANSPORTATION

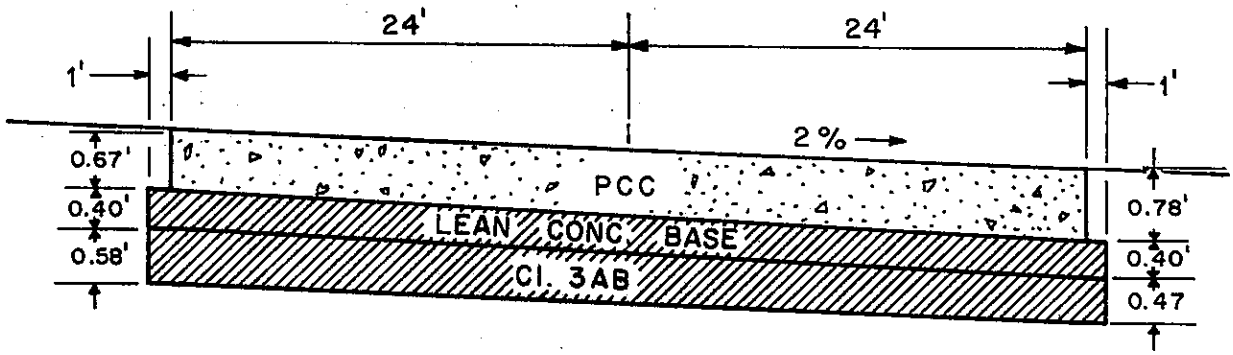
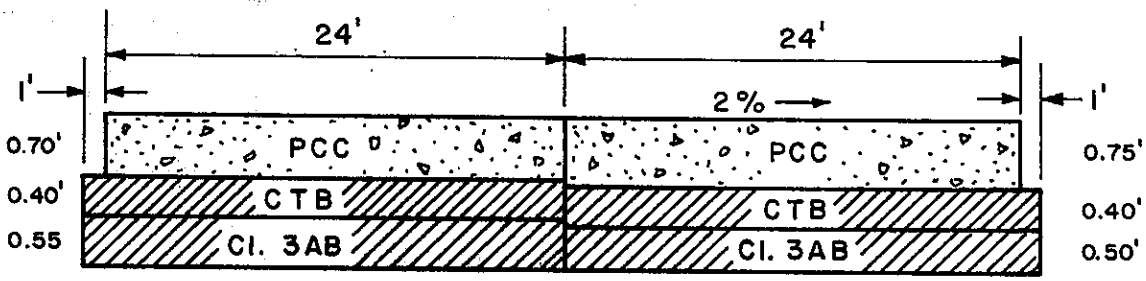
Figure 3

No problems were encountered in the placement or compaction of the CTB. Production was held up or slowed numerous times, however, due to the subgrade pumping and failure requiring repair. As seen in Figure 3, there was only about 6 inches of aggregate base over the embankment material. This latter material had considerable clay in it and was very critical as to optimum moisture content. Due to frequent rains before base placement, too much moisture had soaked into the embankment in some places.

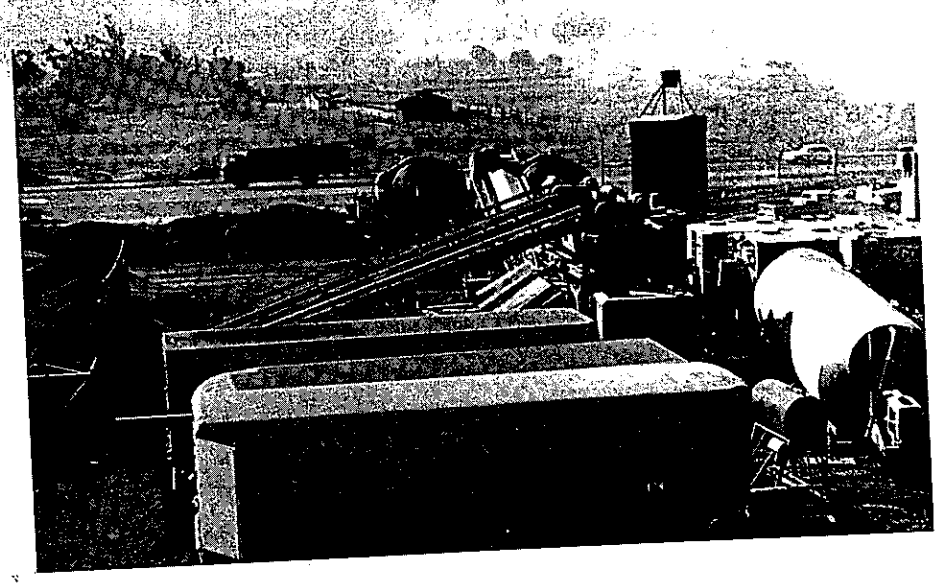
Figure 5
Batching Plant Used for Concrete, LCB and CTB

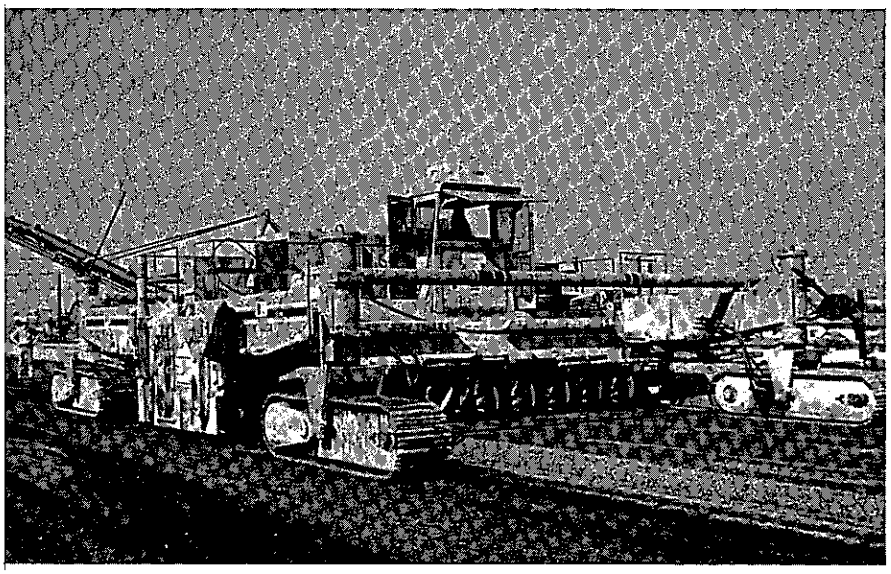
Figure 6
CTB Placing Operation

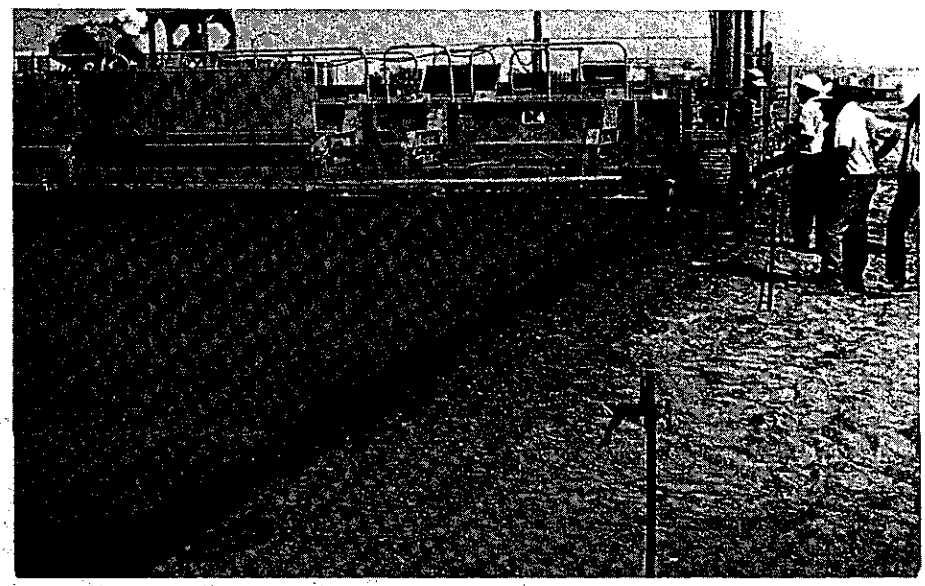
Figure 9
Finished LCB Surface

The finished LCB slab had the appearance of a conventional PCC pavement slab except for lack of surface texture. Occasional minor irregularities from stoppages of the paving machine were left untouched. At two such locations small concentrations of excessively fine or clay-like material were detected. The source of the fines was probably from the raw material stockpile or native soil under the stockpile. It is assumed that the additional vibration from the paving machine at a stopped location tended to concentrate fines at the surface. Concern for this condition was minimal and overall structural integrity appeared to be unaffected.
