| 1 REPORT NO<br>FHWA-CA-TL-5167-77-20 | 2 GOVERNMENT ACCESSION NO | 3 RECIPIENT'S CATALOG NO |
| 4 TITLE AND SUBTITLE<br>FAULTING OF PORTLAND CEMENT<br>CONCRETE PAVEMENTS | | 5 REPORT DATE<br>July 1977 |
| 9 PERFORMING ORGANIZATION NAME AND ADDRESS<br>Office of Transportation Laboratory<br>California Department of Transportation<br>Sacramento, California 95819 | | 10 WORK UNIT NO |

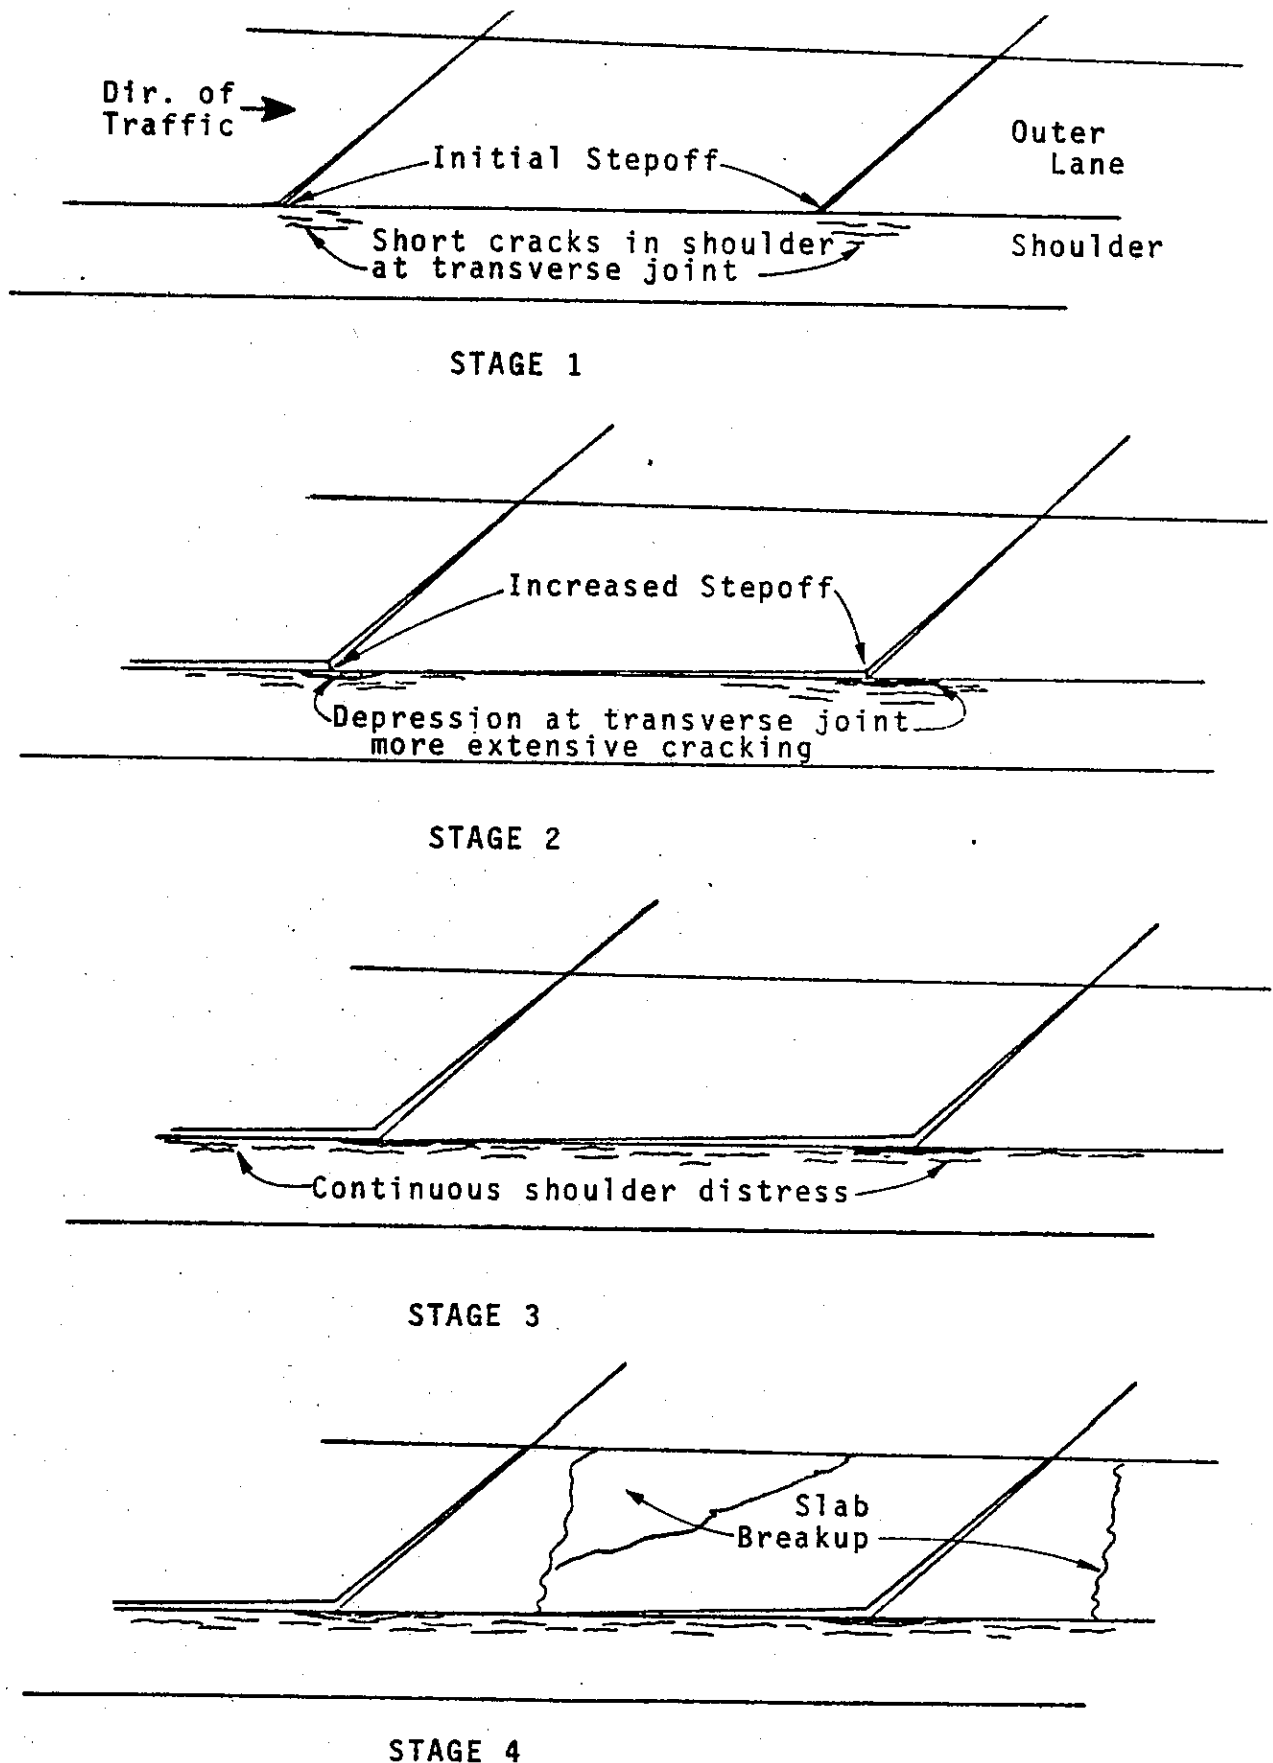
Figure 1

Typical stages in the life of a concrete pavement are shown
in Figure 1. In Stage 1, the initial step-off, say less than
1/16 inch (1.5 mm), is accompanied by shoulder cracking loca-
ted primarily on the down traffic side of the joint. As the
step-off increases in Stage 2, the cracking is extended longi-
tudinally and is accompanied by a shoulder depression in the
vicinity of the joint. It is .at this point that maintenance
of the shoulder becomes necessary. The depressions are filled
with localized patches and the cracks are filled with a hot-
poured sealer. The depression of the shoulder is an indica-
tion that the underlying material is being moved.

In Stage 3, the riding quality of the road is seriously
affected. It may be necessary to grind the pavement, removing
a tapered segment from the slab surface. Shoulder maintenance
may call for a continuous patch one to two feet (0.3 to 0.6 m)
in width.

In Stage 4, the slabs can no longer carry traffic without
breaking up because of the nonuniform support conditions.
While cracks in the concrete may follow a somewhat irregular
pattern, they quite often start on the outside edge of pave-
ment, 5 or 6 feet (1.5 or 1.8 m) down traffic from the joint
and are skewed to the left. Step-off is in the range of 1/8
to 1/4 inch (3 to 6 mm) with occasional joints in excess of
3/8 inch (9 mm). An overlay is necessary at this point to
restore riding quality.

TYPICAL STAGES IN THE LIFE OF A CONCRETE PAVEMENT

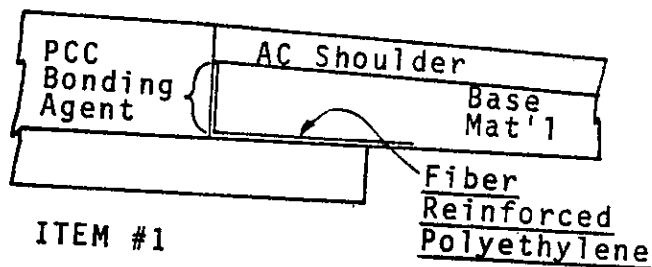
**ITEM #1**

Two foot wide strip is bonded to edge of pavement prior to shoulder construction. Membrane prevents base fines from migrating under pavement slab.

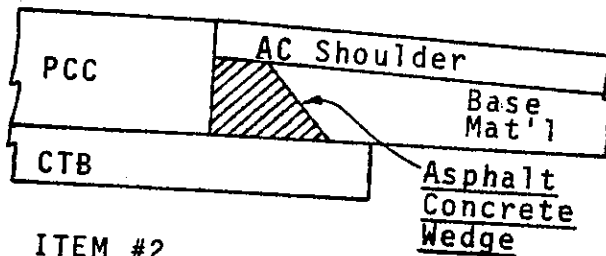
**ITEM #2**

Asphalt concrete wedge provides non-erodible material adjacent to pavement slab. Also provides support to shoulder edge.

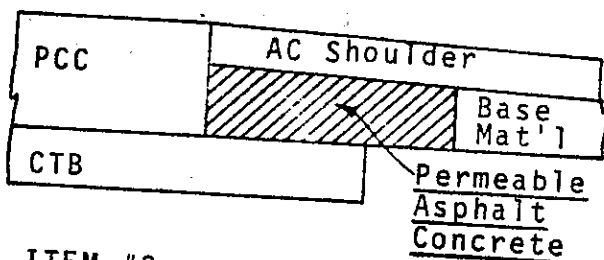
**ITEM #3**

Performs as Item 2, above, used on existing highway in effort to arrest progression of faulting. Permeable material distributes water along shoulder allowing percolation throughout.

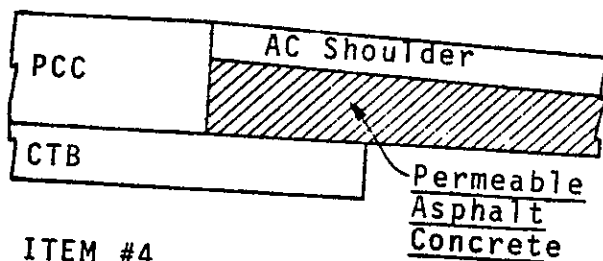
**ITEM #4**

Drains free water from beneath slab and is non-erodible. Water must be allowed to escape at outer shoulder edge.

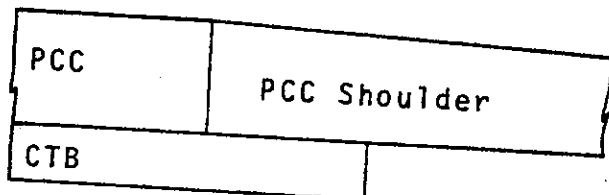
**ITEM #5**

Provides non-erodible shoulder and supplies structural support to outer pavement slab.

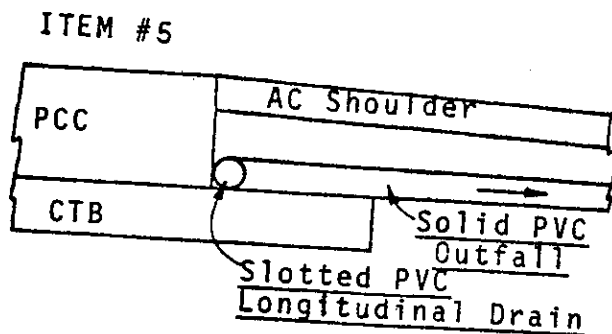
**ITEM #6**

Slotted longitudinal drain collects free water from beneath pavement slab. Water is discharged through outfall lines at appropriate intervals.

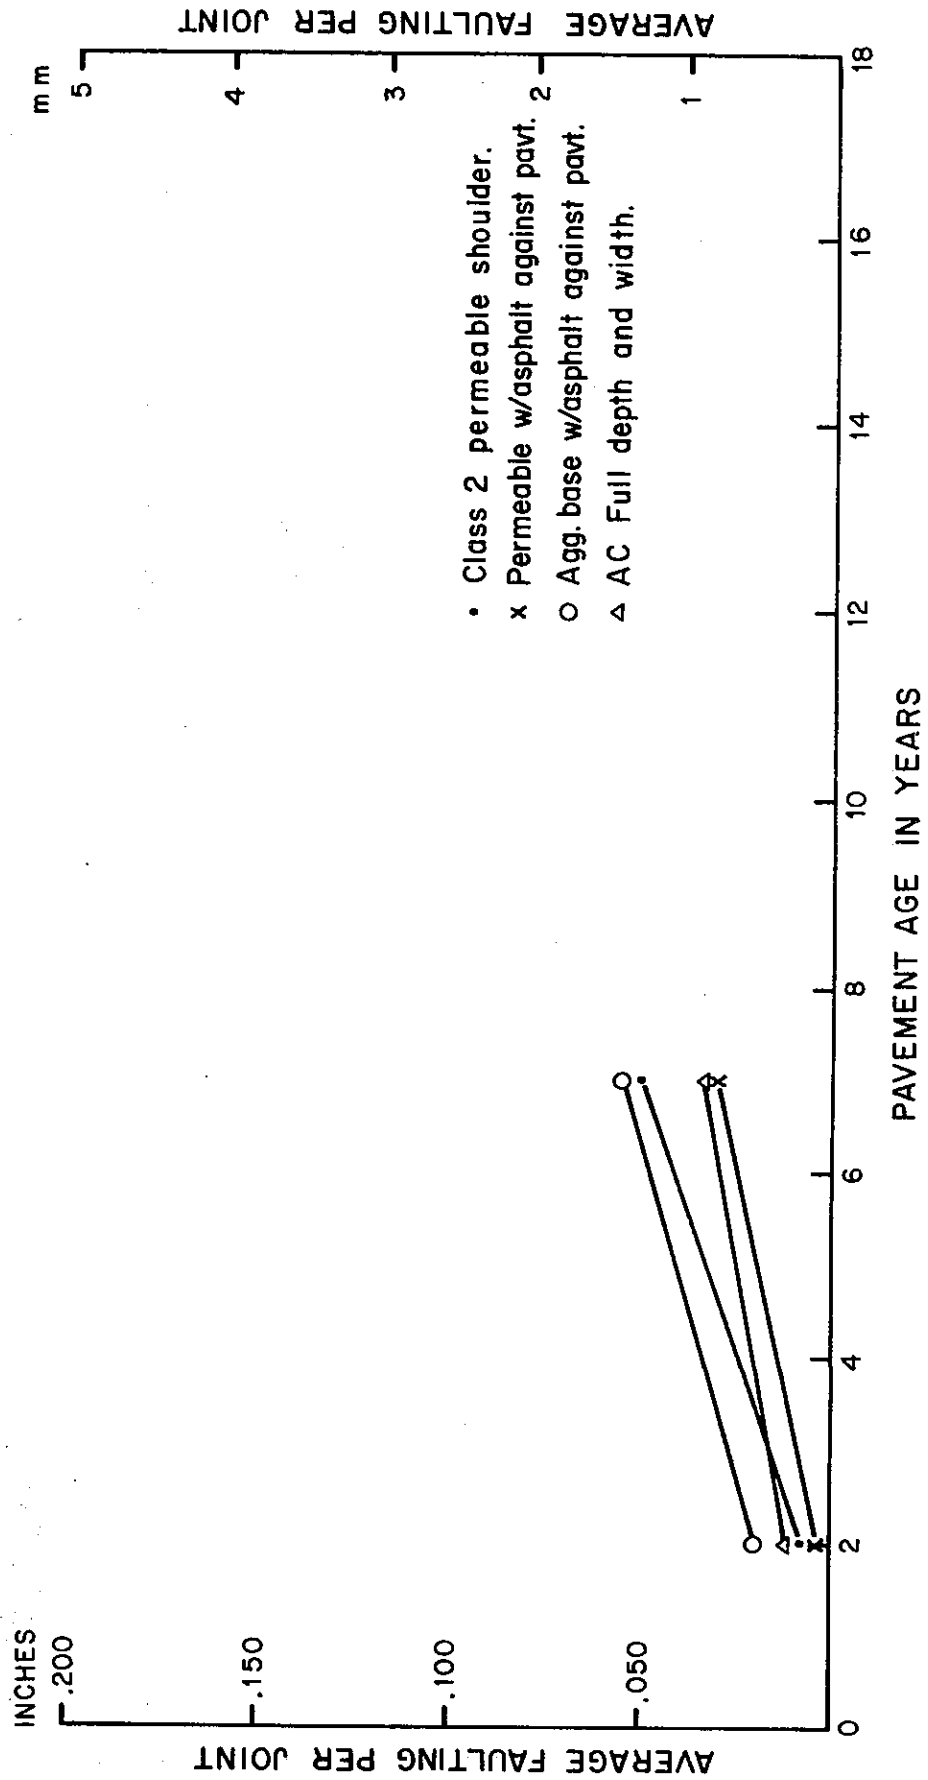
Figure B-23

Figures B-23 and B-24 indicate that short joint spacing may also reduce the rate of increase. These joints were cut at staggered spacing with a total of 4 joints in 31 feet (9.45 m). A loaded truck was run over the pavement at an early age to induce cracking at each weakened plane. Faulting of the shorter slabs tends to be about one half that of normal length slabs, though over a given length of pavement the total amount of faulting would be about the same. And, as determined by measurements across joints, the same is true of longitudinal movements of the slabs in the two different sections. Less

opening of the joints probably means better aggregate inter-
lock and load transfer, and some reduction in the pumping
action. This condition is comparable to continuously rein-
forced pavement where cracks occur 4 to 6 feet (1.2 to 1.8 m)
apart but are held closely together by the steel.
