REPORT NO. FHWA-CA-TL-78-29

PERFORMANCE OF EXPERIMENTAL PCC PAVEMENT SECTIONS

FINAL REPORT

SEPT., 1978

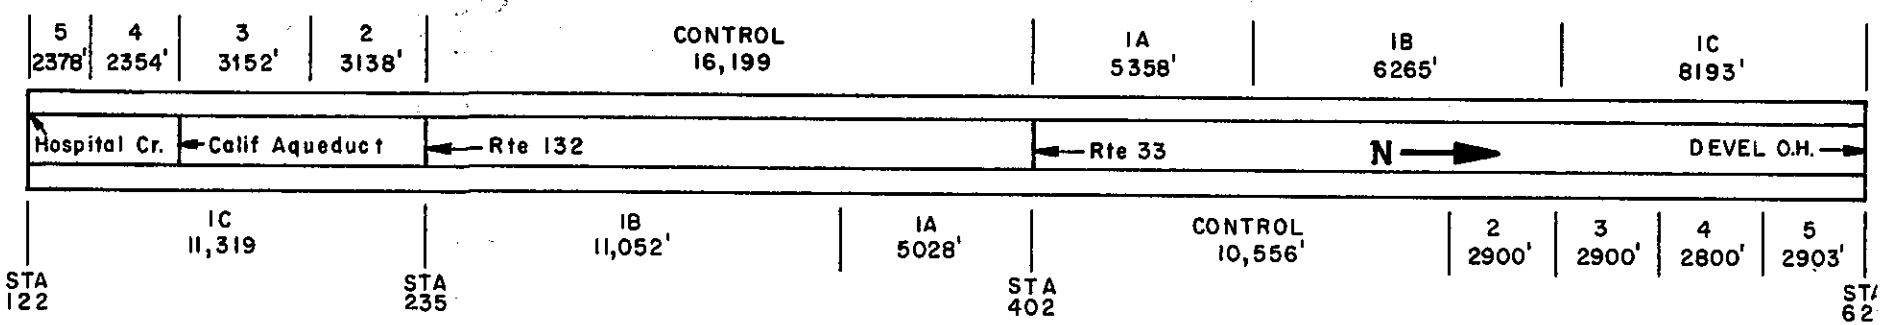
Figure 1

LAYOUT OF TEST SECTIONS
