STATE OF CALIFORNIA
DEPARTMENT OF TRANSPORTATION
DIVISION OF FACILITIES CONSTRUCTIONS
OFFICE OF TRANSPORTATION LABORATORY

AN EVALUATION OF PCC PAVEMENT TINE TEXTURING PATTERNS

1. REPORT NO.	2. GOVERNMENT ACCESSION NO.	3. RECIPIENT'S CATALOG NO.
FHWA/CA/TL-85/05

4. TITLE AND SUBTITLE	5. REPORT DATE
AN EVALUATION OF PCC PAVEMENT TINE TEXTURING PATTERNS	November, 1985
	6. PERFORMING ORGANIZATION CODE
7. AUTHOR(S)	8. PERFORMING ORGANIZATION REPORT NO.
B. F. Neal	54-633366
9. PERFORMING ORGANIZATION NAME AND ADDRESS	10. WORK UNIT NO
Office of Transportation Laboratory California Department of Transportation Sacramento, California 95819	11. CONTRACT OR GRANT NO. F81TL22
12. SPONSORING AGENCY NAME AND ADDRESS	13. TYPE OF REPORT & PERIOD COVERED Interim 1981-85
California Department of Transportation Sacramento, California 95807	14. SPONSORING AGENCY CODE

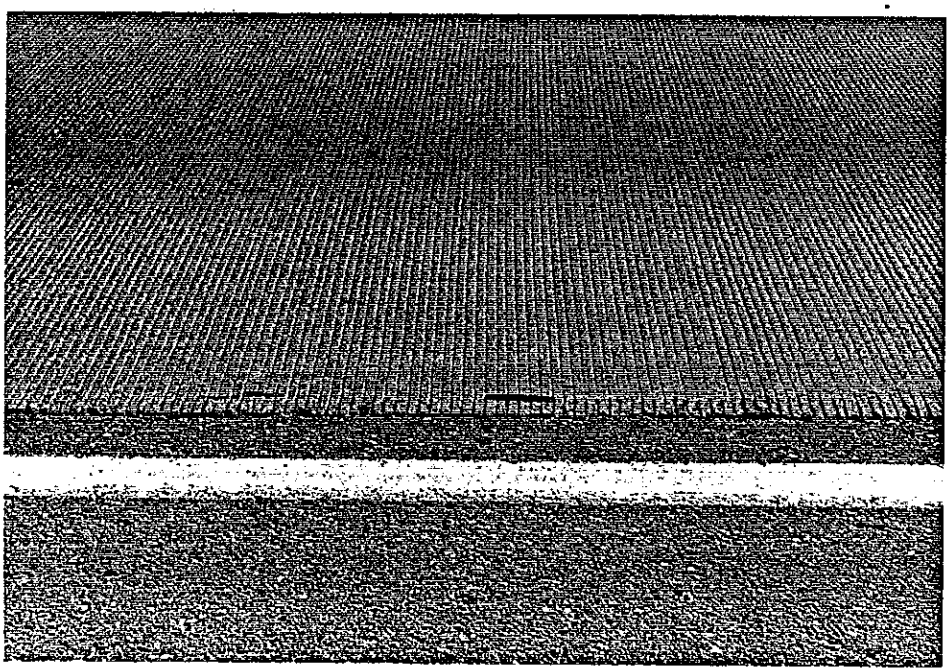
Photographs taken in April, 1985 show typical conditions of the transverse (1 and 2) and longitudinal (3, 4, and 5) texturing on the I-580 project. The tine devices had the metal tines spaced at 3/4 inch on centers. Photo 6 is of longitudinal texturing on an earlier project where the tines were spaced at 1/2 inch on centers. This was considered to form land areas too narrow, many of which were sharp edges. After this construction project, the 3/4 inch c-c spacing was adopted as standard.

Photo 1. Transverse tine texture, 3/4 inch c-c.

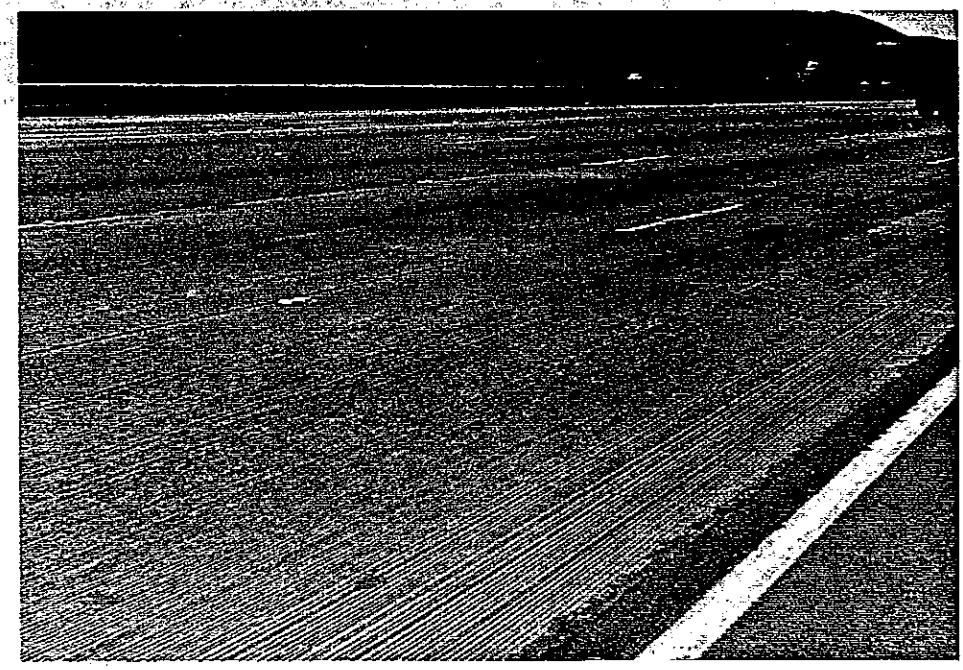
Photo 2. Close-up of transverse tine texture.

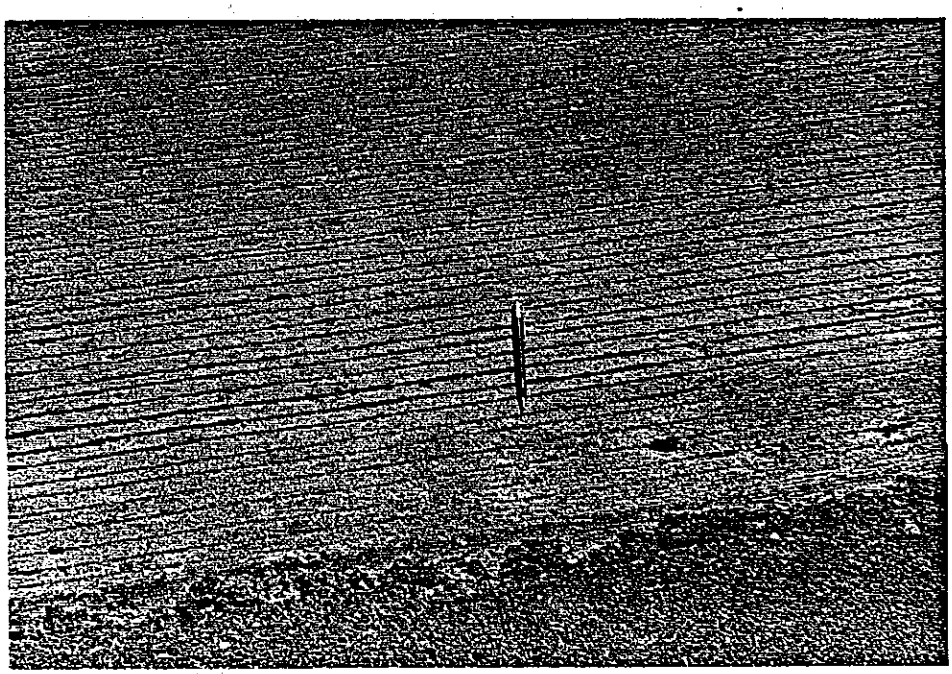
Photo 3. Longitudinal tine texture, 3/4 inch c-c.

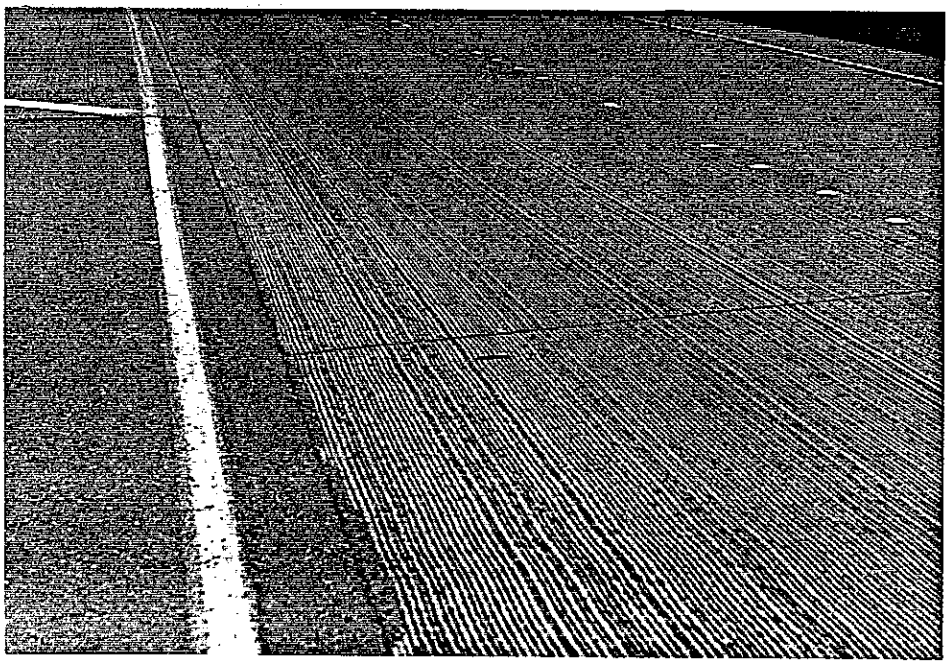
Photo 5. Longitudinal tine texture, 3/4 inch c-c.
