Subject: Design Information Bulletin 83-01: CALTRANS Supplement to Federal Highway Administration (FHWA) Culvert Repair Practices Manual

CALTRANS SUPPLEMENT TO FHWA CULVERT REPAIR PRACTICES MANUAL

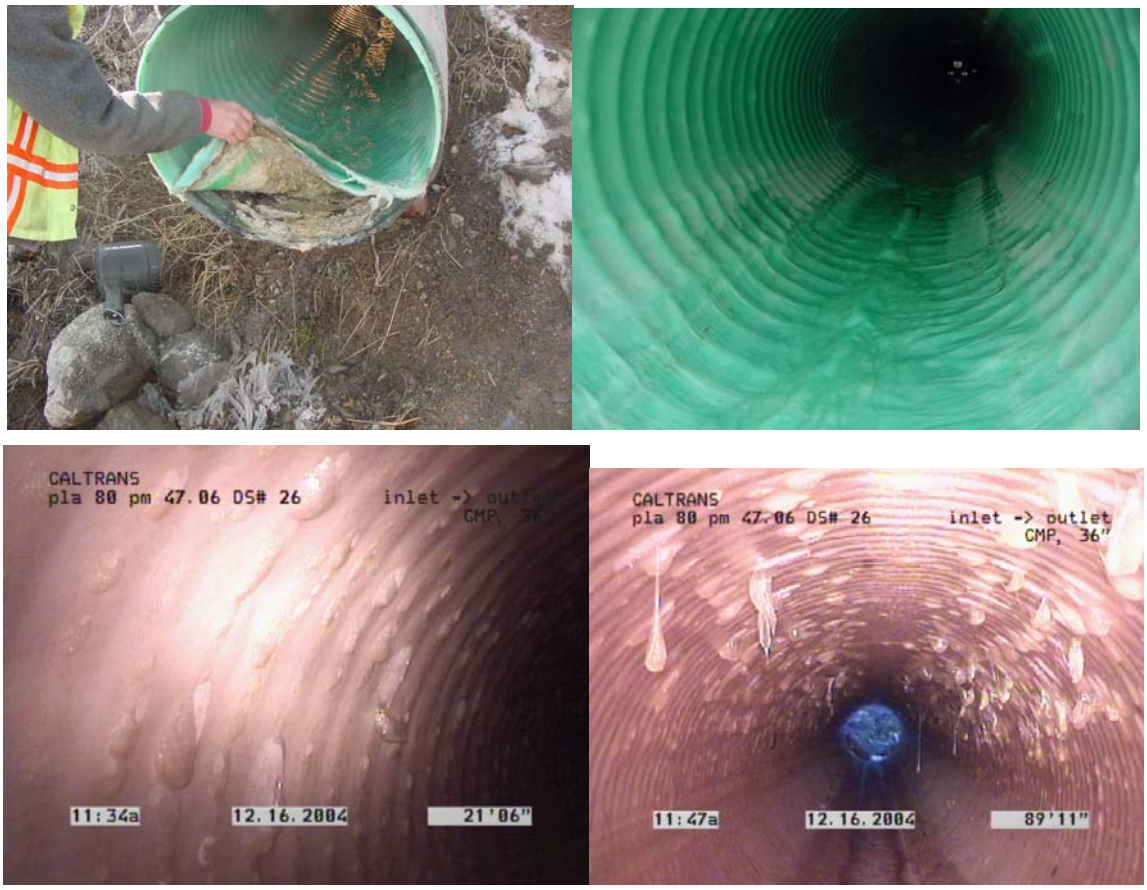
Examples of delamination, bubbling and rippling in lined CMP host pipes

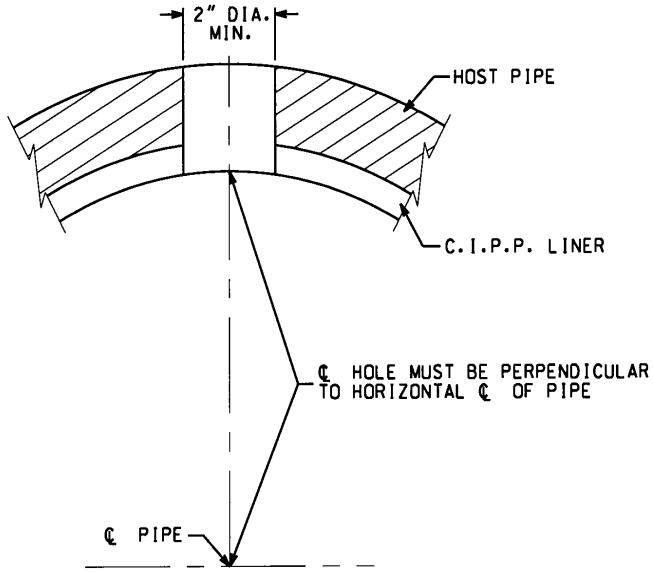
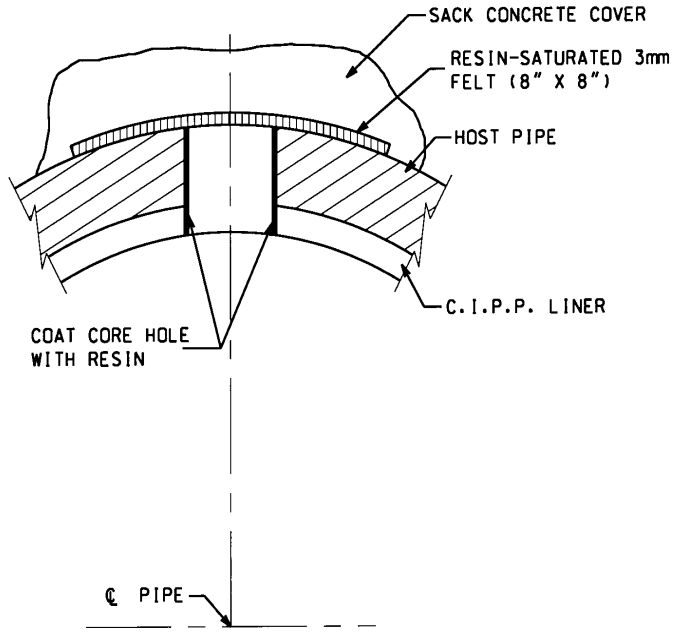
FIGURE 1: C.I.P.P. LINER CORE SAMPLING

Figure 1 on the next page depicts core sampling and repair to host pipe.

CORE HOLE REPAIR

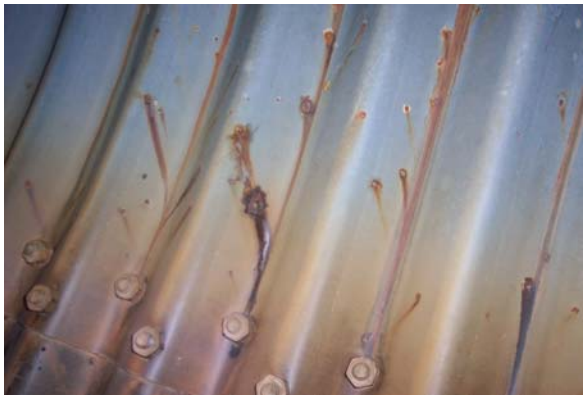
Total loss of invert and existing nuts showing minimal wear

Typical local corrosion cells. Note that the corrosion is coming in from the backside, thus the pipe is in worse condition than it appears. See picture of void found from probing during construction.

36 inch Bitumen coated CMP tie-in. Note rust stain below from perforated invert. Perforations in invert to 36 inch CMP allowed water to leak behind 96 inch culvert

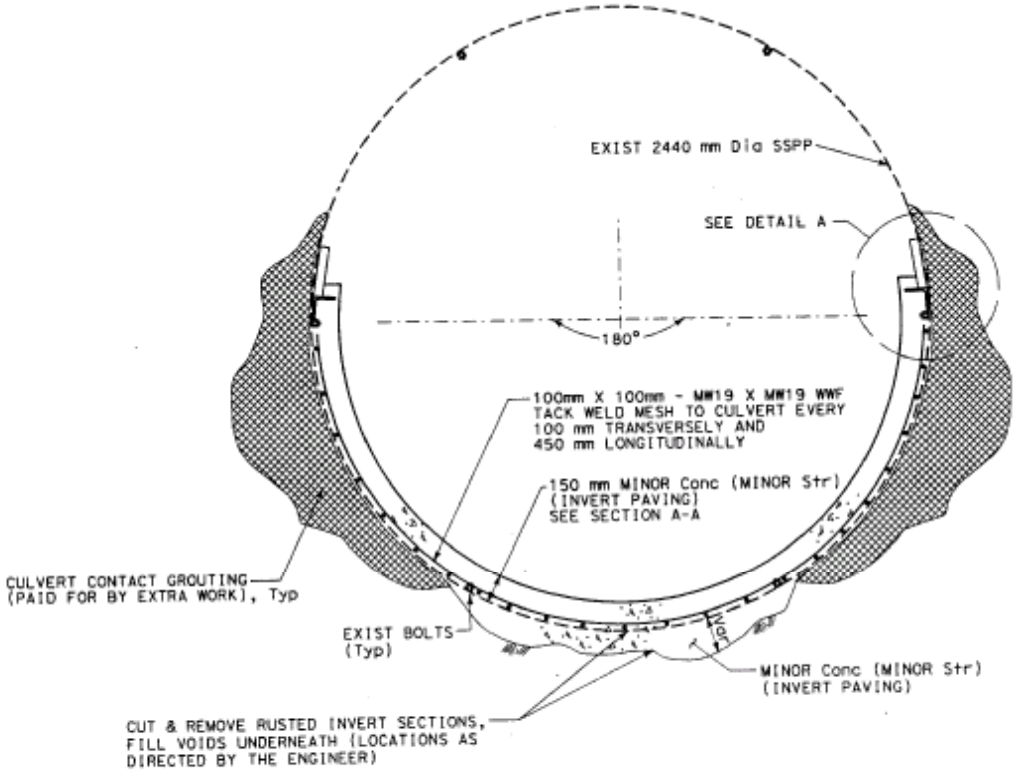
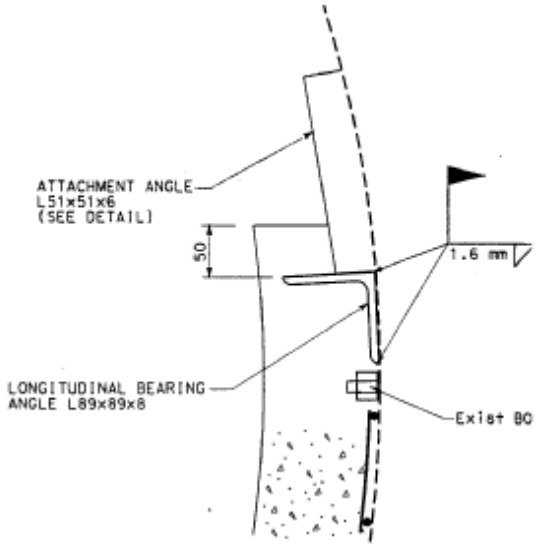
PIPE INVERT PAVING DETAIL

As outlined above, the GPR and CPT testing was incomplete relative to the voids below the springline directly behind the pipe and outside the limits of testing (i.e., ramps). Therefore, Geotechnical Design recommended exploratory probing for voids at 2, 4, 8 and 10 o ‘clock positions every 6 feet along culvert using a ½ inch (No. 4), 4 foot long rebar. Any voids found, were to be filled by low-pressure contact grouting with a maximum injection pressure not to exceed 5psi measured at the nozzle. The exploratory work and subsequent contact grouting was included into the contract and paid for by Extra Work (see detail on next page).

An 32 inch plastic slip liner was also included into the contract to rehabilitate the 230 foot long, 36 inch diameter, and bitumen coated CMP connecting into the SSPP at the center in the median.

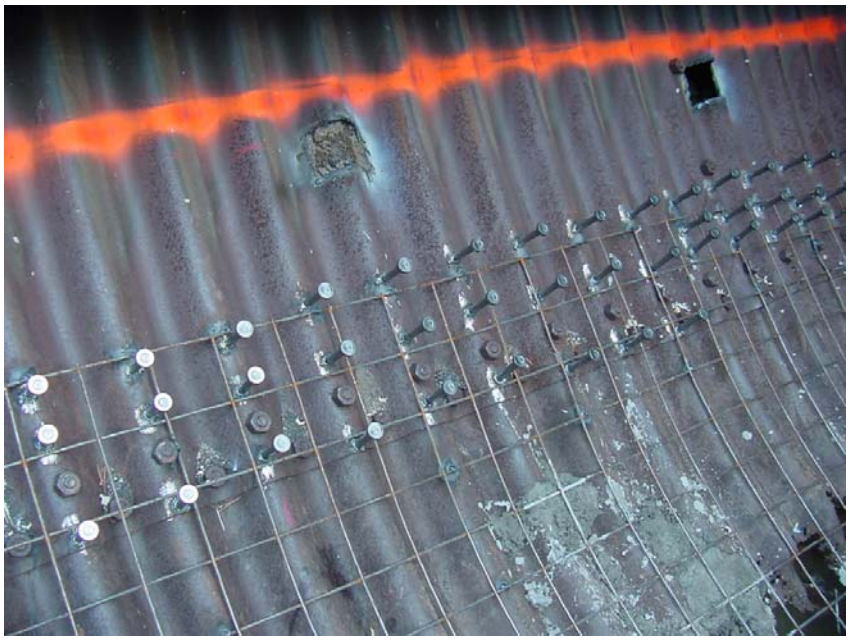
was discovered near the outlet of the eastbound pipe above the springline at the 10 o' clock position. In both pipes the most significant voids were found at the inlet.

Coupons cut in sidewall of culvert for probing and grouting

A decision was made to use polyurethane foam grout rather than cementitious grout to fill the voids behind the culvert. The decision to use polyurethane grout was based primarily on the fact that an agreement with the cementitious grouting contractor regarding Force Account rates could not be reached. Furthermore, the District already had a Maintenance service contract with a company called Uretek for slab jacking and had some success with the material for jacking operations (including this site in January 2003). Although the foam has been used in PCC slab raising work for several years on many California State Highways, there were concerns that the Uretek foam may have environmental impacts and durability issues, since it had not been used for this type of application. The Resident Engineer explained the environmental concerns with cementitious grout migrating into the creek during placement and stated that Uretek had provided data showing the foam to be inert and that it would not leach into the creek. This material is supposed to be inert in a live stream environment and will not absorb water. When first placed, high-density polyurethane rigid closed cell hydro-insensitive grout is supposed to form a mechanical seal by expanding twelve times its liquid volume in 8-12 seconds.

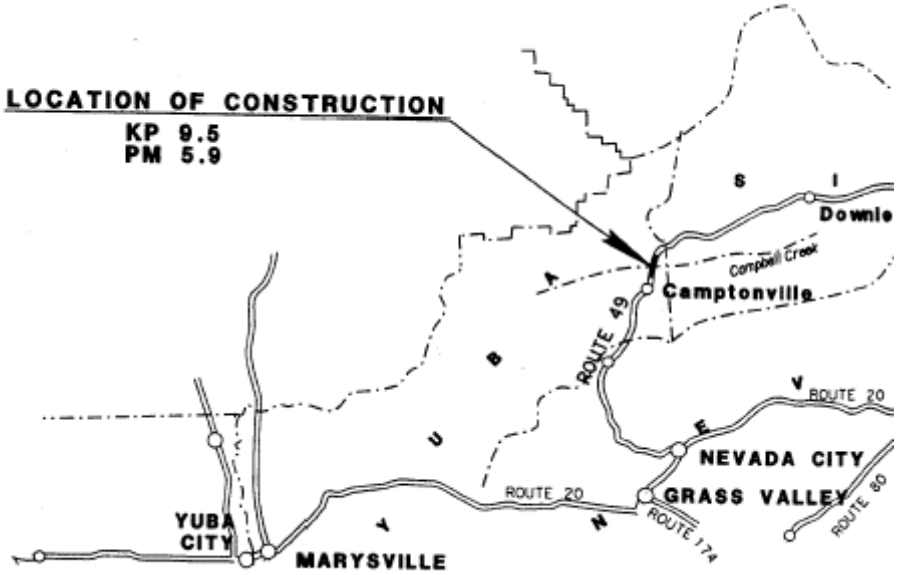
In 2002, Area Maintenance reported that the soffit of a 108-inch x 262 feet Structural Steel Plate Pipe (SSPP) culvert was collapsing causing the pavement above the pipe to crack. This culvert was originally constructed in 1940 as cross drainage for Campbell Creek on Highway 49 near Camptonville (see map above).

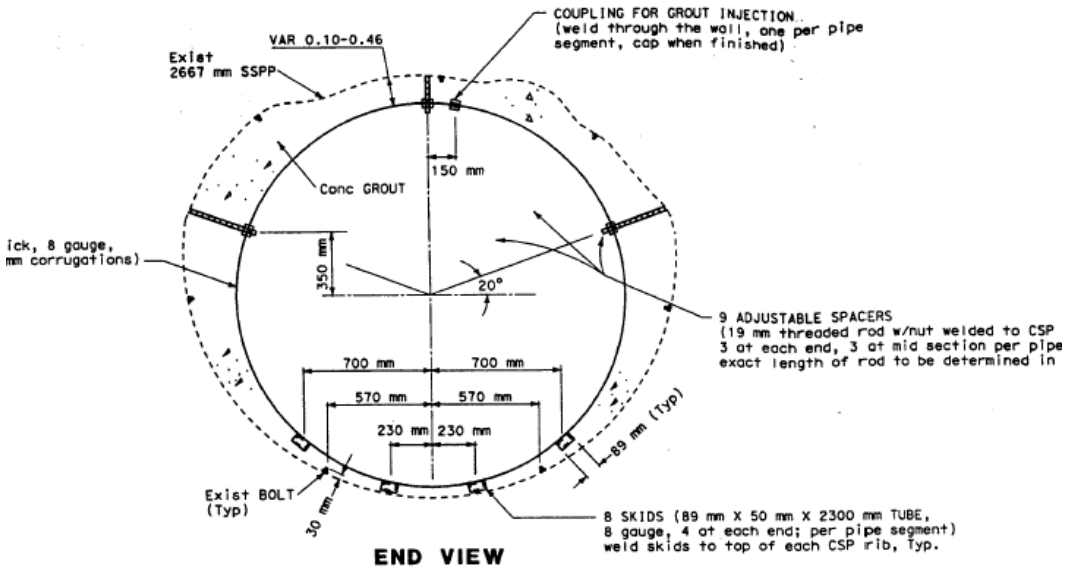
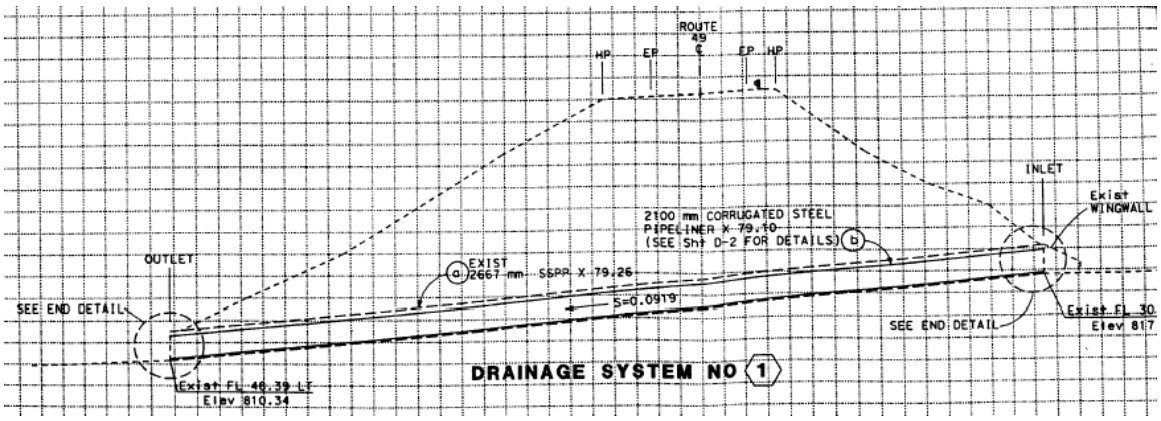
The resulting hydrostatic pressure at the downstream end from continuous grouting of the annular space between the existing culvert and the 84-inch CSP liner placed inside caused the liner to float and buckle with grout leaking out of the liner's joints which had been specified as watertight with gaskets. The grouting operation was immediately stopped and a Contract Change Order (CCO) was developed.

Grout from leaking joints in invert

Grouting through grout port in soffit of liner
