1. REPORT No.
FHWA-CA-TL-78-13

4. TITLE AND SUBTITLE
Vehicular Impact Tests of Precast Concrete Median Barriers With Corrugated Ends And Tensioned Cables

9. PERFORMING ORGANIZATION NAME AND ADDRESS
Office of Transportation Laboratory
California Department of Transportation
Sacramento, California 95819

13. TYPE OF REPORT & PERIOD COVERED
Final Report

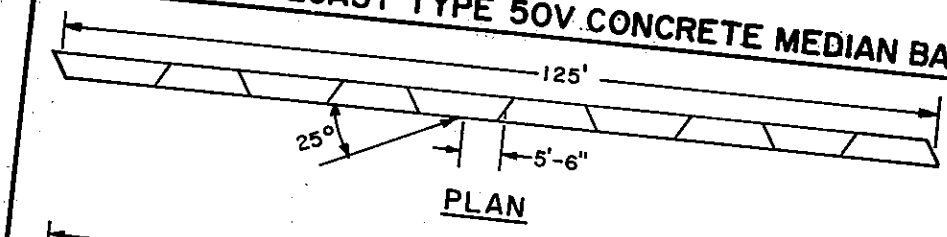
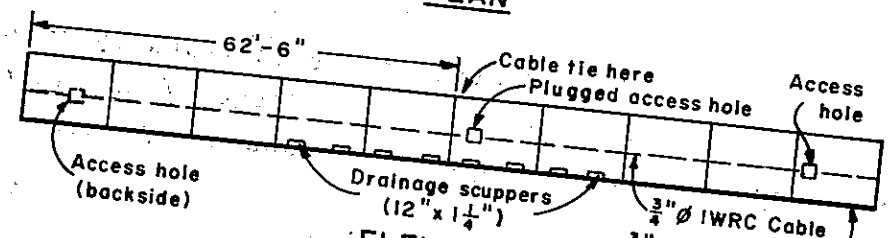
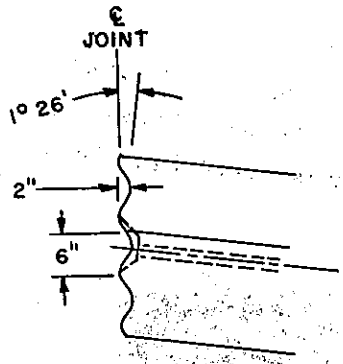
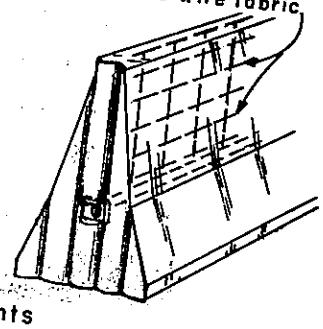
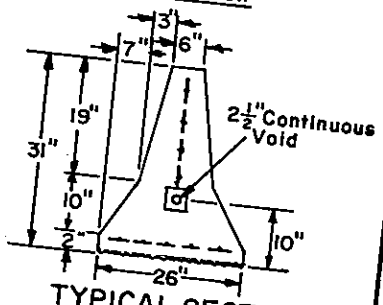
Figure 2. PRECAST TYPE 50V CONCRETE MEDIAN BARRIER DESIGNS (1,2)

- 12'-6" Barrier segments
- Corrugated vertical concrete shear key
- Welded wire fabric: (4x4-W3xW3) 16" x 12'-0" placed vertically along ℄ & 20" x 36" placed above drainage scuppers.
- Cable tie at middle of barrier
- Barrier placed on continuous 3/4" x 26" polystyrene pad (1-lb/ft³)
- Cable tension prior to impact: Upstream-17,640 lbs. Downstream-14,780 lbs.
- Temporary barrier installation

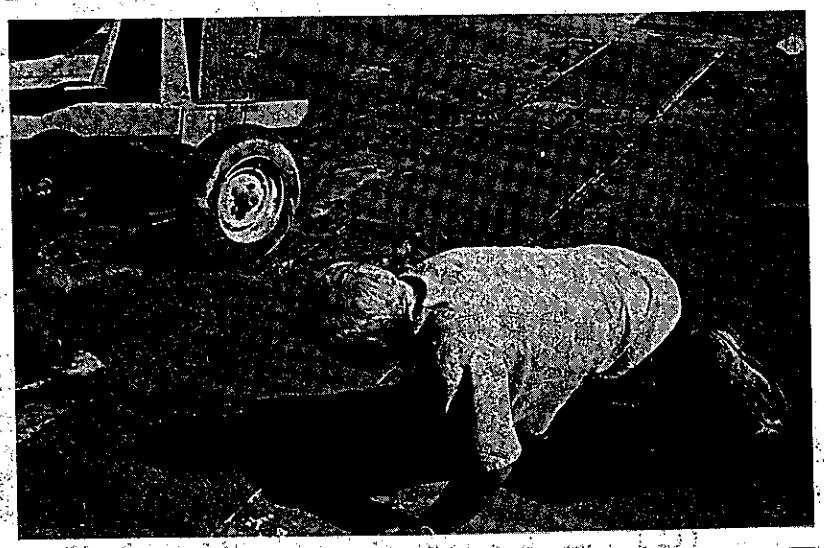
Grout pads used for Test 332 were constructed in the same manner as those for the field installation described in the Appendix in an attempt to exactly simulate that barrier. The grout was mixed in a small mixer and placed in steel forms two or three barrier lengths ahead of the segments being placed, Figure 4. The AC pavement was swept but not wet down before placement of the grout. The grout was fairly stiff and as noted by post test observations did not slump enough to achieve active contact over the complete bottom area of all barrier segments. No leveling blocks were used to control segment height above ground.

Figure 4. Grout Bed Construction, Test 332.

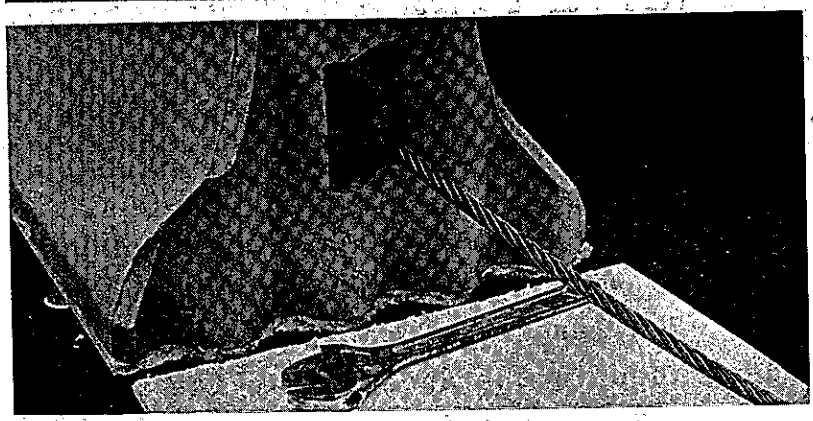
Figure 5. Cable Threaded Through Barrier Segment.

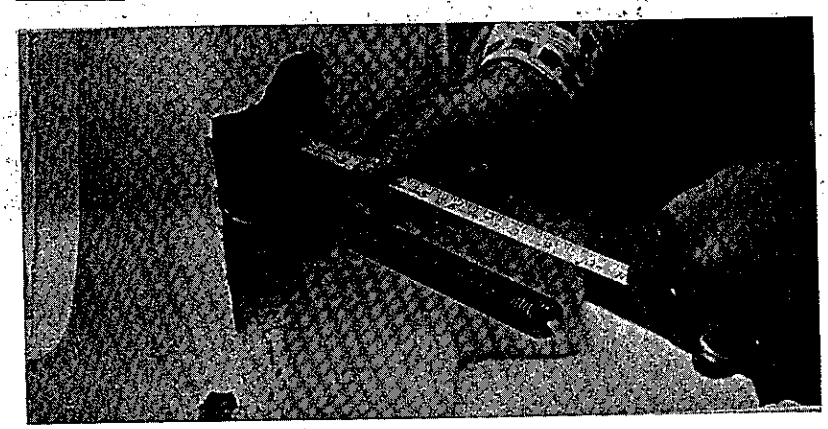
Figure 6. Threaded Stud, Nut, and Bearing Plate.

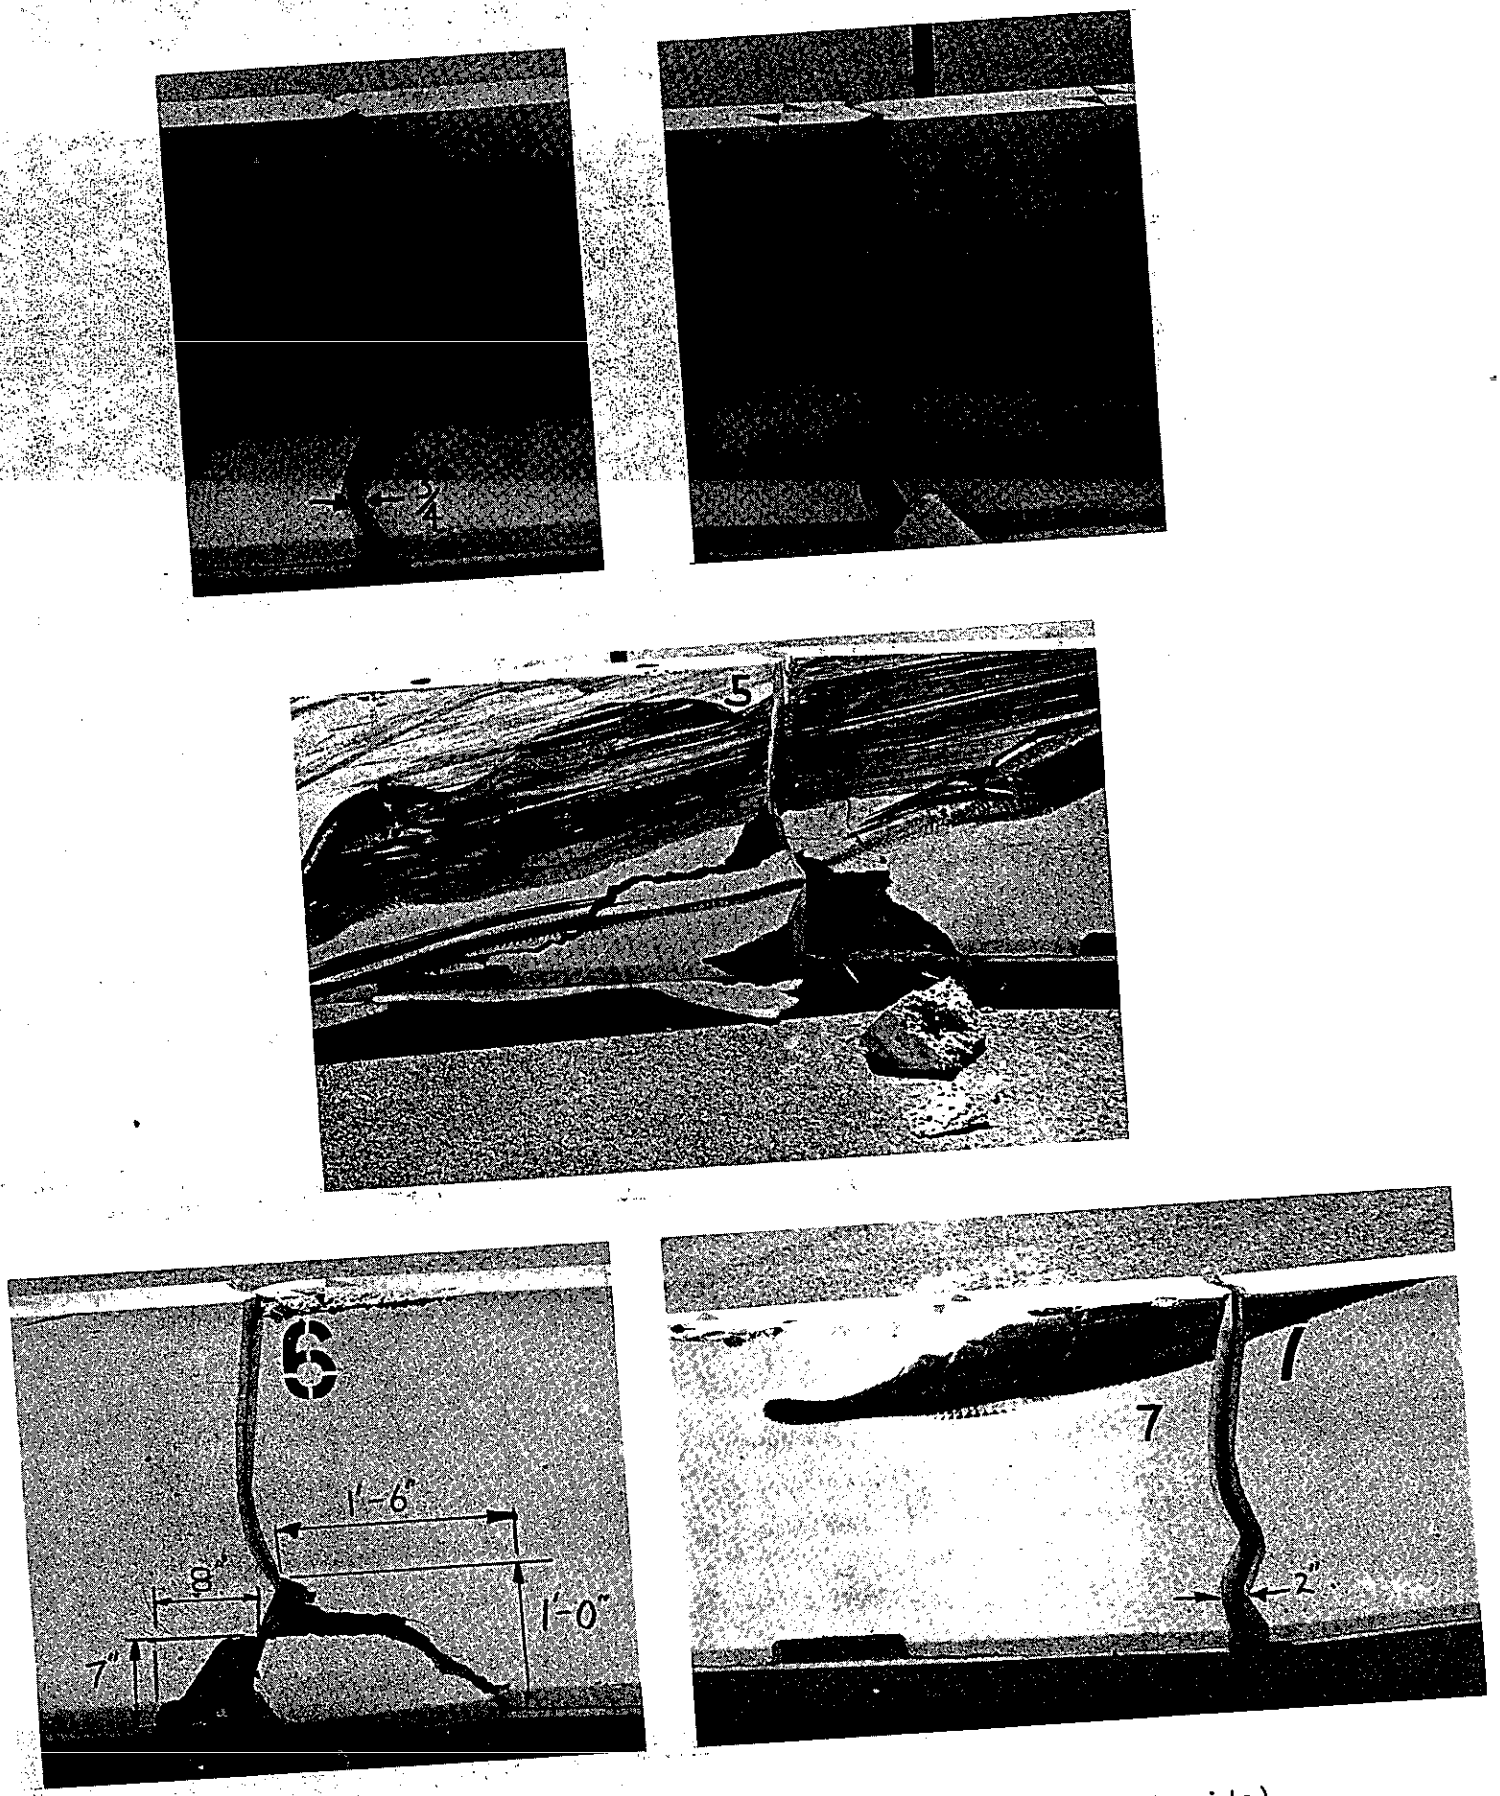
Due to the large deflections and the tight fitting joints there was considerable spalling of the concrete at the corners of the segments, Figures 8 and 9. Figure 10 shows the damage and scuff marks on the barrier where primary vehicle contact occurred.

Figure 8. Barrier Damage and Movement (impact side) at Joints 3, 4, 5, 6 and 7, Test 331.

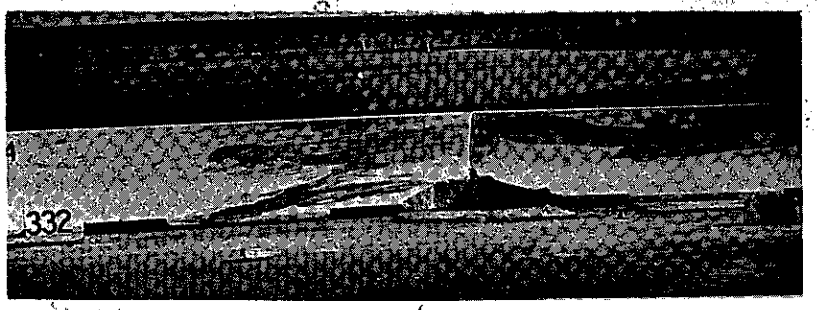
Figure 17. Primary Impact Area, Test 332.

It should be noted that in both Tests 331 and 332 there was extensive spalling of the corners of the barrier segments which deflected. Also, a flexural failure occurred near the middle of the first barrier segment hit during Test 332. These segments would all need to be replaced. This represents less than desirable structural adequacy when compared with the performance of continuous CMB which is typically undamaged in severe impact tests.

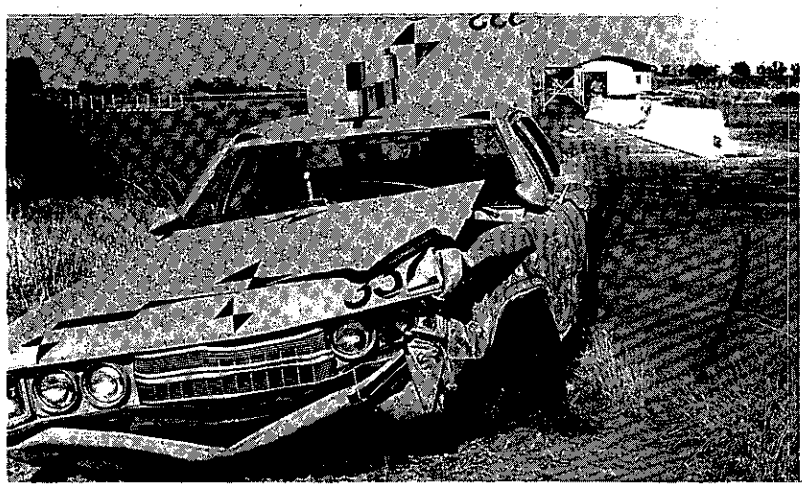
Figure 18. Vehicle Damage, Test 332.

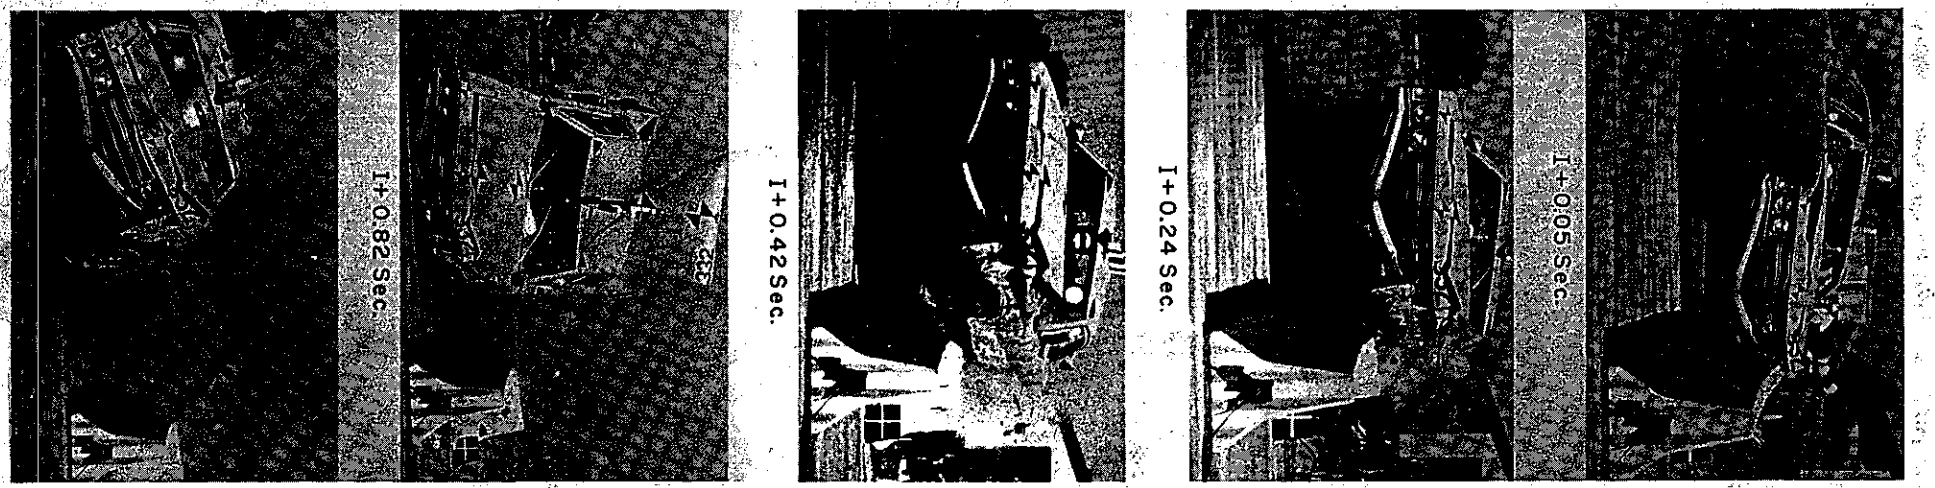
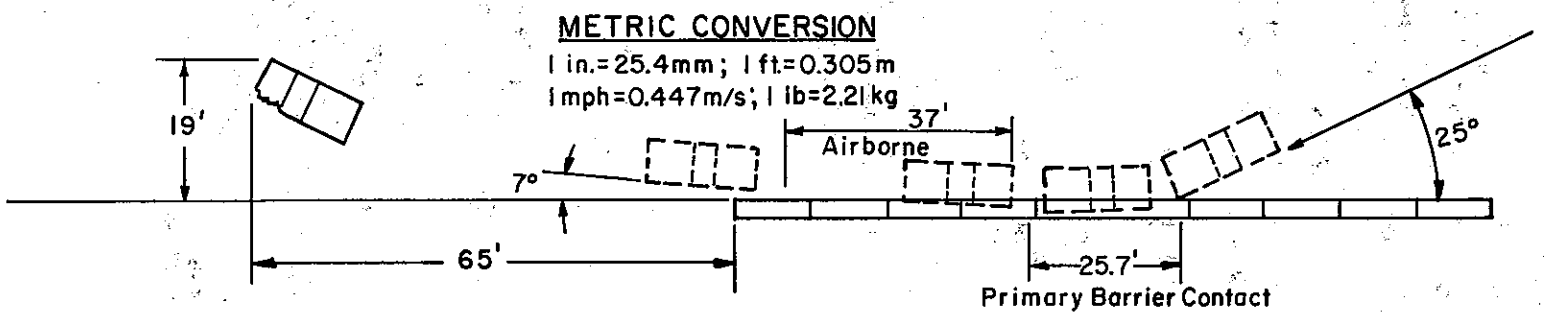
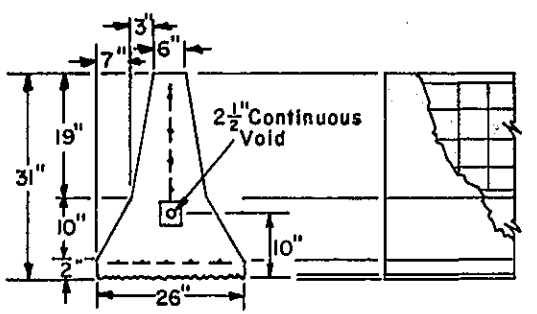
Figure 19,

Barrier. . .Precast Type 50 V CMB on 1" Grout Pad with continuous 3/4" ø IWRC Cable
Joint Connection. . . 2-in.deep corrugated vertical shear key with 6-in. pitch
Segment/barrier lengths, ft. 12.5/125
Cable Tension
Load before impact, lbs. 4880
Max. load increase during impact, lbs. 2720
Max. Perm.lateral joint displ. . . . . .28.5 in
Vehicle Acceleration (max. 50m sec.avg.)
Lateral . . . . . 9.0g's
Longitudinal. . . . . 4.9g's
Dummy Restraint . . . . . Lap belt
Max. Vehicle Rise/Roll . . . . . 5.3ft/-13°

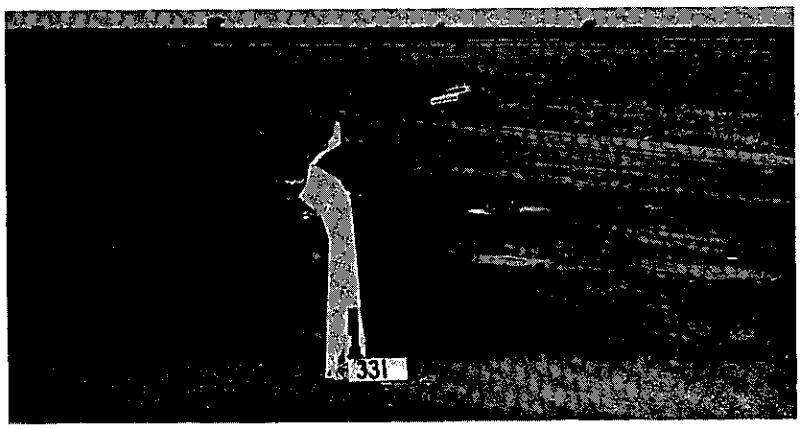
In Test 331 the large barrier deflection caused the vehicle to become airborne on a hazardous trajectory over the top of the barrier. If the barrier had been longer, the vehicle easily might have toppled over the backside of the barrier or rolled over. In Reference 4 more weight was given to tilting of the barrier segments than to lateral deflection as the cause of vehicle vaulting. Due to the low tilt angle of under 6° (0.11 rad) in Test 331 and a lateral deflection more than that in a similar previous Caltrans test, Test 292(4), it now appears that large lateral deflection alone can be a primary cause of vehicle vaulting in severe impact tests. This negates any possible benefits claimed in the form of reduced vehicle decelerations caused by barrier deflection for this type of barrier. It should be noted that differences in vehicle suspensions and crushability also may affect vehicle vaulting tendencies during CMB impacts.

Figure 20, Post Impact Vehicle Trajectory, Test 331

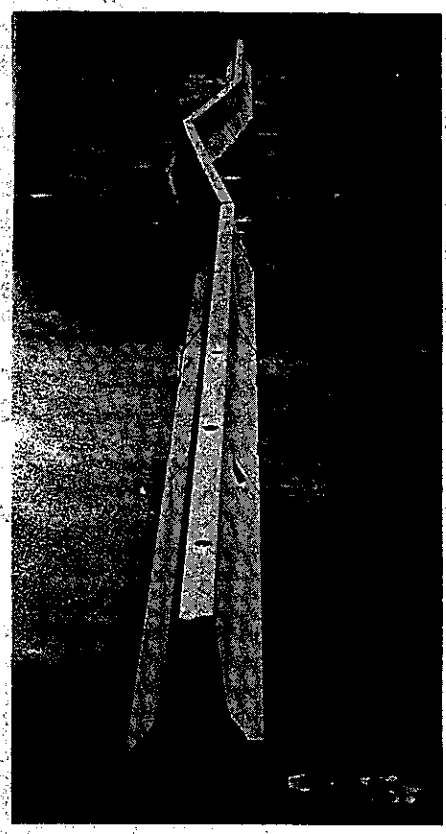
In Test 332 the maximum barrier deflection was an inch more than in Test 331 but the vehicle was redirected in a less hazardous manner than in Test 331. Had the test vehicle not gone over the cable guidance post in Test 332, causing it to roll toward the barrier, it is speculated that the vehicle trajectory might have been similar to that in Test 331.

Figure 21. Post Impact Vehicle Trajectory, Test 332.
