CRASH TESTING OF VARIOUS TEXTURED BARRIERS

DEPARTMENT OF TRANSPORTATION
ENGINEERING SERVICES
MATERIALS ENGINEERING AND TESTING SERVICES

September 2002

1. REPORT NO. FHWA/CA/TL-2002/03	2. GOVERNMENT ACCESSION NO.	3. RECIPIENT'S CATALOG NO.	
4. TITLE AND SUBTITLE CRASH TESTING OF VARIOUS TEXTURED BARRIERS		5. REPORT DATE September, 2002

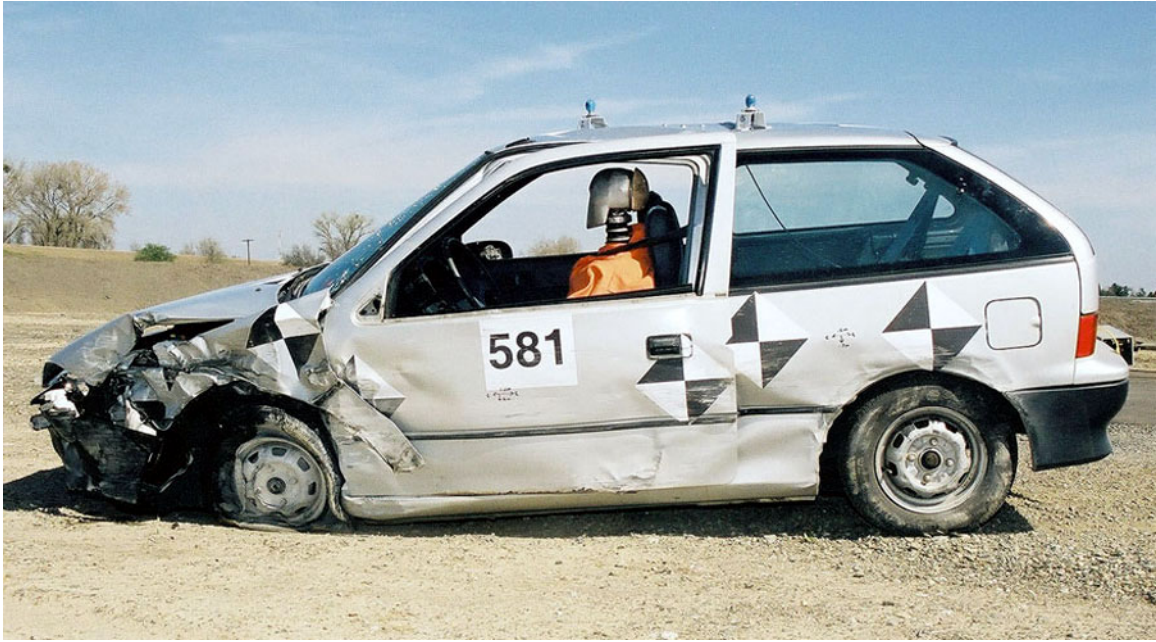
Figure 2-5 Test vehicle after Test 581

The left front quarter section of the vehicle was moderately damaged in the initial impact with the barrier. The left front fender, hood, bumper, headlamp area, grille, and suspension components were all affected. The driver side doorframe was deformed outward but the door remained latched. The left front tire was also ruptured. Some minor damage along the left side of the vehicle and to the left rear quarter occurred as the vehicle continued to contact the barrier after the initial impact. The maximum deformation of the driver side floorboard was 105 mm, mostly in the vicinity of the wheel well. This was within the generally accepted limit of 150 mm.³ Nevertheless, this deformation was of some concern because it occurred in the narrowest part of the driver footwell and was greater than what is usually seen in an 820C test. Moreover, it was the result of the left front wheel being pushed back in the wheel well, indicative of snagging. The decision to run test 3-11 on the cobble texture was based on snagging concerns.

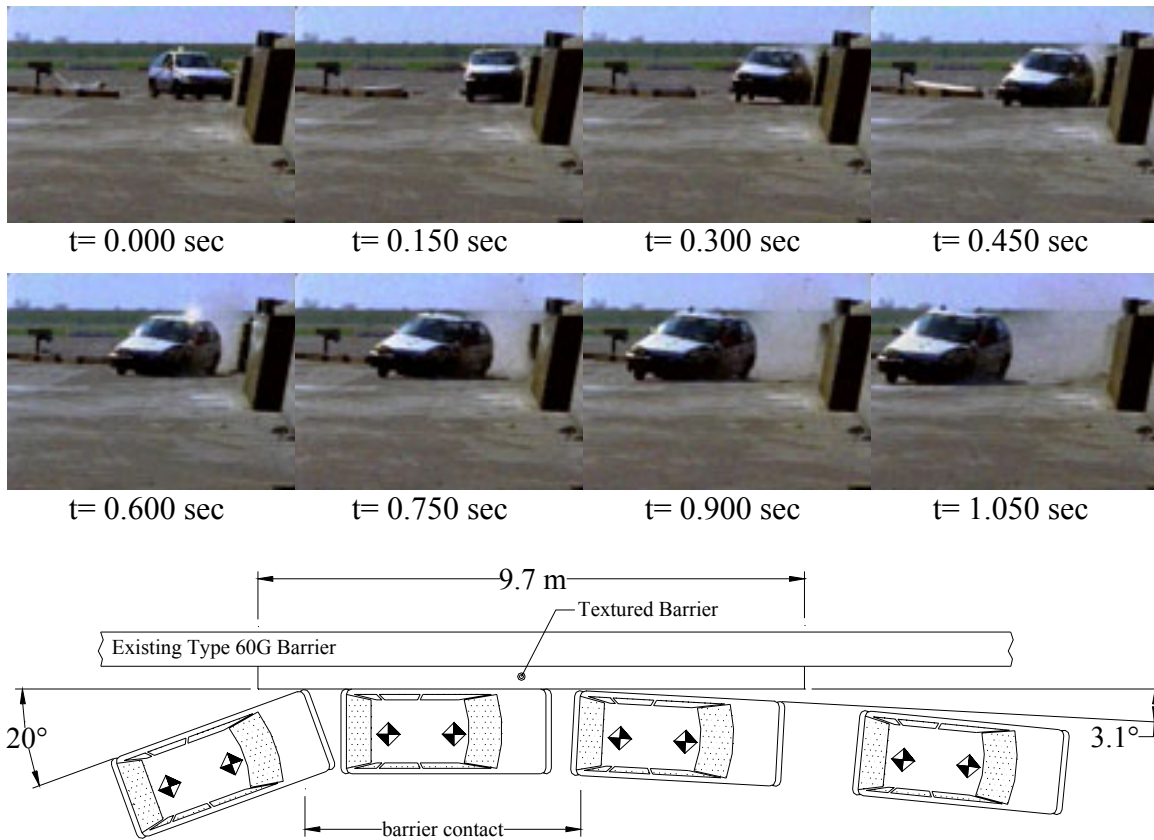
Figure 2-9 Impact sequence and diagram for Test 581

Barrier Damage: Minor scrapes, gouges, and chipping on some cobbles. The barrier would not require immediate repair.

The damage to the barrier was cosmetic in nature and would not need immediate repair to remain crashworthy. This damage consisted of minor scrapes and gouges in the concrete surface of the barrier which. The gouges and scrapes could be filled or patched on-site by maintenance crews.

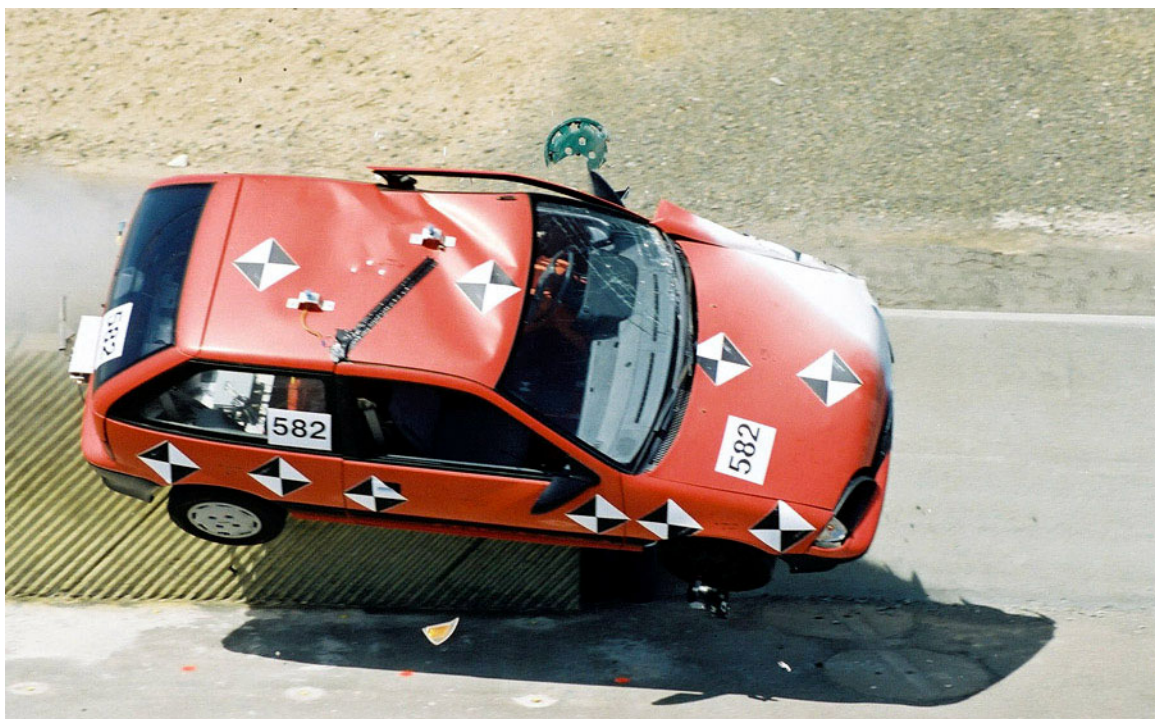
Figure 2-12 Test vehicle 582 during the Test
(the vehicle rolled over twice to the left after landing)

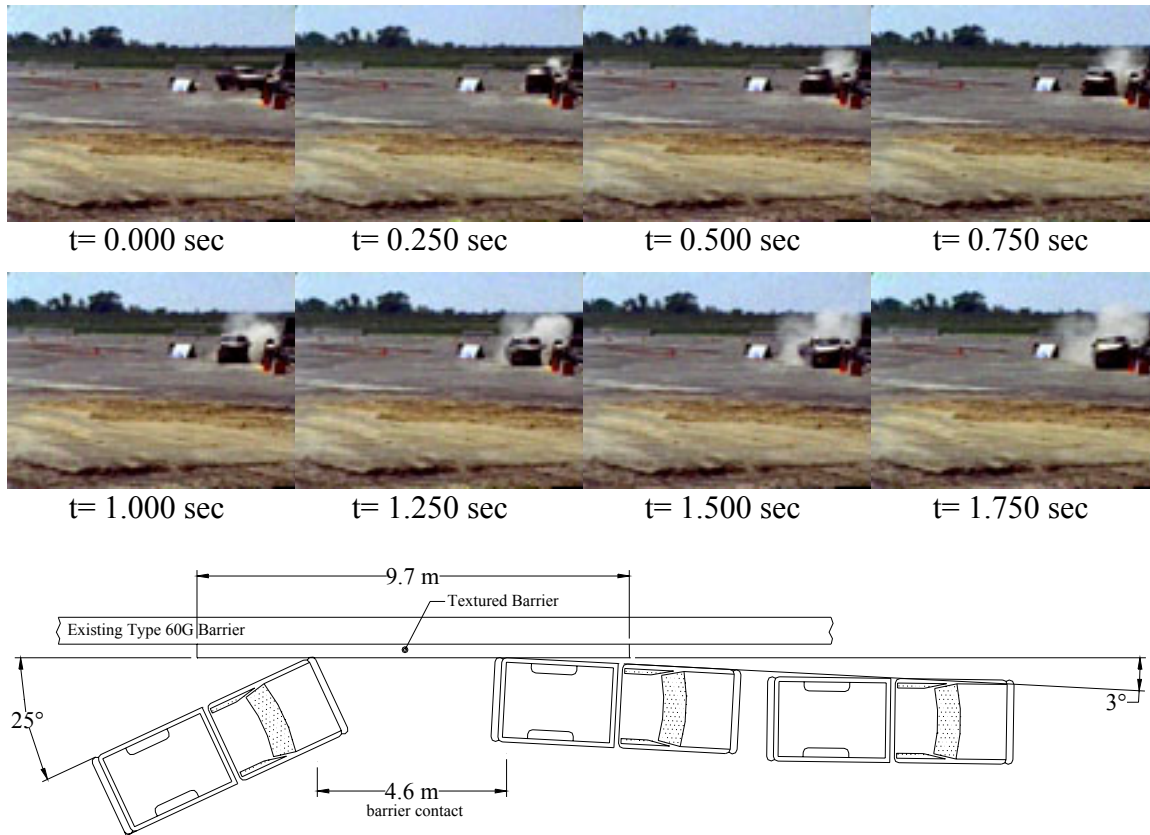
Figure 2-23 Impact sequence and diagram for Test 583

- Test Barrier:** Type: 1220-mm high, deep cobblestone textured barrier with a Type 60 profile
 Length: 9.75-m total length
 Test Date: April 24, 2001
- Test Vehicle:** Model: 1990 GMC 2500
 Inertial Mass: 1991 kg
 Impact / Exit Velocity: 100.2 km/h / 69.5 km/h
 Impact / Exit Angle: 25.0° / < 4°
- Test Dummy:** Type: None used
- Test Data:** Occ. Impact Velocity (Long / Lat): 7.43 m/s / -7.23 m/s
 Ridedown Acceleration (Long / Lat): -5.97 g / 11.84 g
 ASI: 1.55
 Exterior: VDS⁽³⁾/CDC⁽⁴⁾ LFQ-6 / 11LDAW7
 Interior: OCDI⁽¹⁾ 1021000
- Barrier Damage:** Minor scraping and gouging of the concrete surface with minor chipping on the downstream edges of some of the cobbles. The barrier would not require immediate repair.

Most of the damage to the barrier was superficial scraping and gouging. The vehicle impact caused some edges of individual cobbles to chip or break off (Figure 2-21 and Figure 2-22). The barrier would not require immediate repair. The gouges and scrapes could be filled on-site by maintenance crews.

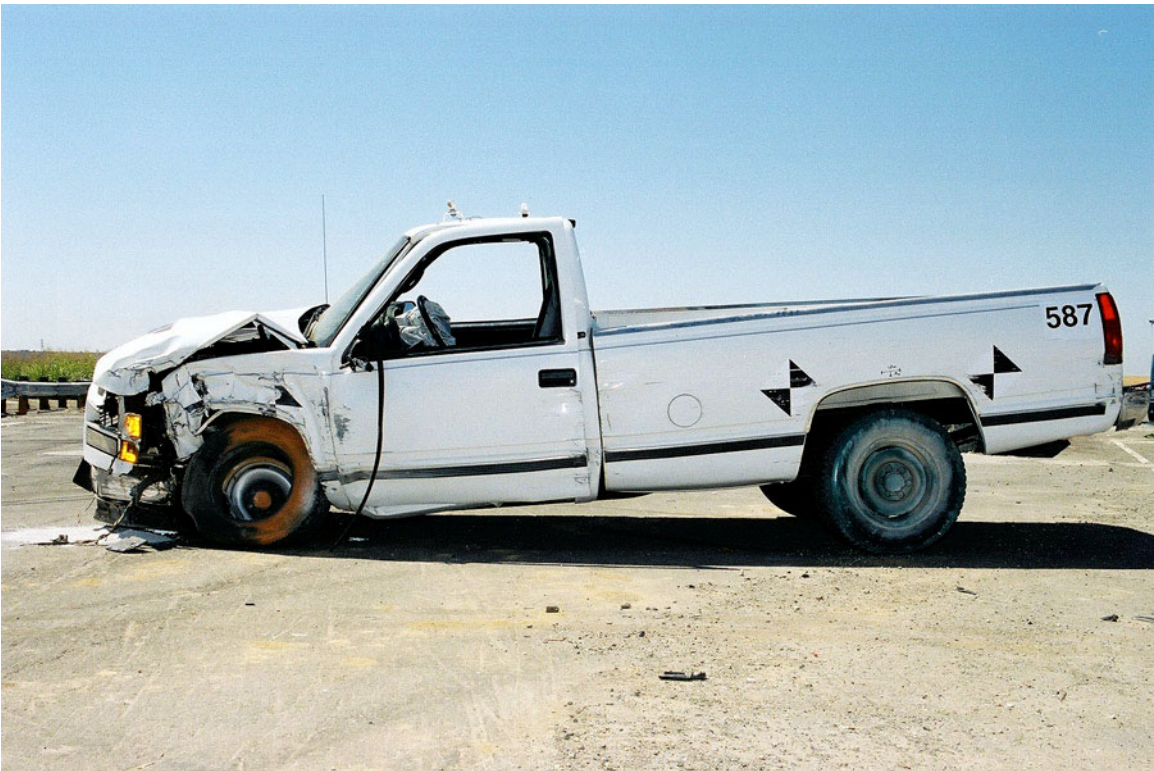
Figure 2-42 Test vehicle after Test 587

The left front corner of the vehicle was moderately damaged in the initial impact with the barrier. The left front fender, hood, bumper, headlamp area, grille, and suspension components were all affected. The driver side doorframe was deformed slightly and buckled outward. Both doors and the hood remained latched. The left front tire was ruptured. There was minor damage along the left side of the vehicle and to the left rear quarter. The left front wheel assembly was pushed rearward which resulted in moderate deformation of the floorboard. The maximum amount of passenger compartment deformation, 171 mm, occurred behind the parking brake pedal in the upper left corner of the footwell area. While this is over the accepted limit of 150 mm, it is in an area where a driver's foot is not likely to be located. The area of the floorboard where the driver's feet would more likely be located was deformed a maximum of 102 mm.

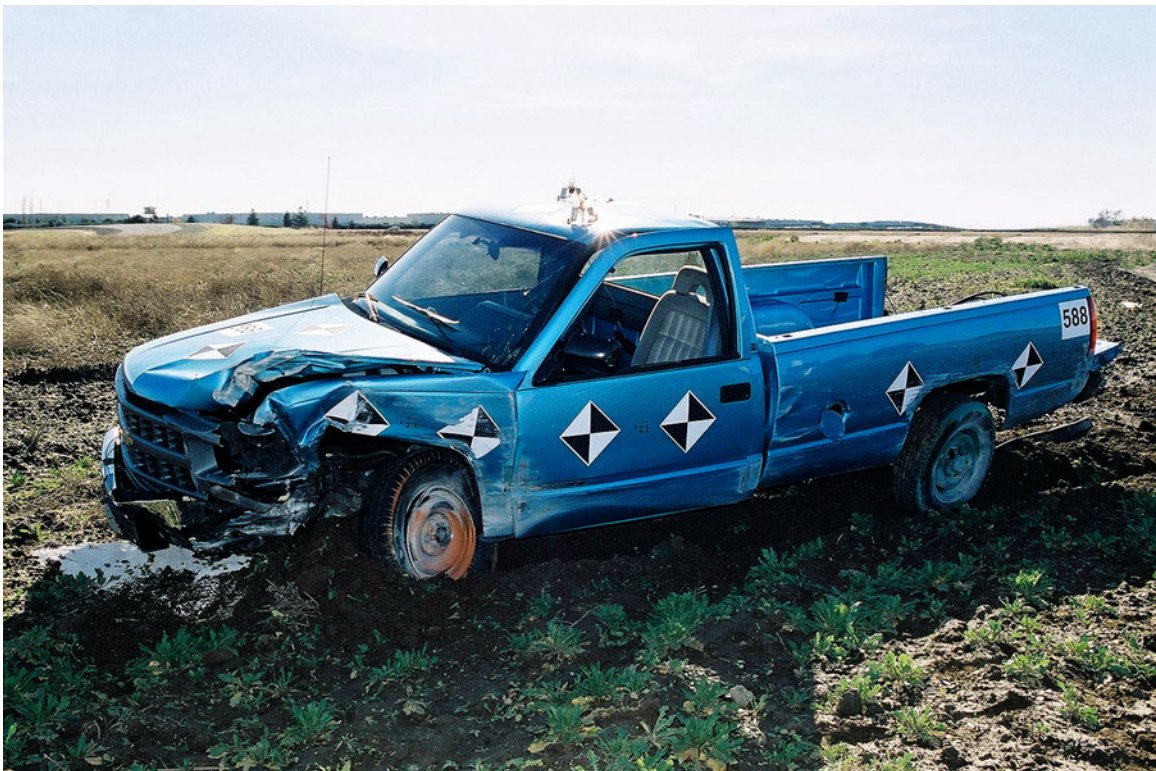
Figure 2-50 Test vehicle after Test 588

The impact angle was set to 25° by placement of the guide rail and high-speed film analysis indicated the actual impact angle was 24°. The impact speed of 100.3 km/h was obtained by an average of two different speed traps located just upstream from the impact point. The test vehicle impacted the barrier 2.4 m downstream of the leading edge of the barrier as intended. The left front corner of the vehicle began to deform and the vehicle began to yaw slightly right (positive) as the impact progressed. At 0.08 seconds after impact the upper section of the driver side door frame was deformed outward to a maximum opening of about 209 mm.

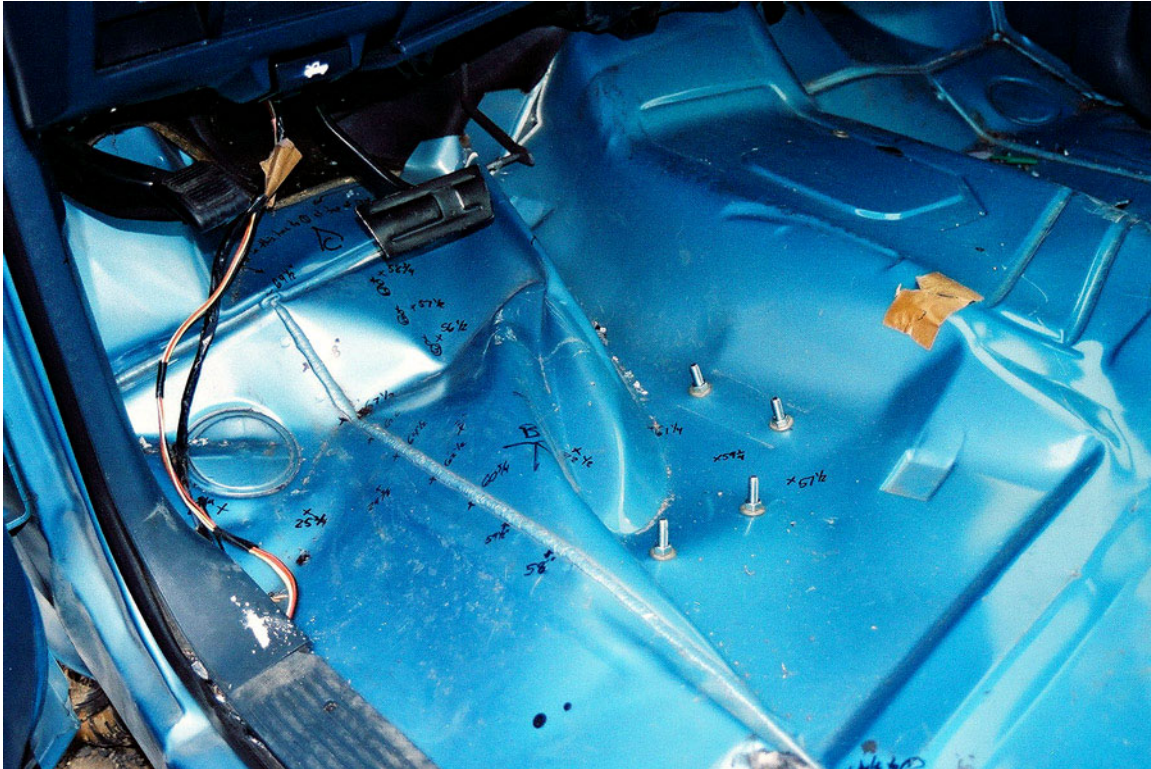
Figure 2-55 Vehicle floorboard after Test 588

The left front corner of the vehicle was moderately damaged in the initial impact with the barrier. The left front fender, hood, bumper, headlamp area, grille, and suspension components were all affected. The driver side doorframe was deformed slightly and buckled outward. Both doors and the hood remained latched. The left front tire was ruptured. There was minor damage along the left side of the vehicle and to the left rear quarter. The force of the initial impact drove the left front tire and rim assembly rearward into the underside of the driver side floorboard. This caused some deformation (buckling) of the floorboard which did not exceed 134 mm. This was within the accepted limit of 150 mm.

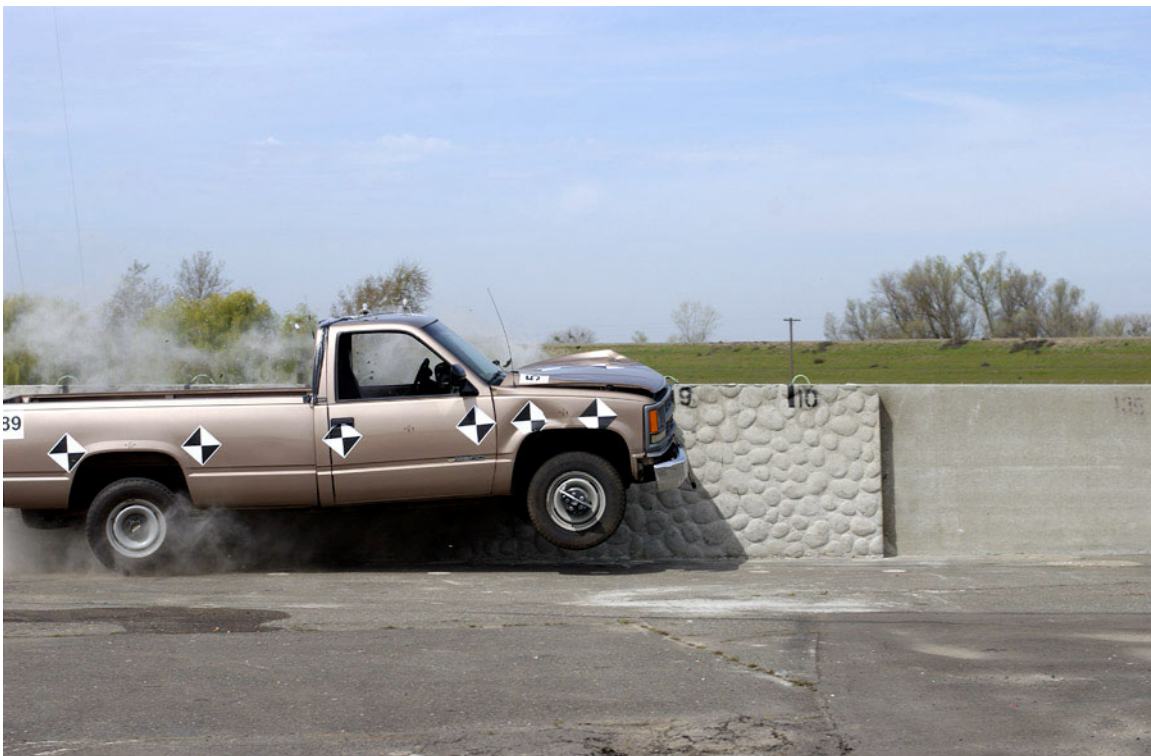
Figure 2-56 Test 589 (0.2 seconds after impact)

The impact angle was set at 25° by placement of the guide rail. Film analysis indicated that the impact angle was 23.6°. The impact speed of 100.8 km/h was obtained by an average of two different speed traps located just upstream from the impact point. The test vehicle impacted the barrier 1.2 m downstream of the leading edge of the barrier as intended. The left front corner of the vehicle began to deform and the vehicle began to yaw right (positive) as the impact progressed. At 0.1 seconds after impact the upper section of the driver side door frame was deformed outward to a maximum opening of 225 mm. The vehicle attained a slight degree of positive pitch (nose up) to a maximum of 2.6° at 0.18 seconds. The back left side of the vehicle contacted the barrier at 0.2 seconds after the initial impact. This secondary impact by the rear of

the vehicle damaged the left rear quarter section while essentially stopping the positive yaw of the vehicle. The maximum roll was less than 5.3° as the left side of the vehicle climbed a short distance up the face of the barrier approximately 0.22 seconds after impact. At 0.3 seconds after initial impact the vehicle lost contact with the barrier. The exit speed was determined through film analysis to be 76.7 km/h and the exit angle was less than 3.3° . The front tires regained contact with the pavement at 0.53 seconds after impact and the rear tires touched down about 0.2 seconds later. The vehicle was redirected and completed a 180° spin as it continued into the run-out area. The brakes were applied 1.1 seconds after the initial impact as indicated by the firing of the brake flash mounted on top of the vehicle. The vehicle came to rest in an open area approximately 30 m downstream from the end of the barrier. Figure 2-56 through Figure 2-60 show the pre-test and post-test condition of the test vehicle and test article. Sequence photographs of the impact for Test 589 are shown as Figure 2-61 on the data summary sheet on page 54.

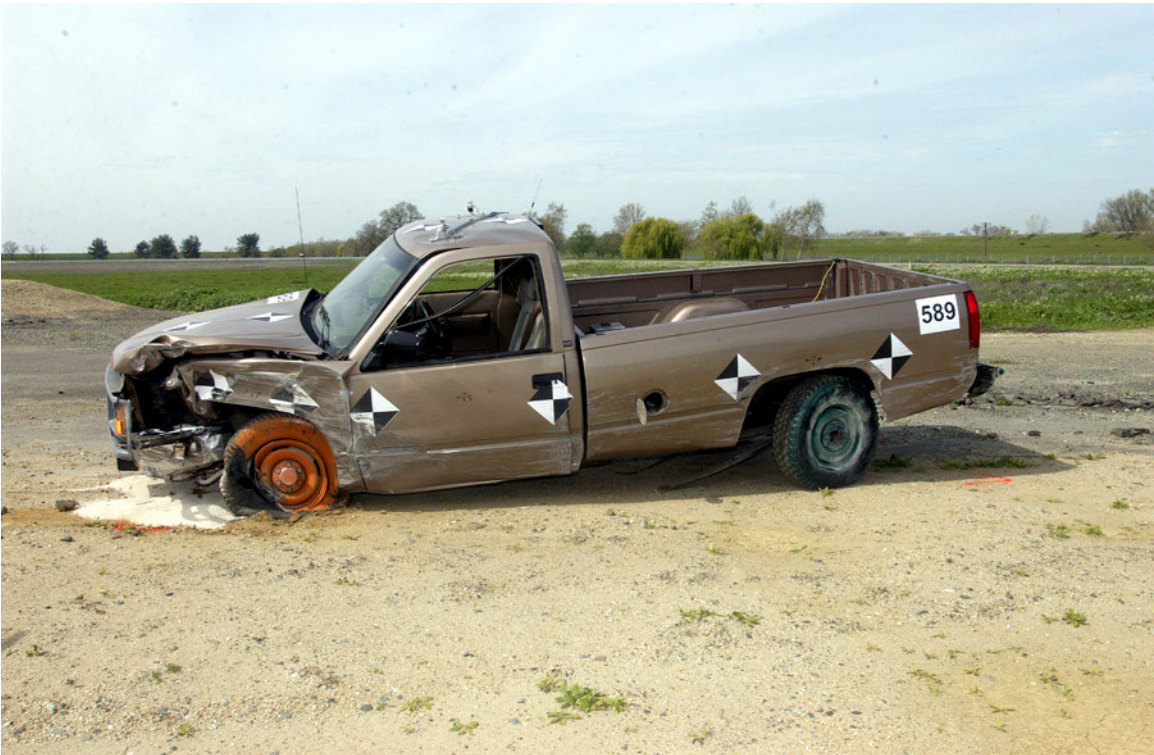
Figure 2-58 Test vehicle after Test 589

The left front corner of the vehicle was moderately damaged in the initial impact with the barrier. The left front fender, hood, bumper, headlamp area, grille, and suspension components were all affected. The driver side doorframe was deformed slightly and buckled outward. Both doors and the hood remained latched. The left front tire was ruptured. There was moderate damage along the left side of the vehicle and to the left rear quarter. The left side of the rear axle broke loose from the leaf spring mount and was pushed rearward. This allowed the drive shaft to disengage from the rear of the transmission and drag along the ground. This situation has resulted in rollover exit trajectories in other crash tests using a similar 2000P vehicle.

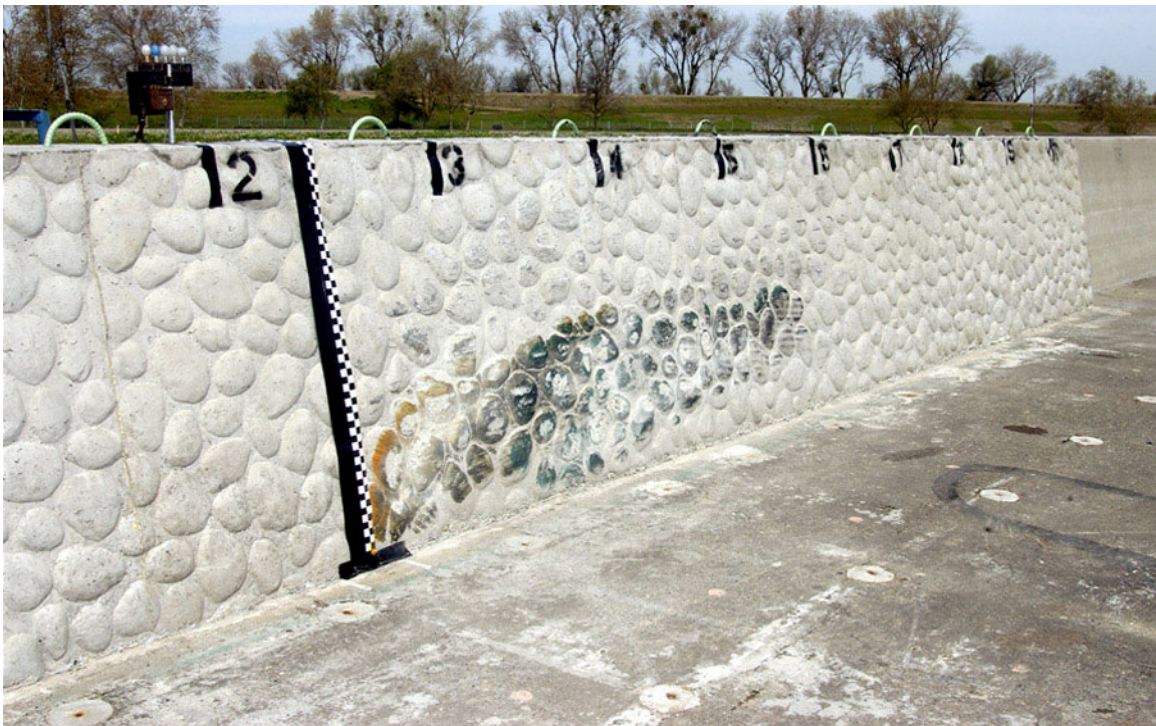
Figure 2-60 Shallow cobblestone test article after Test 589

Barrier Damage: Minor scraping of the “stone” surface. No chipping or gouging was observed. The barrier would not require immediate repair. The barrier would not require immediate repair.

There was essentially no permanent damage to the barrier during Test 589. The vehicle did cause minor scrapes and gouges in the concrete surface of the barrier. The barrier would not require immediate repair and the gouges and scrapes could be filled on-site by maintenance crews.

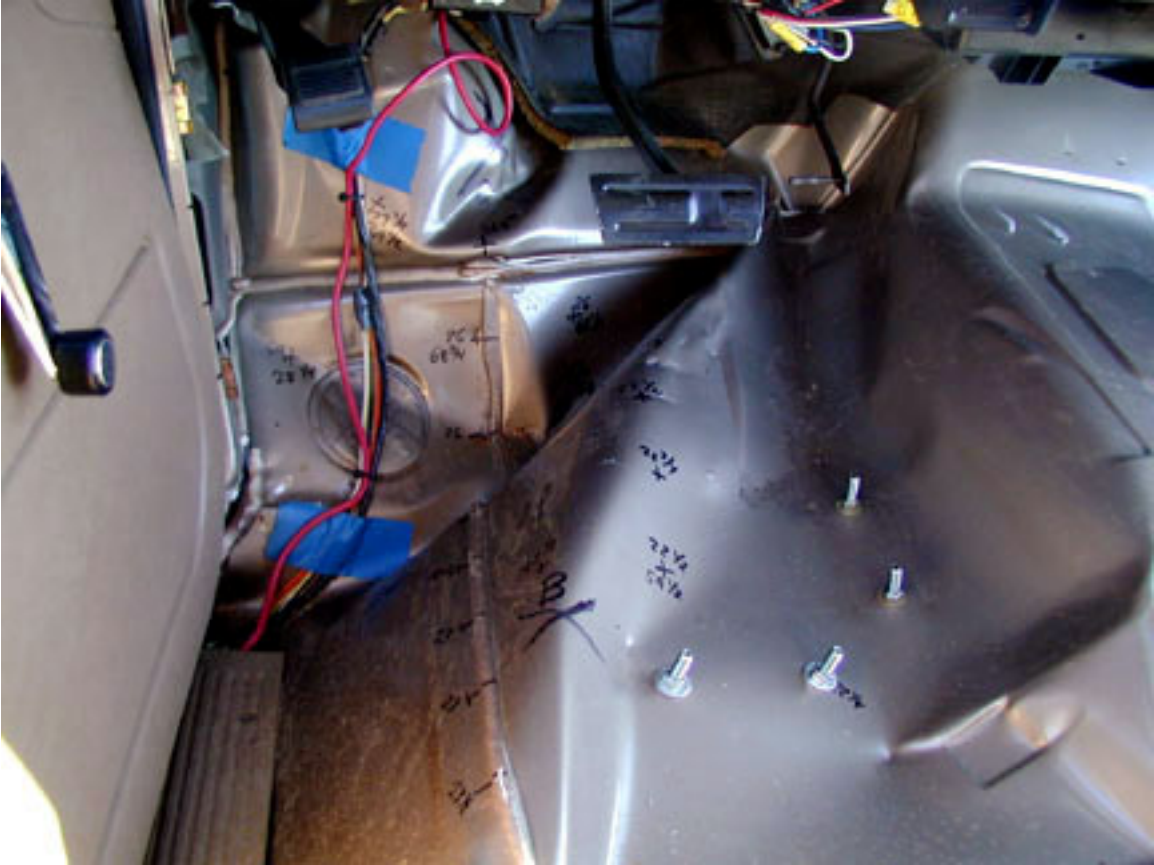
Figure 2-63 Vehicle floorboard after Test 589

The force of the initial impact drove the left front tire and rim assembly rearward into the underside of the driver side floorboard. This caused a maximum floorboard deformation (buckling) of 133 mm which is less than the accepted limit of 150 mm.
