Vehicle Crash Tests of the Type 70 Bridge Rail

January 1998

VEHICLE CRASH TESTS OF THE TYPE 70
BRIDGE RAIL

FINAL REPORT # FHWA/CA/ESC-98-06

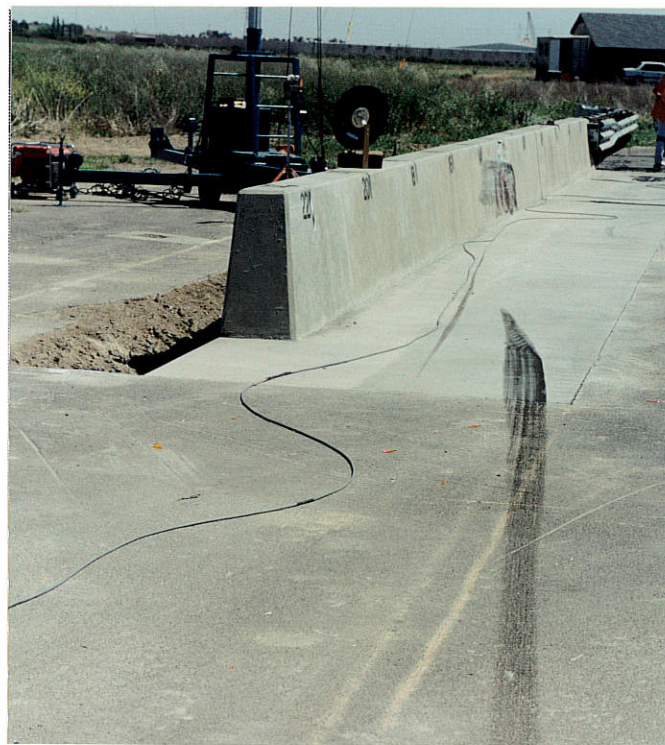
Figure 2.12 - Test 511 Downstream View Of The Type 70 Barrier

Barrier damage was cosmetic only, consisting of scrapes and tire marks. Both of the right side tires left marks along the face of the barrier for the 6.5 meters of contact. Small amounts of concrete spalled from the face of the barrier where the vehicle's sheet metal made contact.

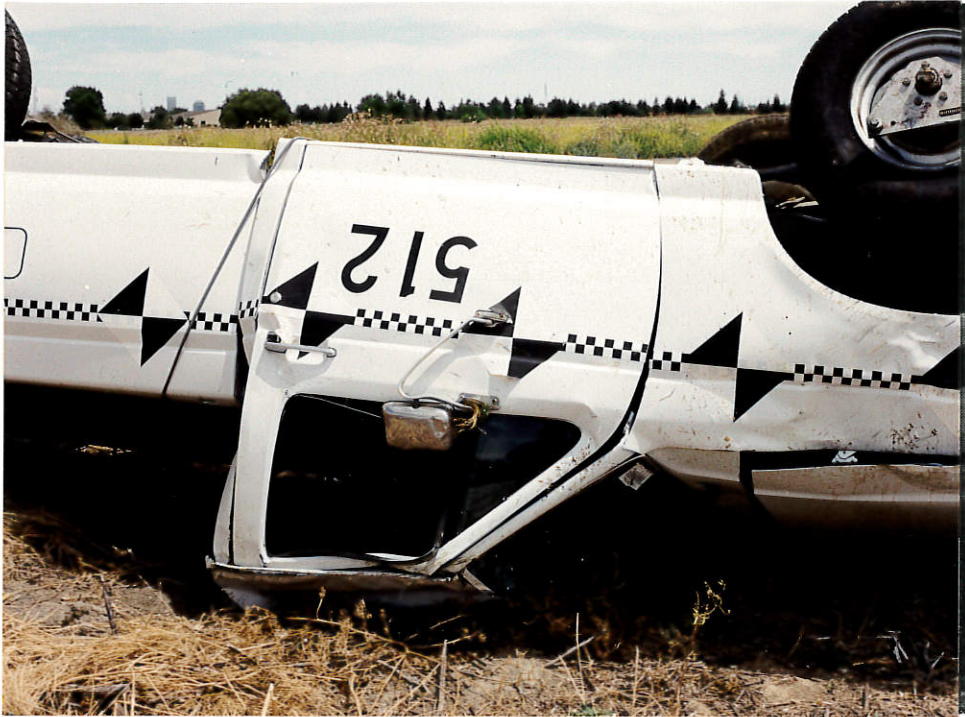
Figure 2.20 - Final Position Of Test Vehicle 512

The rollover caused major damage to all sides of the vehicle including the top and undercarriage. With the forward end of the drive shaft broken loose from the transmission, it was allowed to swing freely but did not detach from the rear axle. The passenger side of the cab was crushed to a level even with the bottom of the door window.
