DEPARTMENT OF TRANSPORTATION
DIVISION OF ENGINEERING SERVICES
Transportation Laboratory
5900 Folsom Boulevard
Sacramento, California 95819-4612

**METHOD OF EVALUATING BEND TEST RESULTS OF
FUSION-BONDED EPOXY COATINGS ON
ASTM DESIGNATION: A 934/A 934M STEEL REINFORCEMENT**

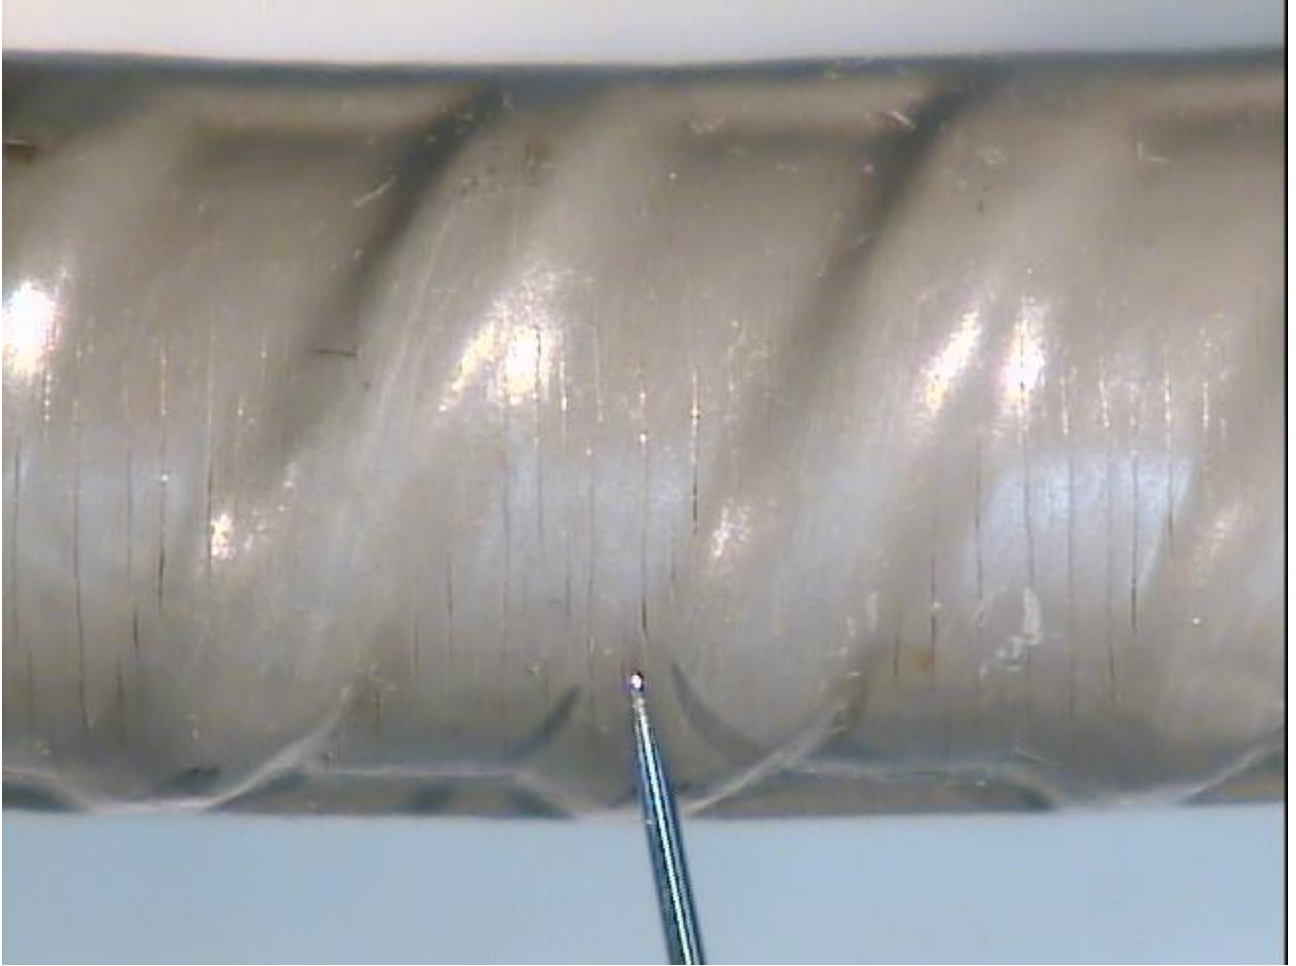
Figure 2. Breaks in the coating after bending that have been identified as coating discontinuities. The discontinuities have a repeated pattern that extends over the entire bend radius. The test bar has failed the bend requirements of this test method.

6. Figures 2 through 5 may be used to assist in identifying and classifying coating breaks.

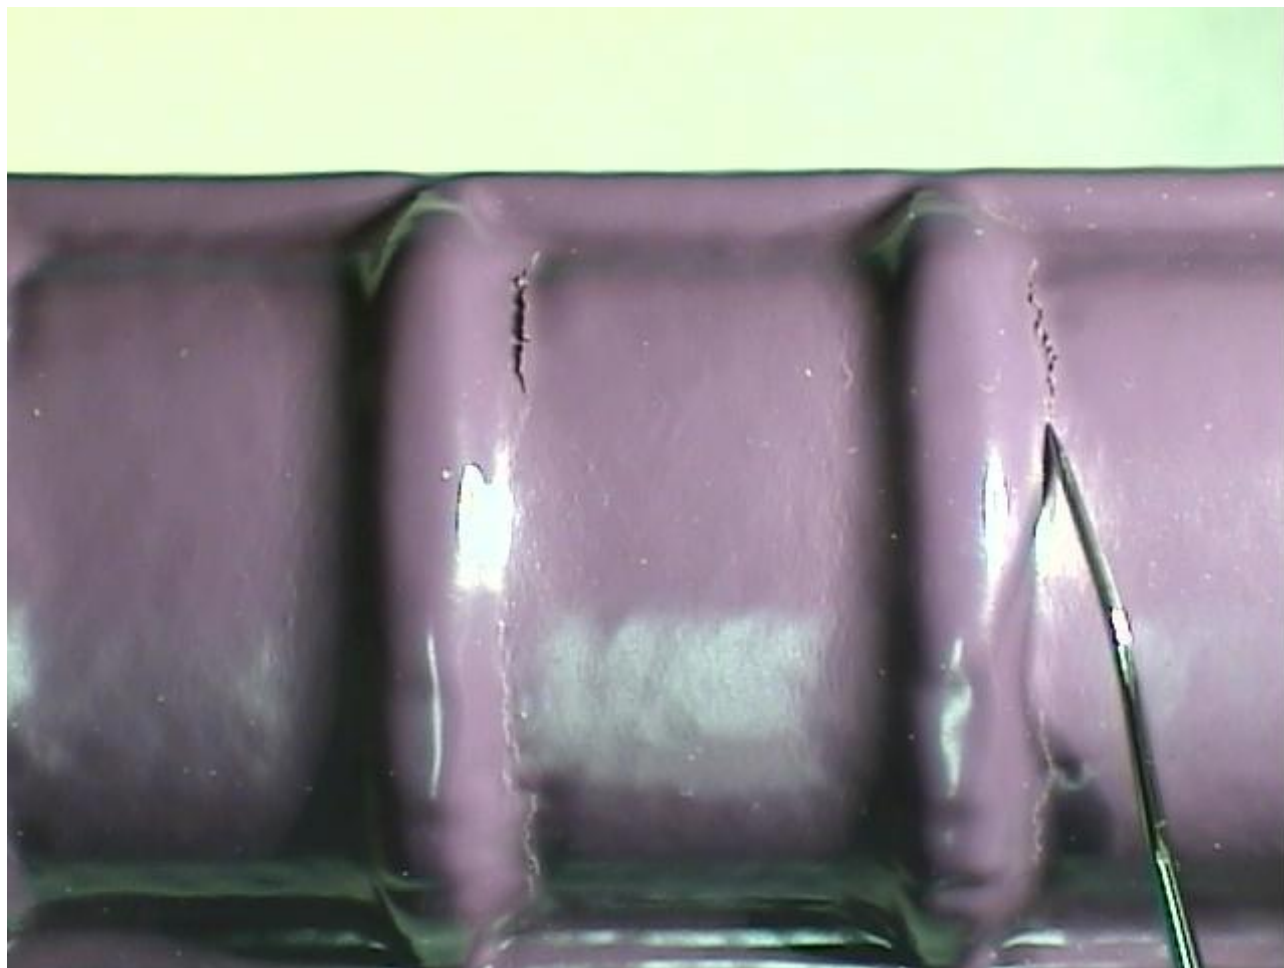
Figure 3. Test bar showing two of three breaks in the epoxy coating at the outer bend radius of a test bar. The breaks appear to be cracks that expose the underlying metal. Exposed underlying metal can be confirmed, if needed, by viewing with a 10X-magnification device.

1. Cracks and coating discontinuities in improperly cured fusion-bonded epoxy-coatings will usually appear at multiple locations along the outside bend radius of the test bar.
2. Three or more cracks on the outside bend radius of the test bar constitute nonconforming material. (See Figures 3 & 4)
3. Three or more coating discontinuities on the outside radius of the test bar constitute nonconforming material. (See Figure 2)
4. Breaks, cracks or coating discontinuities within the coating at contact points of mandrel devices used to produce the bend in a bar for the bend test should be disregarded.
5. Stretching and/or discoloration of the epoxy coating within the outside radius of the test bar after bending does not constitute nonconforming material. (See Figure 5)

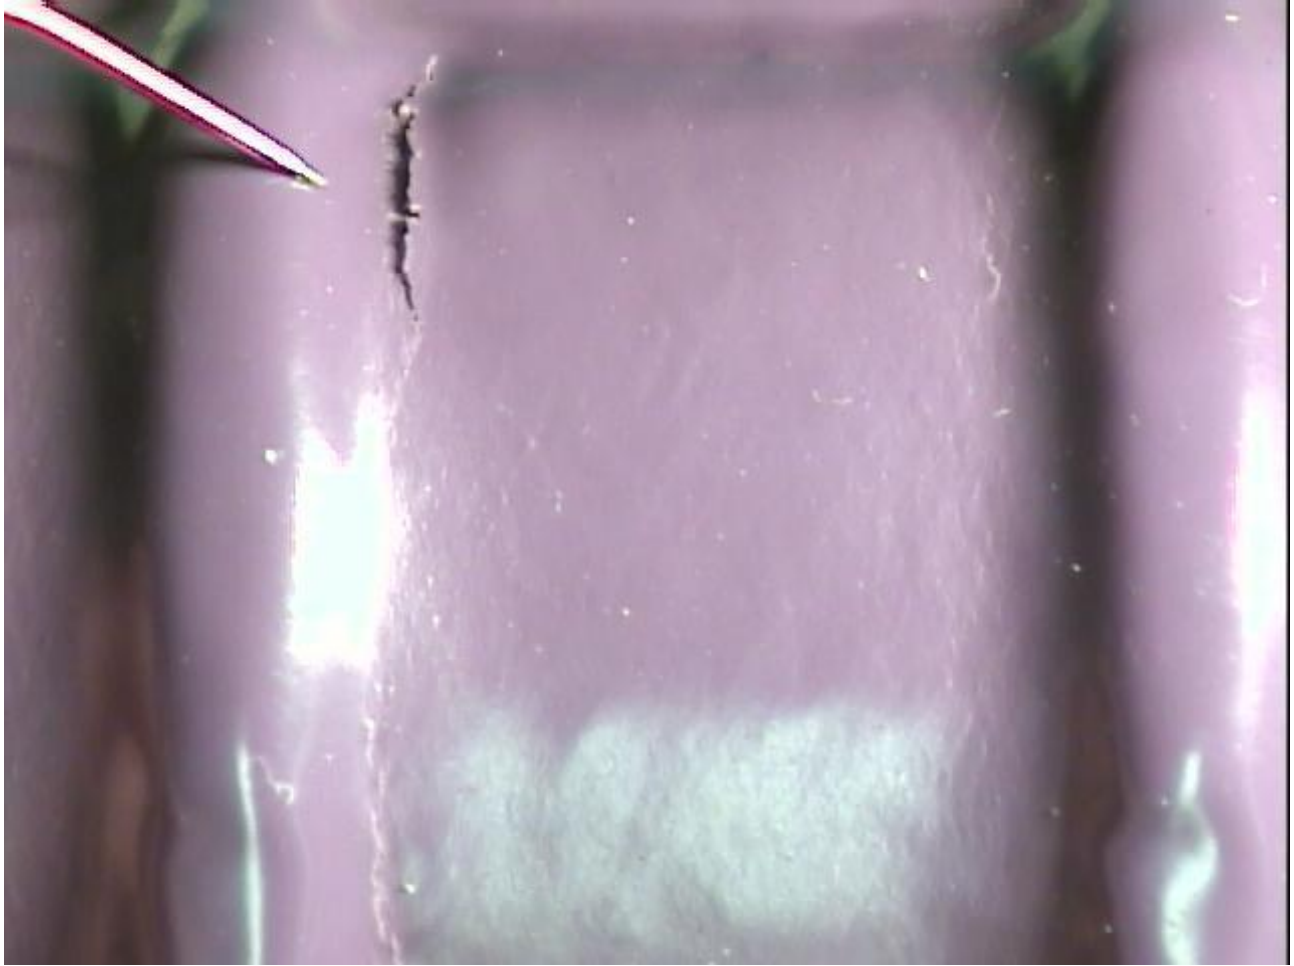
Figure 4. 10X magnification of the test sample from the photograph shown in Figure 3. The magnified view shows that the coating is separated from the bar surface and the underlying metal is exposed. The two other breaks on the test bar sample were also identified as cracks. Since the test bar incurred three cracks after bending, it has failed the bend requirements of this test method.

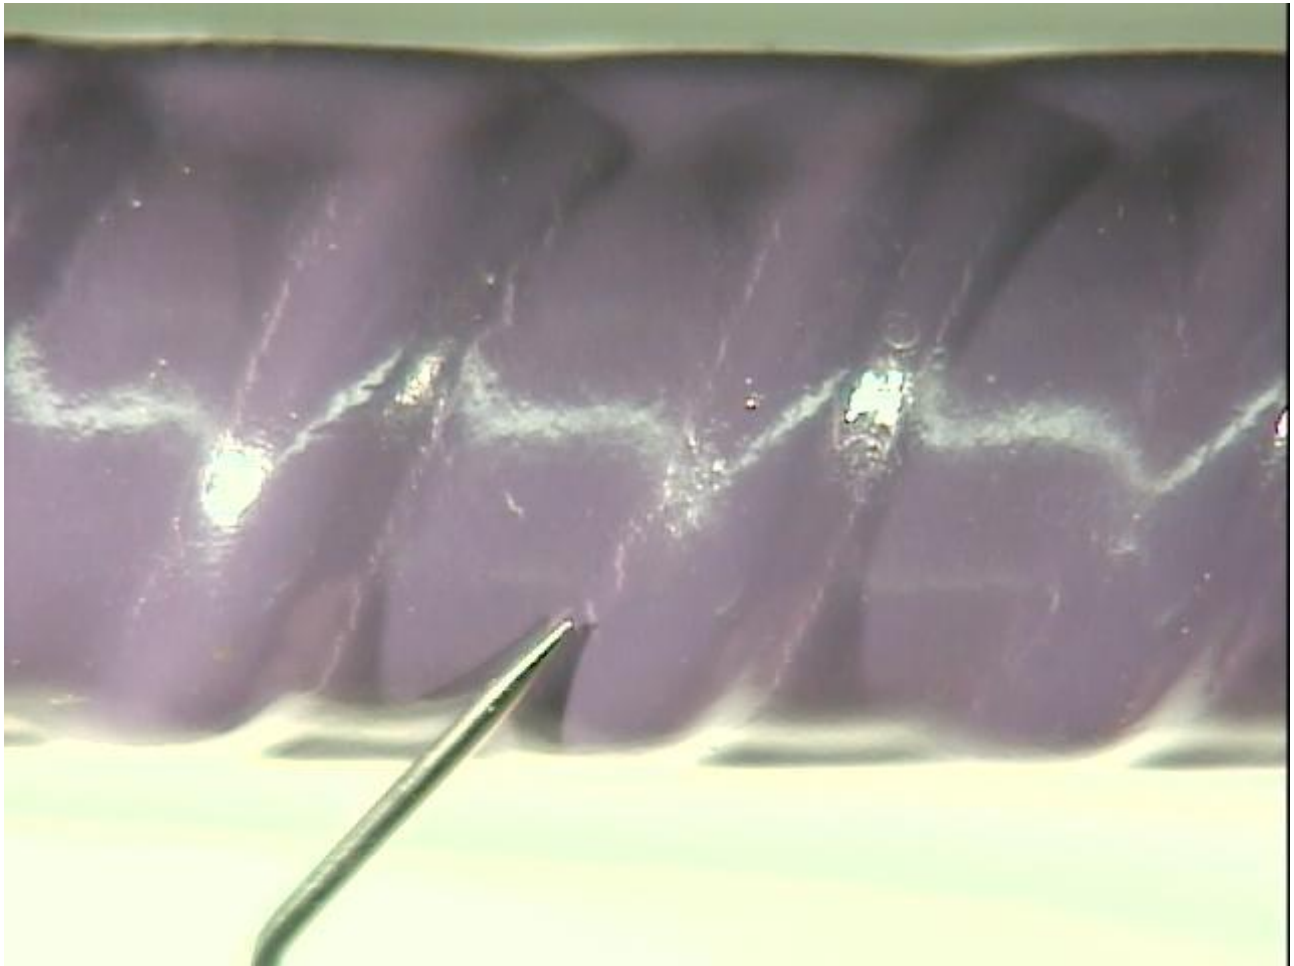
Figure 5. Test sample showing discoloration in coating after the bend test. This type of discoloration is due to stretching of the coating during bending and is typical. Discoloration of the coating after bending does not constitute a failure of the bend test.
