DEPARTMENT OF TRANSPORTATION
DIVISION OF ENGINEERING SERVICES
Transportation Laboratory
5900 Folsom Boulevard
Sacramento, California 95819-4612

**METHOD FOR EVALUATING BEND TEST RESULTS OF
FUSION-BONDED EPOXY COATINGS ON
ASTM DESIGNATION: A 934/A 934M STEEL REINFORCEMENT**

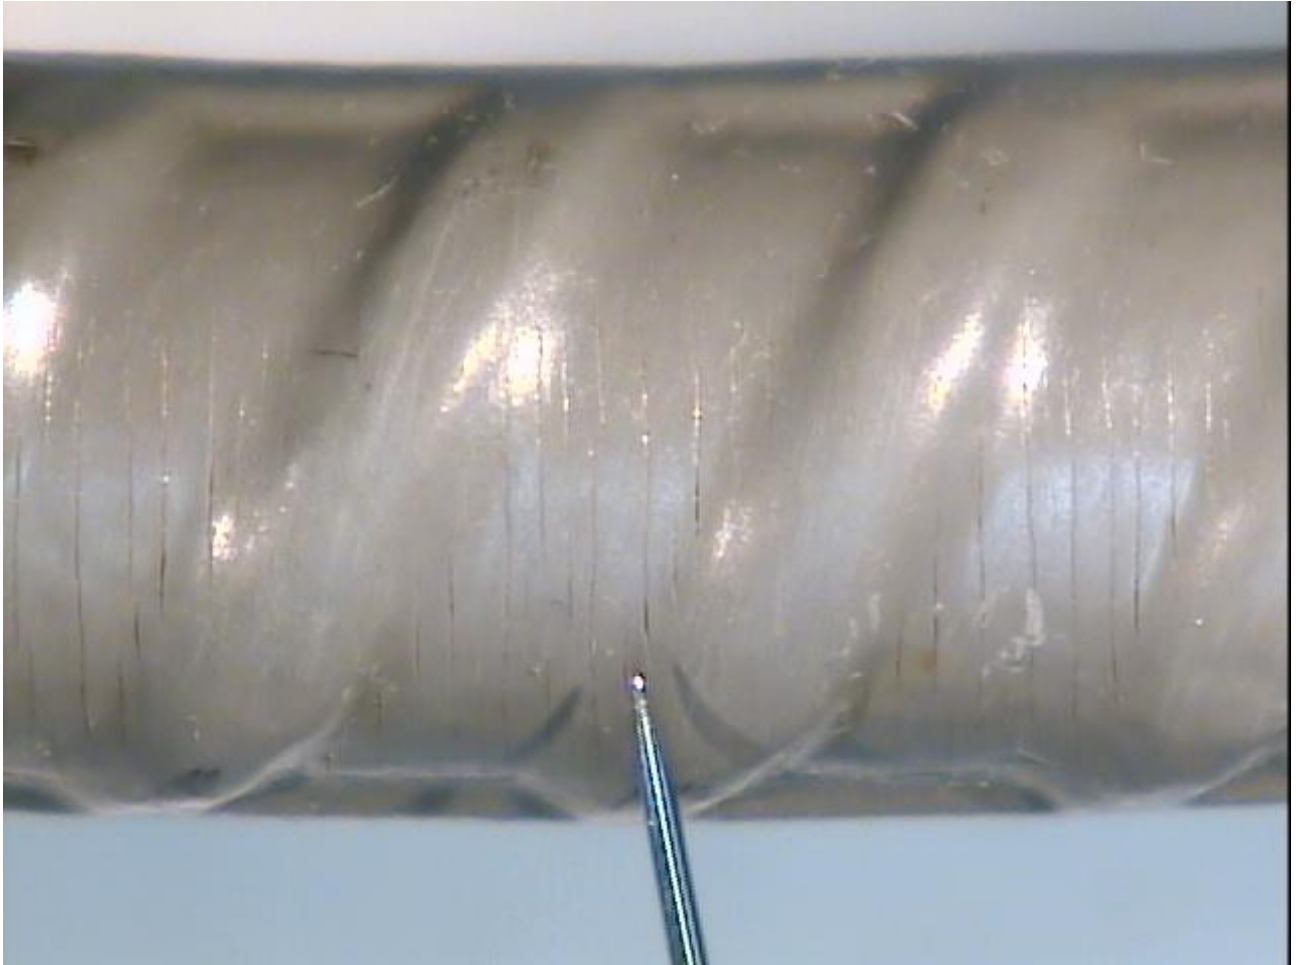
Figure 2 Breaks in the coating after bending that have been identified as coating discontinuities. The discontinuities have a repeated pattern that extends over the entire bend radius. The test bar has failed the bend requirements of this test method.

8. Figures 2 through 5 may be used to assist in identifying and classifying coating breaks.

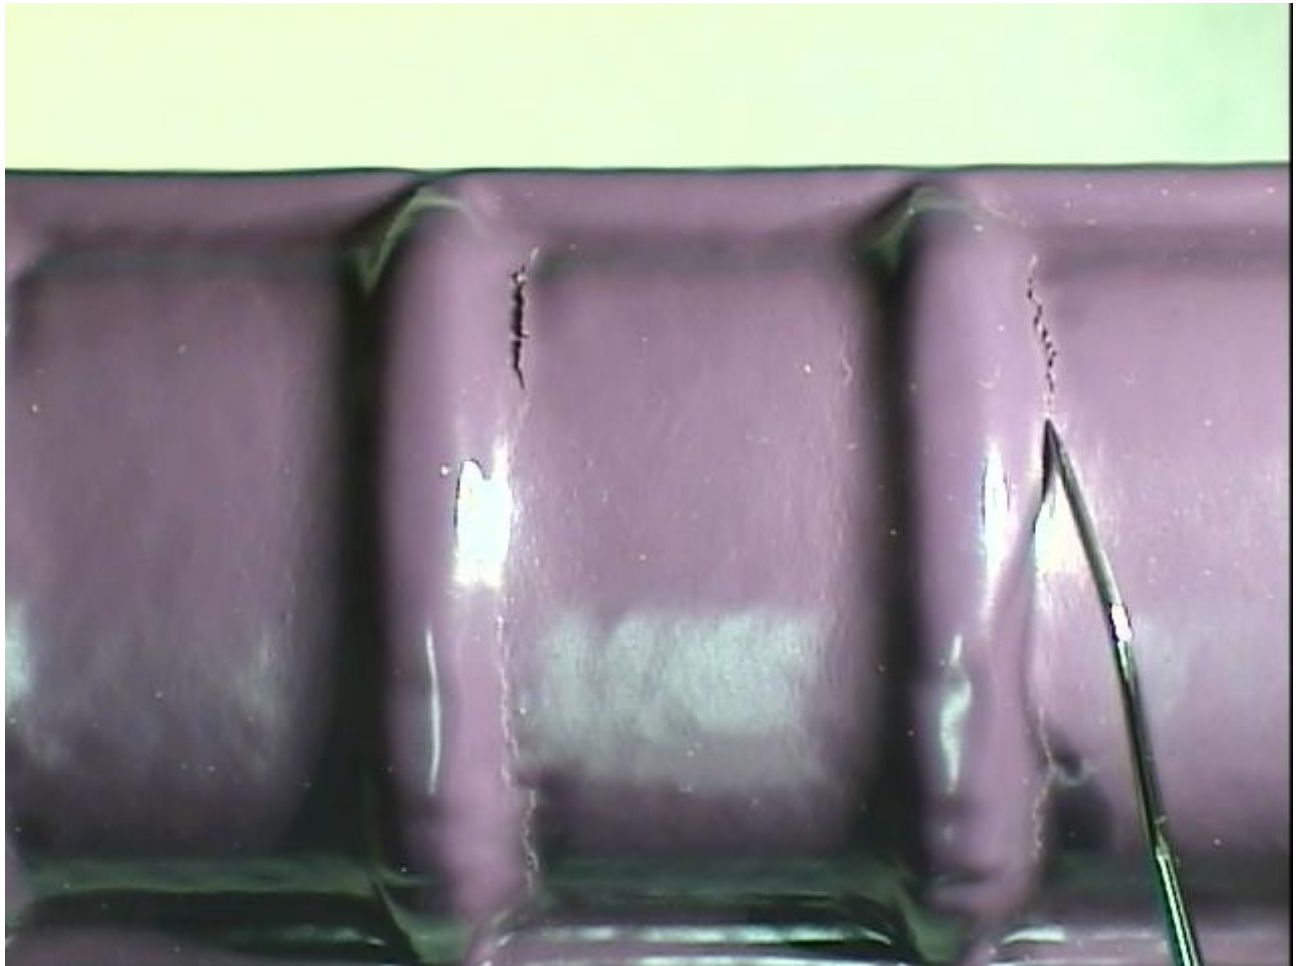
Figure 3 Test bar showing two of three breaks in the epoxy coating at the outer bend radius of a test bar. The breaks appear to be cracks that expose the underlying metal. Exposed underlying metal can be confirmed, if needed, by viewing with a 10X-magnification device.

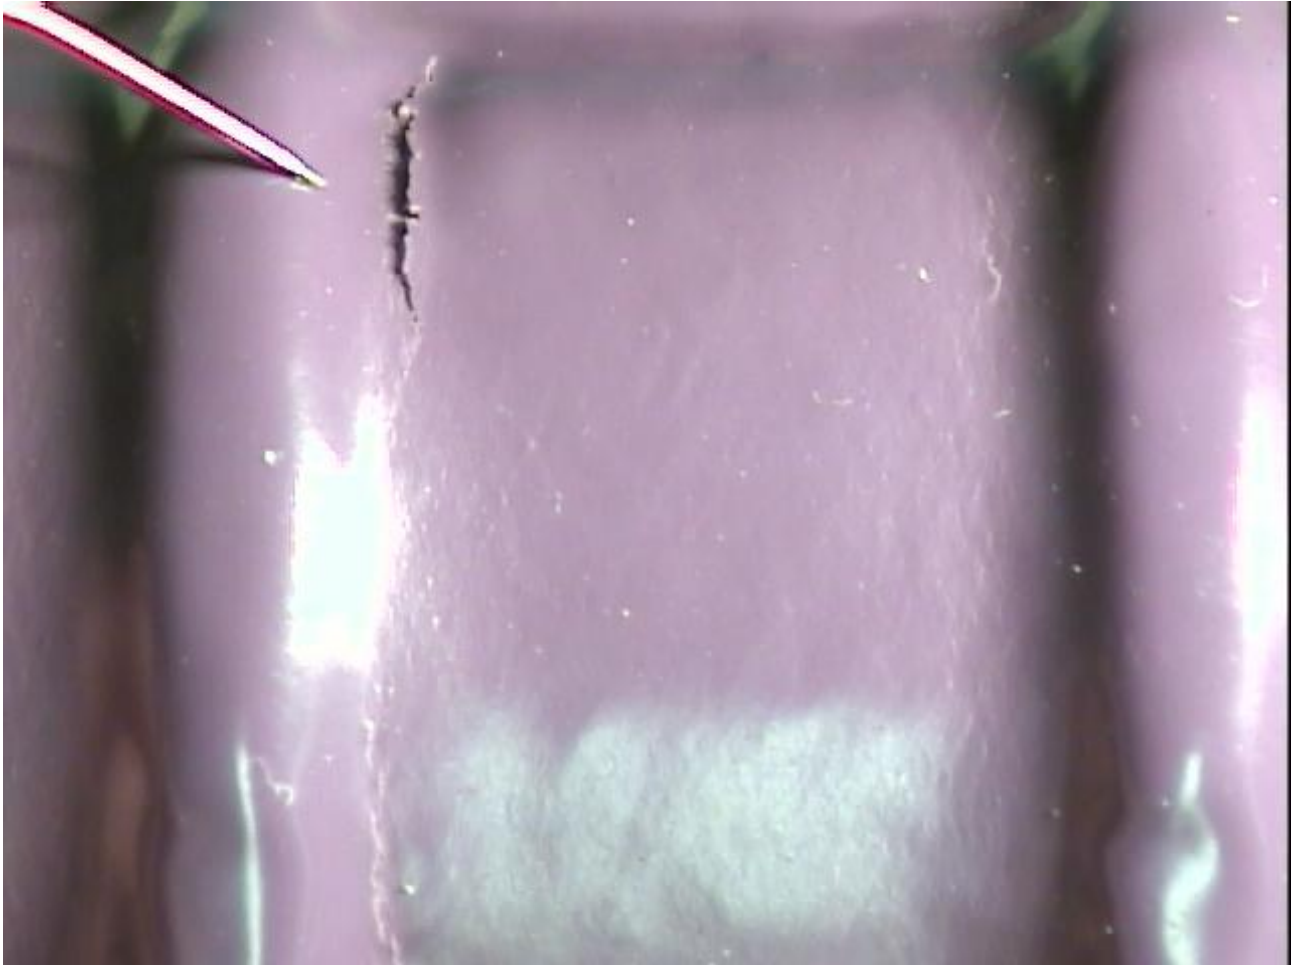
Figure 4 10X magnification of the test sample from the photograph shown in Figure 3. The magnified view shows that the coating is separated from the bar surface and the underlying metal is exposed. The two other breaks on the test bar sample were also identified as cracks. Since the test bar incurred three cracks after bending, it has failed the bend requirements of this test method.

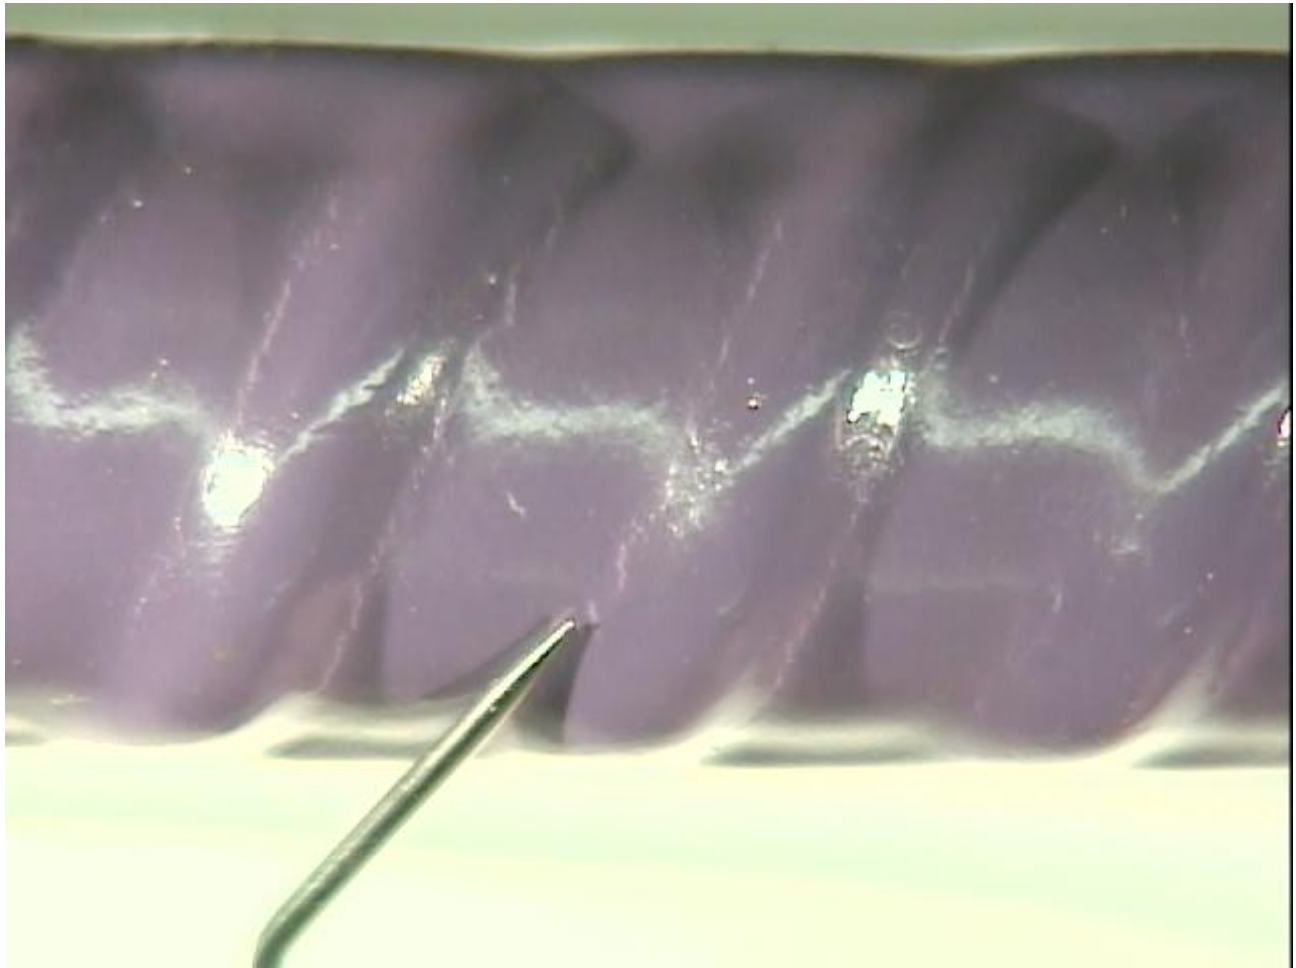
Figure 5 Test sample showing discoloration in coating after the bend test. This type of discoloration is due to stretching of the coating during bending and is typical. Discoloration of the coating after bending does not constitute a failure of the bend test.
