DEPARTMENT OF TRANSPORTATION
DIVISION OF ENGINEERING SERVICES
Transportation Laboratory
5900 Folsom Boulevard
Sacramento, California 95819-4612

**METHOD FOR EVALUATING BEND TEST RESULTS OF
FUSION-BONDED EPOXY COATINGS ON
ASTM DESIGNATION: A 934/A 934M STEEL REINFORCEMENT**

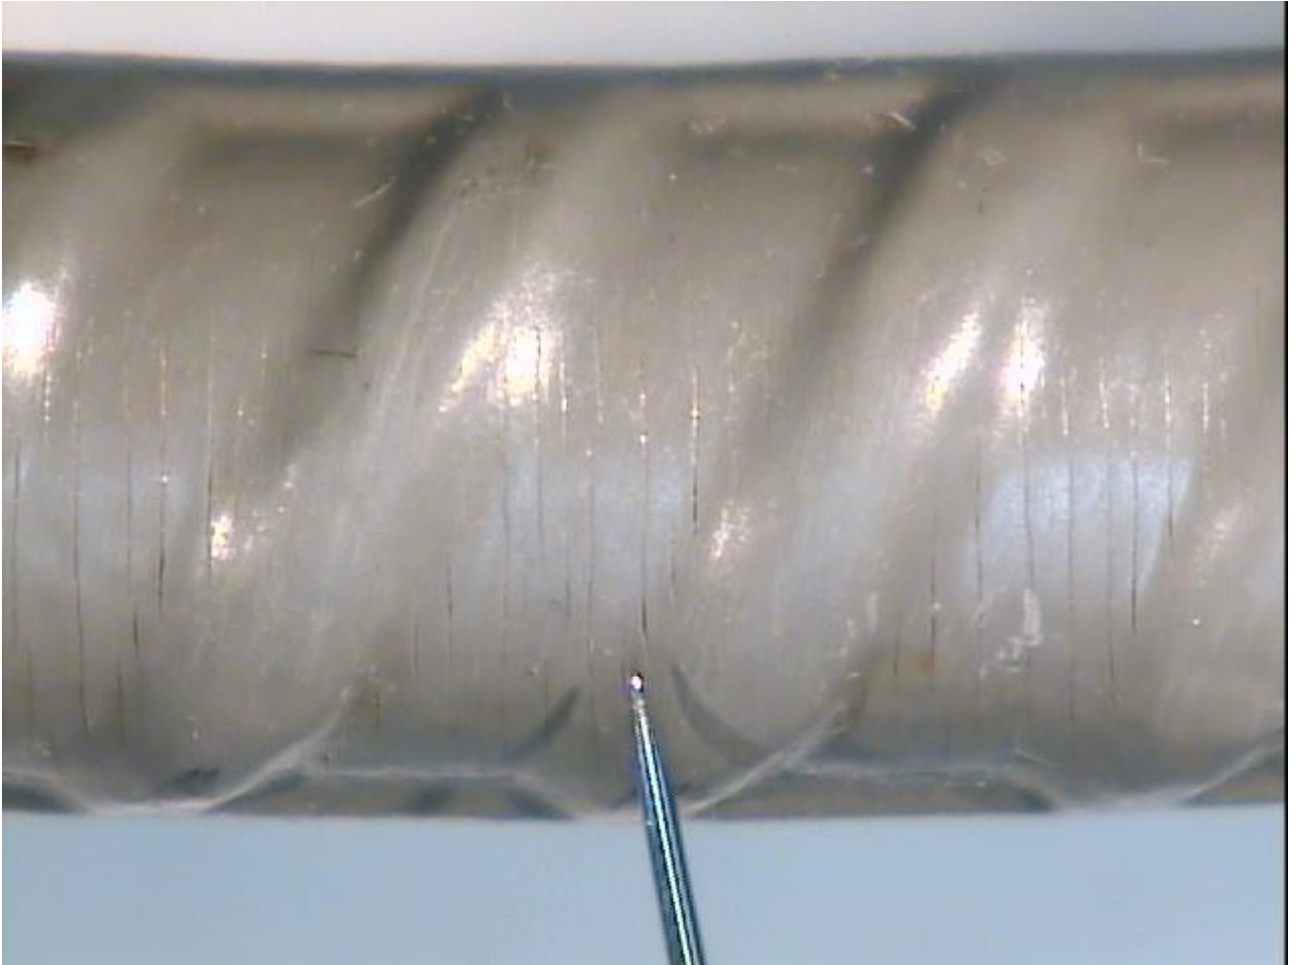
Figure 2 Breaks in the coating after bending that have been identified as coating discontinuities. The discontinuities have a repeated pattern that extends over the entire bend radius. The test bar has failed the bend requirements of this test method.

8. Figures 2 through 5 may be used to assist in identifying and classifying coating breaks.

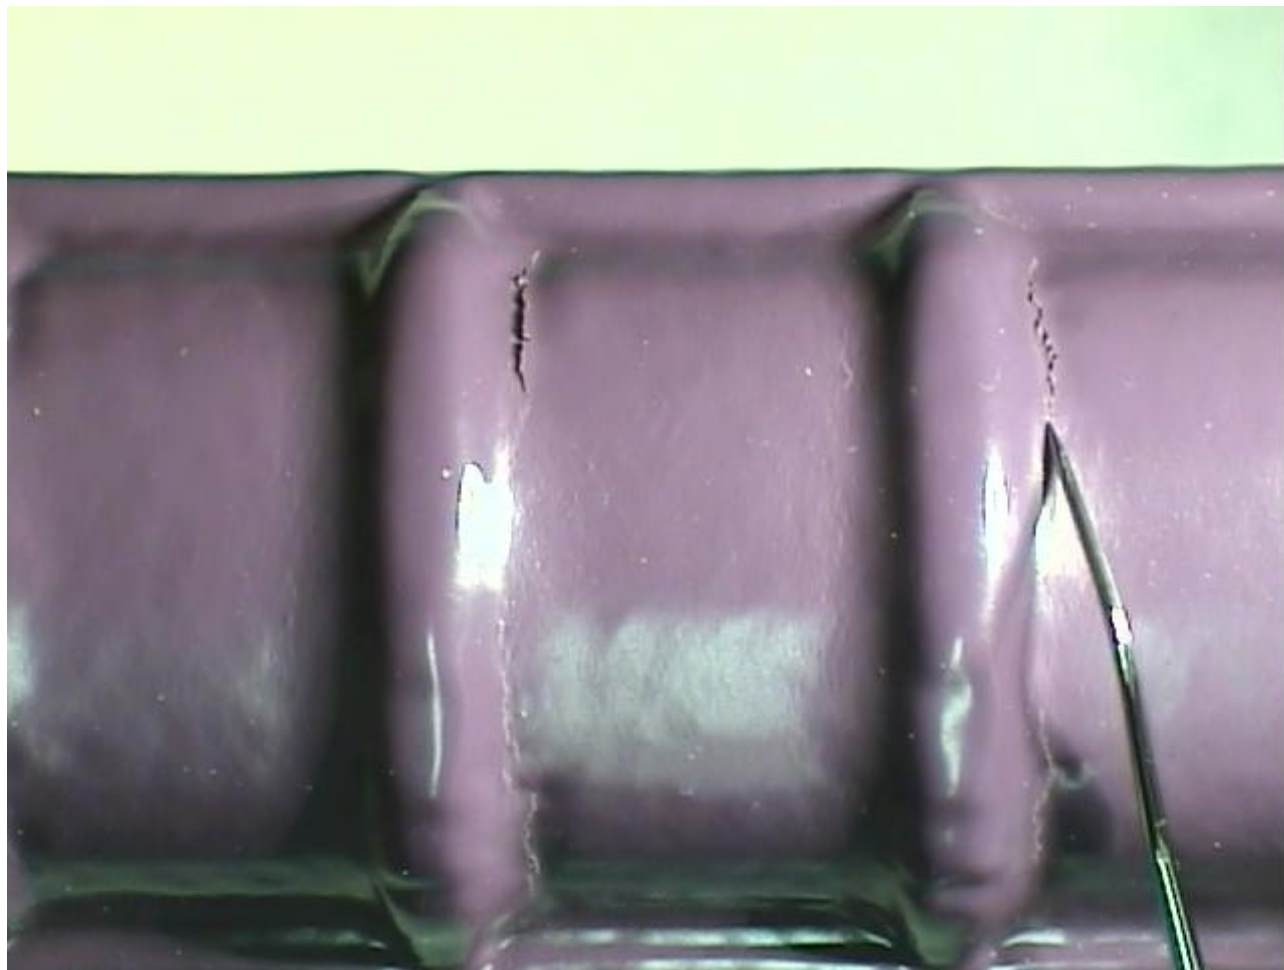
Figure 3 Test bar showing two of three breaks in the epoxy coating at the outer bend radius of a test bar. The breaks appear to be cracks that expose the underlying metal. Exposed underlying metal can be confirmed, if needed, by viewing with a 10X-magnification device.
