APPENDIX B

GUIDELINES FOR IDENTIFYING AND REPAIRING LOCALIZED AREAS OF DISTRESS IN AC PAVEMENTS PRIOR TO CAPITAL PREVENTIVE MAINTENANCE OR REHABILITATION REPAIRS

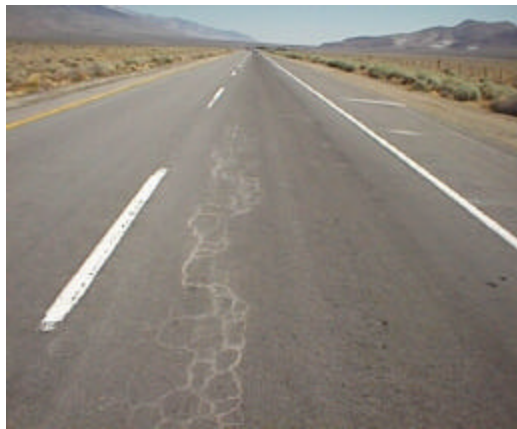
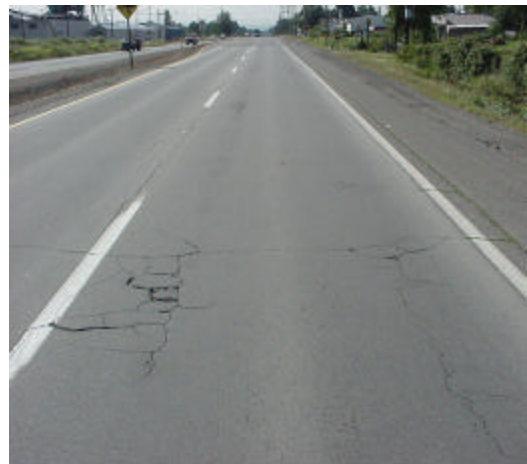
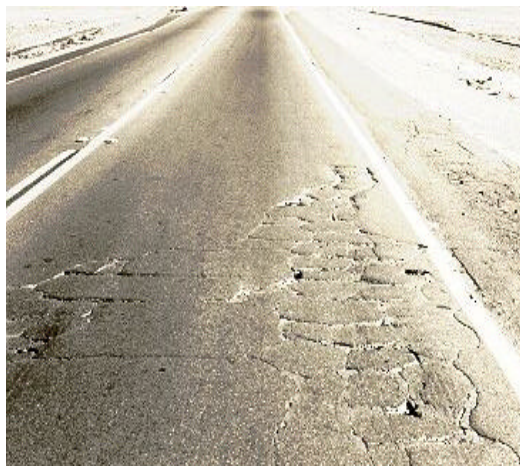
a) Alligator Cracks

Alligator cracking is characterized by interconnected or interlaced cracks in the wheel path, forming a series of small polygons, (generally less than 1 foot on each side). The cracking resembles the appearance of alligator skin, thus the term alligator cracking. Alligator cracking is a load-related distress and occurs when the wheel loads exceed the design of the roadbed.

2. Alligator Cracking
Alligator cracking is probably caused by a saturated base or subgrade. Therefore, correction should include removal of the wet material and installation of needed drainage. When water is a factor in the cracking, drainage should first be corrected.

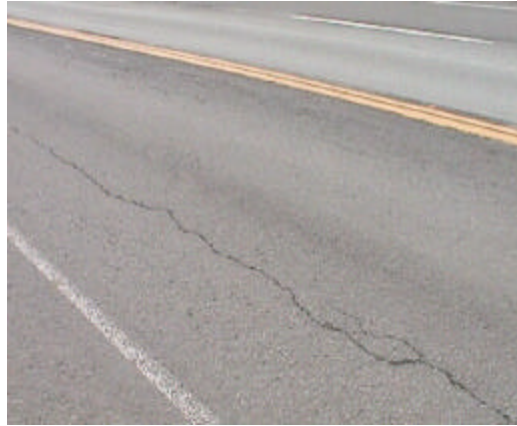
b) Longitudinal Cracks

Longitudinal cracks are non-load-associated cracks. Longitudinal cracks are single cracks approximately parallel to the centerline. These cracks are primarily due to the contraction and shrinkage of the surface course, reflection from underlying pavement joints, poorly constructed paving joints, or roadbed settlement.

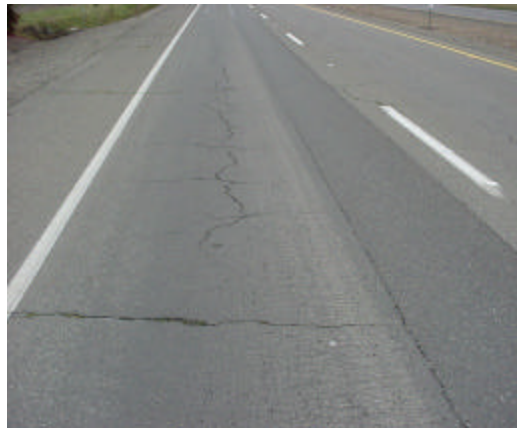
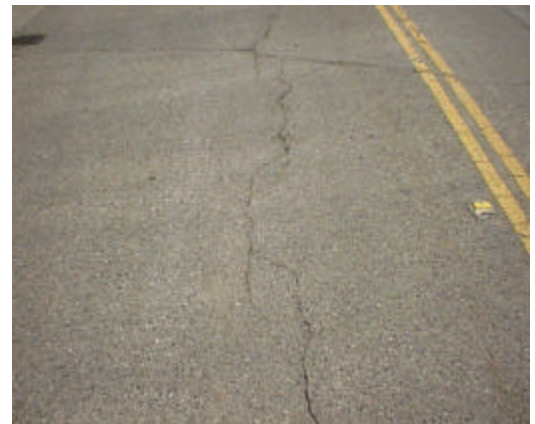
c) Transverse Cracks

Transverse cracks are non-load-associated cracks. Transverse cracks appear approximately at right angles to the centerline. These cracks are primarily due to the contraction and shrinkage of the surface course or reflection from underlying pavement joints.

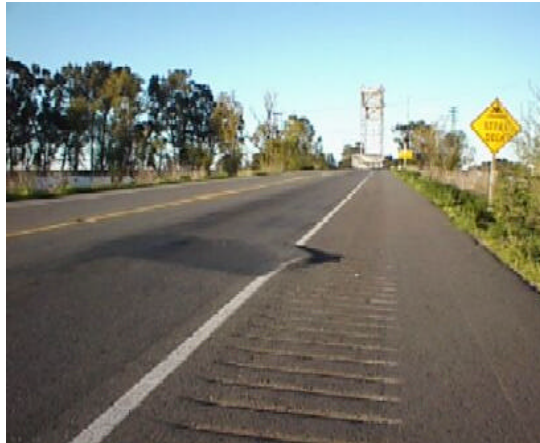
c) Settlement

Settlement is a noticeable or abrupt vertical distortion from the original pavement profile or cross-slope. Settlement is often associated with fill areas. This condition may also have associated cracking, Settlement Cracking.

Settlement in localized areas of limited size is sometimes accompanied by cracking. When water collects in these depressions, they become not only a source of pavement deterioration but also a hazard to motorists.

Depressions are caused by traffic loads heavier than that for which the pavement was designed, by poor construction methods, or by consolidation deep within the subgrade. Edge cracks and depressions can also be caused by the lack of lateral or shoulder support for the asphalt pavement.

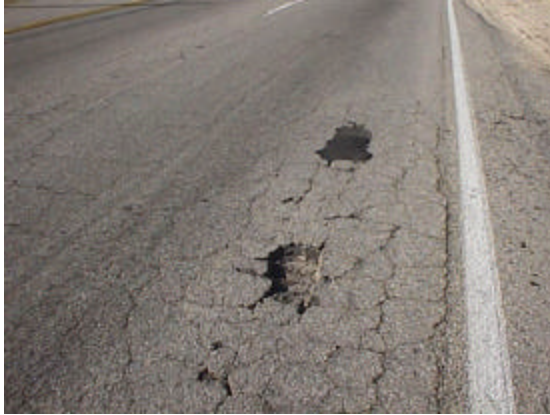
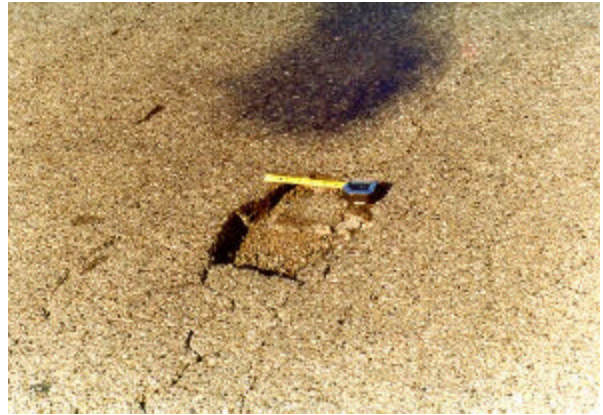
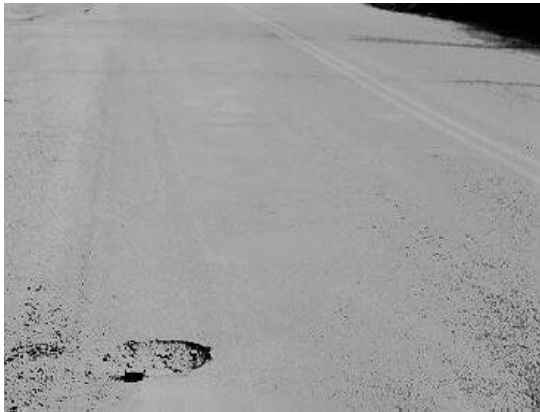
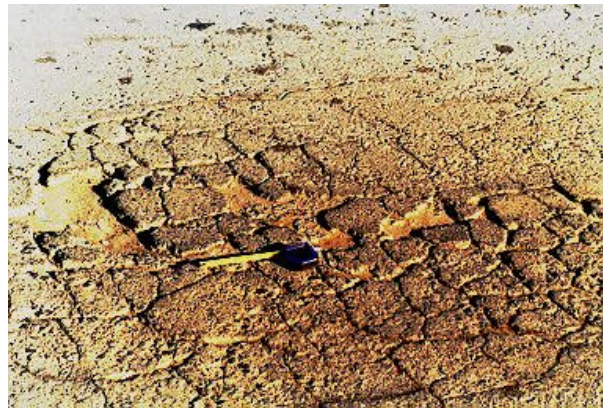
a) Pot Holes

Potholes are isolated, bowl-shaped holes in the pavement of various sizes. Generally, potholes are a result of the loss of alligatored pavement and, if so, they can be irregular in shape due the adjacent alligatored pavement. They frequently appear when maintenance is not promptly applied once the distress that is causing them appears.

1. Potholes
Potholes typically are the result of localized asphalt disintegration under traffic. A pothole is usually caused by weakness in the pavement resulting from too little asphalt, too thin an asphalt surface, too many fines, too few fines, or poor drainage. Potholes frequently appear when it is difficult, because of inclement weather, to make permanent repairs. Temporary repairs usually involve cleaning out the hole and filling it with a premixed asphalt patching material.

Recommended Repair: Permanent repair is made by constructing a partial depth or deep patch that completely removes the affected area and replaces it with new AC and base materials, as necessary.
