STATE OF CALIFORNIA • DEPARTMENT OF TRANSPORTATION	
TECHNICAL REPORT DOCUMENTATION PAG	Ε

Evaluation of Sensys Networks Wireless Magnetometers for Traffic Signal and Ramp Meter Actuation

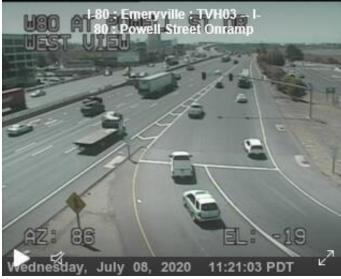
Figure 2 - Sensys detection zones at ramp meter location

The magnetometers were placed in the lanes to establish six separate detection zones, including "Demand" zones (D1 & D2), "Passage" zones (P1 & P2) and "Queue" zones (Q1 & Q2) for each of the two on-ramp lanes (see Figure 2). Video was recorded from a CCTV camera mounted on a dedicated pole just North of the onramp. The camera view was positioned appropriately to capture either the queue or demand/passage zones (see Figure 3).

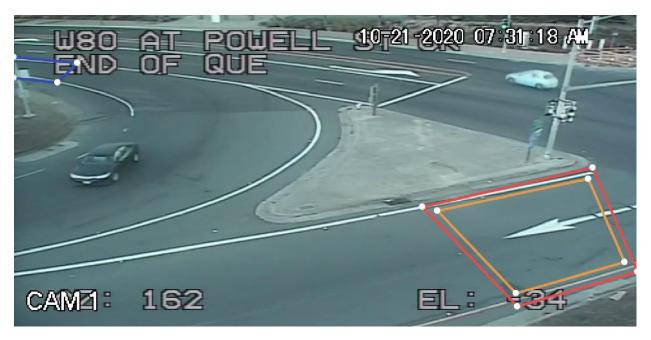
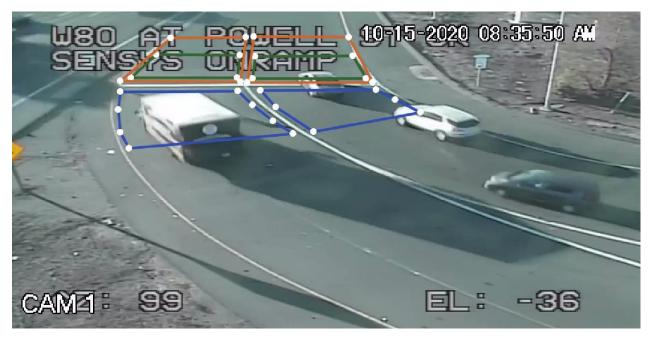
Figure 3 - Caltrans' CCTV camera views of the ramp meter location

(Queue detection zones – above)

(Demand and Passage detection zones – above)

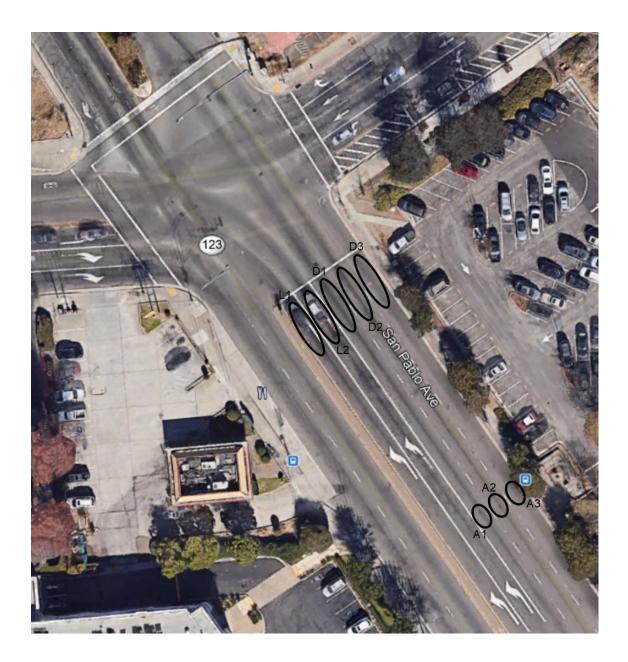
Figure 5 - Sensys detection zones at signalized intersection location

The magnetometers were placed in the lanes to establish eight separate detection zones, including a "Demand" zone for each of the three through lanes (D1, D2 & D3), an "Advanced" zone for each of the three through lanes (A1, A2 & A3) and a "Left turn" zone for each of the two left turn lanes (L1 & L2). (See Figure 5). Video was recorded from a CCTV camera mounted on a signal standard at the Northeast corner of the intersection (see Figure 6).

At the Northbound approach of the intersection of San Pablo & Cutting, there are 3 through lanes and two left turn pocket lanes. The through lanes have stop bar and advanced inductive loops, so 6 detection channels (1/lane/detection zone) were needed, which required 3 2-channel contact closure cards. The two left turn pocket lanes have stop bar inductive loops, so 2 additional detection channels were needed, which required another 2-channel contact closure card (see Figure 5). A total of 4 cards was needed (see Figure 27).

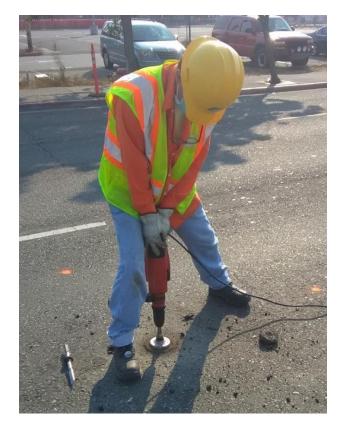
Figure 8 - Drilling hole in pavement

Both sites used Sensys wireless magnetometers embedded under the surface of the road. Four-inch diameter holes were drilled, vacuumed and partially filled with epoxy sealant. Magnetometers were placed in the holes, and the holes were filled to the road surface (see Figures 7 through 12). 18 magnetometers were installed at the Powell Street ramp meter location, and 23 magnetometers were installed at Cutting/San Pablo intersection location. It took a four-person crew about three hours for each installation.

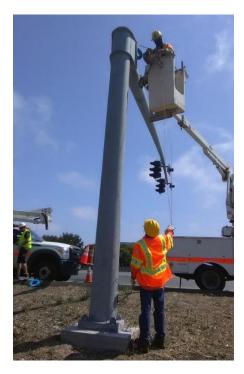
Figure 13 - Pulling Cat5e cable into ramp meter standard with fish tape

The Sensys magnetometers communicate wirelessly with a Sensys Serial Port Protocol (SPP) Radio, either directly or through a Sensys repeater, depending on the distance. The SPP radios and repeaters were mounted on the ramp meter standard and the CCTV pole at the ramp meter location. They were mounted on the traffic signal standard and a "Trailblazer" sign pole (part of the I-80 connected corridor project) at the intersection (see Figures 13 through 18).

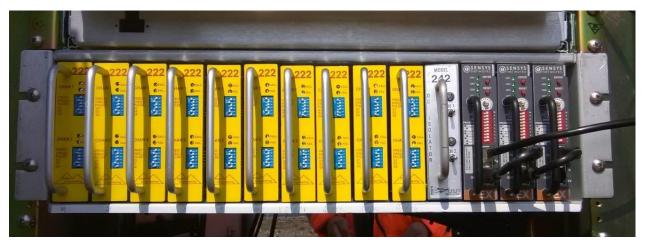
Figure 26 - Sensys contact closure cards in three rightmost slots

At the onramp to Southbound I-80 just North of Powell Street, there are 2 queue detection zones, one for ramp entry from Northbound Frontage Road traffic and one for ramp entry from Southbound Frontage Road traffic. There are 2 corresponding demand (stop bar) detection zones and 2 passage (downstream of stop bar) detection zones (see Figure 2). Therefore, in order to detect Northbound entry and Southbound entry traffic independently, a total of 6 detection channels (1/lane/detection zone) was needed, which required 3 2-channel contact closure cards (see Figure 26).

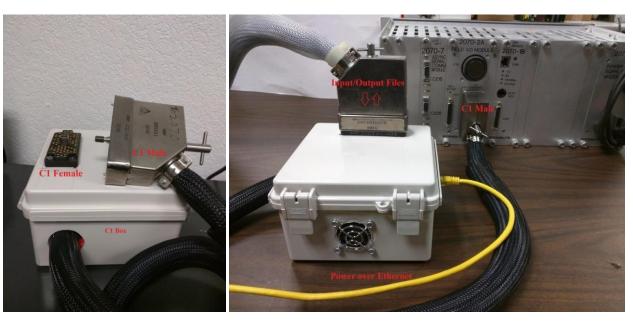
C1 Reader connected between the controller and the cabinet Figure 28 - C1 reader

The C1/C11 reader (see Figure 28) samples all logic signals on the 104-pin C1 connector cable and the 19-pin C11 connector cable between the controller and the cabinet. This includes the detection input file, into which the inductive loop detector cards and the Sensys contact closure cards were plugged (see Figure 29). The C1 and C11 logic signals were recorded concurrently with the video at both test locations.

C1 Reader data collector

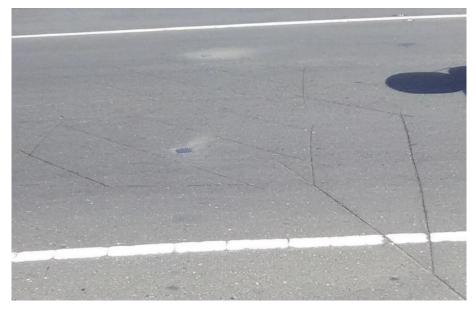
Figure 32 - two Sensys magnetometers installed abreast in unusually wide lane

At the ramp meter, the Sensitivity of the Sensys detectors was a little lower than that of the loops. The two lanes of this ramp meter are unusually wide. They are almost 24 feet, or twice the standard width, in some places. This contributed to the relatively low Sensitivity values in general, and for the Q detection zones in particular (see Table 1). In the case of the Sensys detectors, this is probably because only one magnetometer was installed for each Q detection zone. On the other hand, Sensys installed two adjacent magnetometers for each Demand and Passage detection zone (see Figure 32), which resulted in higher Sensitivity values (see Table 1). The unusual width of the lanes also seems to have accommodated queue skipping by several vehicles, as observed in the videos, particularly during periods of heavy congestion. These queue skipping vehicles tended to bypass both the Sensys and loop detectors and probably contributed to the generally lower Sensitivity values for the ramp meter compared to those of the intersection.
