STATE OF CALIFORNIA
DEPARTMENT OF TRANSPORTATION
ENGINEERING SERVICE CENTER,
OFFICE OF MATERIALS AND FOUNDATIONS

**VEHICLE CRASH TESTS OF THE
TYPE 80 BRIDGE RAIL**

1. REPORT NO. FHWA/CA/ESC-98/06 Part 3	2. GOVERNMENT ACCESSION NO.	3. RECIPIENT'S CATALOG NO.	
4. TITLE AND SUBTITLE VEHICLE CRASH TESTS OF THE TYPE 80 BRIDGE RAIL		5. REPORT DATE March 1999

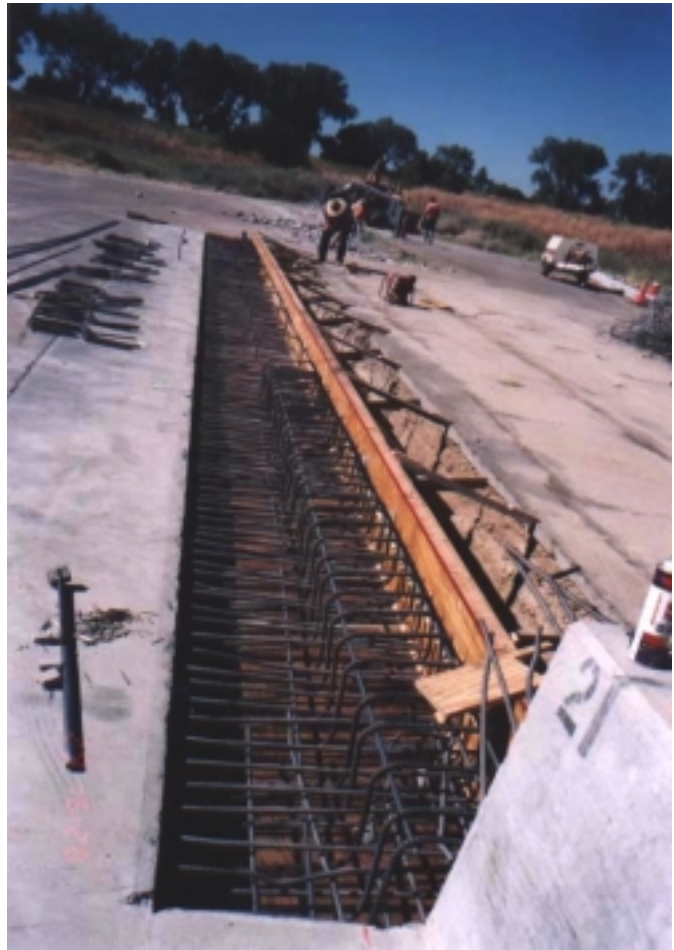
Figure 2-2 Concrete Anchor Block with Simulated Bridge Deck Reinforcing Steel

The bridge rail was constructed in several stages. An existing anchor block with a simulated bridge deck was utilized for the new bridge rail. The existing simulated bridge deck was demolished with the reinforcing steel retained for use in the new deck, shown in Figure 2-2. Additional reinforcing steel was added to the steel retained, including bars which looped up out of the deck approximately 200 mm above the deck surface. The forms for the new simulated deck were completed and concrete was poured level to the deck surface, Figure 2-3. Forms were then placed to support the concrete and reinforcing steel for the barrier base and posts, Figure 2-4.

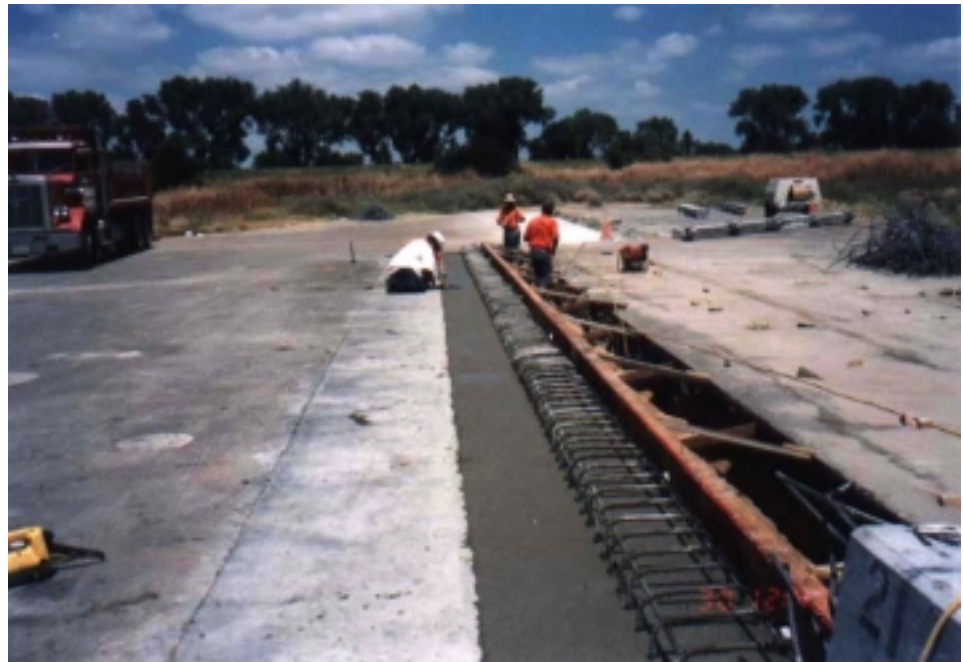
Figure 2-3
Simulated Bridge
Deck Construction

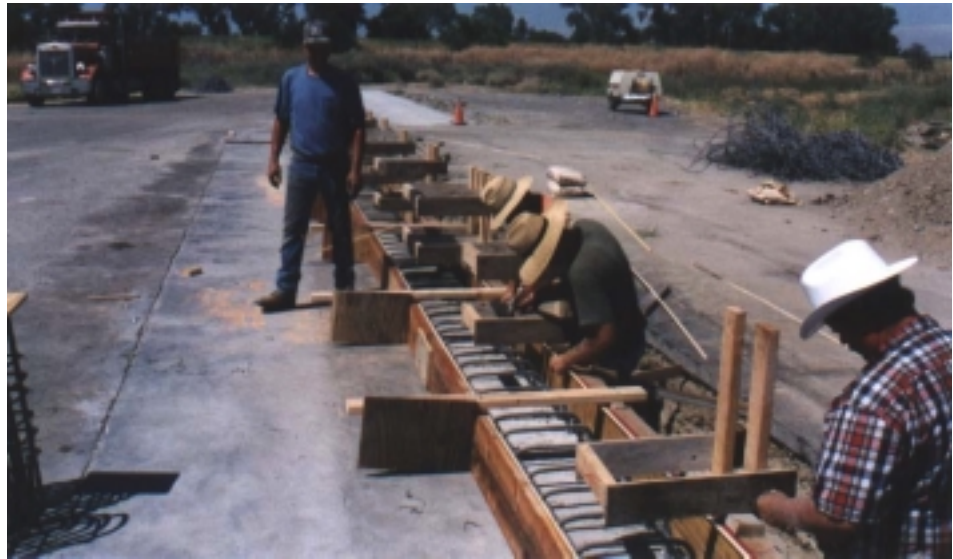
Figure 2-4 Form Construction for Curb

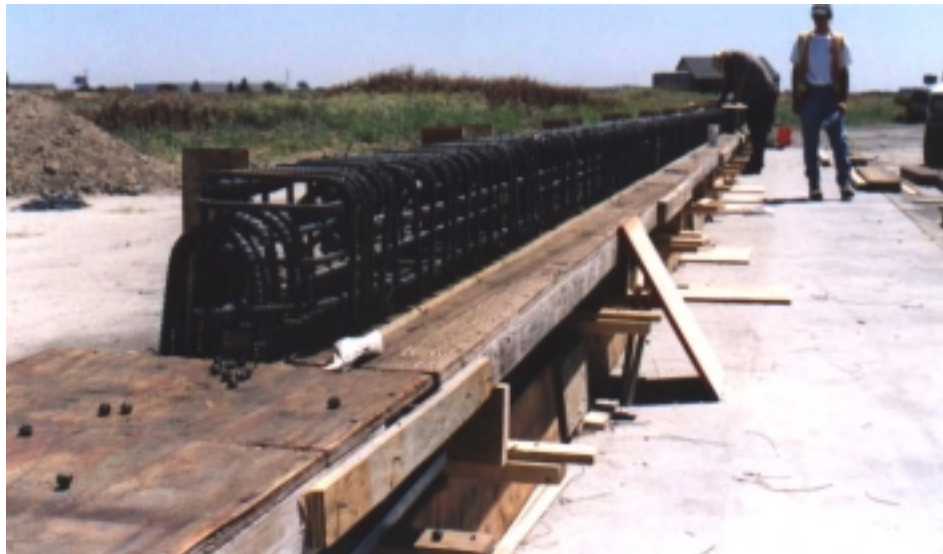
Figure 2-5 Steel Placement for Beam Section

Next, the reinforcing steel was installed for the beam section of the barrier, Figure 2-5 through Figure 2-8. Longitudinal reinforcing for the beam was mechanically butt spliced in place. After all of the post and beam reinforcing was tied in place and the forms set, the last concrete pour was completed. In all occurrences wood forms were used and the concrete was vibrated. Figure 2-10 through Figure 2-12 depict the completed barrier.

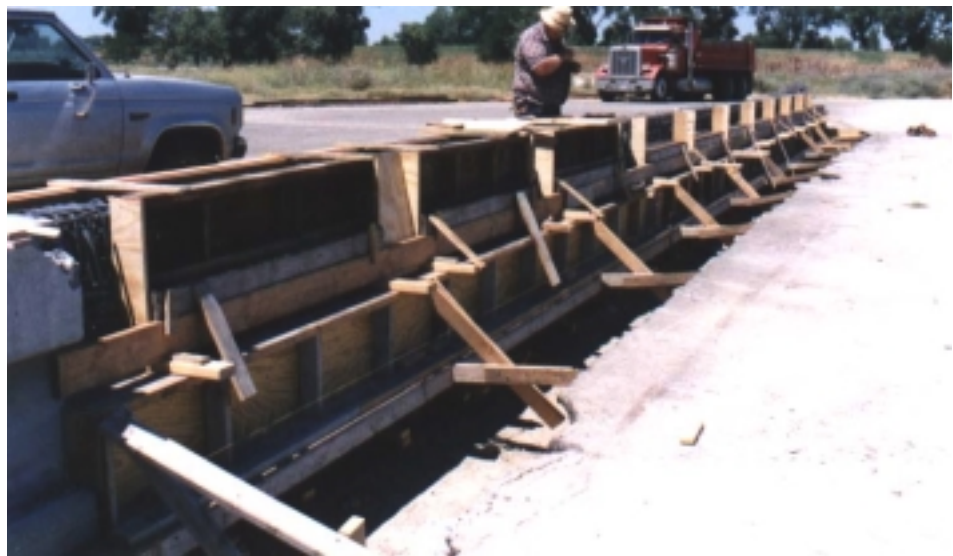
Figure 2-6 Form Placement for Beam Section

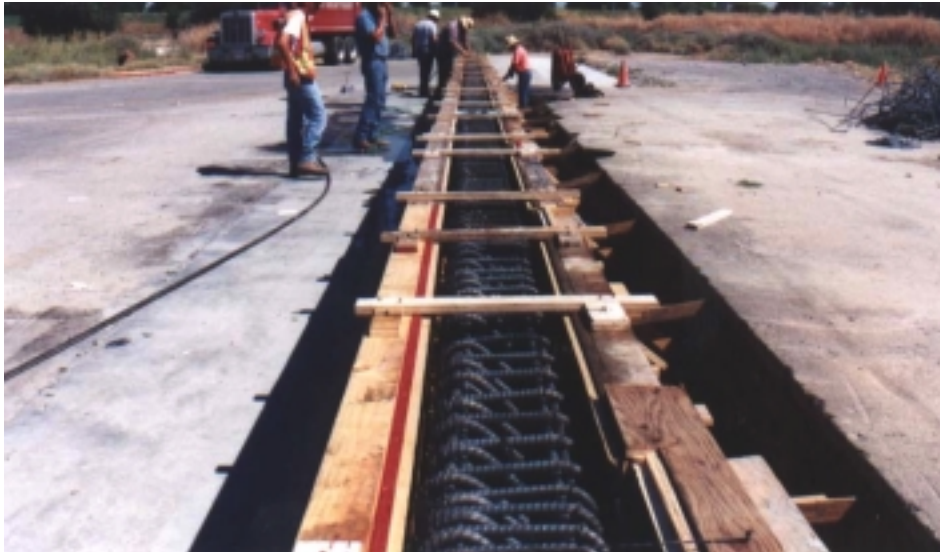
Figure 2-8 Top
View of Forms for
Beam Section

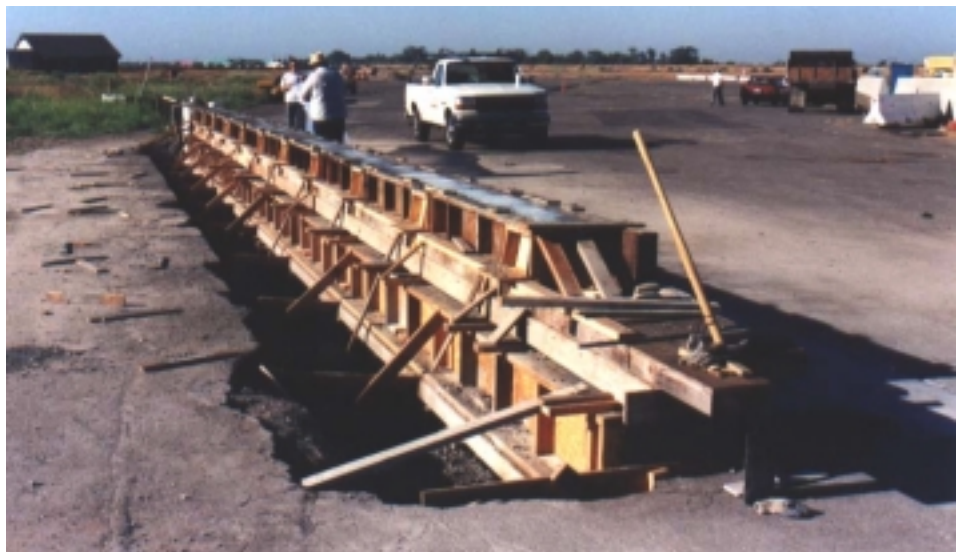
Figure 2-9
Concrete Work
Complete

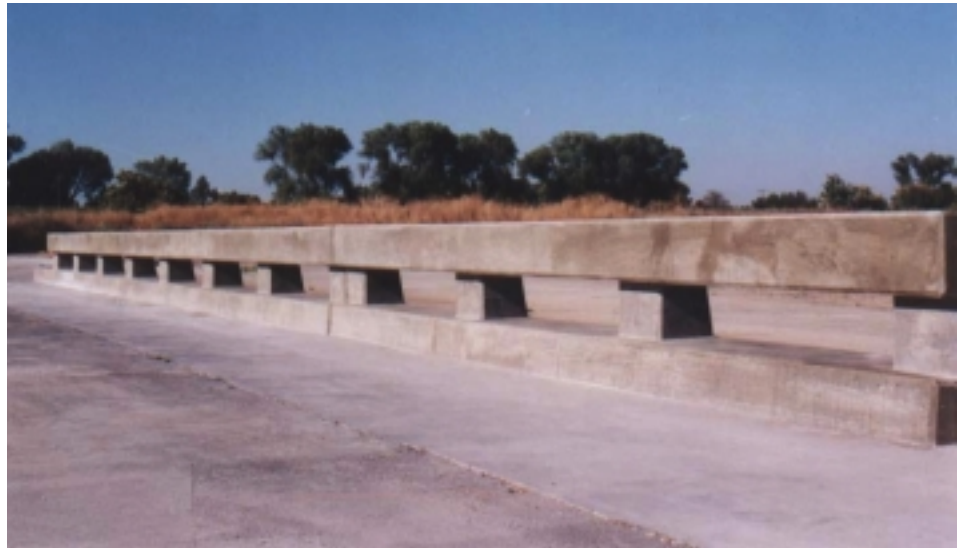
Figure 2-10
Completed Type 80
Bridge Rail

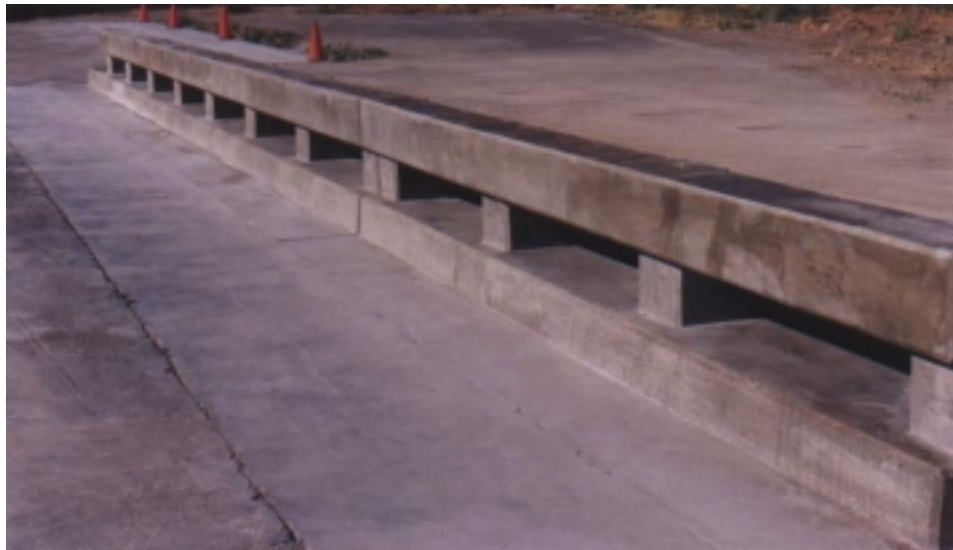
Figure 2-11
Completed Type 80
Bridge Rail

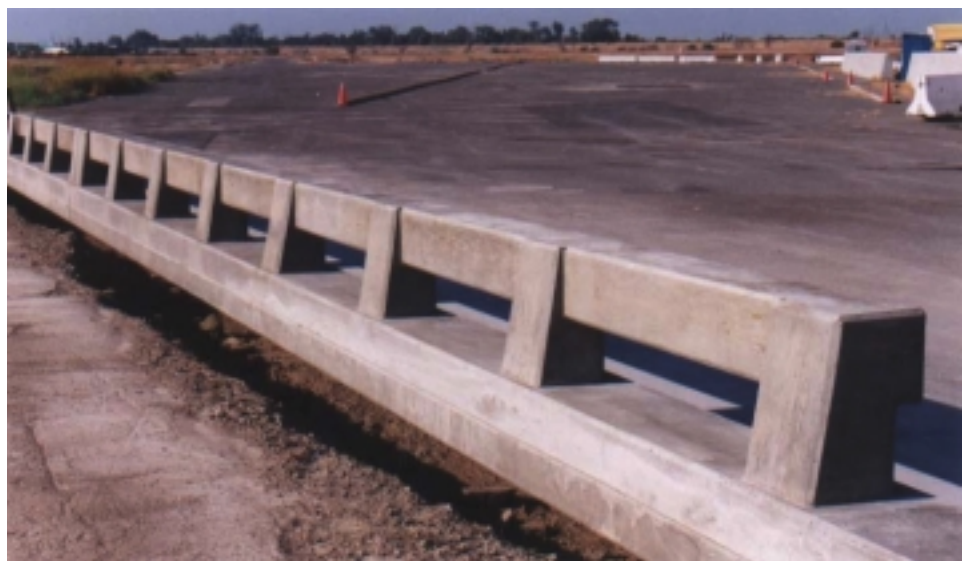
Figure 2-12
Backside of
Completed Bridge
Rail

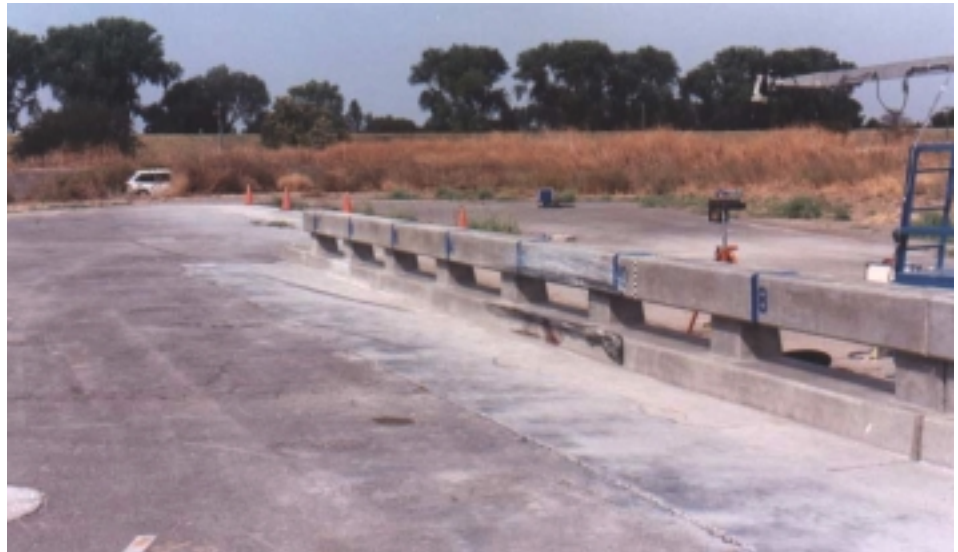
Figure 2-19 Post Impact View of Barrier and Vehicle 544

Contact with the bridge rail continued for approximately 2.5 m, determined by visible marks on the rail. The left rear wheel rose off the ground to a maximum of 0.1 to 0.15 m. As shown in Figure 2-19 through Figure 2-21, there were some black tire marks on the face of the barrier posts, but there was no evidence of wheel snagging. At 0.097 s after impact, the dummy's head was out of the right front passenger window. The dummy's head did not come into contact with the barrier or any other items and returned to its original position once the lateral accelerations decreased.

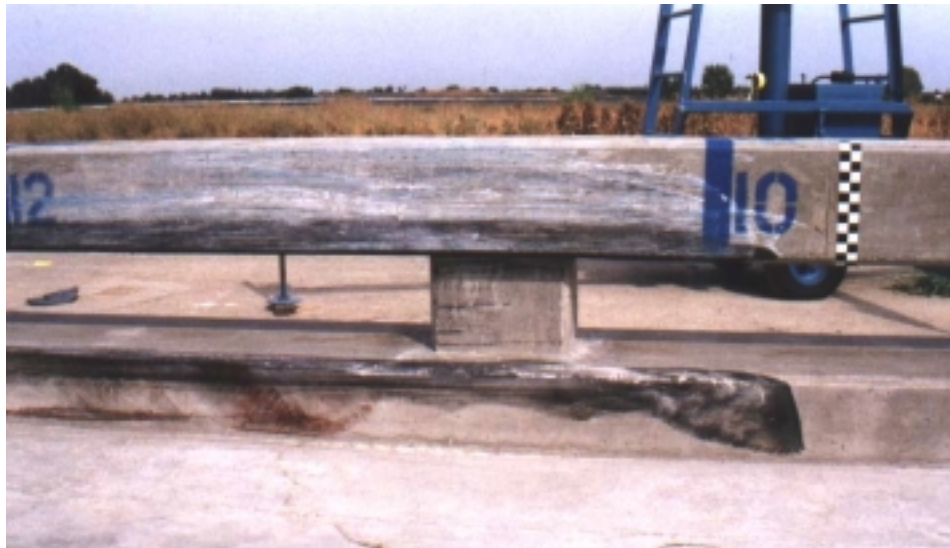
Figure 2-20 Post Impact Bridge Rail Scuff Marks Test 544

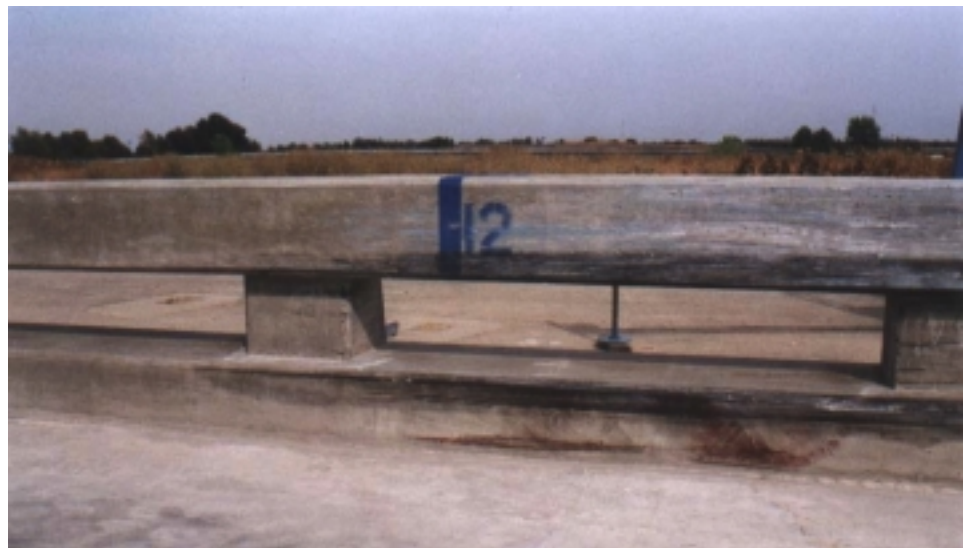
Figure 2-21 Post Impact Bridge Rail Scuff Marks Test 544

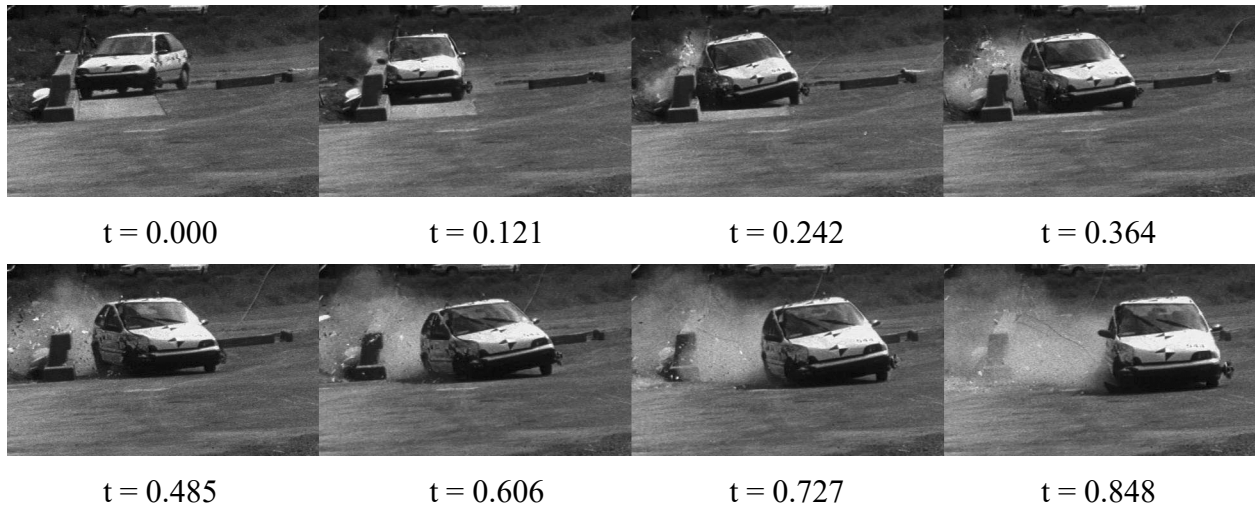
Figure 2-22 Test 544 Data Summary Sheet

Test Agency California DOT
 Test Number 544
 Test Date September 16, 1998

Barrier Damage: Superficial scuffing

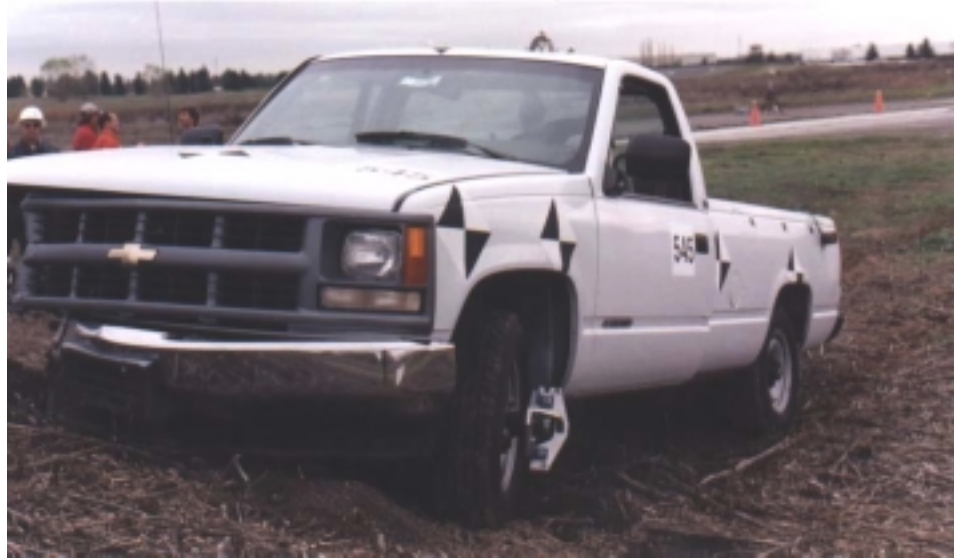
Figure 2-26 Final Position Of Test Vehicle 545

The vehicle stayed in contact with the rail for approximately 4.2 m. The exit angle and speed were 7 ° and 88.5 km/h respectively. The vehicle remained upright throughout and after the collision. Brakes were applied 0.829 s after initial contact with the rail and the stopping point for the vehicle was 58 m from the point of last contact with the barrier. Figure 2-26 through Figure 2-28 shows the vehicle in its resting position.

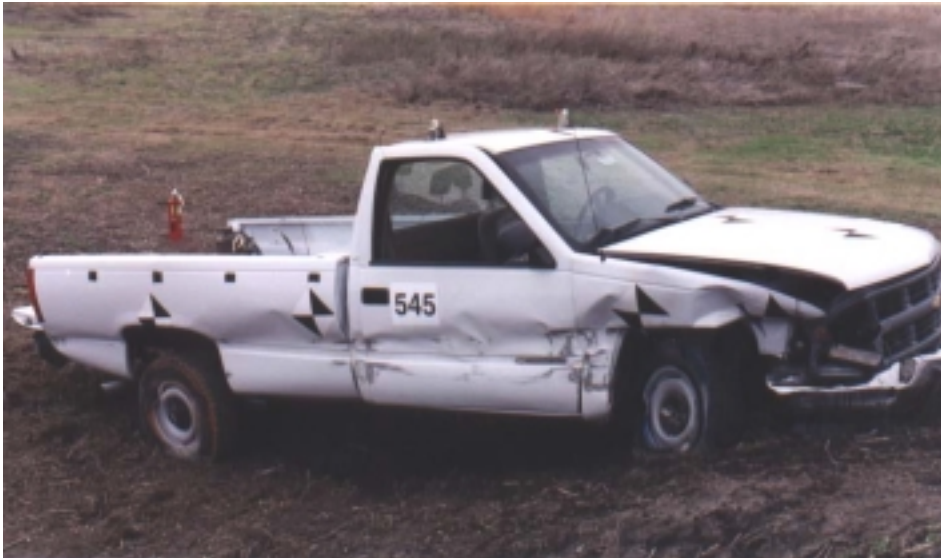
Figure 2-27 Post Impact Side of Test Vehicle 545

The vehicle received damage from the right front corner to the right rear corner, Figure 2-27. The right front and right rear wheel rims were deformed and the tires deflated. The left side wheels and tires were undamaged. The spare tire was forced from its undercarriage storage location and ended up about 15 m from the vehicle resting position.

The initial impact occurred on the right front quarter panel, resulting in substantial buckling and scraping, Figure 2-27. The right side of the bumper was pushed back about 260 mm. As the vehicle continued along the rail the entire right side was deformed where it contacted the bridge rail beam face. As a result, the right door did not operate due to moderate buckling and scraping. The truck bed was also scraped and buckled along the right side and the entire bed shifted to the right 40 mm. The tailgate did not function but the hood and left door were left in good condition and were operable. The roof of the truck did not have any signs of buckling. The windshield was cracked but remained mounted. The left and rear windows were not cracked.

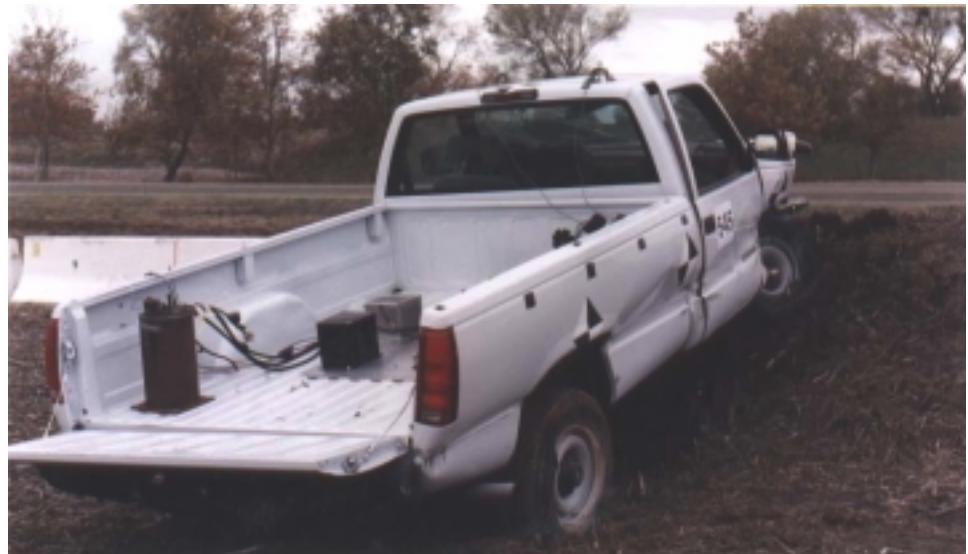
Figure 2-28 Rear Post Impact View of Vehicle 545

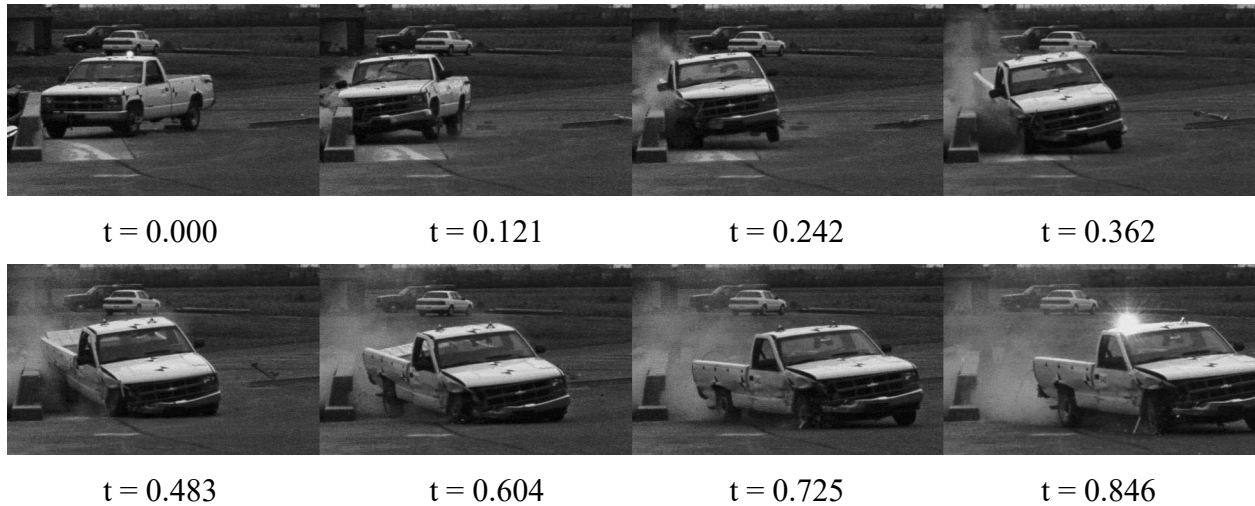
Figure 2-32 Test 545 Data Summary Sheet

Test Agency California DOT
 Test Number 545
 Test Date December 2, 1998

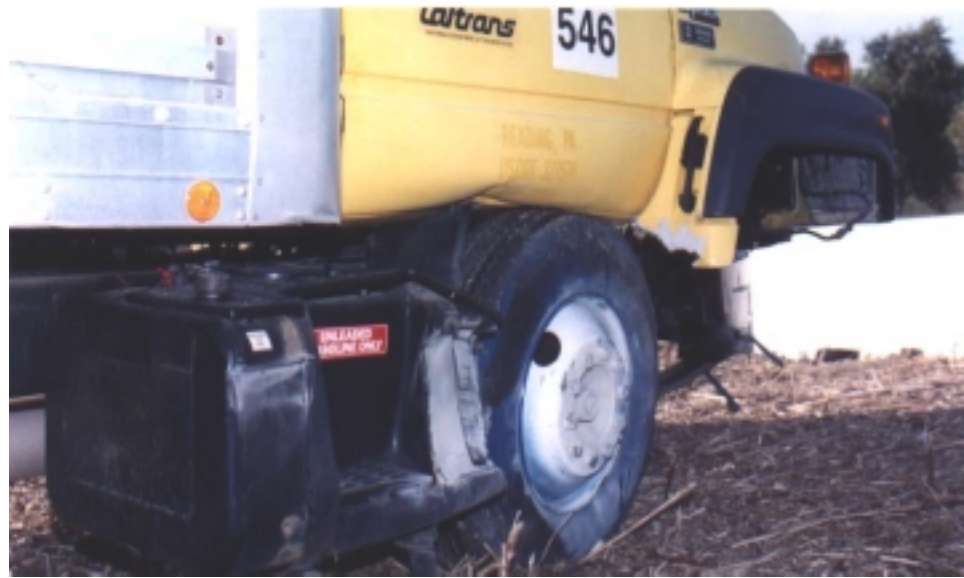
Figure 2-39
Close-up of Right
Front Wheel Area

The majority of damage occurred to the right front corner of the truck. The impacting tire was pushed back into the rear of the wheel well which severed the u-bolt connecting the leaf springs to the front axle. The steering rod and front axle on the right side were bent rearward. The battery box, located directly under the passenger door was completely crushed. The fuel tank was pushed rearward and moderately deformed while in contact with the beam face, Figure 2-39.

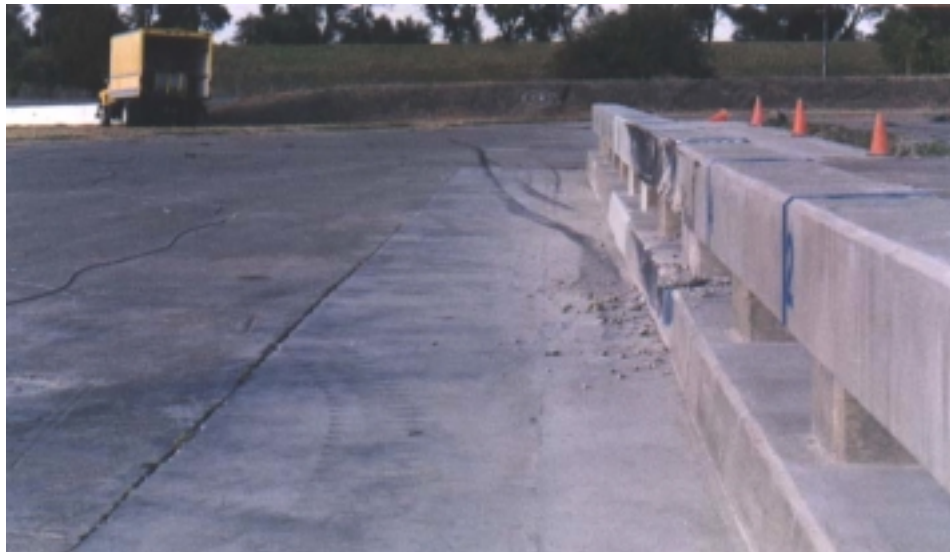
Figure 2-40
Barrier and Resting
Point of Vehicle

The 8056 kg van-bodied truck impacted the bridge rail at 80.1 km/h and 15.0 degrees. The impact location was 0.7 m in front of the bridge rail expansion joint, Figure 2-42. At impact the vehicle rolled to the right lifting both left wheels off the ground about 0.8 m. The U-bolt holding the front right leaf springs to the front axle broke, allowing the right front wheel to be pushed back under the cab, Figure 2-39. The vehicle continued to make contact with the barrier for 5 m. The approximate exit angle of the truck after it left contact with the beam face was 8 degrees. The truck then righted itself and continued to move away from the barrier at a shallow angle. The brakes were applied and the truck came to rest about 30 m and 65 m, respectively, from the point of impact, Figure 2-40.

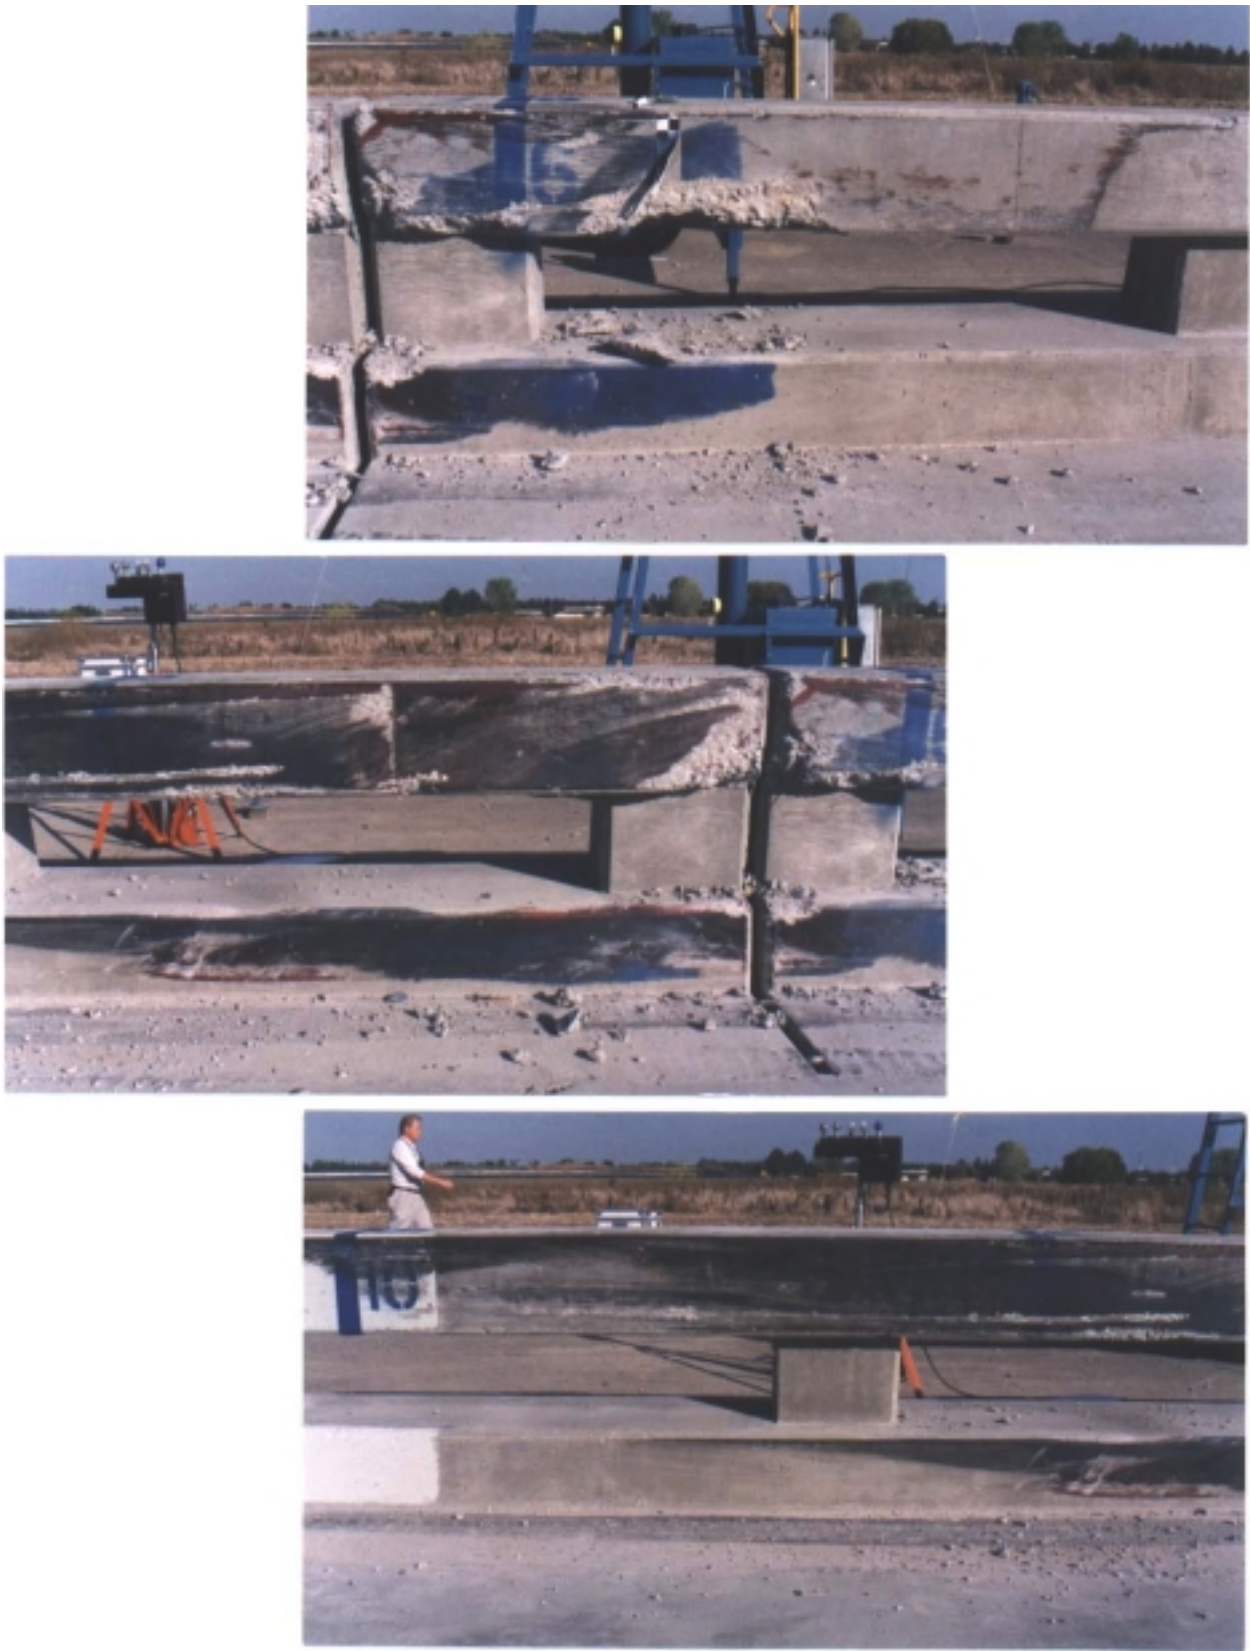
Figure 2-42 Close up of Impact Area

The bridge rail was scraped along the curb and beam section face leaving exposed patches of aggregate and concrete spalls. Most of the spalling occurred 0.75 m upstream of the expansion joint and at the expansion joint, Figure 2-42. The spalls were minor in nature and could be easily repaired. Additional marks were left on the bridge rail from the trucks tires. The right front and rear tires were painted blue and red, respectively.
