2016 FISH PASSAGE ANNUAL REPORT

Report to the Legislature

Prepared: October 2017

Prepared by the California Department of Transportation, Division of Environmental Analysis

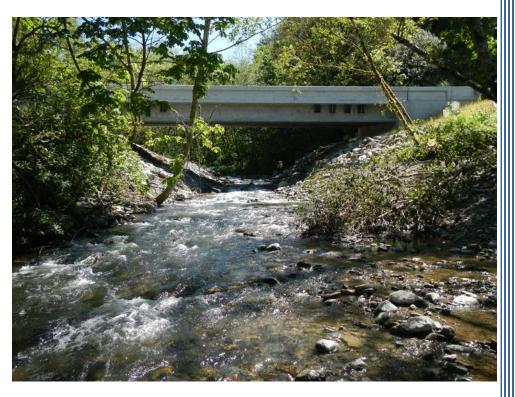
Little Mill Creek (District 1, Eureka), Emergency Bridge Project

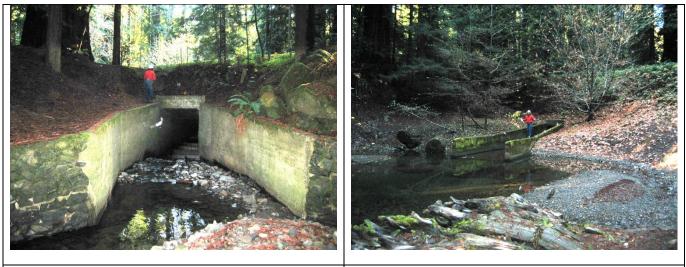
Figure 1. The Fish Creek project will remediate a barrier while protecting redwood trees and reducing scour caused by high velocities.

Fish Creek, culvert inlet. Project will protect 15foot redwood tree seen in the upper left corner.

Fish Creek, culvert outlet. Scour at outlet due to high velocities will be improved by the project.

This location was previously funded as a partial solution (less than 20 feet), which would have incrementally improved fish passage, but would not have provided access for all species and life stages. The previous design would not have fully protected the nearby 15-foot diameter redwood and would not have addressed the identified sediment issue in the Eel River watershed, which is in an area designated as impaired due to sediment. AB 95 funds will be

leveraged with State Highway Operation and Protection Program Stormwater Implementation Program funds to eliminate the barrier to fish passage and improve water quality in the South Fork Eel River watershed to comply with the requirements outlined in Attachment IV of Caltrans' National Pollutant Discharge Elimination System Permit, number CAS000003. A Project Initiation Document was completed on 6/22/2017 and the total costs are estimated to be \$16.8 million. The additional funds will come from the State Highway Operations and Protection Program. Construction is estimated to be completed in Fiscal Year 2021/2022.
