State Route 3 Turnout Study
Weaverville to Coffee Creek
TRI 3 PM 30.86 – 67.89
May 2012

Prepared by: Caltrans, District 2, Office of System Planning
In cooperation with the Trinity County Transportation Commission

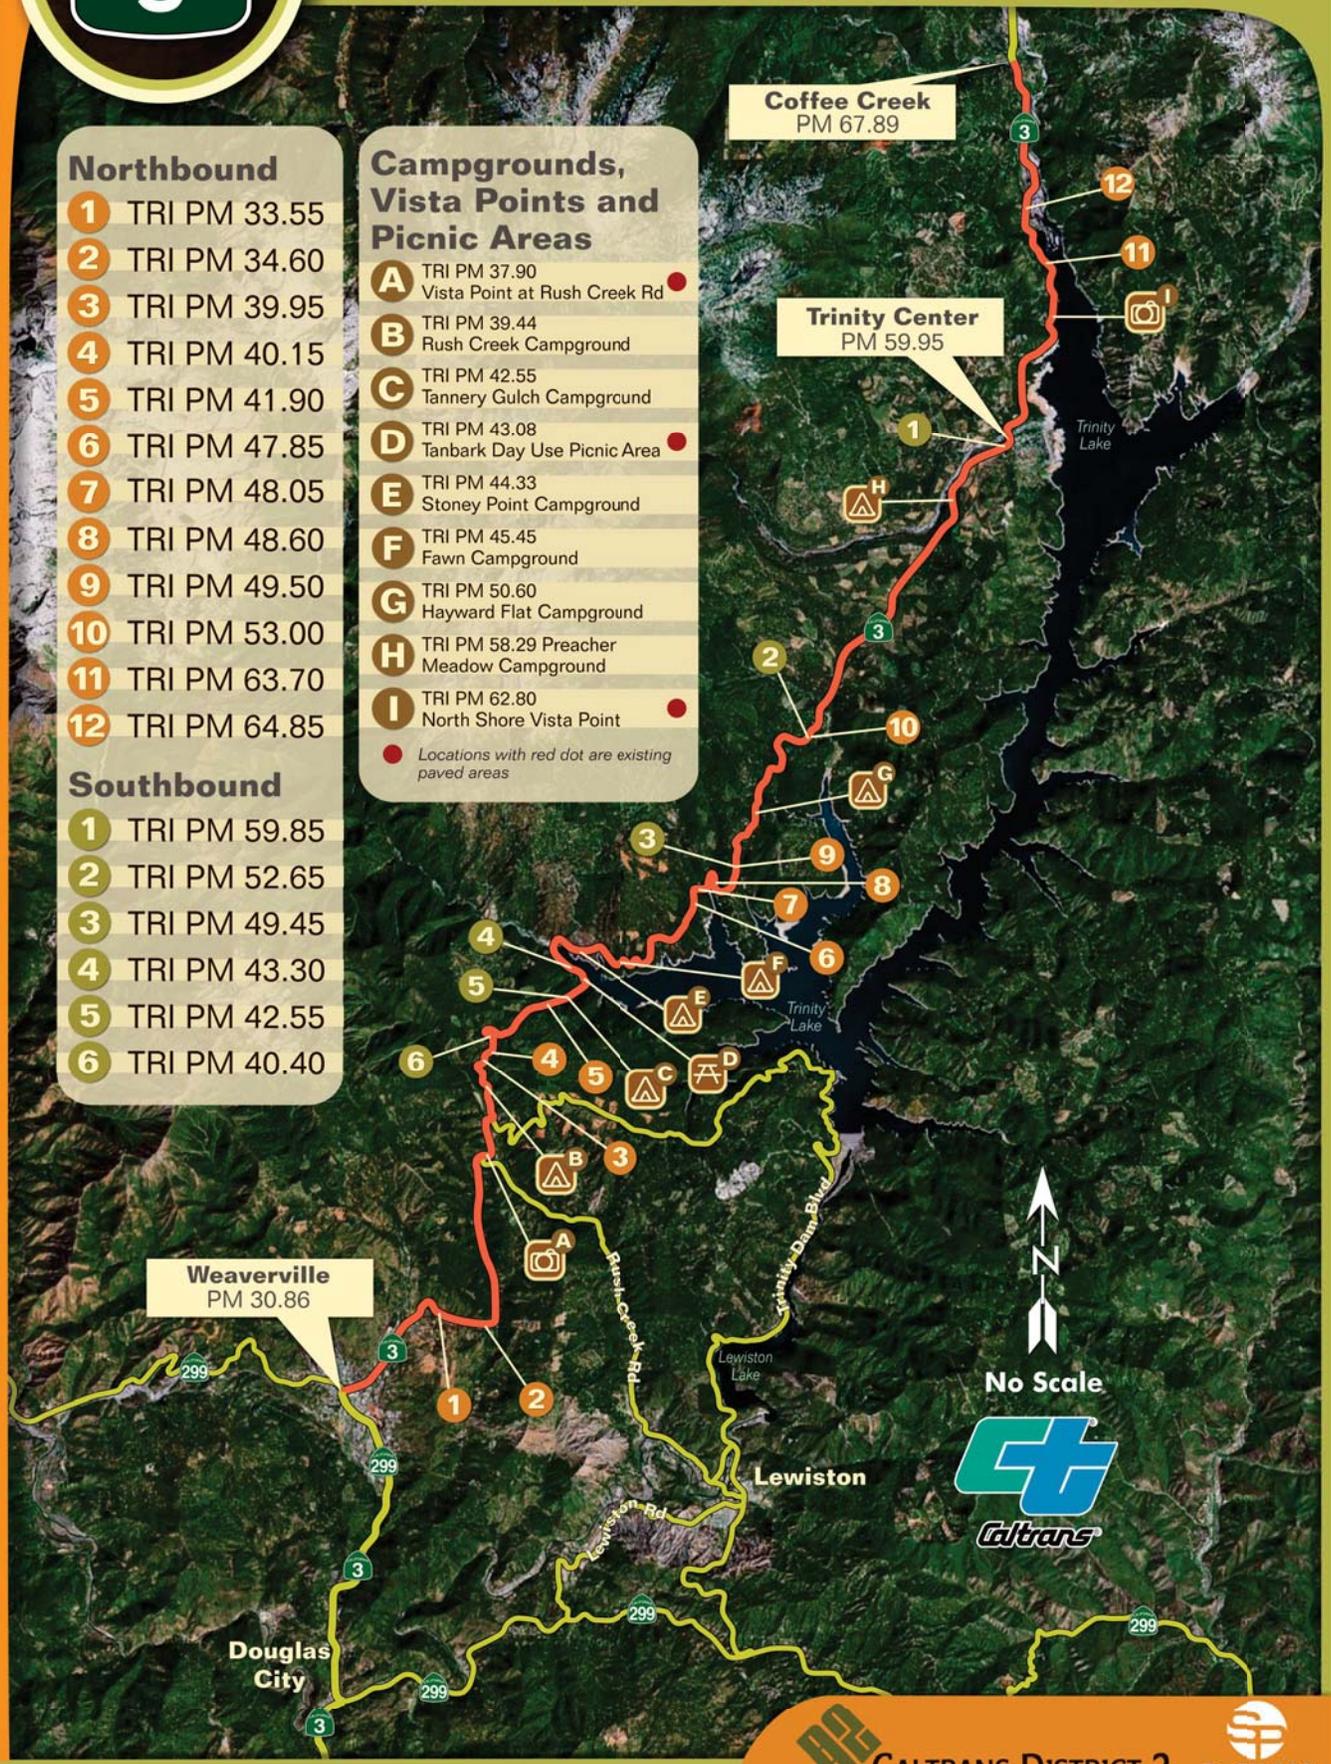
Study Area Map

SR3 Potential Turn Out Opportunities

• Locations with red dot are existing paved areas

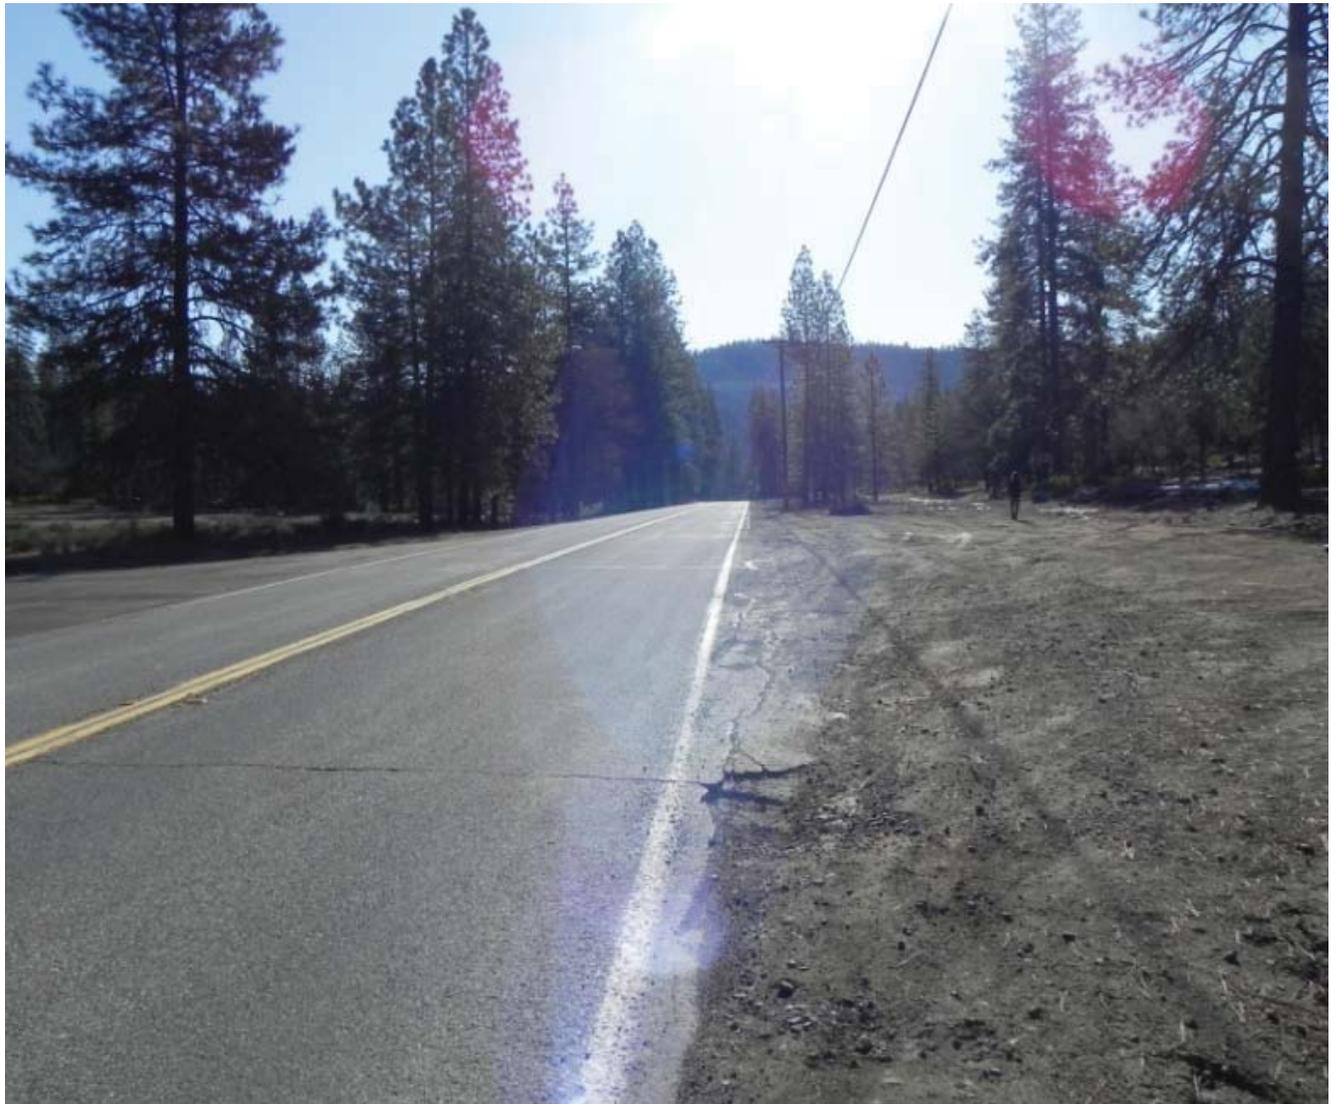
Location	NB 1	PM 33.55	Rank: Medium
Approximate Width	35'		Approximate Length: 200'
Curve	Entry: yes		Exit: no
Sight Distance	May not be available		
Approximate Grade	0 – 2 % uphill		
Passing	Not allowed in either direction		
Current Surface	Dirt, gravel

- Utility Poles along NB edge approximately 220' apart and about 10' back from NB ETW
- USFS road 34N95 directly across from location
- At a trailhead for the Weaver Basin Trail System
- Turn out length could increase to 600' +/- if utility poles are moved

Rank: Medium. This location may not meet the minimum length guideline in the Highway Design Manual. The length of this location could be increased and the rating higher if the utility poles, which are about 10' from ETW, were relocated. Operationally this is a good location to have slower moving vehicles pull off the roadway as it is just over 2.5 miles north of Weaverville and is at the end of a 3-5% climb and a very curve linear section of roadway with no other passing opportunities. This location shows signs of use, which may be due to it being the location of a trailhead for the Weaver Basin Trail System. The fact that it is located at the trailhead may make it eligible for other funding programs.

This location falls within a one mile stretch where four possible turnout locations have been identified, NB 1, 2A, 2B and 2C (PM 33.55, 34.60, 34.70 and 34.80). The highest ranked location in this section is NB 2B (PM 34.70).

Note: Trinity County has indicated interest in this location for a passing lane longer term, with other potential turn out candidates ranked high therefore preferable to pursue in the near term.

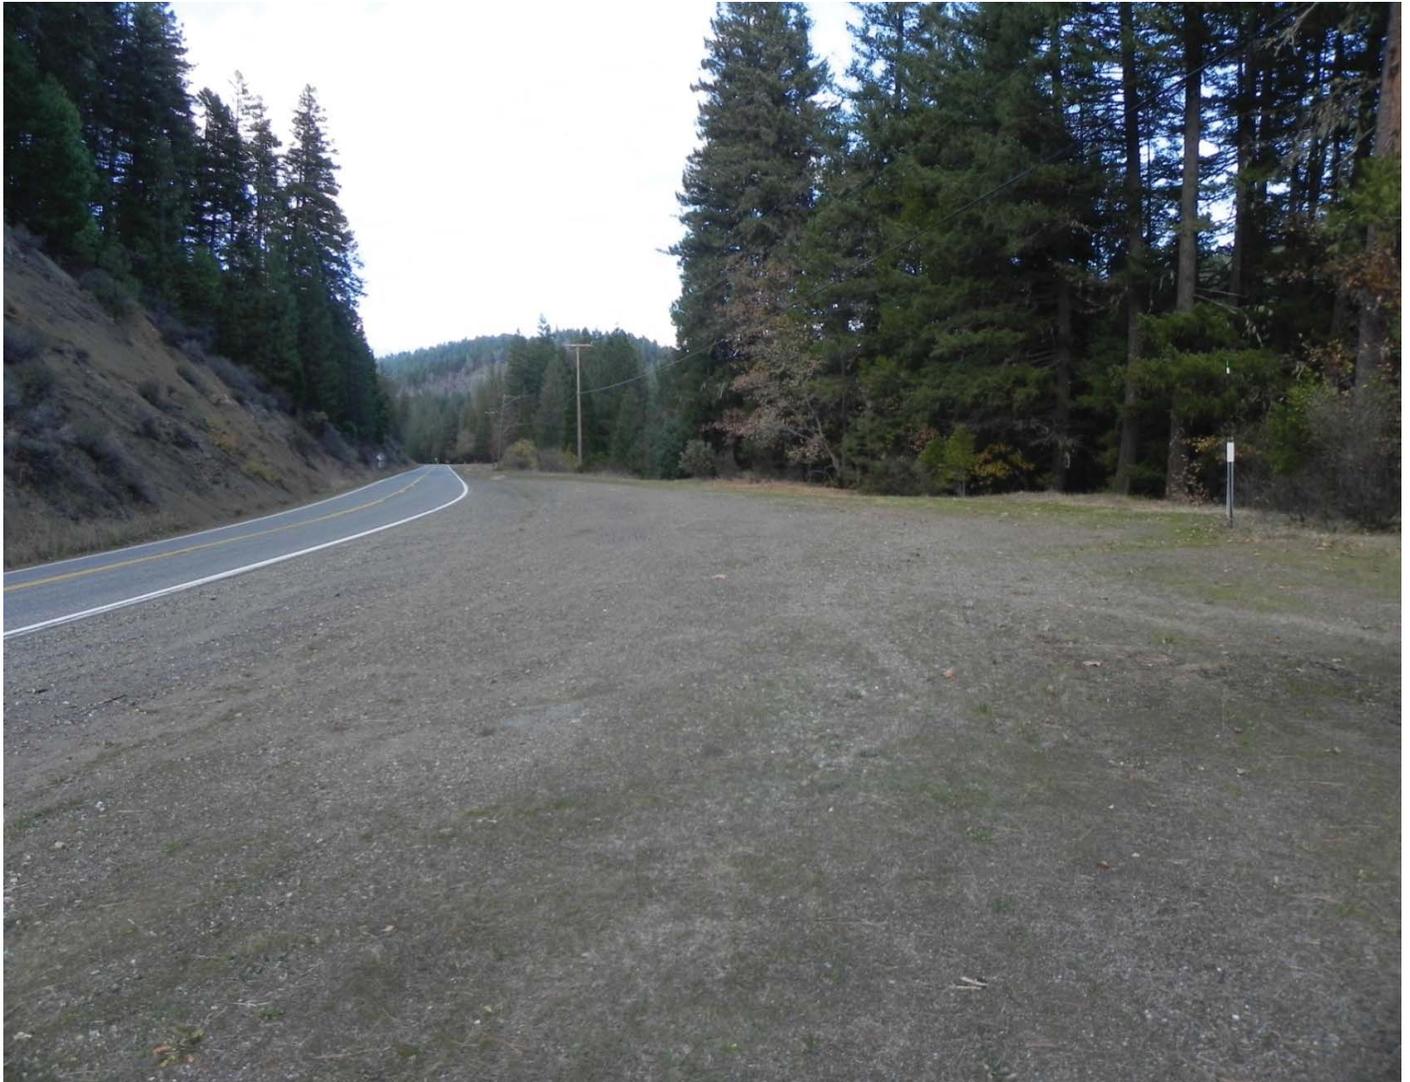
- Very wide
- Looks to be well used
- Possible passing lane location if developed with 2B and 2C
- Power pole approx 40' from ETW at 200' mark
- Power pole spacing is approx 150'

2A Rank: Medium. This location meets the guidelines set forth in the Highway Design Manual. This location looks to be used year round and has good solar exposure. However, approaching this location is constrained by a 35 mph curve which impedes the sight distance.

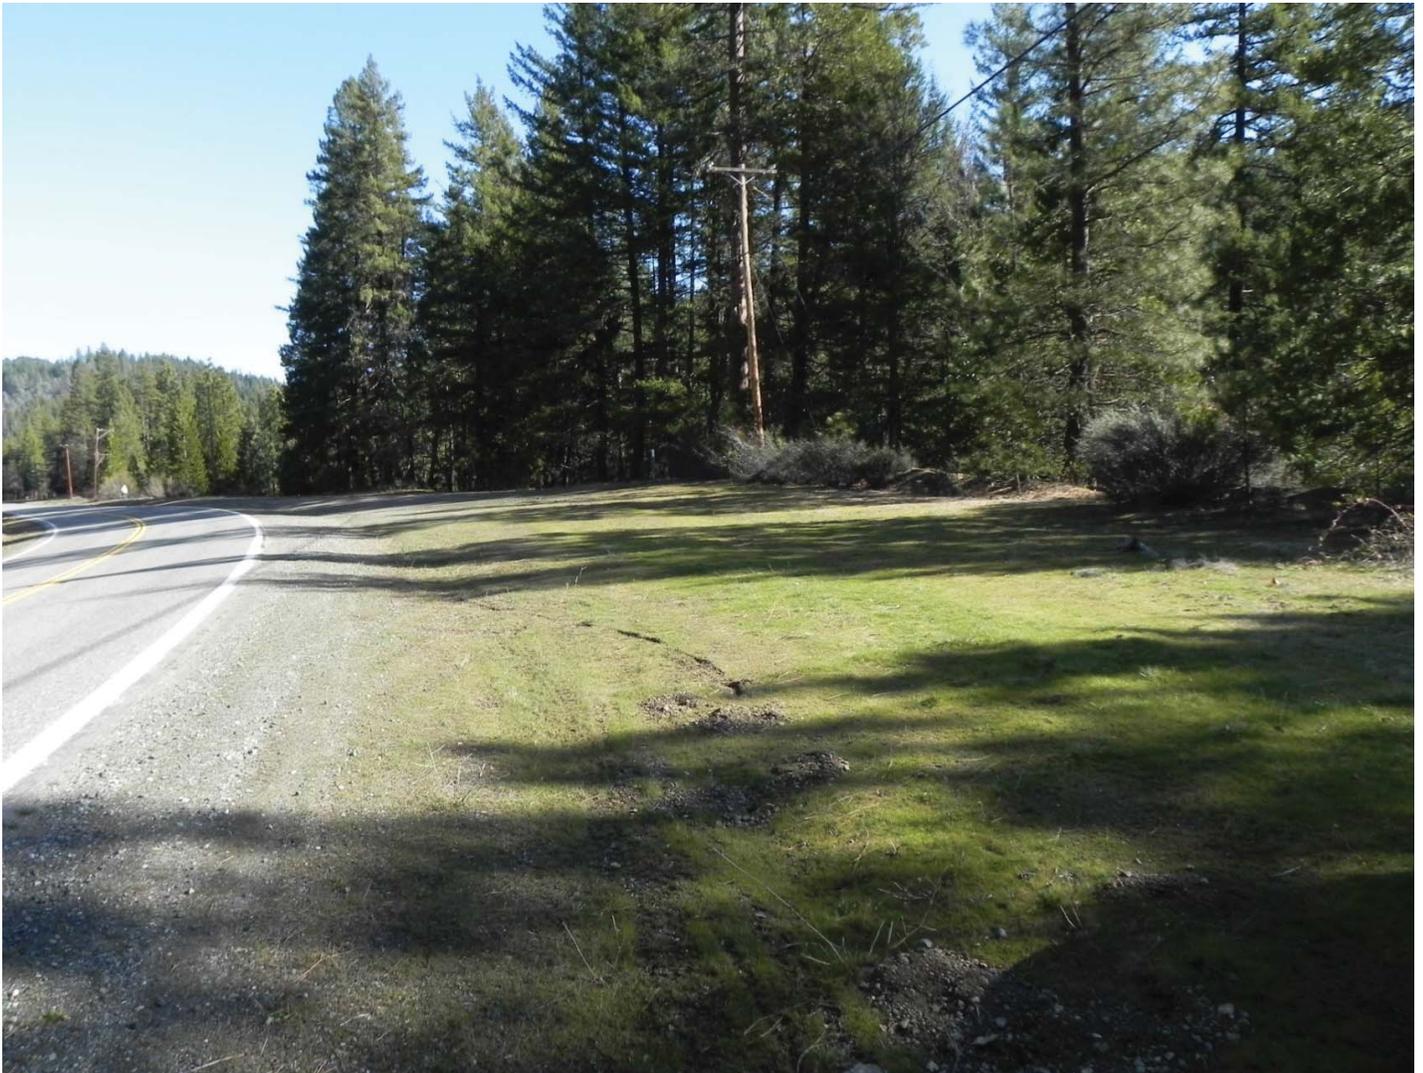
- Passing does not impact because it is in same direction as turnout location
- Site is long and wide
- Site looks to be well used
- Possible passing lane location if developed with 2A and 2C
- Asphalt remnants exist about 15' from ETW

2B Rank: High. This location meets the guidelines set forth in the Highway Design Manual and has the highest benefit based on existing length, width and no constraints. This location is 300' long but could potentially be up to 800' in length if some earthwork (fill) was done between locations 2A & 2B (PM 34.60 & 34.70). If this location was developed, location A and C could still be used as undeveloped turnouts.

In summary, this segment has a few possibilities for development. Out of the three locations studied, 2B ranks the highest due to meeting all the Highway Design Manual guidelines and eliciting the signs of highest usage year round and with little constraints to develop. Locations 2A (PM 34.60) and 2C (PM 34.80) can still be used as informal turnouts if 2B (PM 34.70) is developed. Developing 2B (34.70) does not preclude future development of a passing lane.

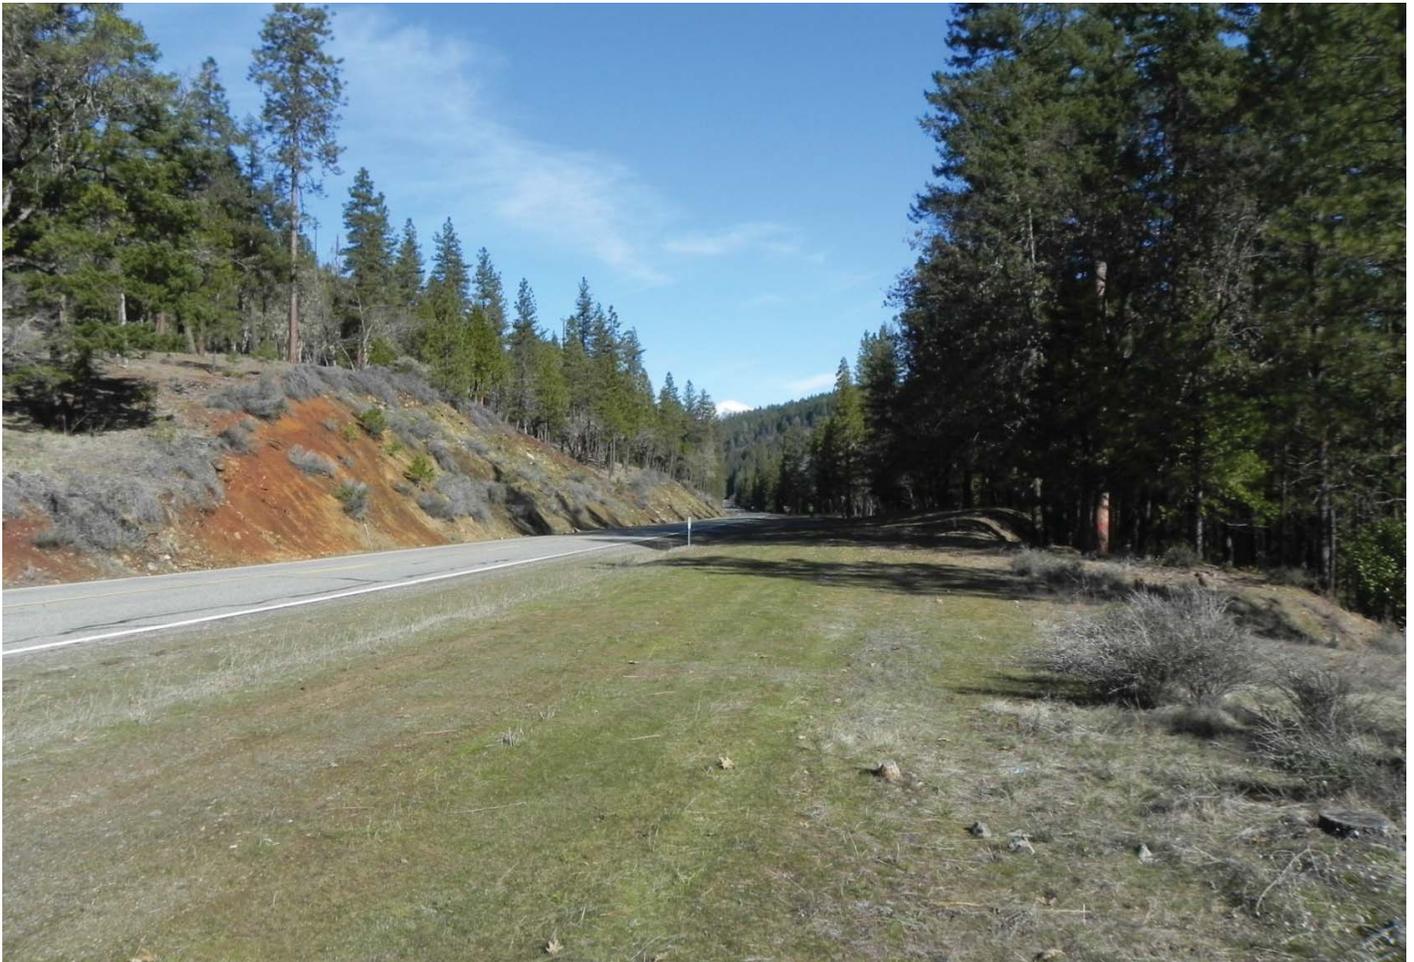
- Turnout not feasible due to being striped for passing in both directions
- Site is very long and wide
- Site looks to be well used
- Possible passing lane location if developed with 2A and 2B
- Power poles on NB shoulder end at PM 34.80
- At PM 34.85 is a culvert – out fall is 20'+ from ETW

2C Rank: Low. Based on the fact that the roadway is striped for passing in the opposite direction it is likely that the Caltrans Headquarters Geometric Reviewer will not approve this location for a turnout.

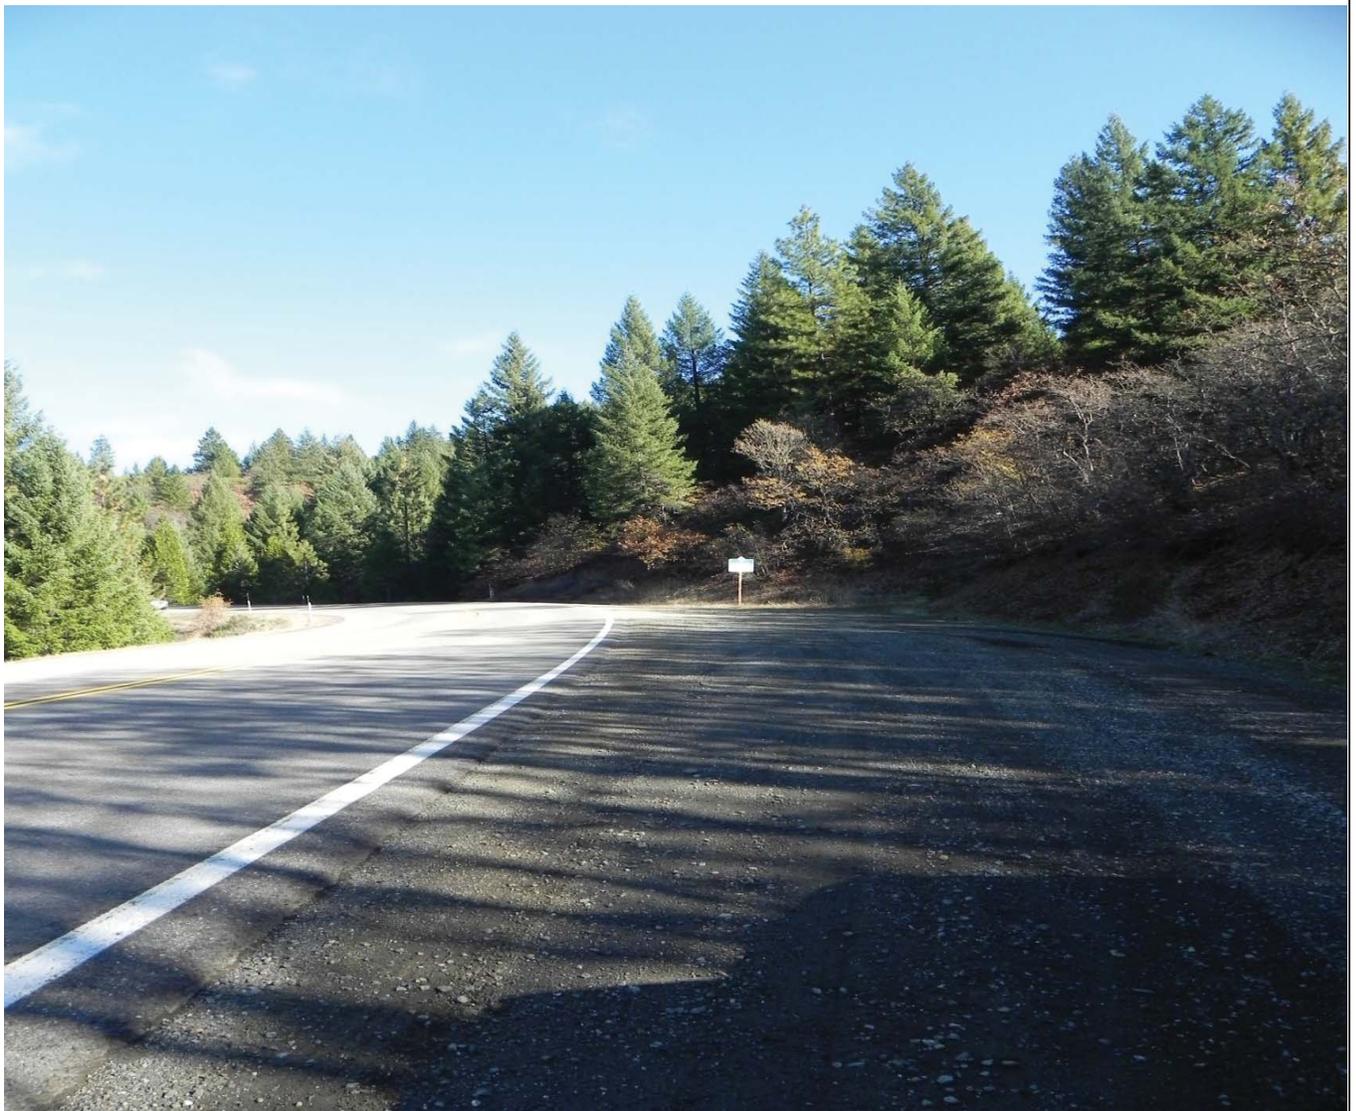
Location	NB 3	PM 39.95	Rank: High
Approximate Width	15– 20'		Approximate Length: 400'
Curve	Entry: yes		Exit yes
Sight Distance	Potentially available		
Approximate Grade	3 – 5 % uphill		
Passing	Not allowed in either direction		
Current Surface	Gravel

- Tree trimming/removal would increase sight distance
- Shows signs of use
- High snow storage area during winter months

Rank: High. This location meets the guidelines set forth in the Highway Design Manual and has a high benefit based on existing length, width and no constraints. This location show signs of use year round. The length of this location (400') is of benefit given the approximate grade is 3-5% uphill making it easier for slower moving vehicles to exit and enter the roadway without completely stopping.

This location falls within a two mile stretch where three possible turnout locations have been identified, NB 3, 4 and 5 (PM 39.95, 40.15 and 41.90). Locations 4 and 5 (ranked medium and low respectively) show signs of standing water or water storage, rock fall nearby and snow storage in winter months. This location is ranked the highest out of the three because it meets the Highway Design Manual criteria, has the least constraints and offers the longest and widest options out of the three. NB 3 (PM 39.95) is roughly four miles from the last ranked high location, NB 2B (PM 34.70), and about eight miles from the next ranked high location, NB 6 (PM 47.85).

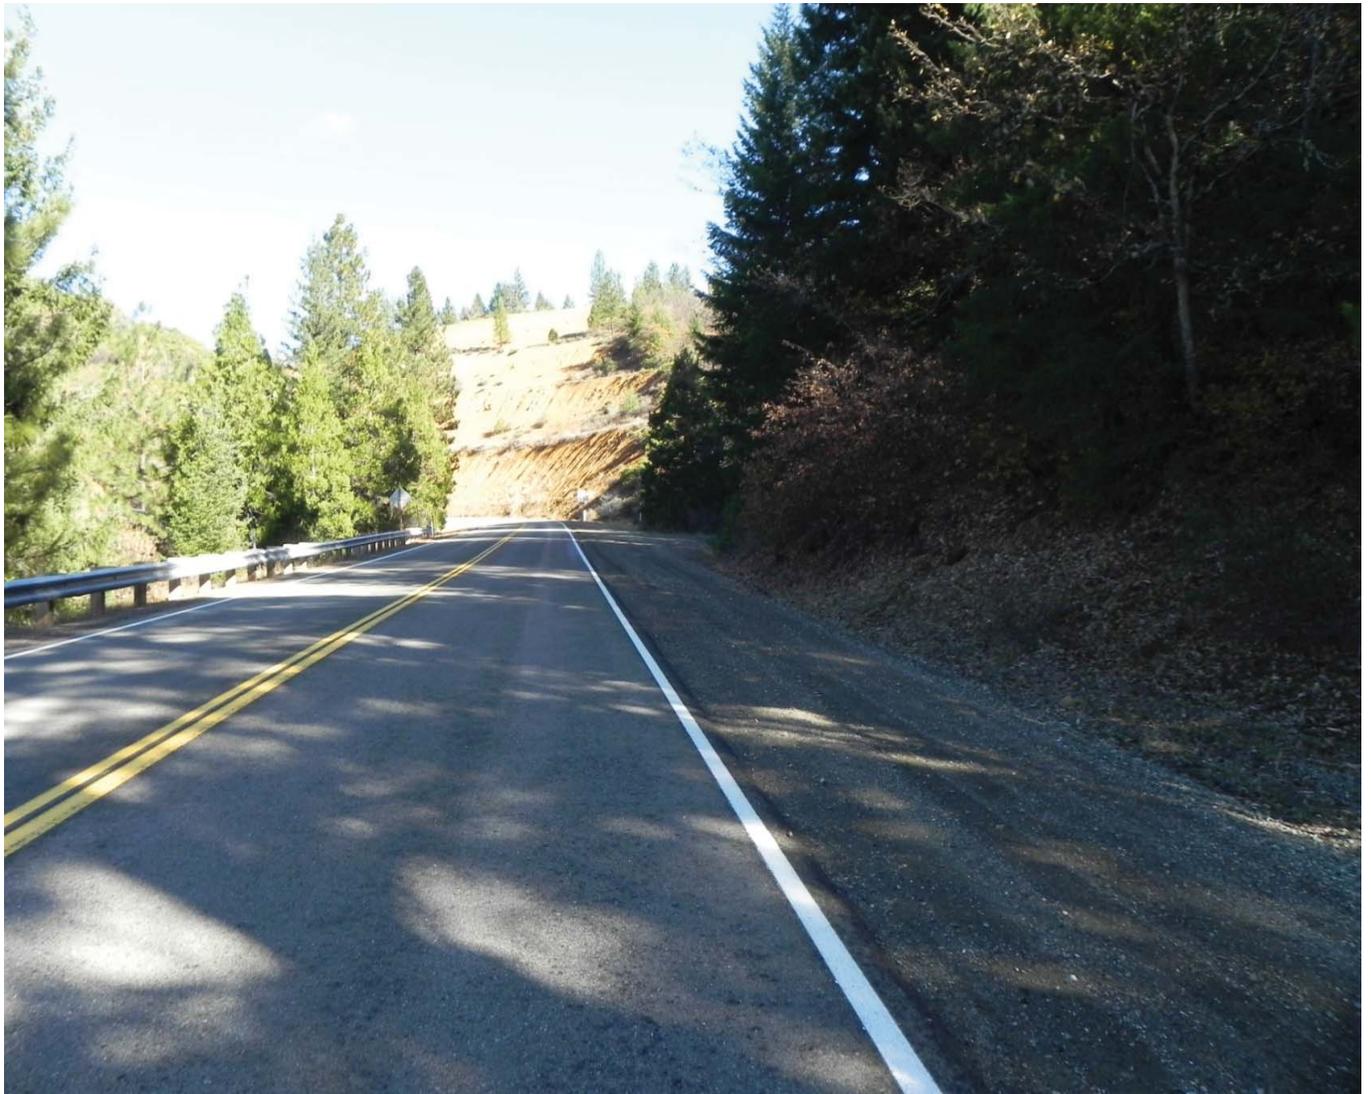
Location	NB 4	PM 40.15	Rank: Medium
Approximate Width	15'	Approximate Length: 400'	
Curve	Entry: yes	Exit: yes	
Sight Distance	May not be available		
Approximate Grade	3-5 % uphill		
Passing	Not allowed in either direction		
Current Surface	Gravel

- Will require some additional earthwork (cut)
- Shows signs of use
- High snow storage during winter months
- Rock fall catchment area begins at north end of this location

Rank: Medium. This location appears to meet the guidelines set forth in the Highway Design Manual, however it will likely require earthwork (cut) to accommodate drainage requirements. The sight distance on is poor due to the approach being on a tight curve. On the north end of this location there is a rock entrapment area that may or may not cause some constraints. This location does not have good solar exposure and is a high snow storage area in the winter months. The length of this location (400') could potentially add benefit to the mobility of the corridor as it is on a 3-5% uphill section which will allow slower moving vehicles to exit and enter the roadway without coming to a complete stop.

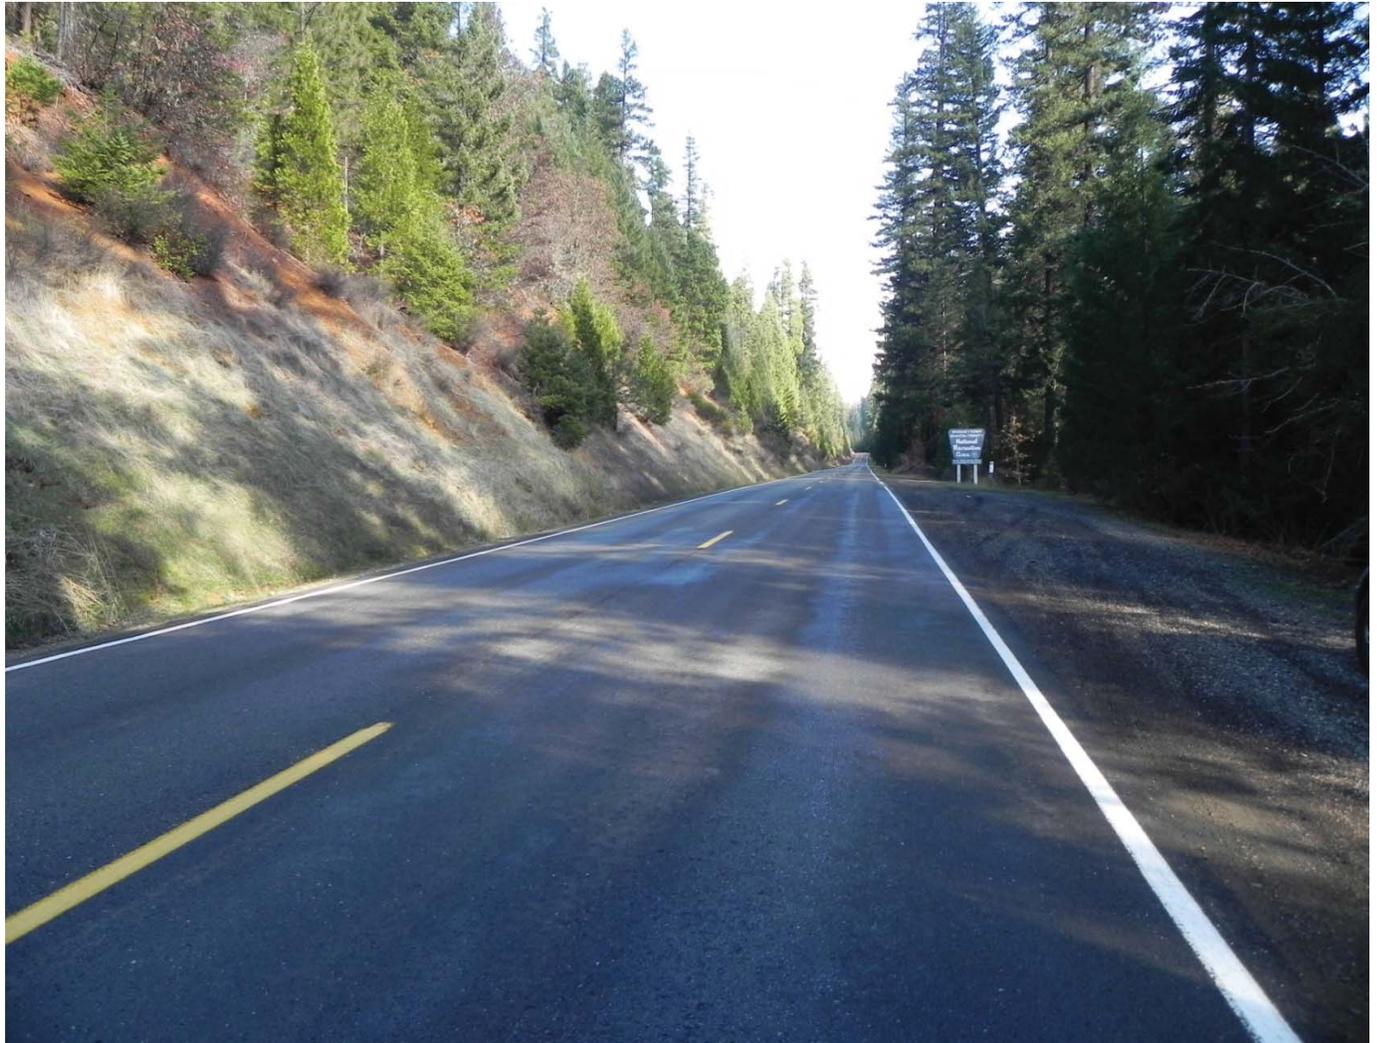
- Turnout not feasible due to being striped for passing in both directions
- May require some additional earthwork (fill)
- At PM 43.1 is the Tanbark picnic area and at 43.3 is the Osprey viewing area
- Creek immediately adjacent
- High snow storage area during winter months

Rank: Low. This location appears to meet the guidelines set forth in the Highway Design Manual, however it will likely require earthwork (fill) to accommodate drainage requirements. The roadway is striped for passing in the both directions; therefore, it is likely that the Caltrans Headquarters Geometric Reviewer will not approve this location for a turnout. There is also a creek crossing immediately adjacent to this location.

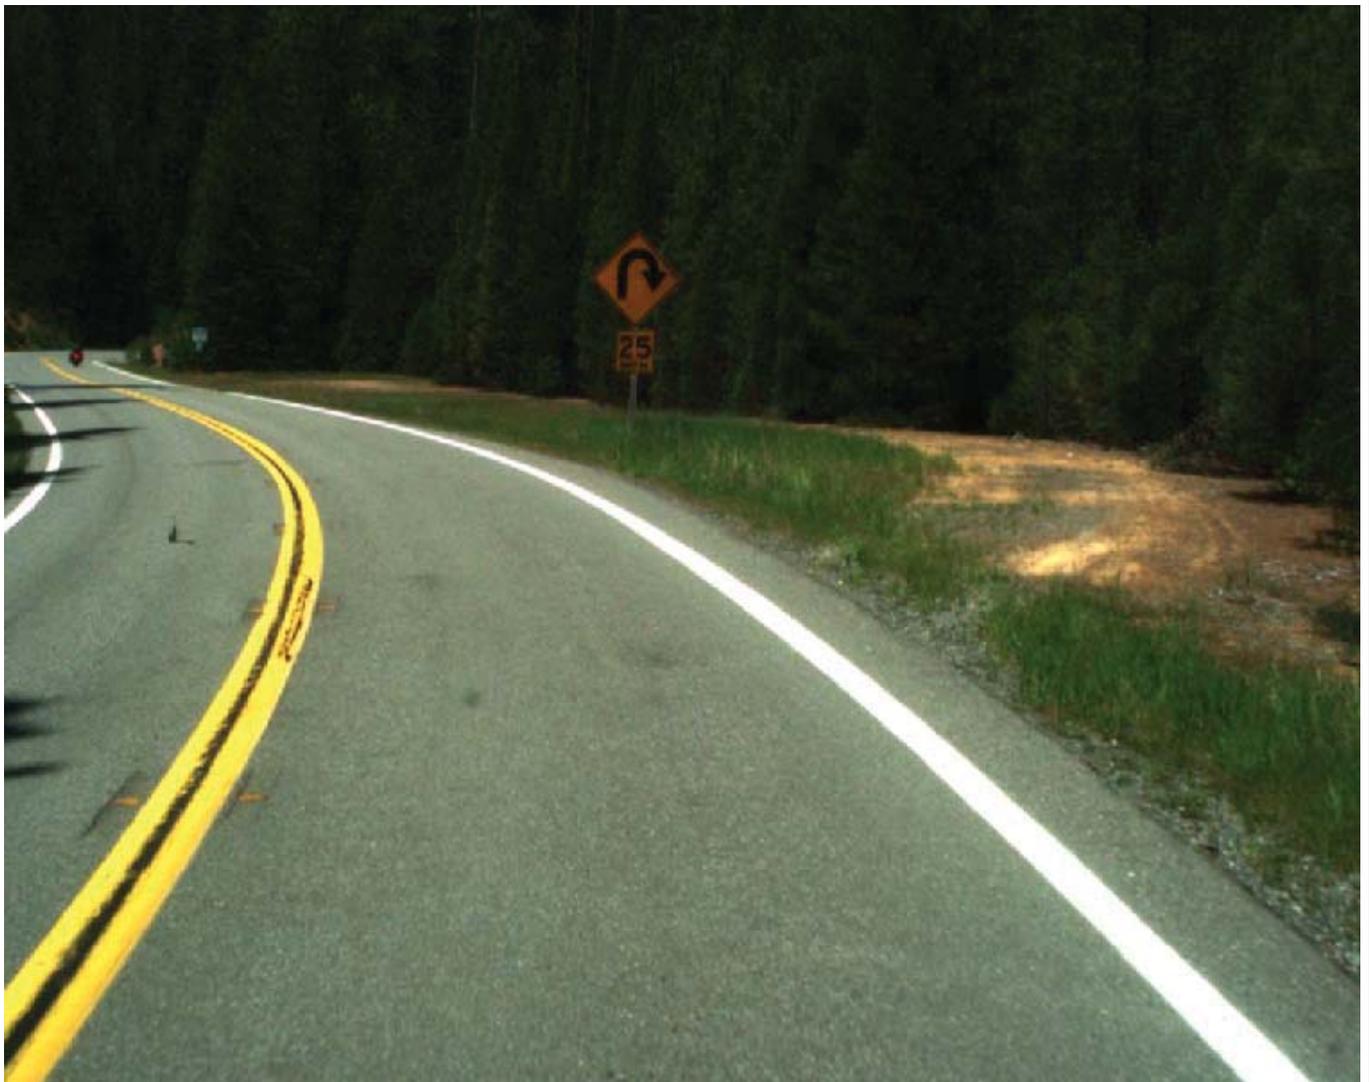
- A 25 mph curve separates NB 6 and 7
- Tree trimming/removal would increase entry sight distance
- Earthwork may be required at taper at north end
- Creek crossing at northern tip of location
- Culvert at PM 47.86 and 47.94

Rank: Medium. This location meets guidelines set forth in the Highway Design Manual. The segment of roadway leading up to this location is very curve linear. A 25 mph curve warning just at the north end separates this location and the next potential turn, NB 7 (PM 48.05). The location is also constrained on the south and north ends with culverts that may need to be improved with any roadway projects. Also, at the north end of this location is a perennial water source.

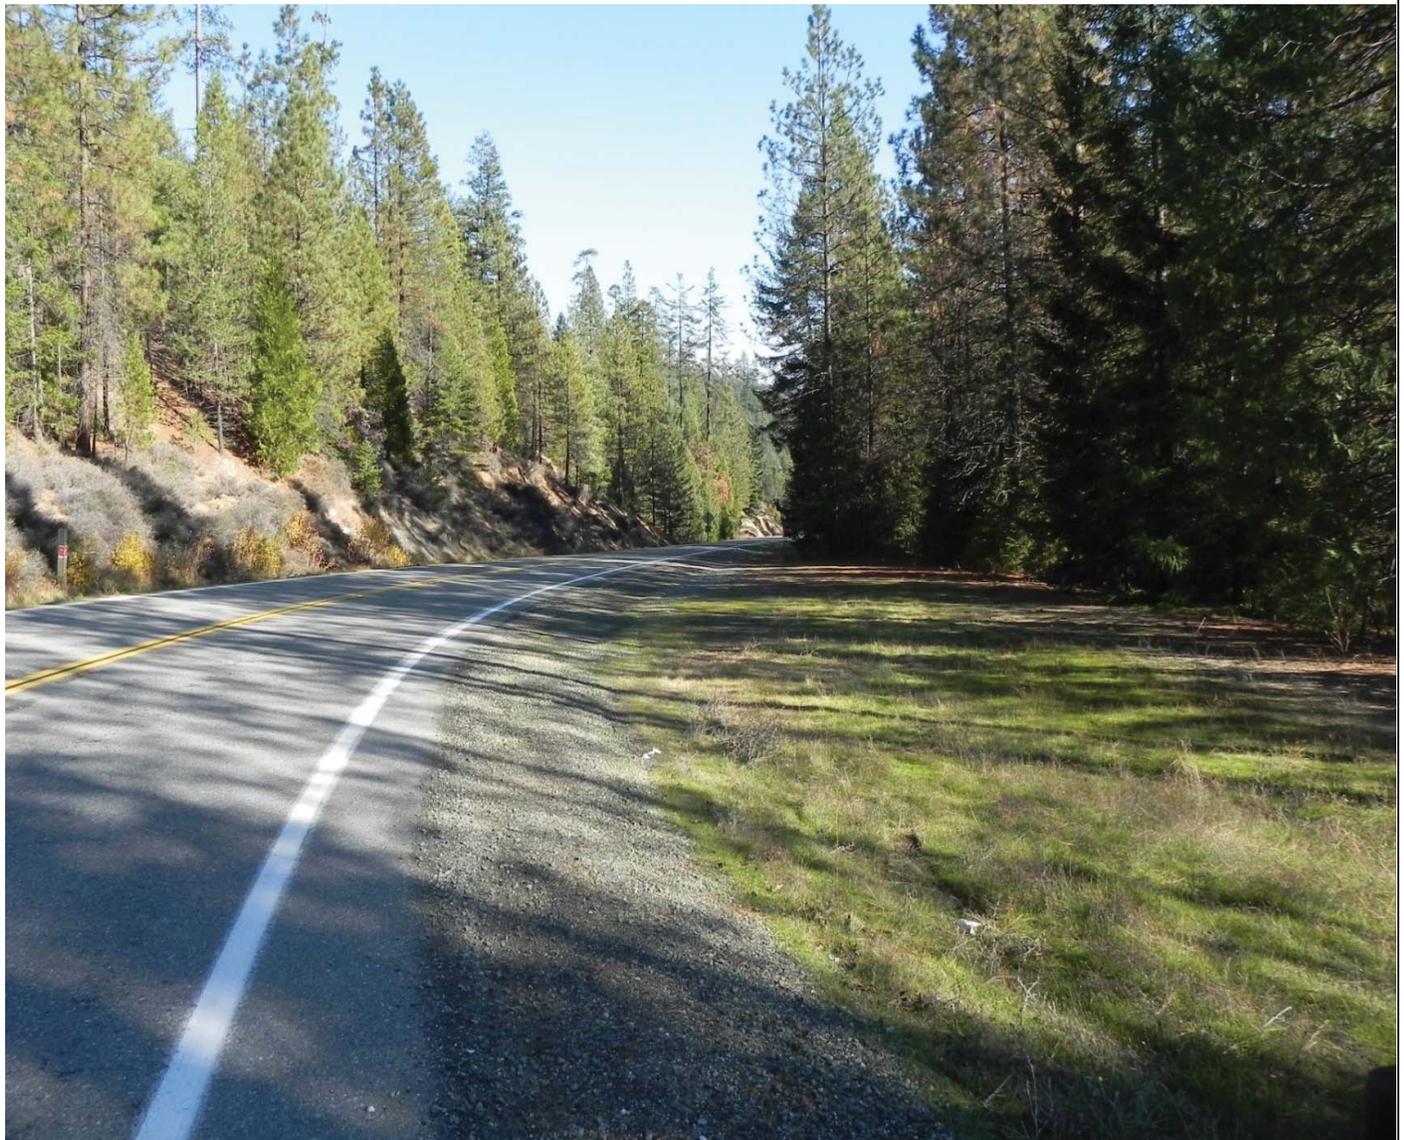
- A 25 mph curve separates NB 6 and 7
- Tree trimming/removal and earthwork may increase sight distance
- Very wet ground and has minor snow storage during winter months
- Creek crossing at very southern tip of location

Rank: Low. This location meets the guidelines set forth in the Highway Design Manual. Coming into this section is very curve linear with a 25 mph curve upon entry of this location making sufficient sight distance difficult to obtain. There tends to be a fair amount of standing water at this location as well as a creek adjacent to it. This location has poor solar exposure and has snow storage during winter months.

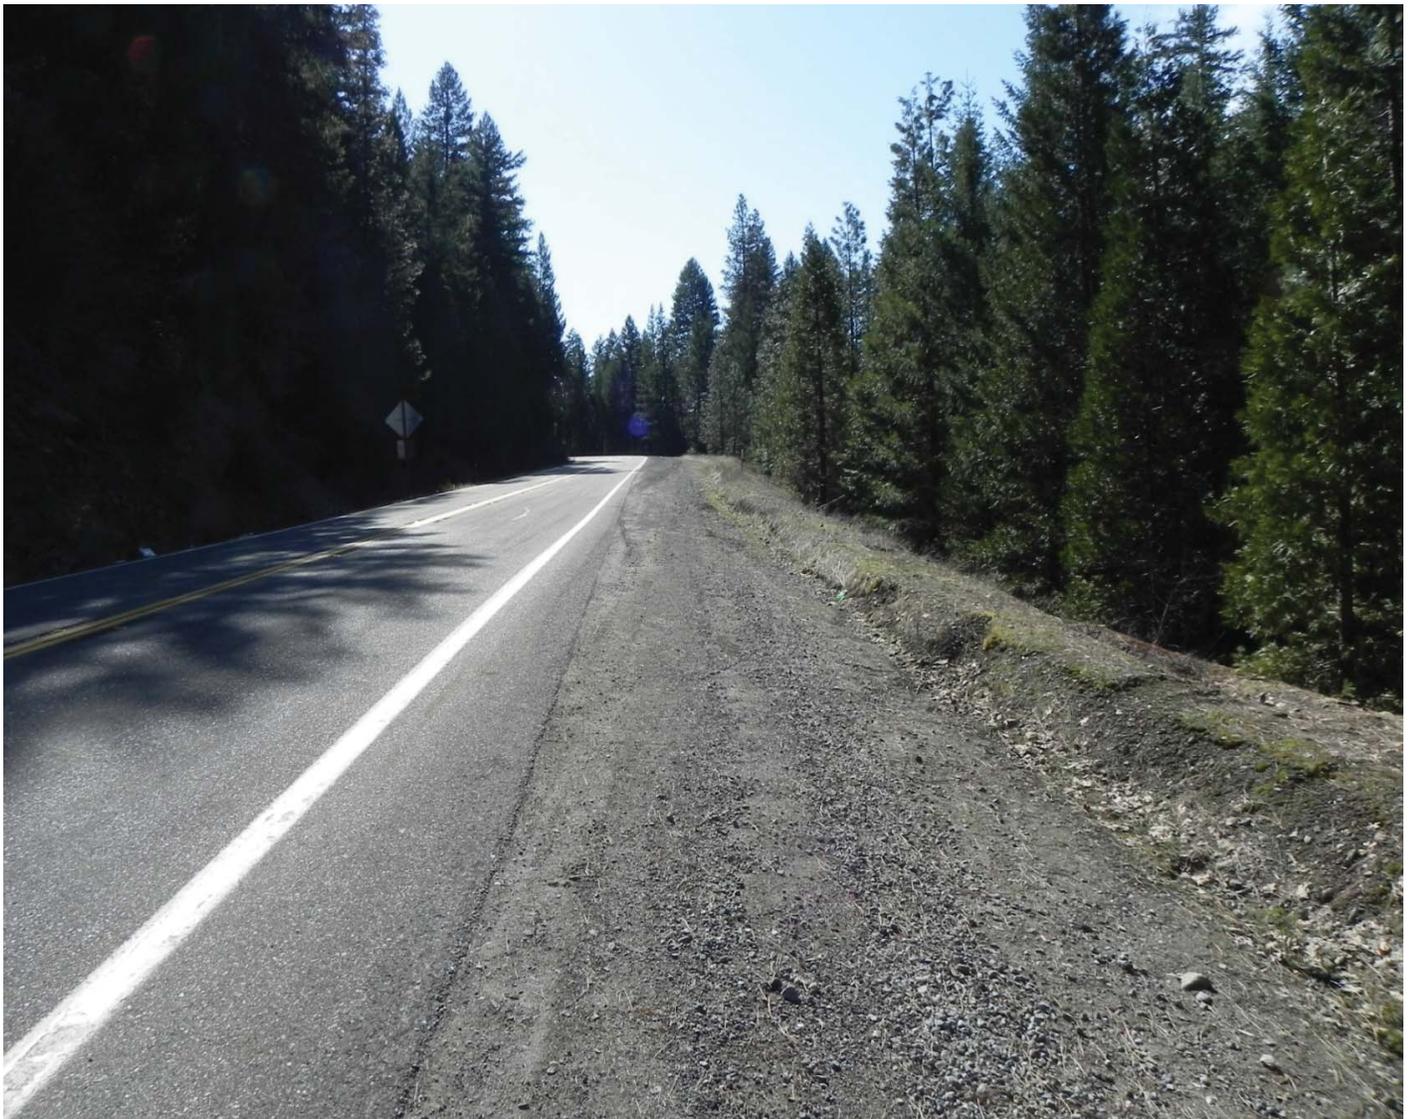
- Possible location for a climbing lane
- Location looks to be well used
- Width varies: 0-250' is 10', 250'-600' is 15', 600'-800' is 30' and 800'-1050' is 20' wide
- Culverts at PM 48.61 and 48.67 – outfall is 15' plus from ETW

Rank: High. This location meets the guidelines set forth in the Highway Design Manual. The length of this location is 900' but could easily be up to 1050' with minor improvements. The width is mostly 15' or more. This location shows signs that it is heavily used year round and has great solar exposure. The length of this location (400') is of great benefit given the approximate grade is 3-5% uphill making it easier for slower moving vehicles to exit and enter the roadway without completely stopping. There is one short section approximately 600' from the south end that may require guardrail due to a drop off.

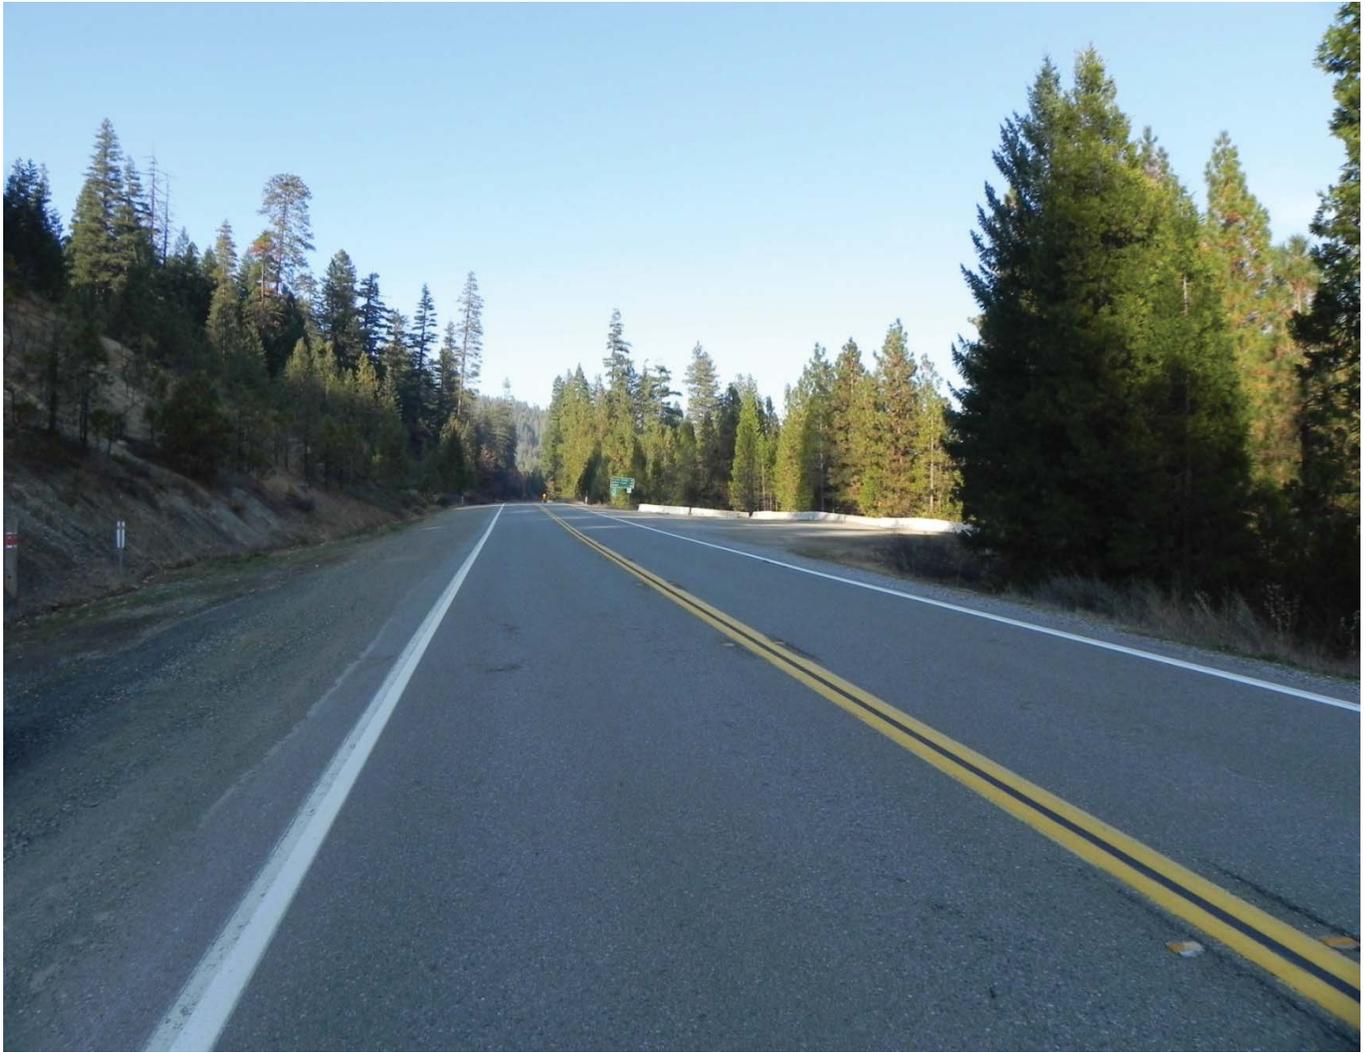
- Location for both a NB and a SB turnout (see SB 3)
- K-rail on NB side
- Tree trimming/removal would increase sight distance
- Area used by maintenance for winter material storage
- Culvert at PM 49.55

Rank: Low. This location meets the guidance set forth in the Highway Design Manual. It is on a 3-5% uphill grade and it would take substantial earthwork (fill) to add any additional length. There is a culvert on the north end (PM 49.55) that would need to be extended with any roadway improvement that included adding length to the site. Maintenance staff stated they use this location at times to store material but feel the width could accommodate their use as well as a turnout. They are in favor of paving it to reduce damage to the edge of pavement from their equipment and vehicles exiting and entering the roadway.
