State Route 3 Turnout Study
Weaverville to Coffee Creek
TRI 3 PM 30.86 – 67.89
May 2012

Prepared by: Caltrans, District 2, Office of System Planning
In cooperation with the Trinity County Transportation Commission

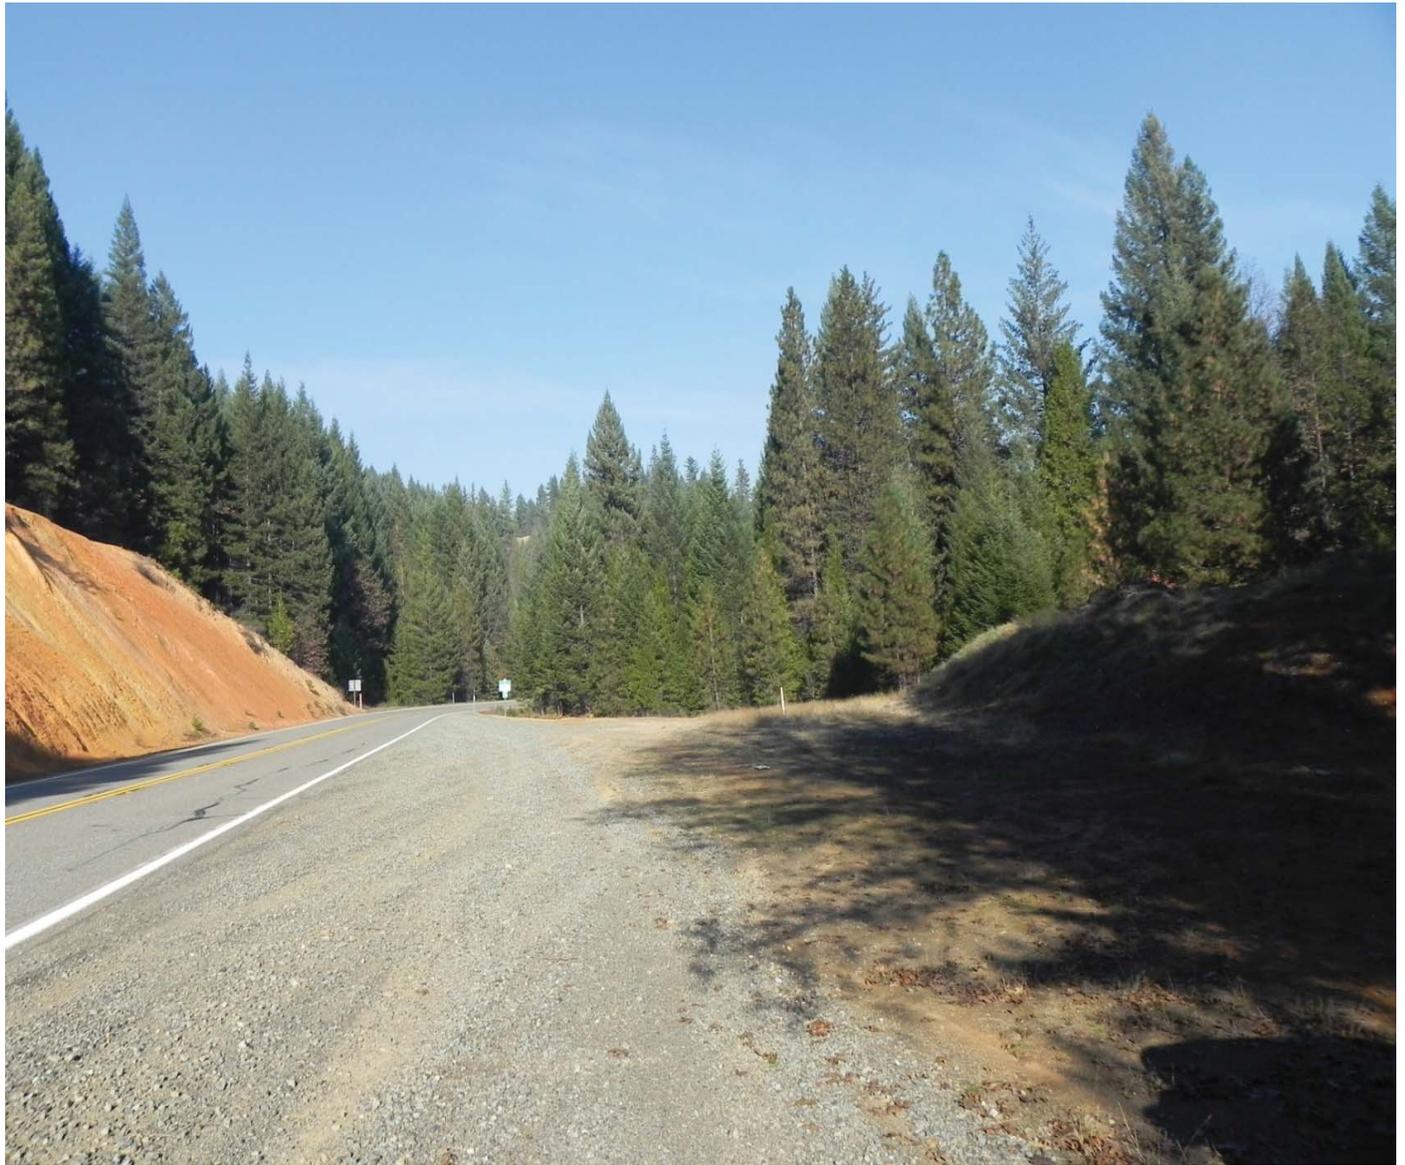
- Looks to be well used
- Great solar exposure

Rank: High. This location meets the guidelines set forth in the Highway Design Manual. With minor earthwork (fill) this site could be made longer. The width of this location exceeds the minimum guidelines and at times is 40' wide. This location shows signs of being highly used year round and has great solar exposure with little snow storage during winter months.

This location is roughly five miles north of the last high ranking potential turnout location, NB 8 (PM 48.60) and about 10 miles south of the next high ranking location, NB 11 (PM 63.70). This location is being recommended for improvement because it meets the Highway Design Manual criteria, requires minimal improvements and will enhance mobility in the corridor given spacing between the other high ranking locations.

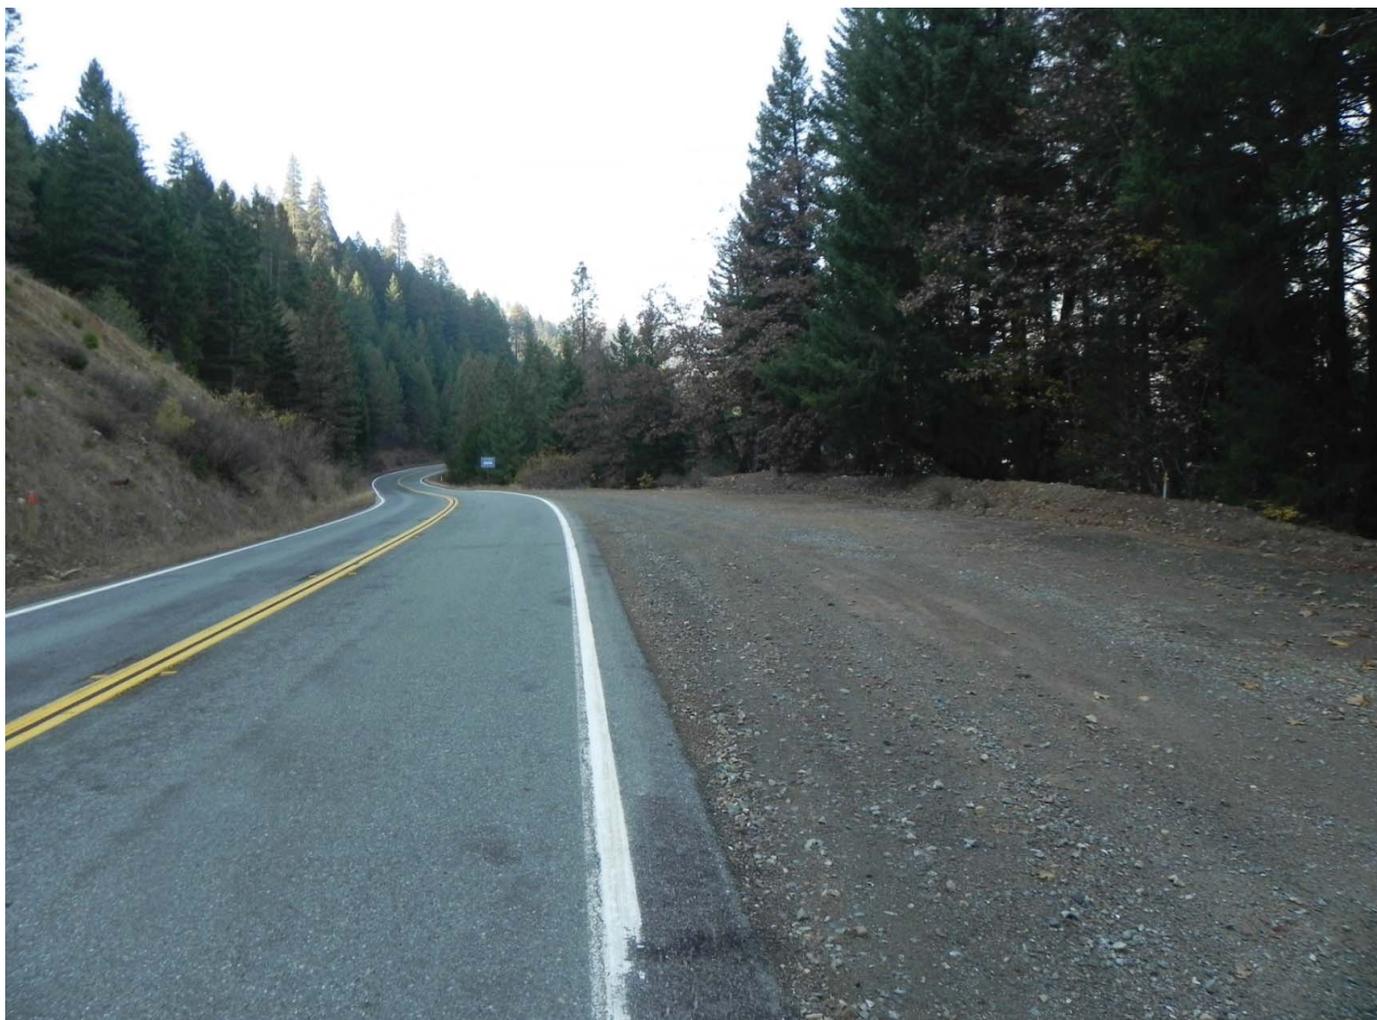
- Tree trimming/removal would increase sight distance
- This location is identified by field maintenance as heavily used and requires significant efforts to keep maintained
- Edge of pavement shows signs of damage from vehicles exiting and entering the roadway
- Great solar exposure
- Drainage system in cut area on north side of highway
- Culvert at PM 63.72

Rank: High. This location meets the guidelines set forth in the Highway Design Manual. This location has good sight distance, great solar exposure and shows signs of use year round. Paving this location would help keep the ETW from getting worn from vehicles exiting and entering onto the roadway. Maintenance staff has expressed that this location works well as a turn out but needs to be paved in order to preserve the edge of pavement and keep dirt and rocks off the travelled way.

This location falls within a 1.5 mile stretch where two possible turnout locations have been identified, this location and NB 12 (PM 64.85). This location is being recommended for improvements in this section of the study corridor. The last potential turnout ranked high was NB 10 (PM 53.00) and is just over ten miles south of this location. The next and last NB potential turnout is NB 12 (PM 64.85) for this study and is located just over a mile north of this location and is ranked medium. It could be cost effective to improve both NB 11 and 12 as little work is needed to either location.

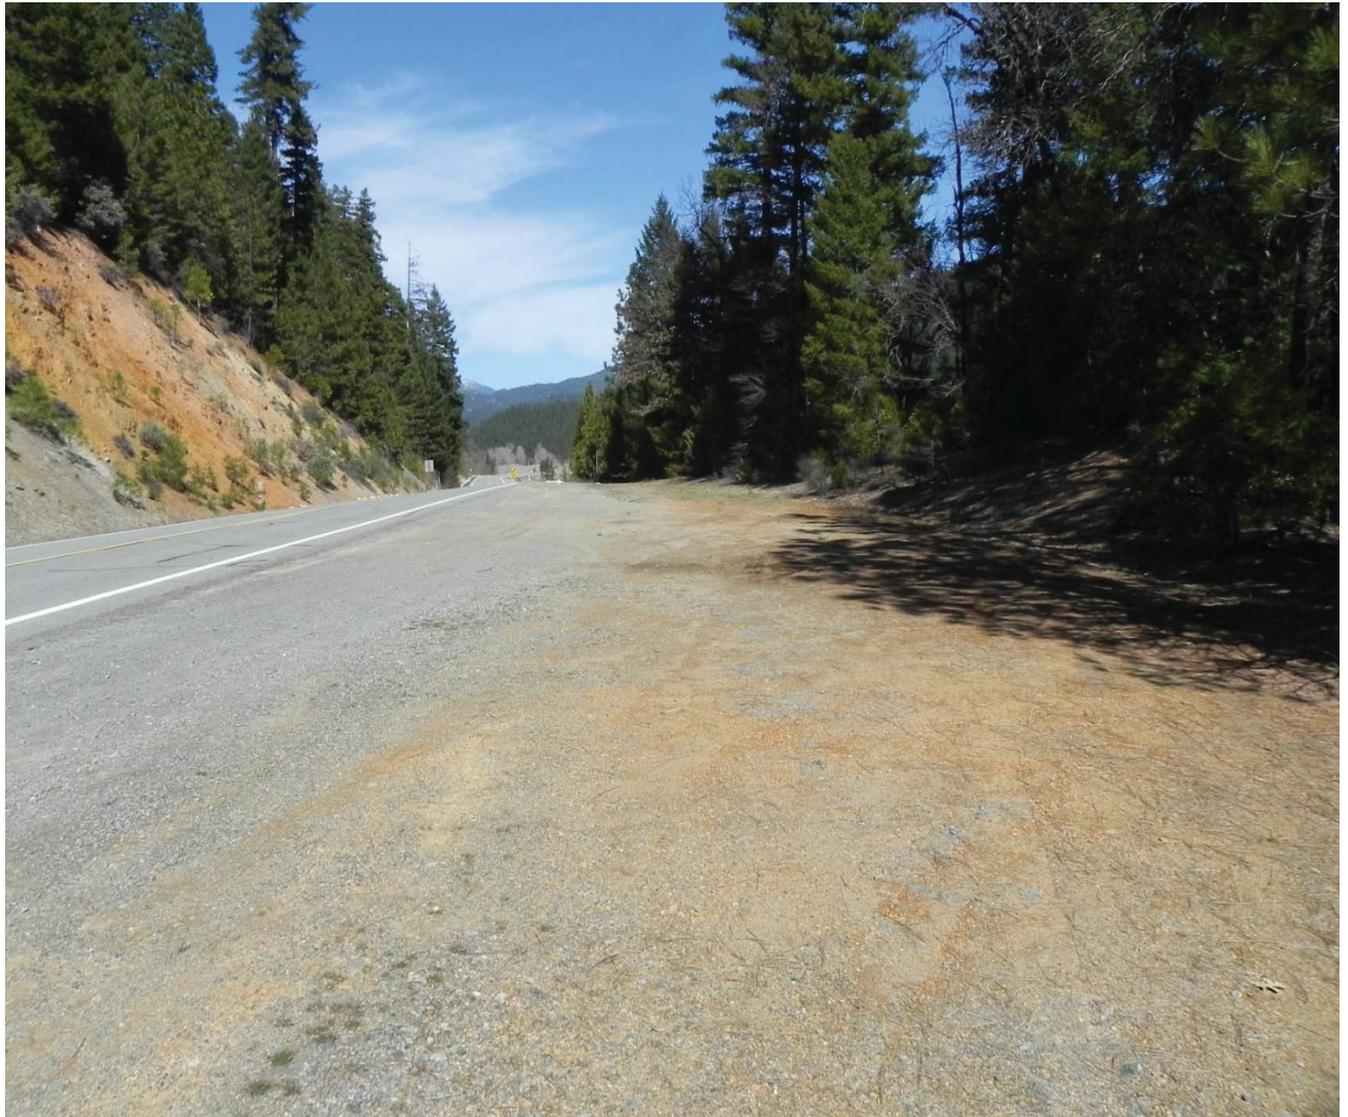
- This is at the north end of Trinity Lake near Eastside Road
- Edge of pavement shows signs of damage from vehicles exiting and entering the roadway
- Culvert at PM 64.94

Rank: Medium. This is the last northbound potential turnout location in this study. This location meets the guidelines set in the Highway Design Manual. This location has good sight distance, great solar exposure and shows signs of use year round. Paving this location would help keep the ETW from getting worn from vehicles exiting and entering onto the roadway.

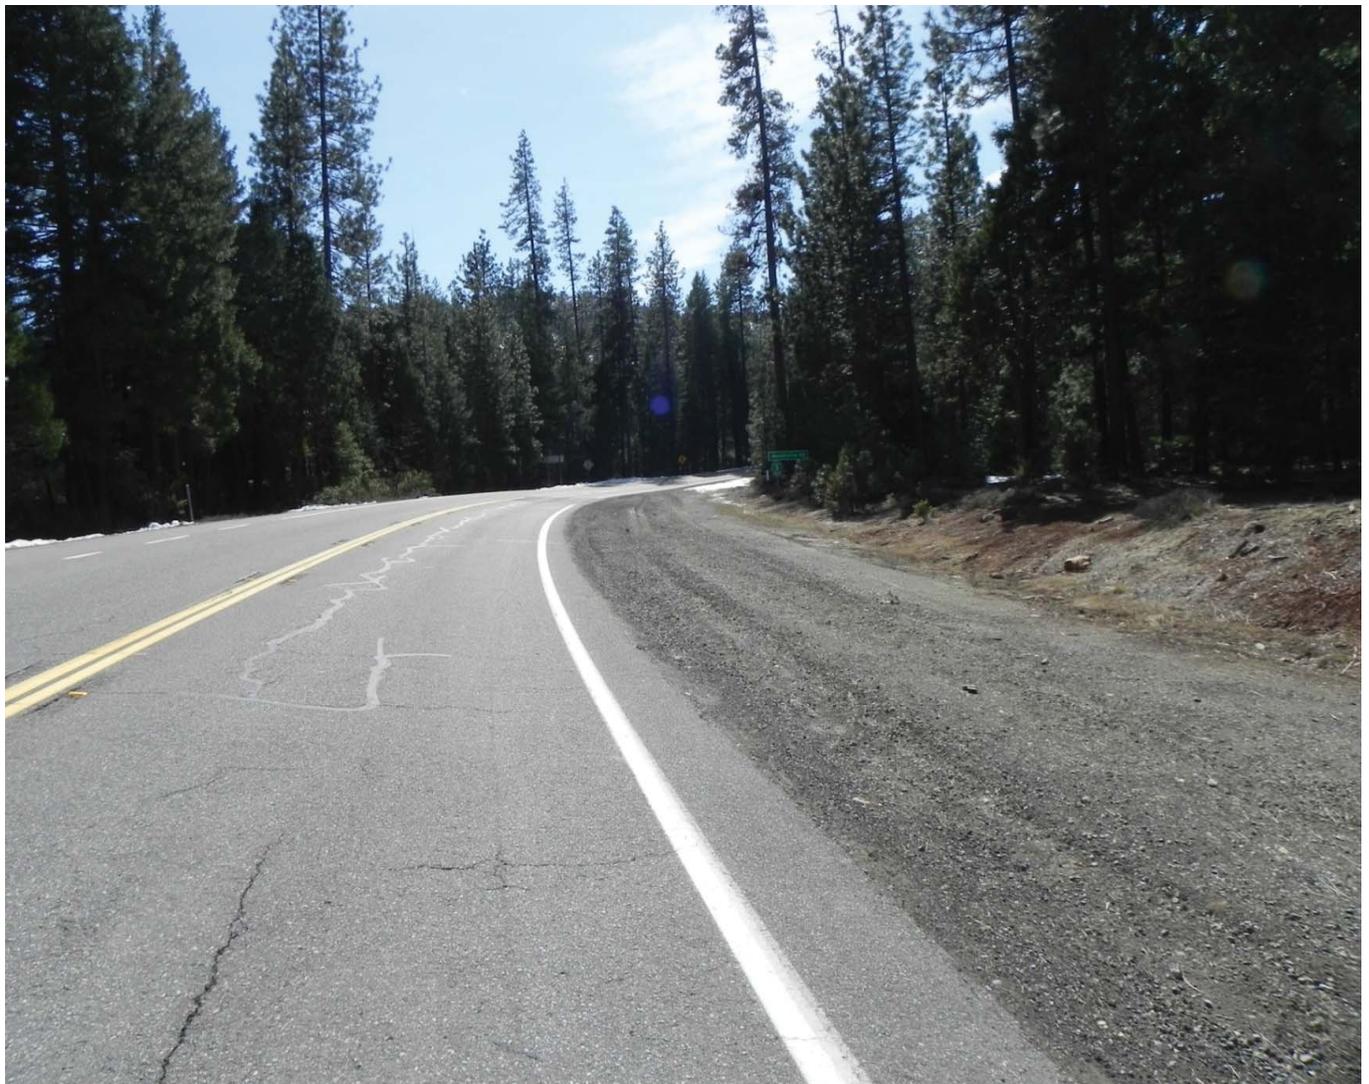
- Directly across from Airport Road, which is to the unincorporated town of Trinity Center
- Just south of Swift Creek Bridge
- Gated utility access road at the beginning of location
- Water line crosses highway just over half way through location
- High pedestrian/bike usage in vicinity of Swift Creek Bridge

Rank: High. This location meets the guidelines set forth in the Highway Design Manual. There is a road connection (Airport Road) across from this location that serves the small community of Trinity Center. Just north of this location is the Swift Creek Bridge, which is currently being looked at for improvements. It may be feasible to incorporate this potential turnout location into the bridge project. This area is known for heavy bike and pedestrian activity.

This location is being recommended for improvement. The next recommended turnout location is SB 3 (PM 49.45) is just over ten miles to the south.

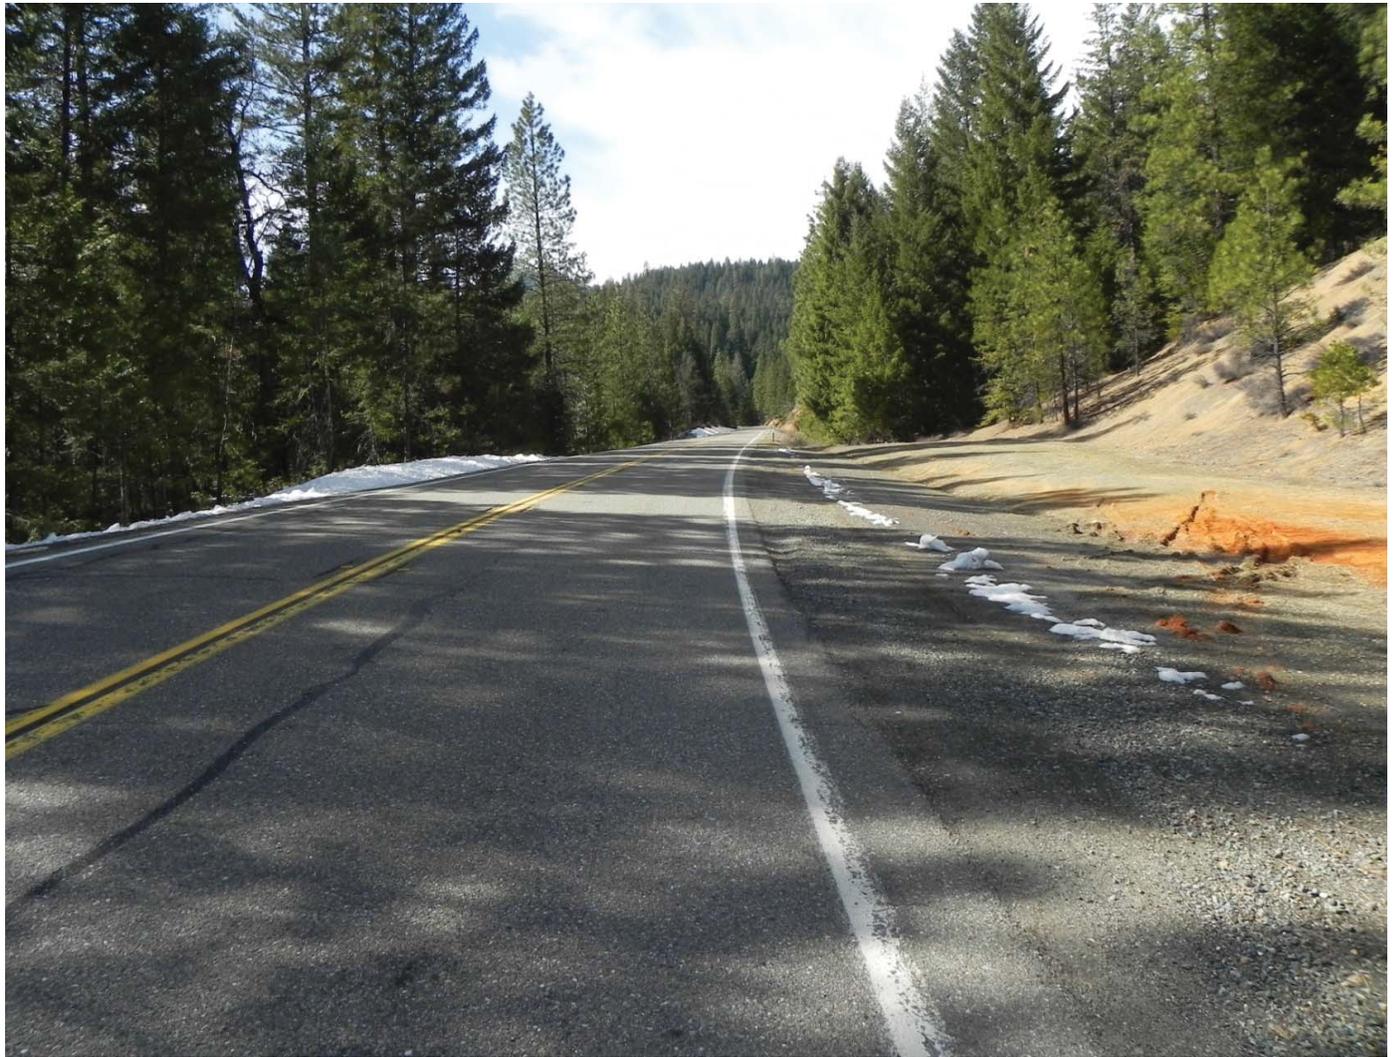
- Could increase length to approximately 450' if fill some spots at entry and exit
- There are trees and vegetation that are indicative of water near the culverts at entry and exit
- Culverts would need to be extended to lengthen this location
- This location is noted by field maintenance as heavily used and requires significant effort to keep maintained during wet or snow weather
- During wet and snow weather mud is pulled onto the roadway

Rank: Low. This location does not meet the length guidelines set forth in the Highway Design Manual. It is also appears there may be the potential environmental concerns due to standing water in the area and growth of some vegetation. If there were no significant environmental issues and some earthwork (fill) and culvert work were done, this location could rank higher. This location has some snow accumulation in winter months but has good solar exposure. Maintenance staff expressed this area is used heavily by trucks which often carry mud back onto the roadway, which tends to create a hazard.

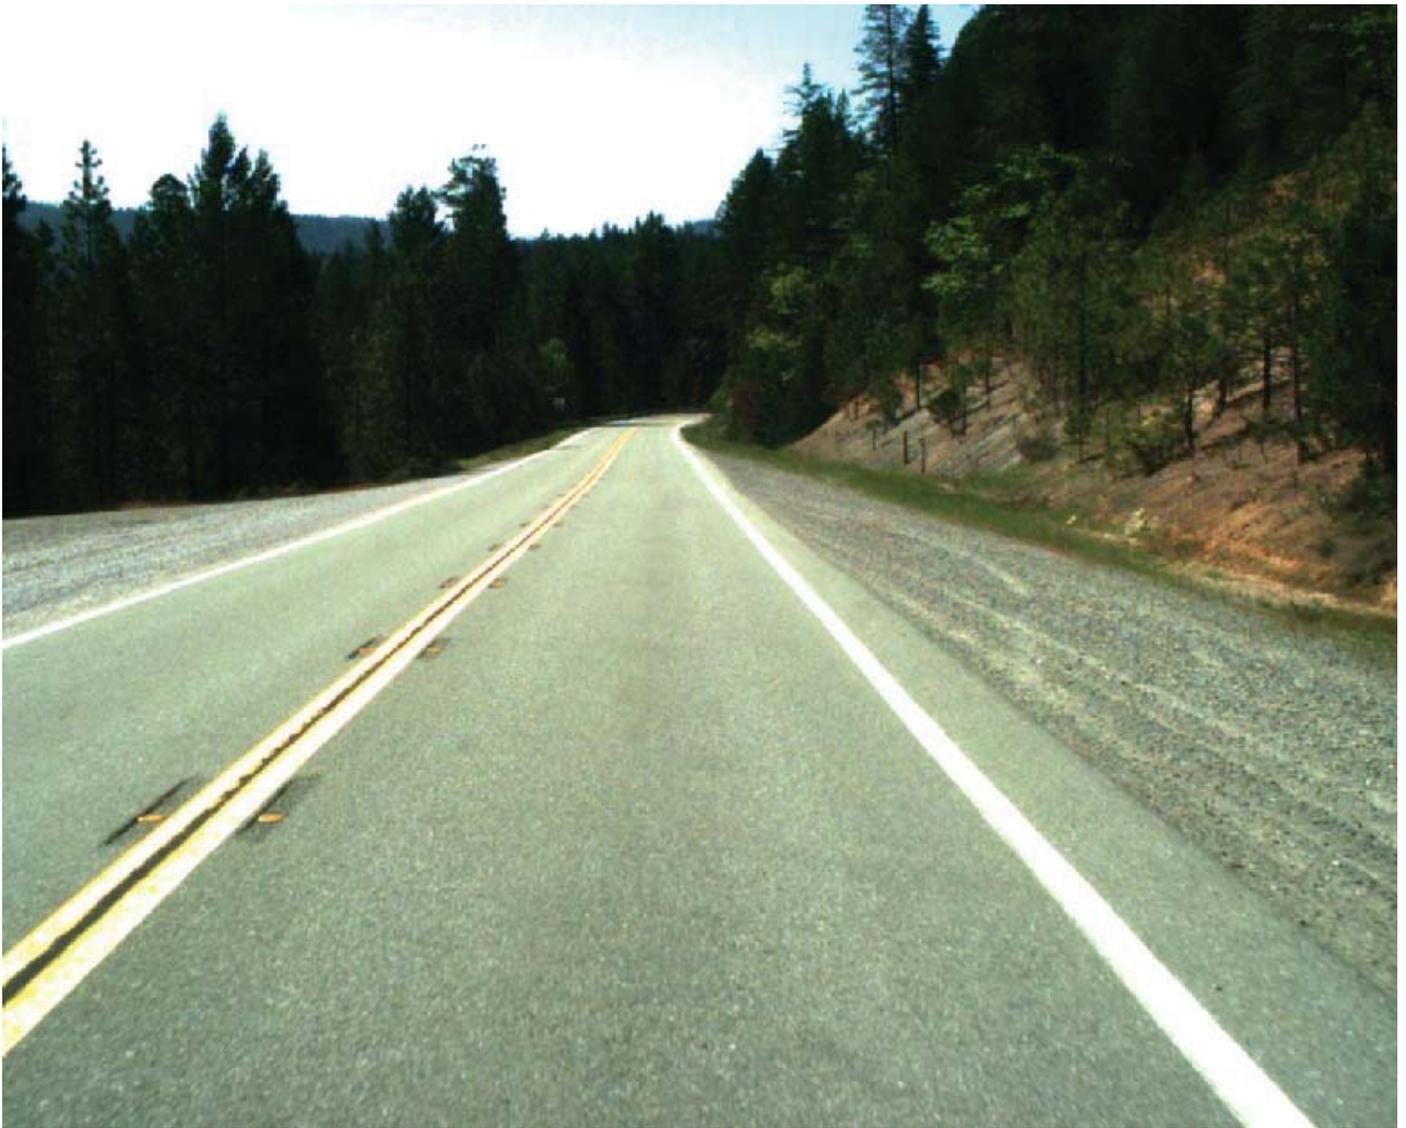
- May need minor earthwork to achieve uniform width (cut)
- Tree trimming / removal would increase sight distance
- Location for both a SB and a NB turnout (see NB 9)

Rank: High. This location appears to meet the guidelines set forth in the Highway Design Manual. This location exceeds the minimum length guidelines, which is very beneficial for tappers and being able to accommodate more than one vehicle off the roadway. This location has great solar exposure and shows little signs of snow accumulation in the winter months. Even though there are slight curves on entry and exit there is good sight distance.

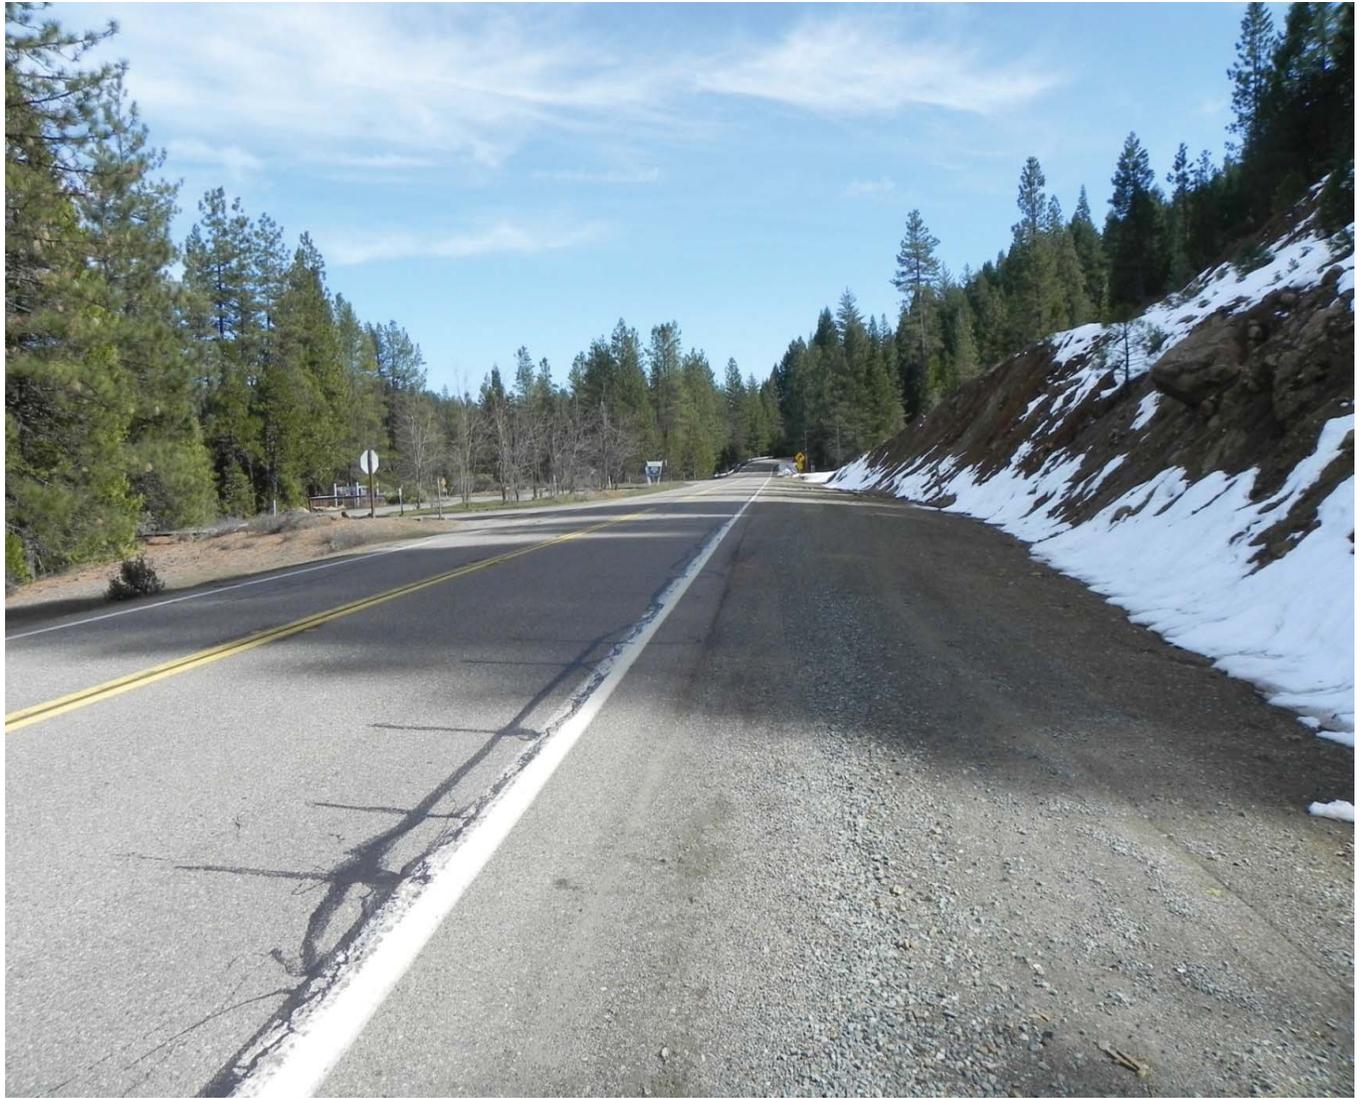
- Location could be longer with some earthwork (cut)
- Perennial stream culvert at PM 43.21
- Location is across from Osprey - National Recreation Area
- Show signs of use
- Culvert at PM 43.38

Rank: High. This location meets the guidelines set forth in the Highway Design Manual. This location exceeds the minimum length guidelines, which is very beneficial for tappers and being able to accommodate more than one vehicle off the roadway. This location offers good sight distance, great solar exposure and shows signs of use year round.

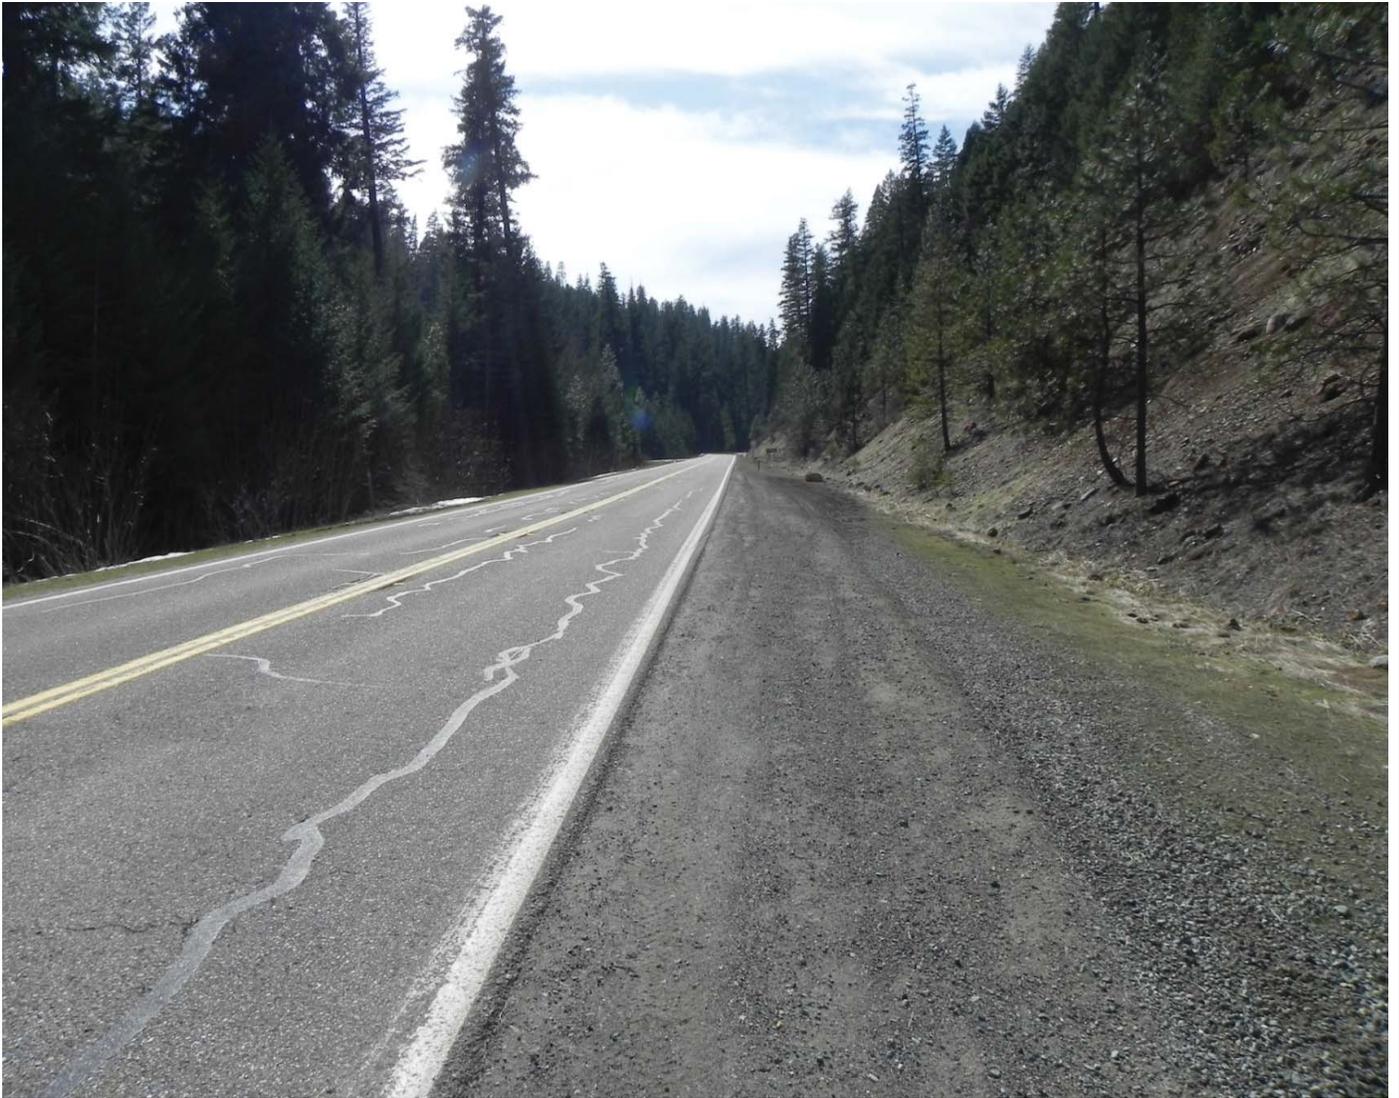
- Tannery Gulch campground entrance is located at the southern end of this location
- Edge of pavement shows signs of damage from vehicles exiting and entering the roadway
- The inlet for culvert at 42.70 would require relocation as it is less than 10' from ETW
- Location shows signs of some rock fall from slope above
- Culverts at PM 42.58, 42.62, and 42.70

Rank: Medium. This location meets the guidelines set forth in the Highway Design Manual. This location exceeds the minimum length guidelines, which is very beneficial for tappers and being able to accommodate more than one vehicle off the roadway. This location offers good sight distance, great solar exposure and shows signs of use year round. Possible issues with this location are there is the potential for drainage or culvert work that would need to be done and there are signs of rock fall from the slope.

The last potential turnout was just under a mile north of this one and is ranked high, SB 4 (PM 43.30). Even though this location is ranked medium and there is another potential turnout closely that is ranked high, this location would add some benefit to the corridor. This location is the last good option for a turnout until the town of Weaverville, which is 12 miles south of here. There is one more potential turnout along this corridor just over two miles south of this location, SB 6 (PM 40.40) that is ranked low and is not being recommended for full development to a turnout.

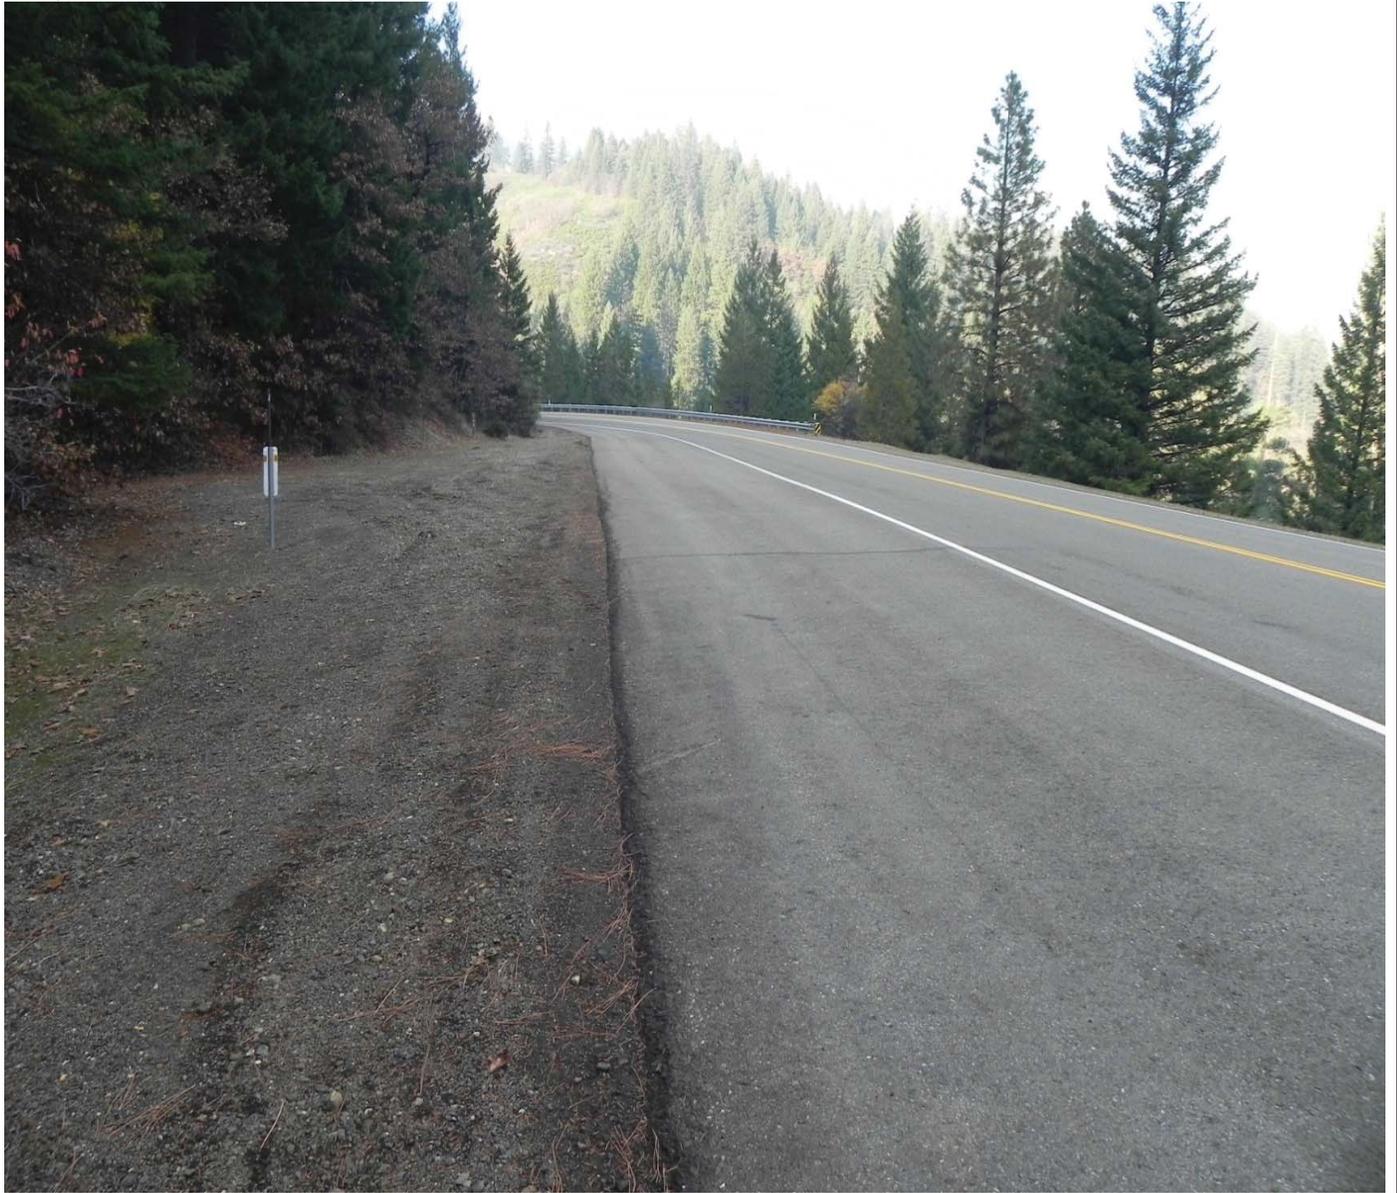
This picture was taken looking northbound

- Minor additions could enhance usage – signage and longer pavement
- Tree trimming / removal and earthwork may increase sight distance

Rank: Low. This location already provides a paved shoulder area for vehicles to get off the roadway but has no signage or advance warning of its existence. Sufficient sight distance will be hard to obtain. There doesn't appear to be any snow accumulation during winter months. This location does show signs of use year round.
