Appendix H Assessment of Erosion Sites on
Offsite Mitigation Parcels in Little
Lake Valley

Willits Bypass Project

Technical Memorandum: Assessment of Erosion Sites On Offsite Mitigation Parcels in Little Lake Valley

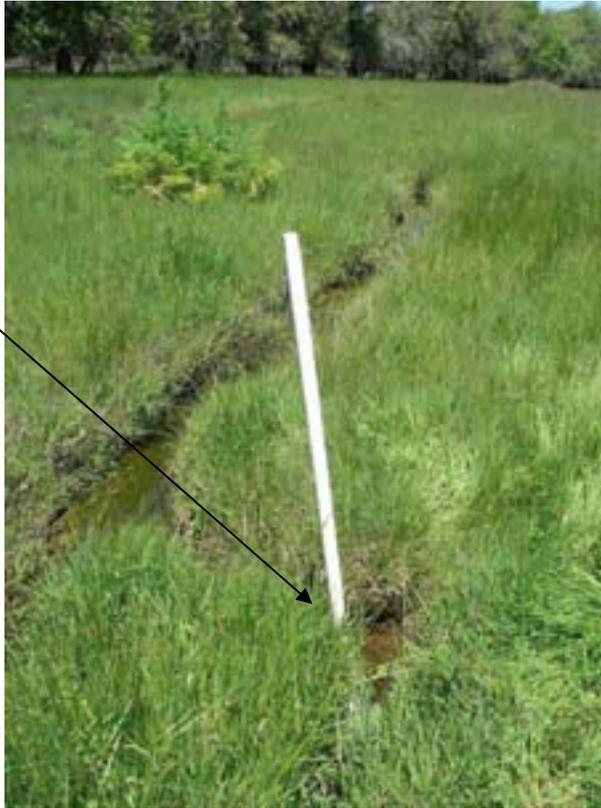
headcut

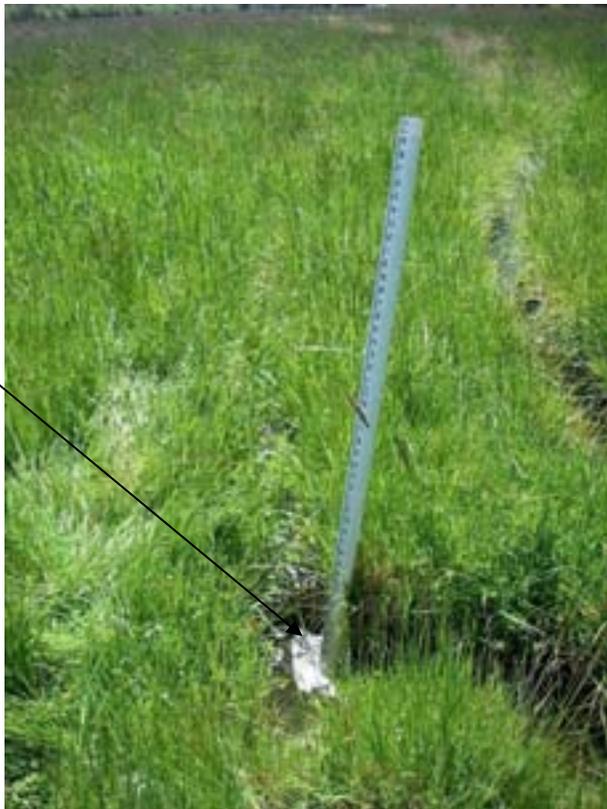
headcut

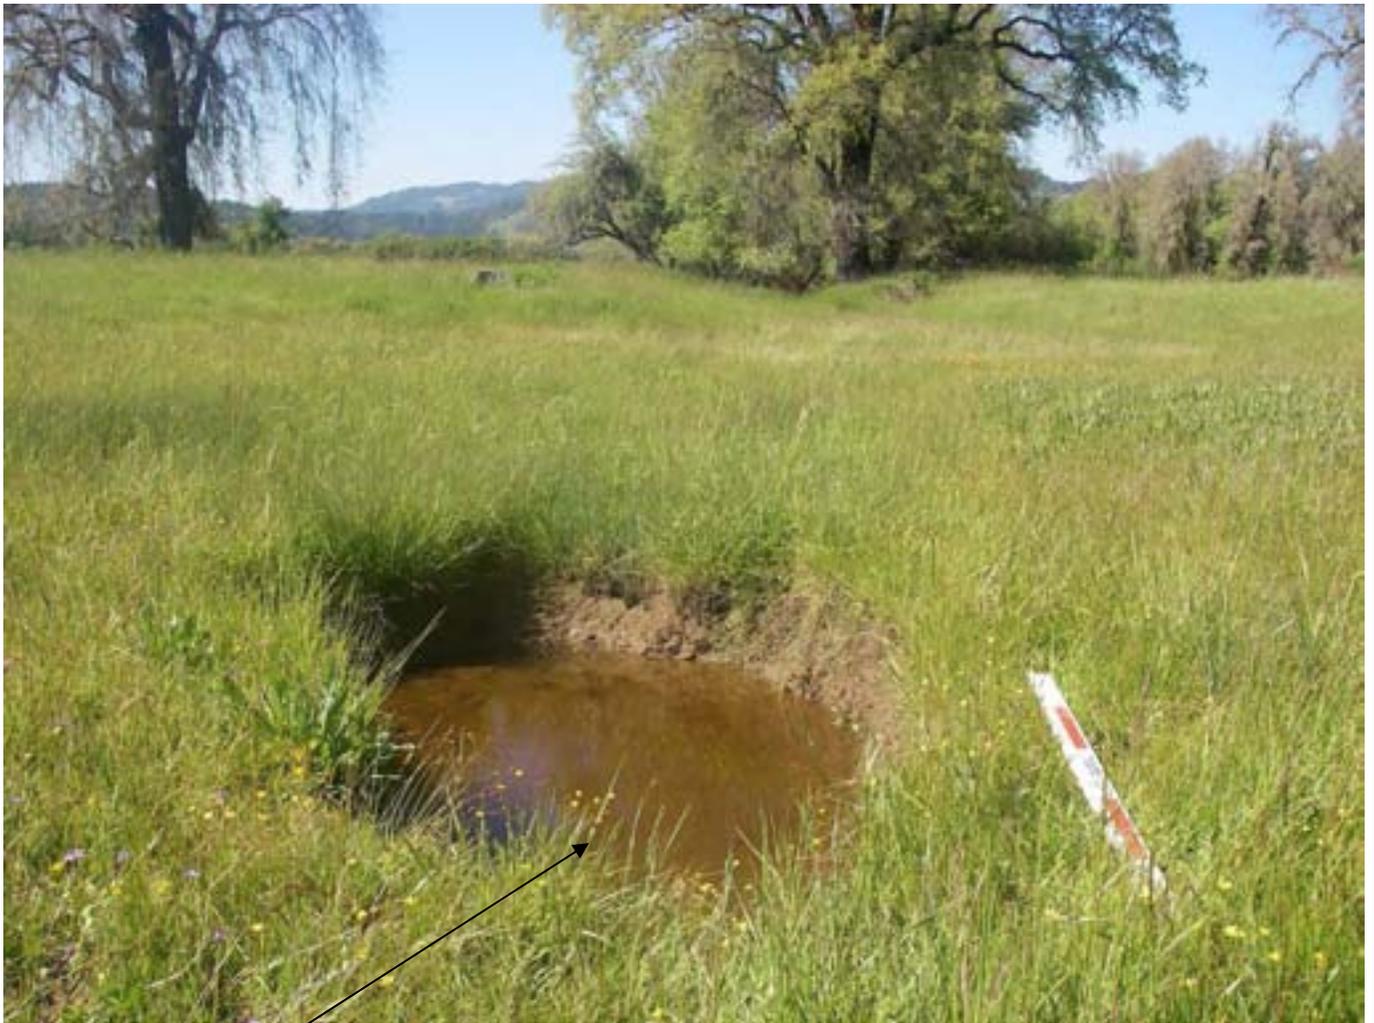
pothole

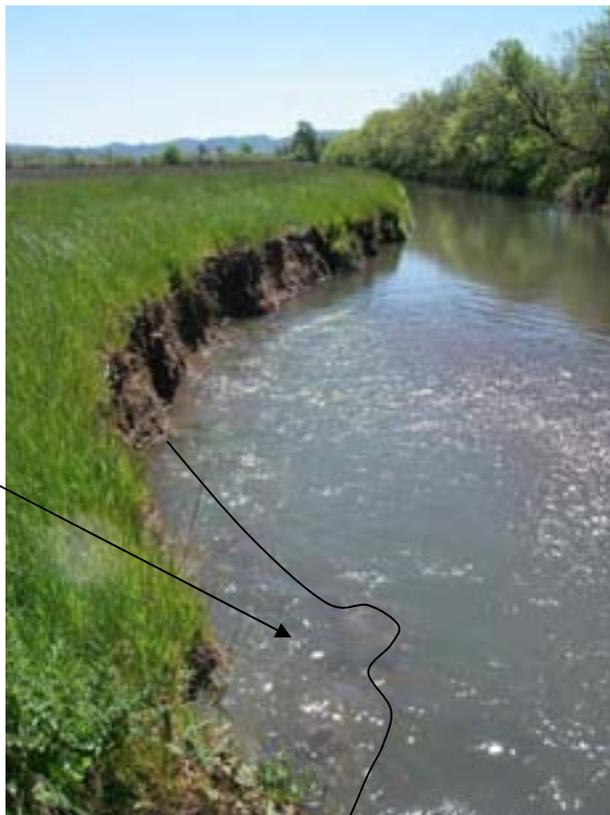
active slumping

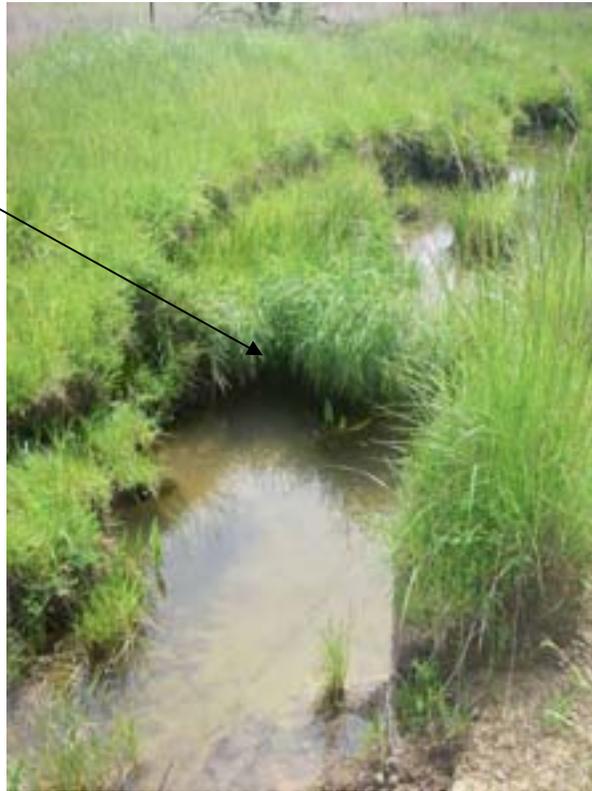
headcut

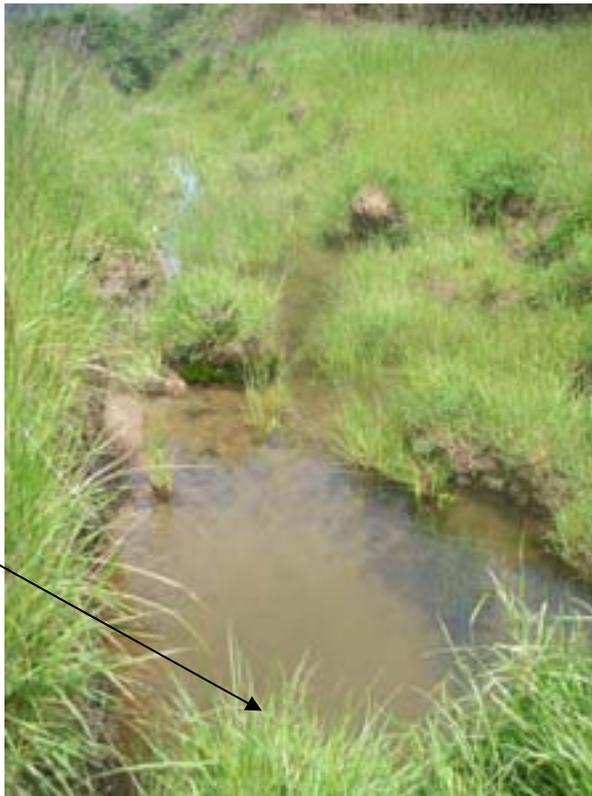
headcut

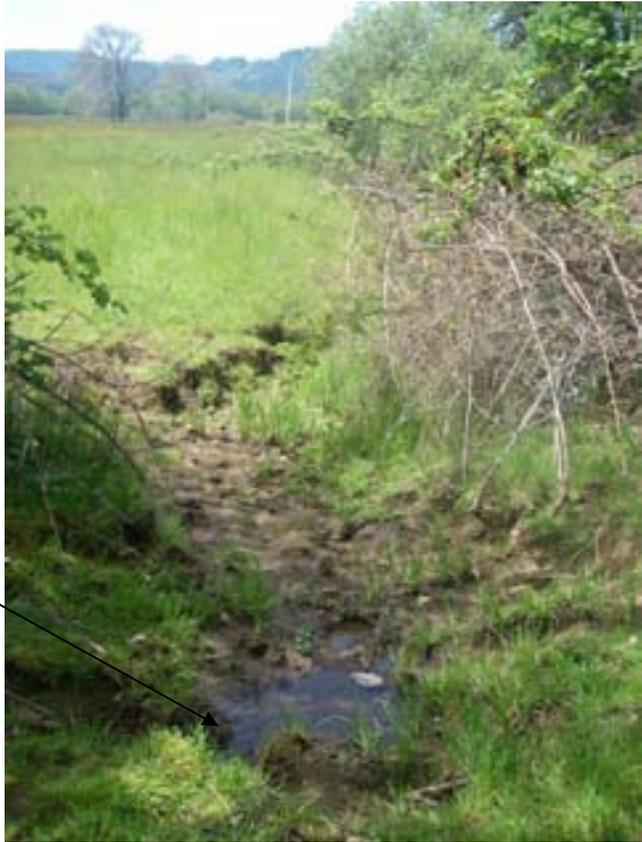
headcut

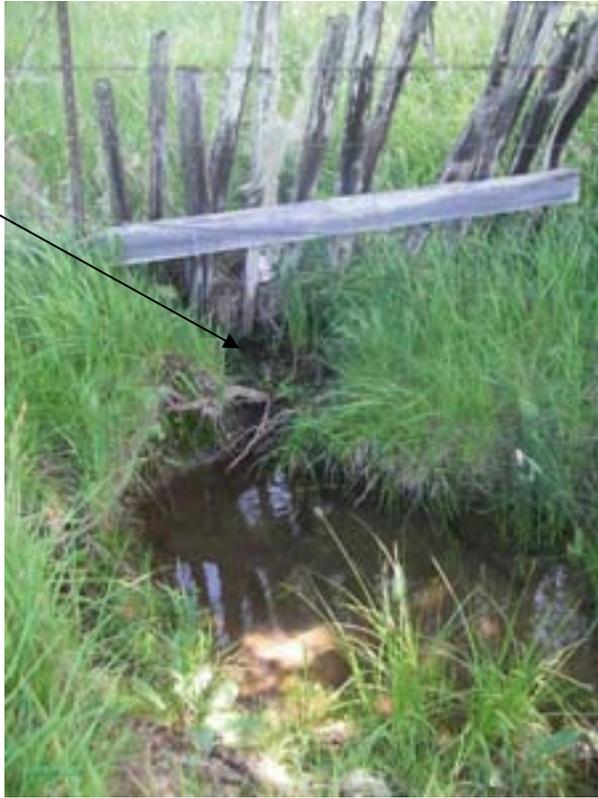
headcut

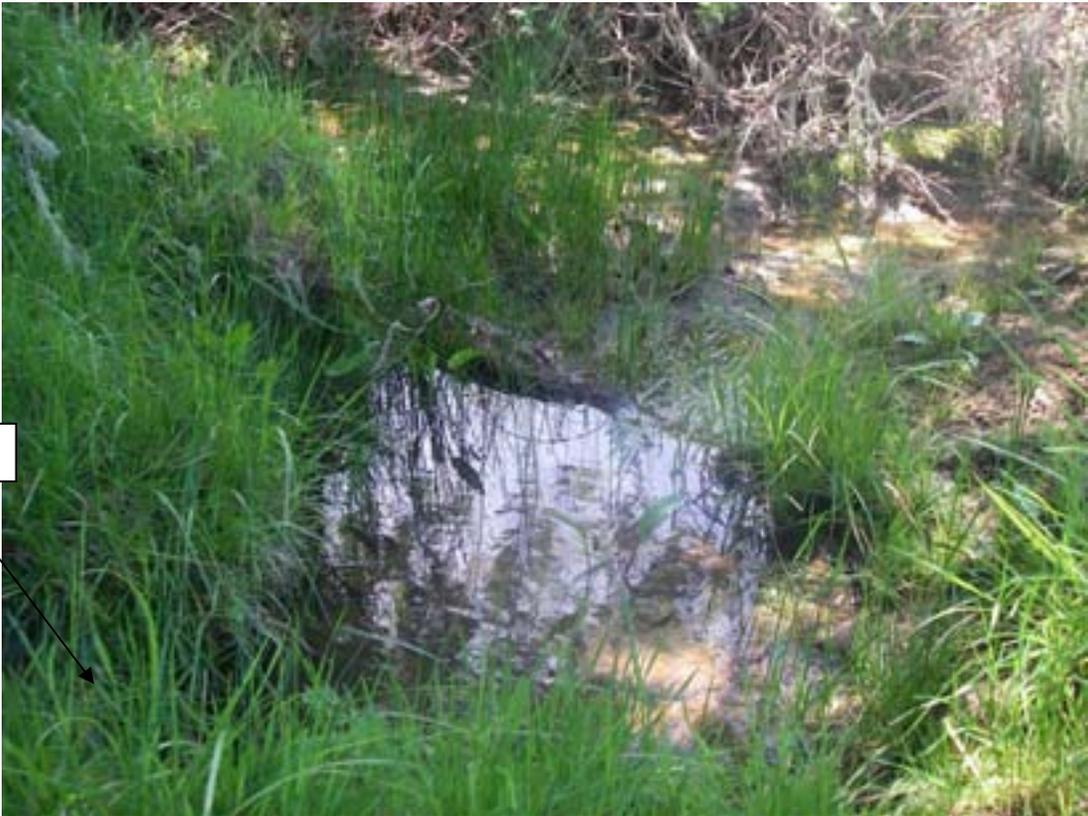
headcut

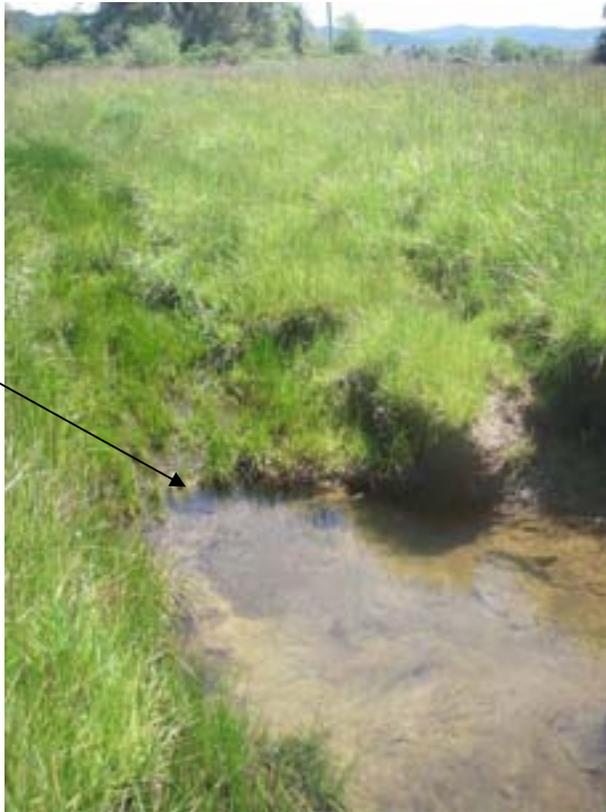
headcut

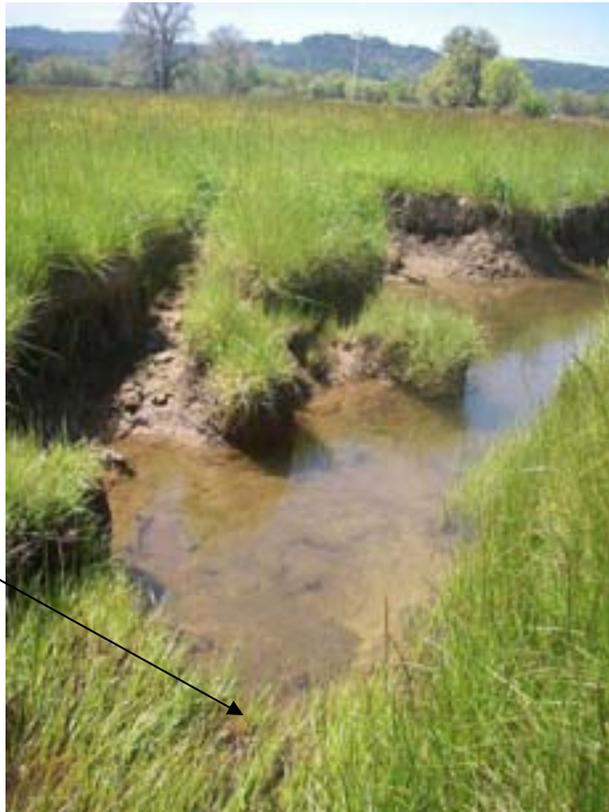
headcut

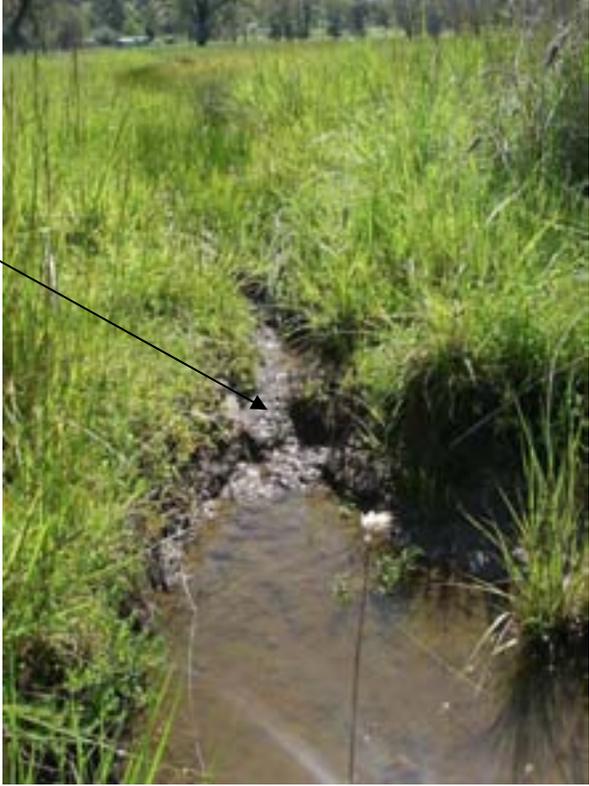
headcut

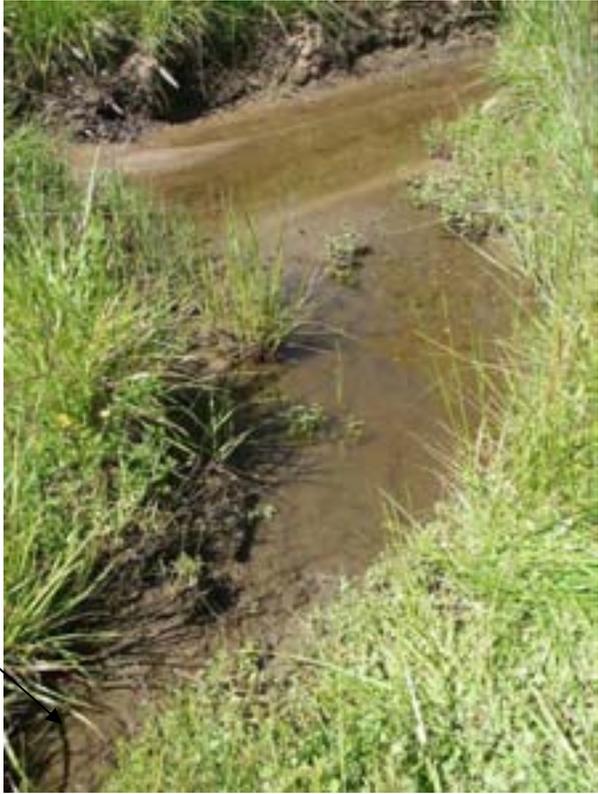
headcut

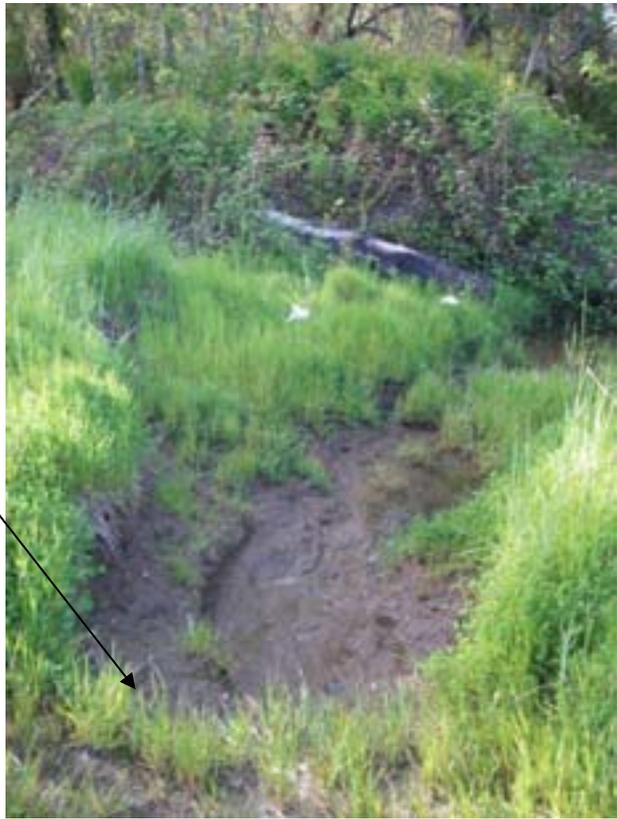
headcut

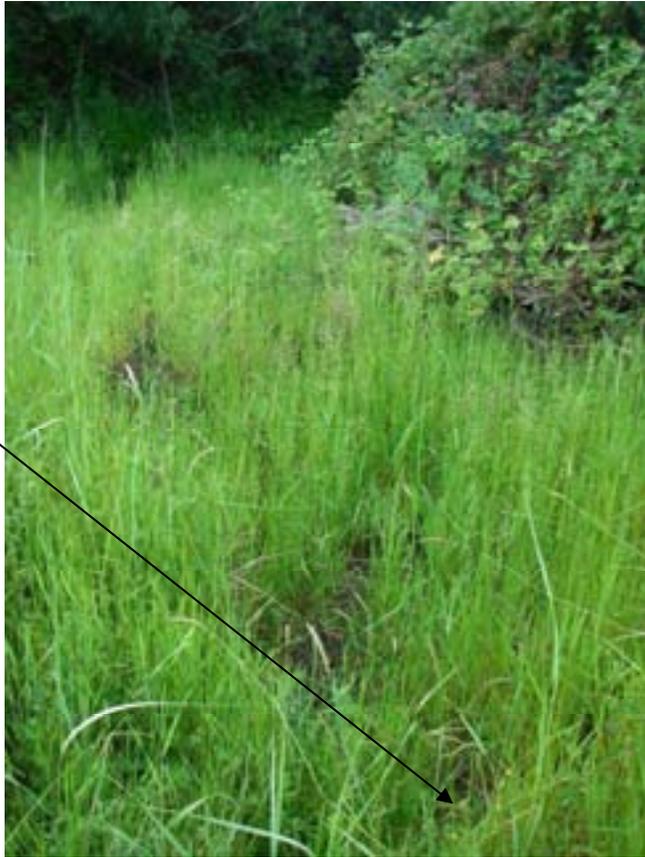
headcut

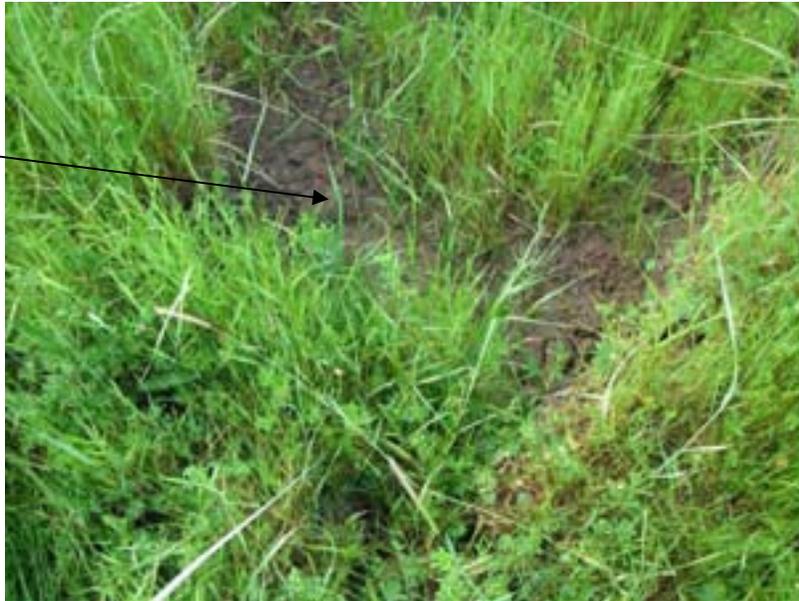
headcut

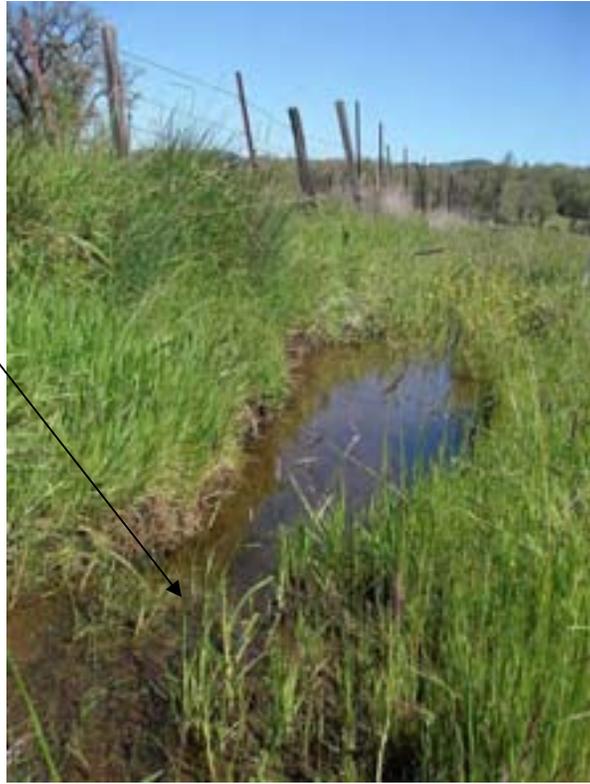
headcut

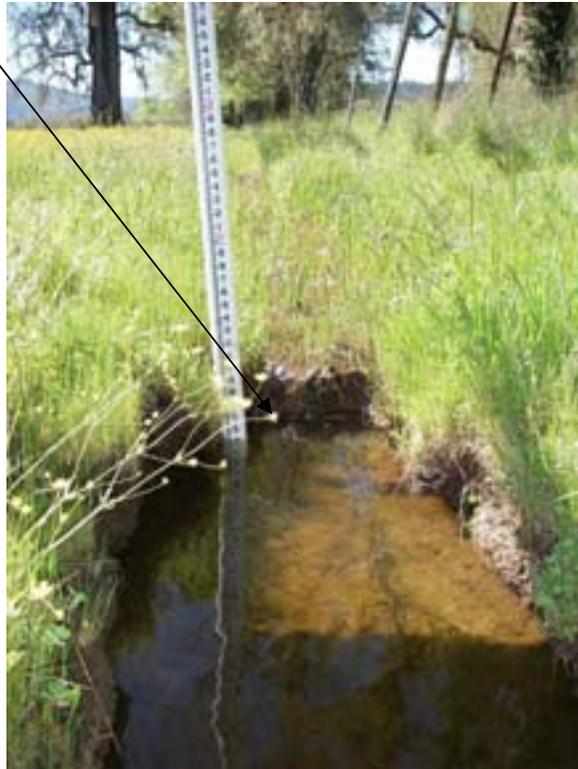
headcut

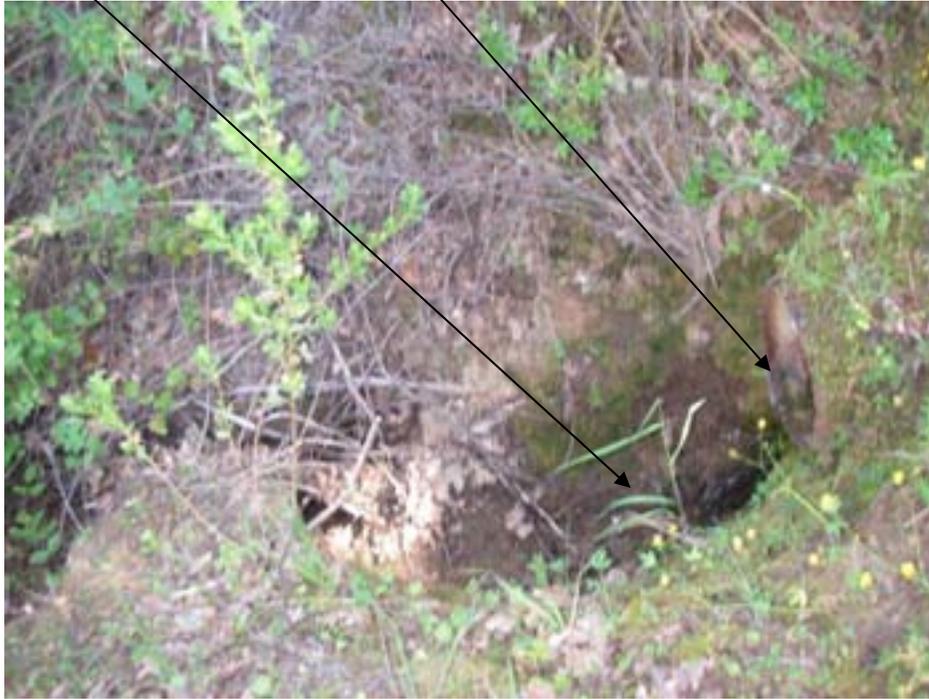
scour area

culvert

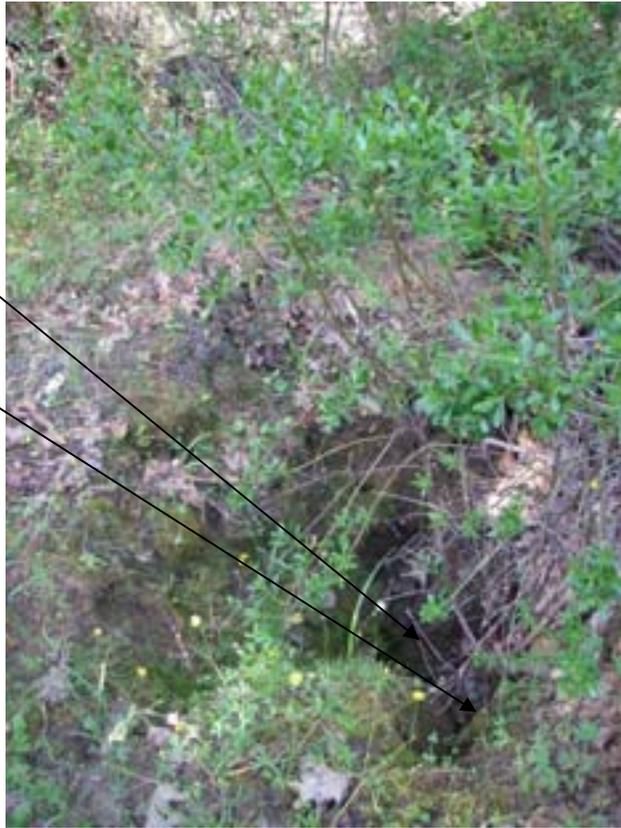
scour area

culvert

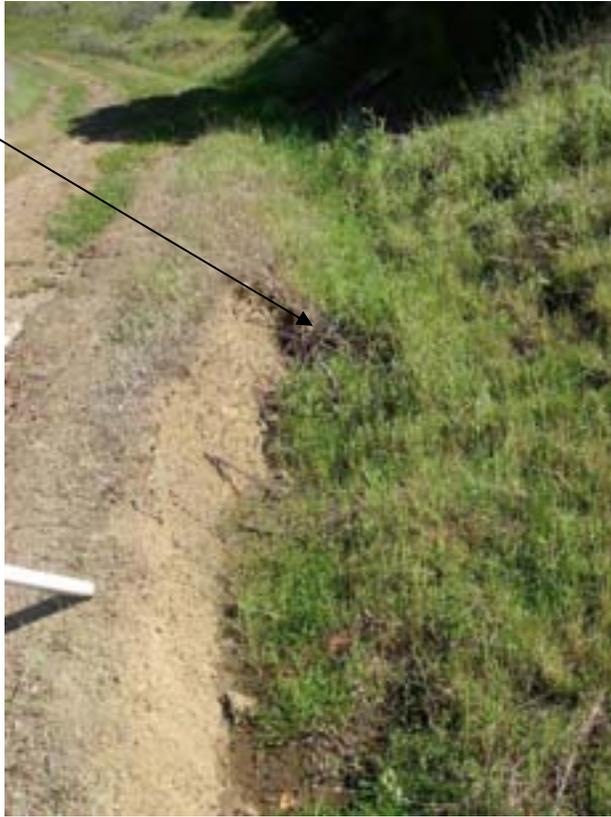
headcut

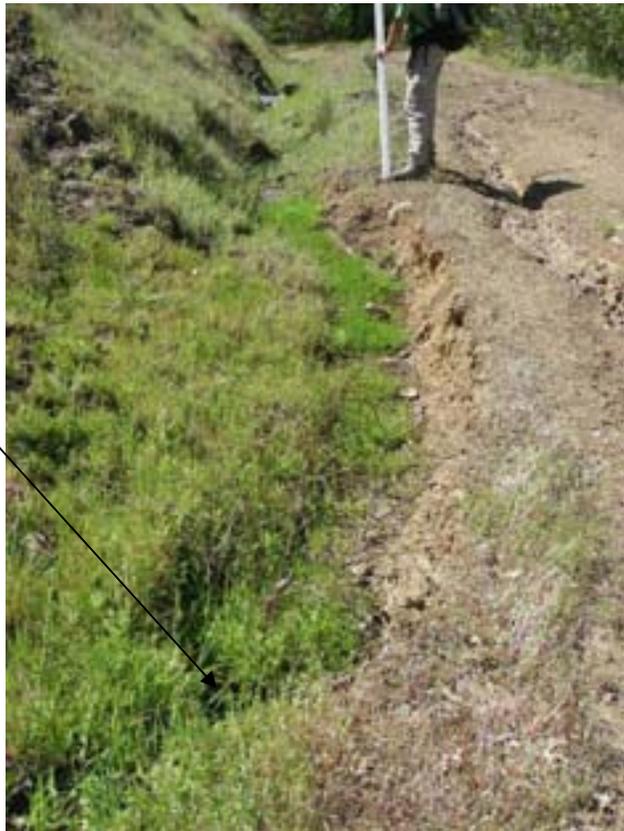
headcut

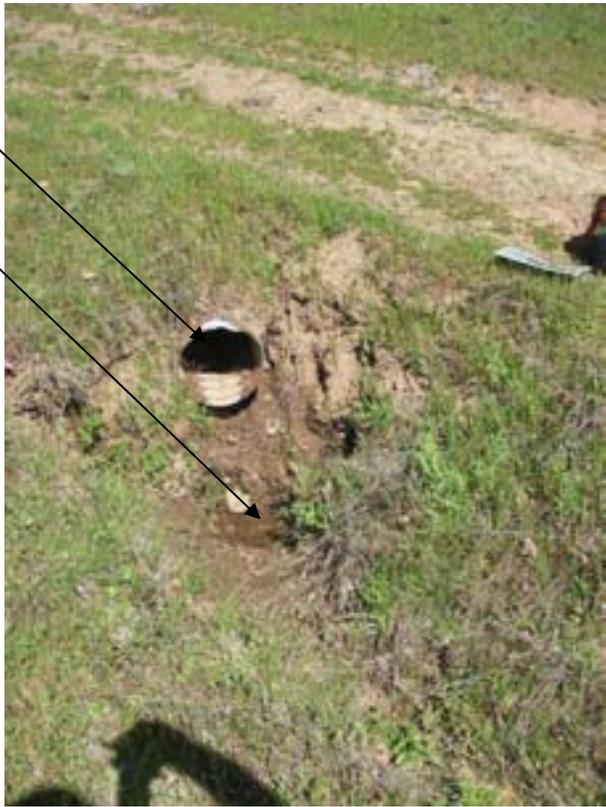
culvert

scour area

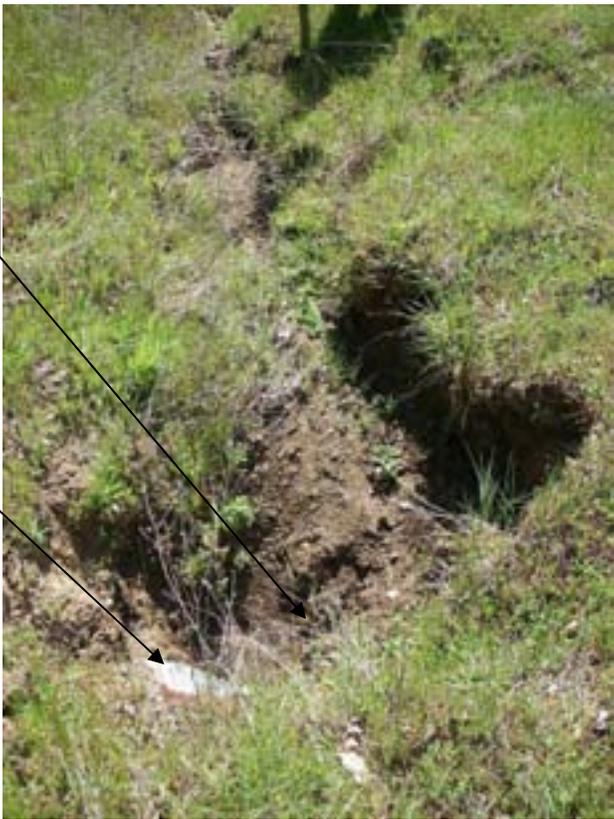
scour area

culvert

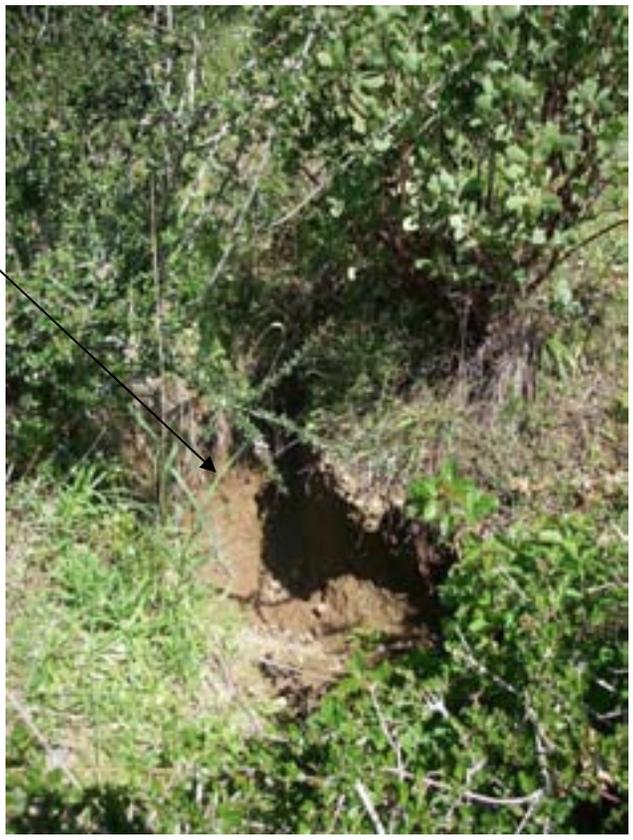
headcut

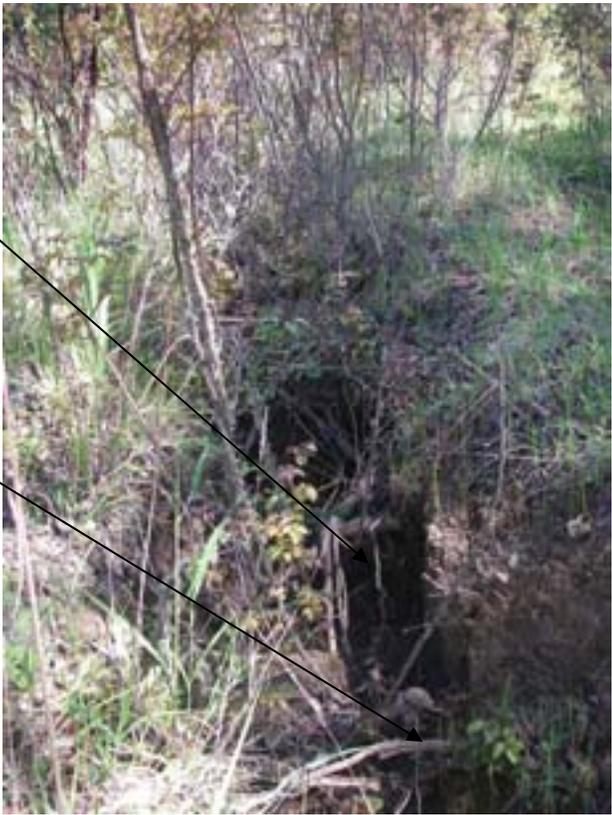
headcut

eroding
gully

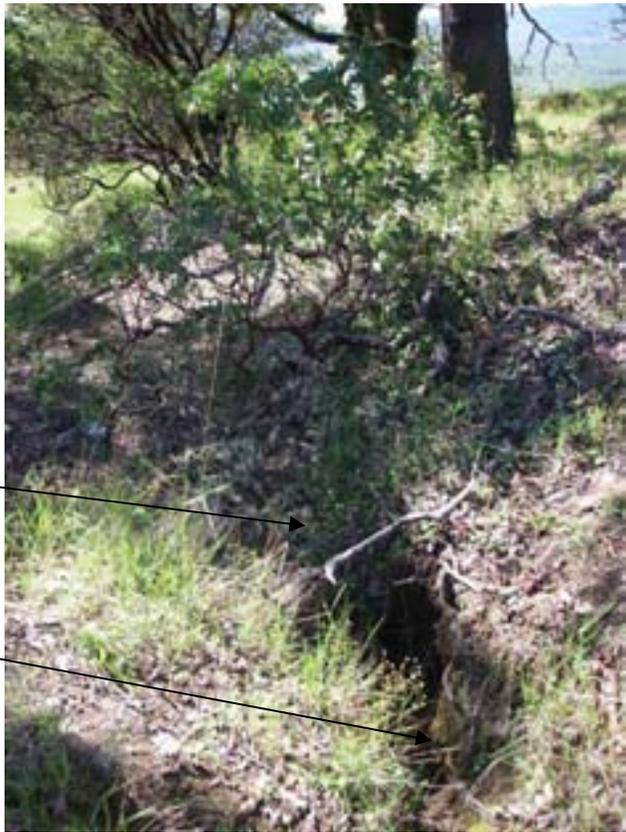
eroding
gully

headcut

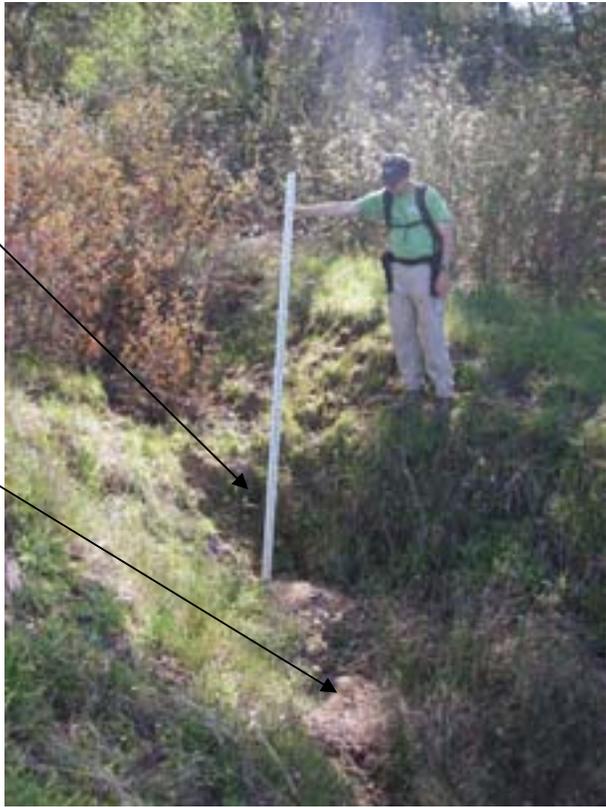
headcut

eroding gully

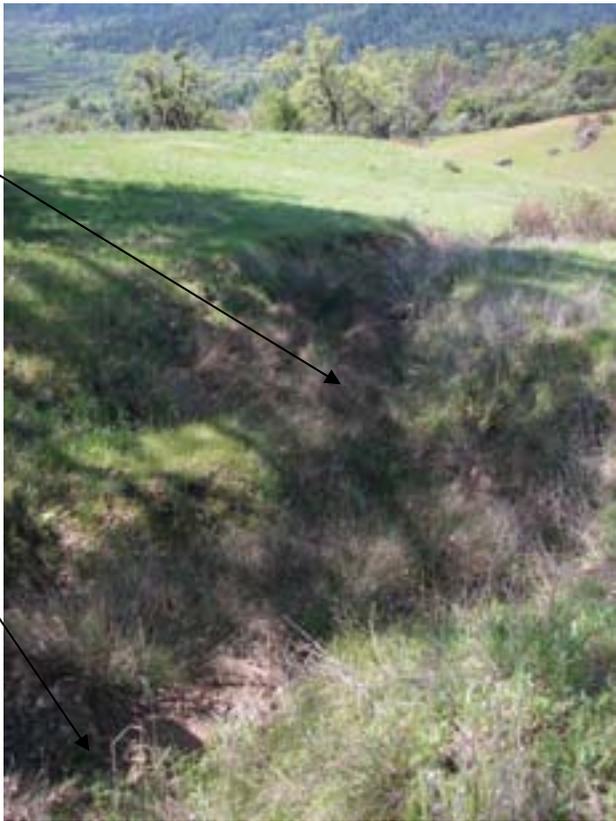
eroding gully

headcut

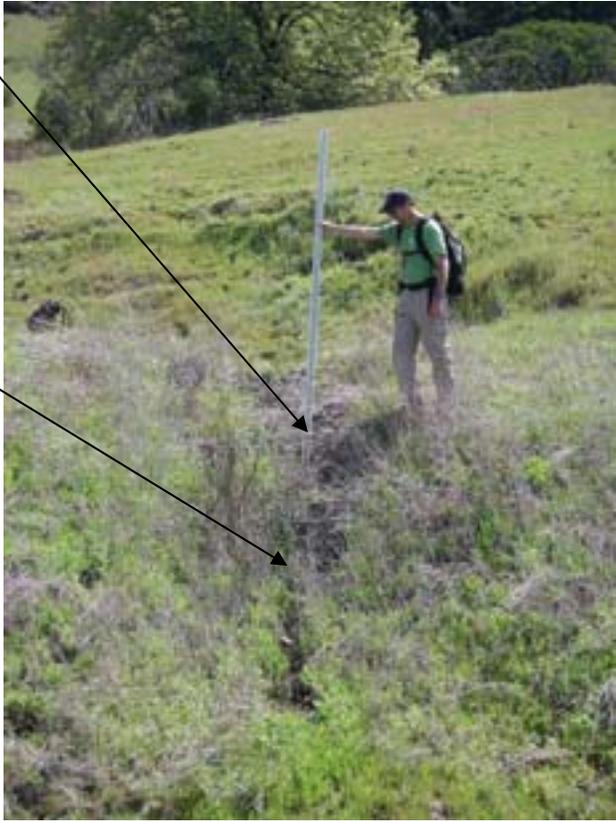
headcut

eroding gully

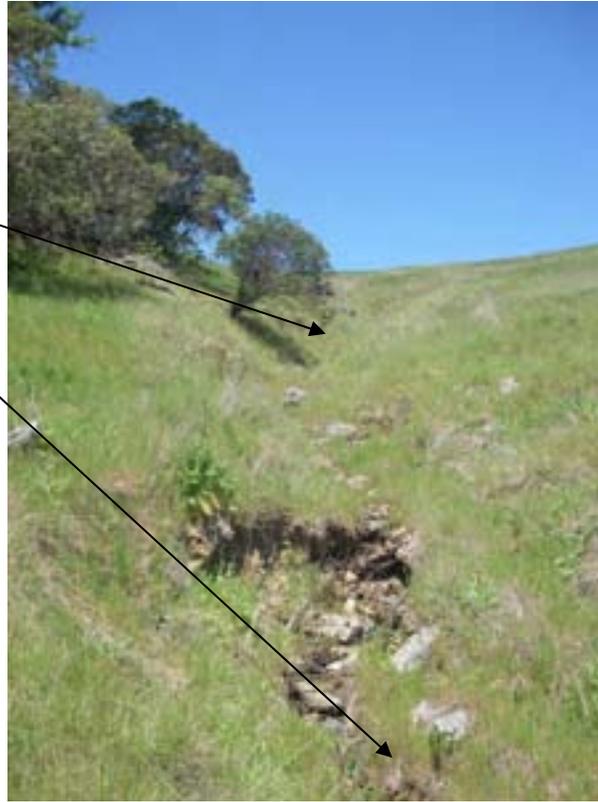
**eroding
gully**

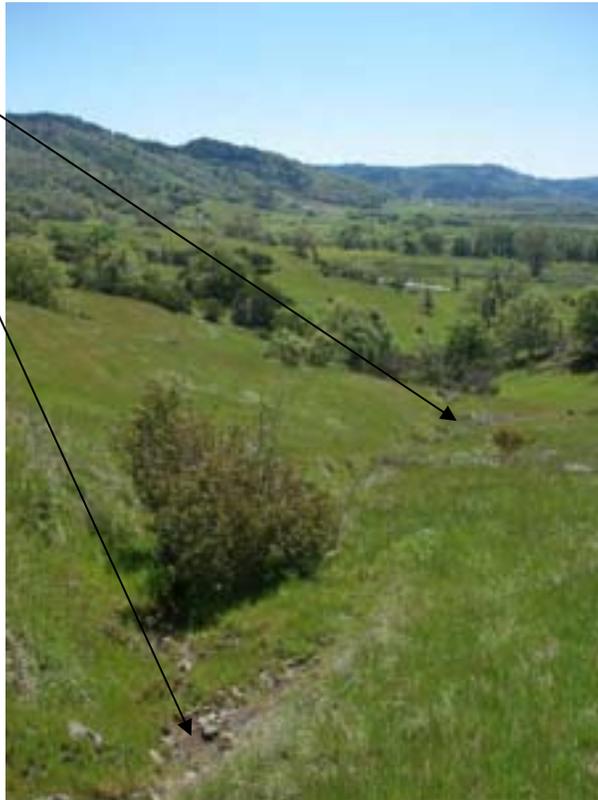
**eroding
gully**

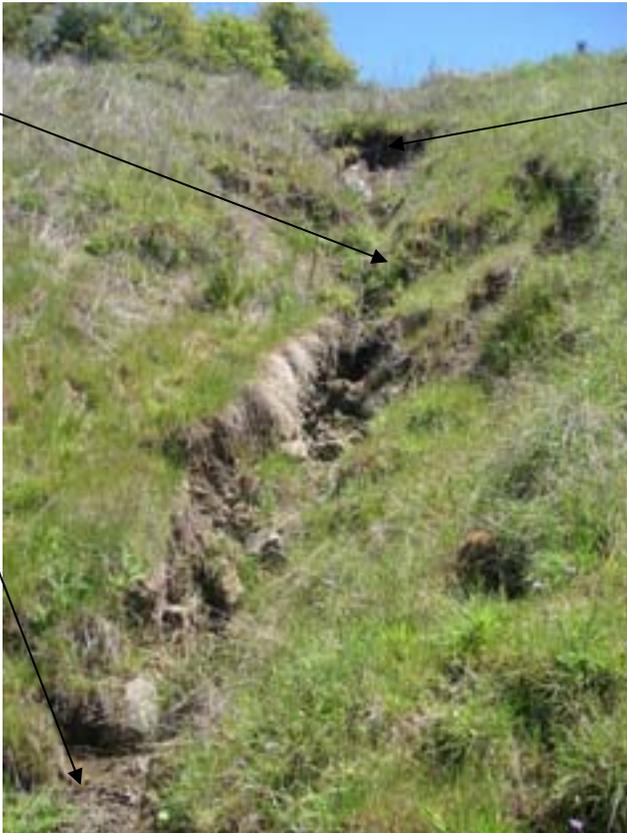
eroding gully

headcut

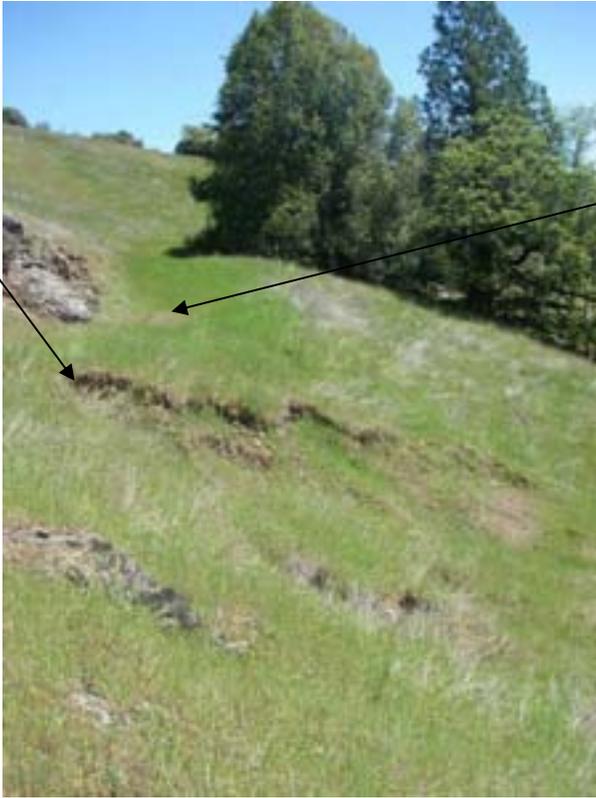
eroding gully

headcut

**slump/
headcut**

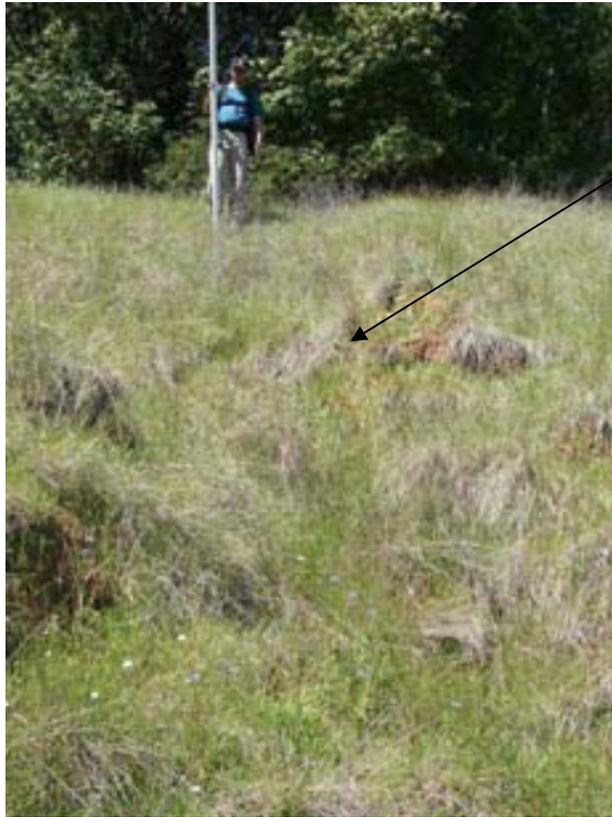
headcut

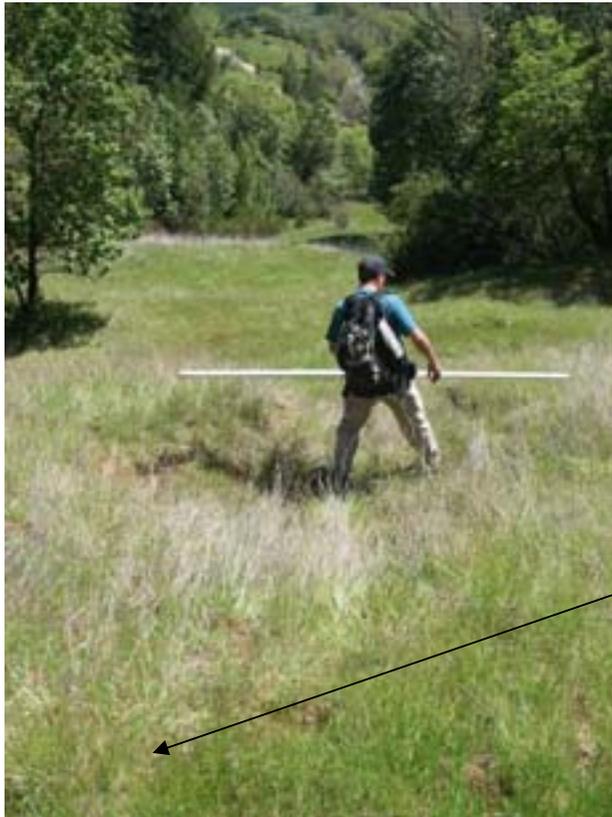
slump/
headcut

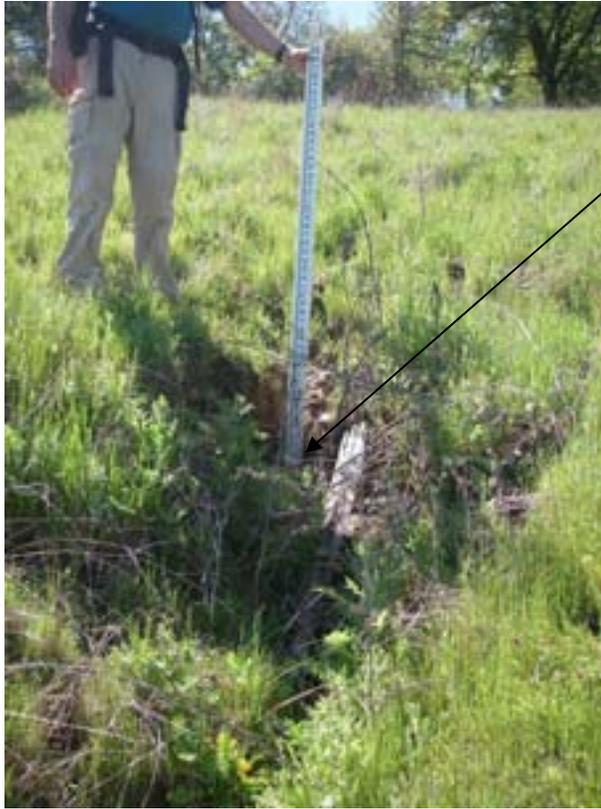
slump/
headcut

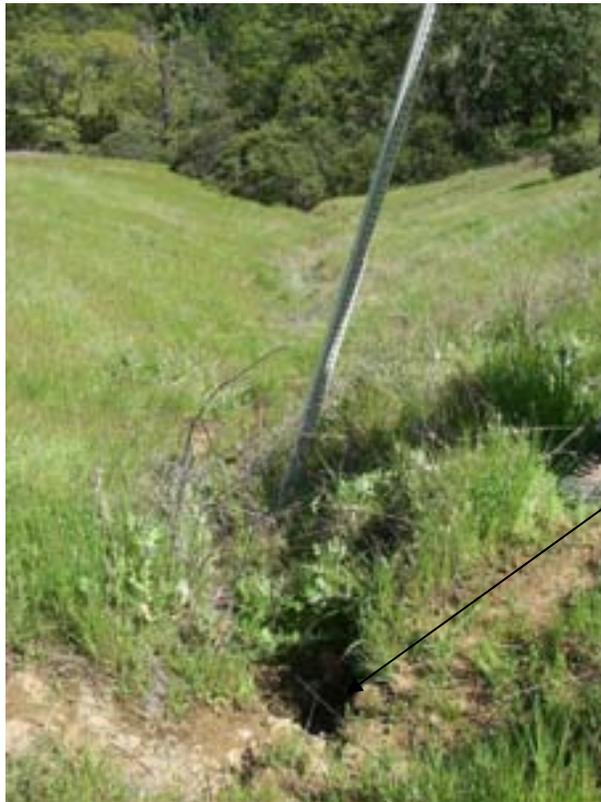
headcut
